Historic England's First World War Submarine Wreck Project

Approaches to Wreck Investigation - Appendix

Summary

Case study – using BULSI to describe UB-107

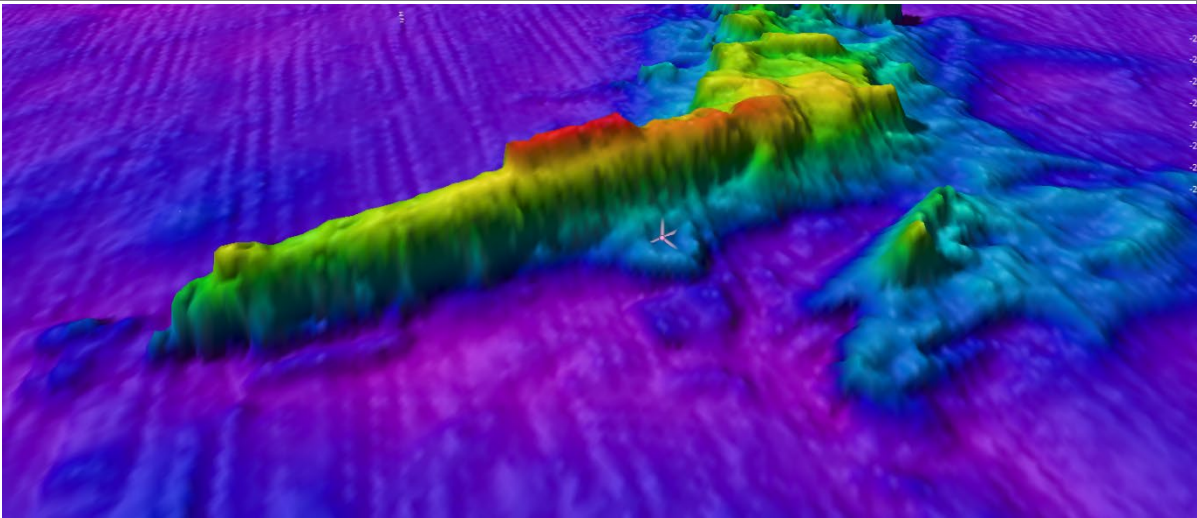
Multibeam image showing the submarine on the seabed, with the remains of the ship to the right and top. Unfortunately, the submarine appears to have been damaged in the 1980s when salvors used explosives to remove the non-ferrous torpedo tubes (see 'Survival' and 'Investigation'). Similar salvage work on the UC-70 off Whitby led to the disturbance of the remains of a crew member.

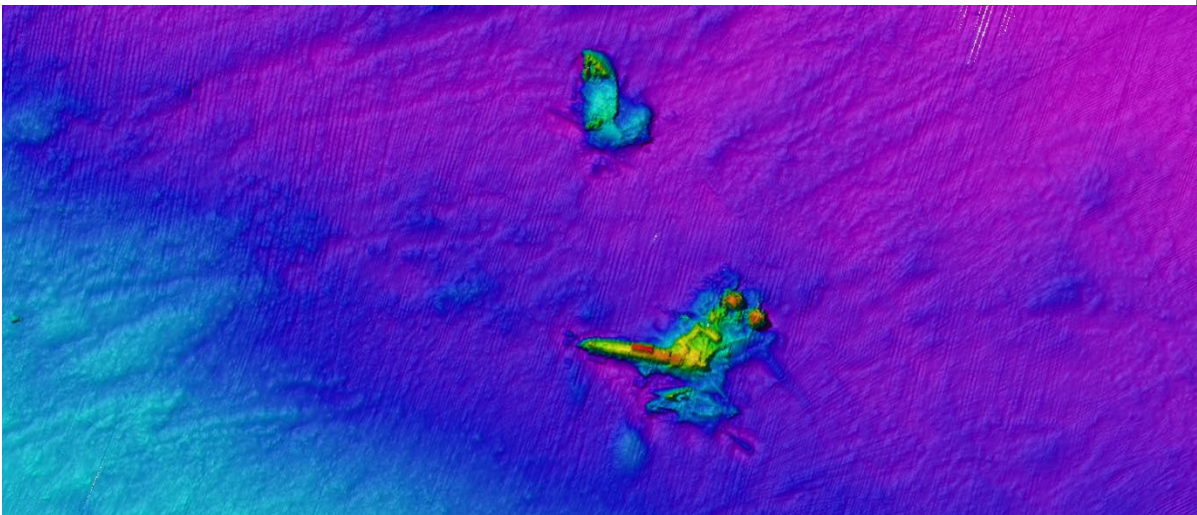
A much wider 'plan' view, north up. The ship split in two and part of it lies to the north. The investigation failed to reach a definite conclusion about whether presence of the ship, the SS Malvina, was co-incidental (see 'Loss'). This image demonstrates just how valuable marine geophysical data can be in providing accurate mapping of wreck sites and the surrounding seabed.

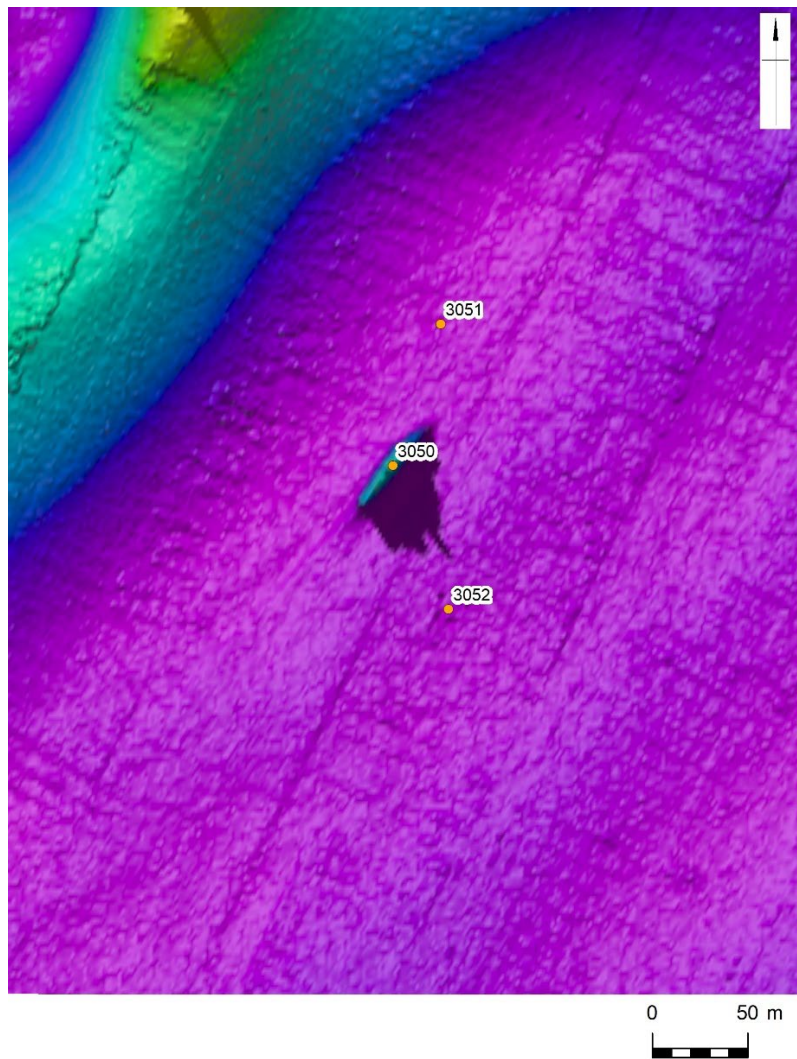
Multibeam image of the D1, processed from existing hydrographic data held by the UKHO. Analysis of the data indicated that there were two outlying anomalies that could be debris from the submarine (3051 and 3052).

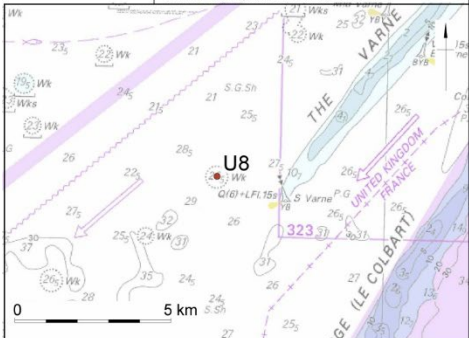
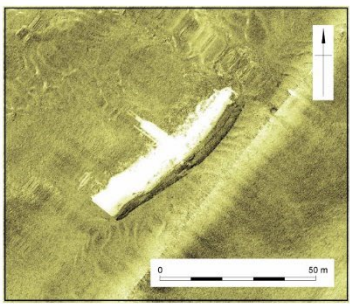
WA ID 7000 U8 UKHO 21102									
Location	377481 E, 5643919 N (UTM31N)								
Archaeological Importance	High								
Geophysical survey dimensions and notes	<p>Dimensions: 57.3m x 6.2m x 6.7m.</p> <p>Long thin outline of a wreck, interpreted as a submarine due to conning tower and periscopes being visible in the sidescan sonar shadow. Height of rest of vessel at 4m. Also observed in the multibeam bathymetry as an upright submarine orientated northeast-southwest, with some structure visible.</p> <p>The wreck appears relatively intact with some external structure visible. There is an associated very large magnetic anomaly of 2063nT, although this was not obtained directly over the wreck and therefore is a minimum value. The bathymetry data indicates some sediment build-up on either side with more on along the west edge of the wreck.</p>								
Build	<table border="1"> <tr> <td>Type</td><td>German Submarine</td></tr> <tr> <td>Construction</td><td>U-Boat Steel</td></tr> <tr> <td>Dimensions</td><td>57m x 10m x 6m</td></tr> <tr> <td>Shipyard</td><td>Germaniawerft, Kiel</td></tr> </table>	Type	German Submarine	Construction	U-Boat Steel	Dimensions	57m x 10m x 6m	Shipyard	Germaniawerft, Kiel

<p>A pseudo-sidescan sonar mosaic image of the U8, 57.3m x 6.2m x 6.7m</p>

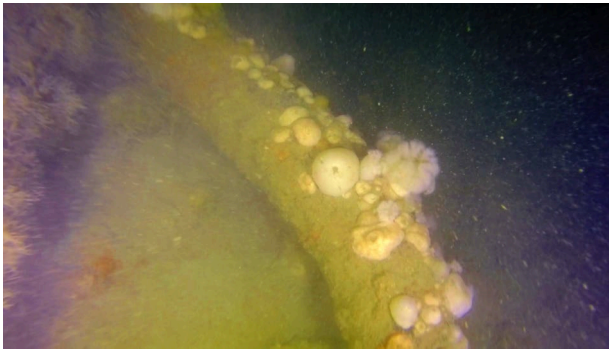
Displaced piping, possible exhaust
29b

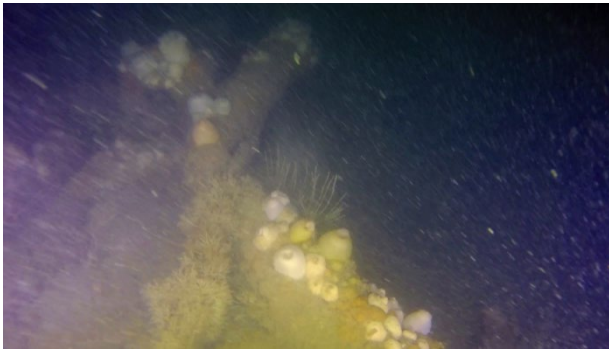
Displaced piping, possible exhaust
30

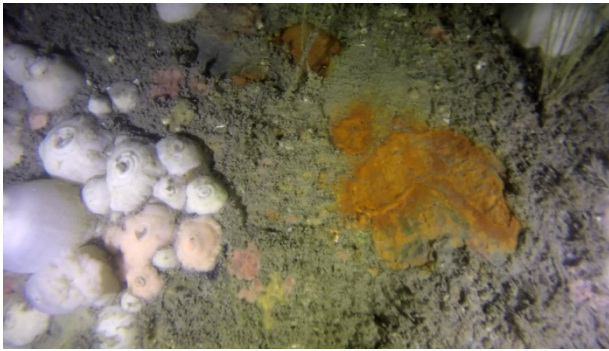
Area of active corrosion
33

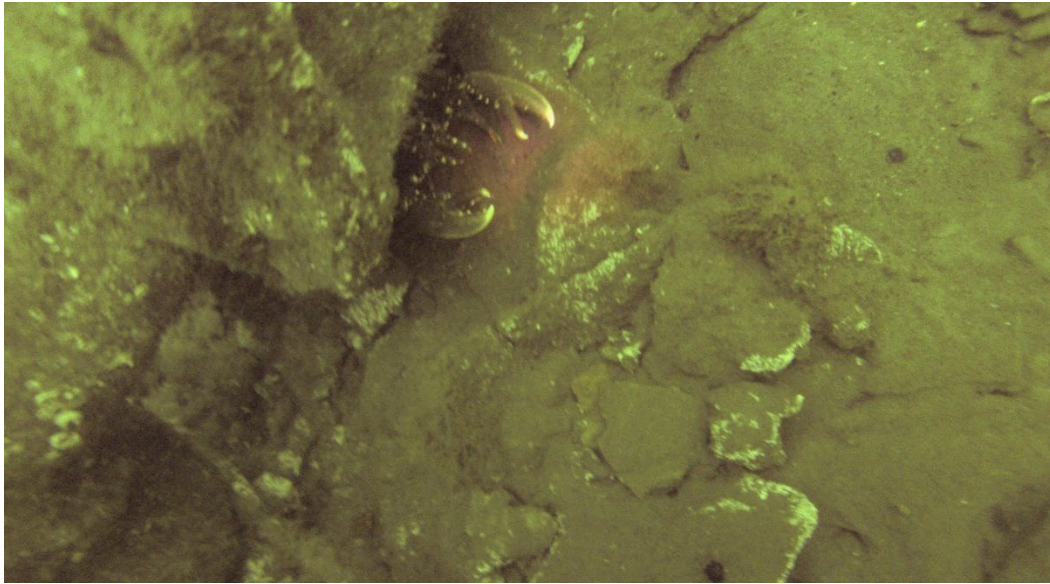
Lobster under the remains of the stern of UC-70

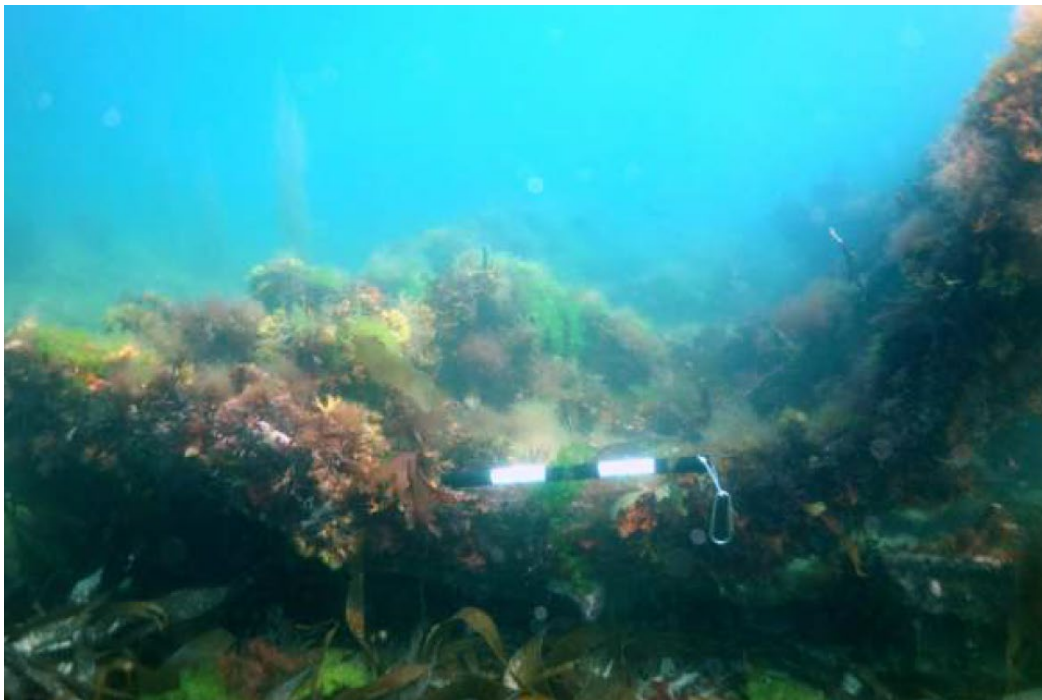
Hard and soft marine growth covering the broken up remains of the bow of the UC-92 in very shallow water just off Castle Beach, Falmouth

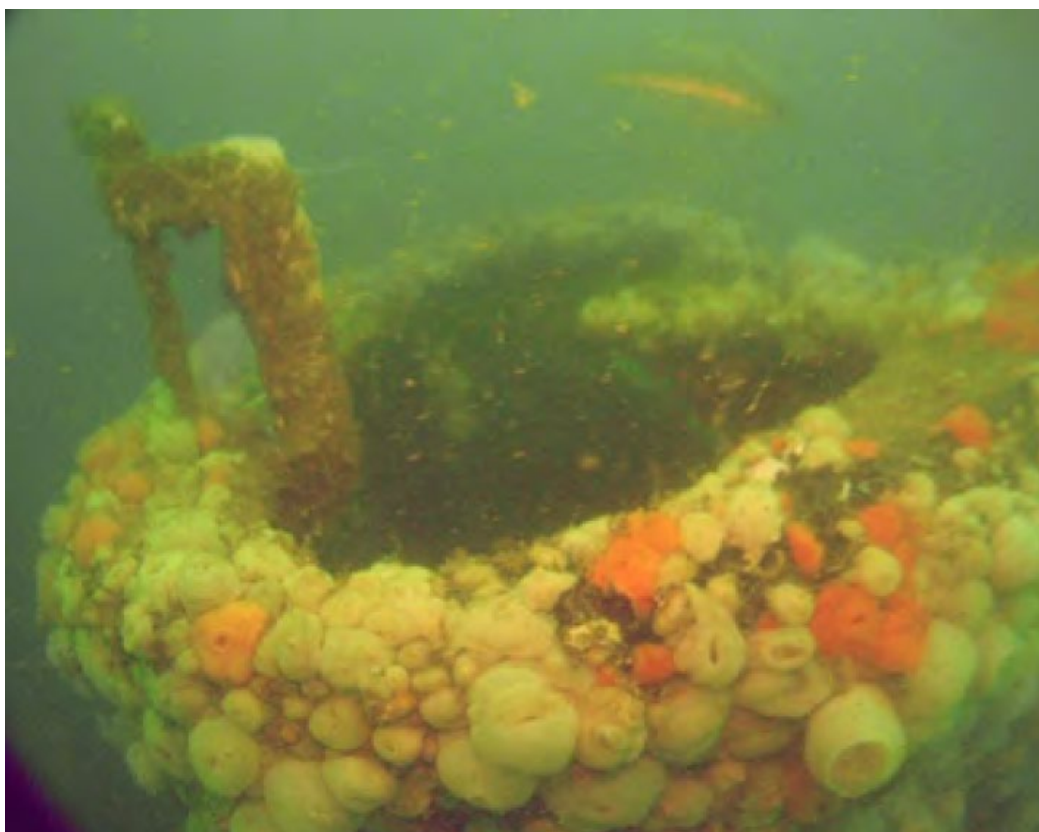
The rich hard and soft marine growth living on the conning tower of the deeper wreck of the very early submarine Resurgam off the North Wales coast. Images of marine growth typical of significantly deeper submarine wrecks where there is little natural light can be seen in Table 4 and Case Study about the D1 above).

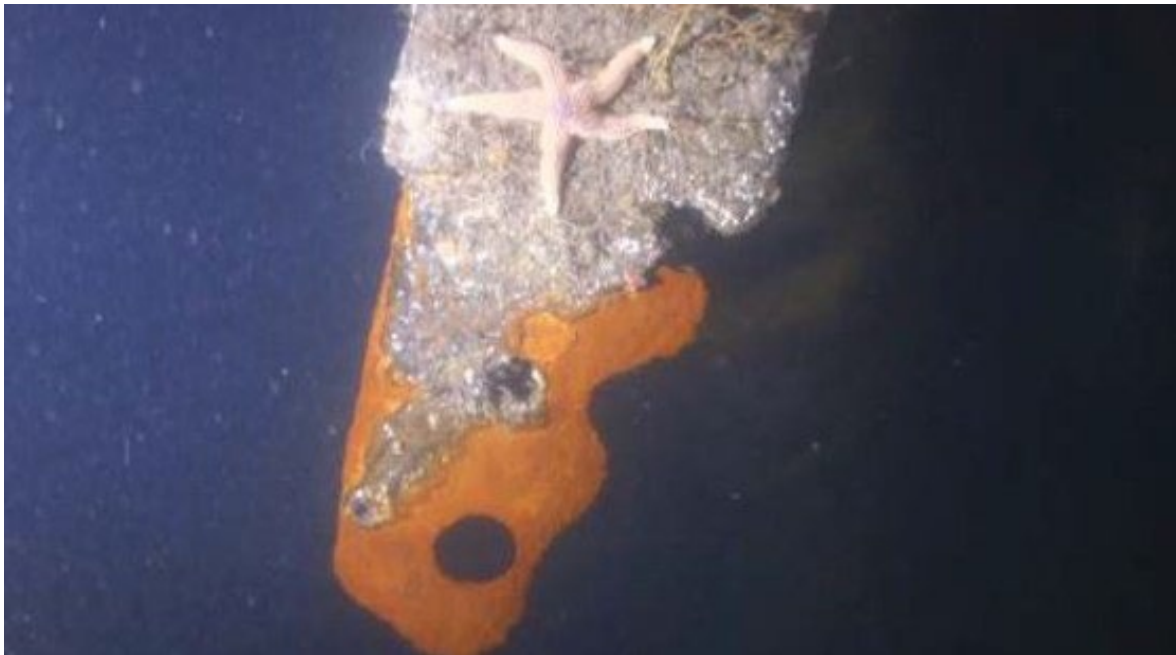
The greater part of the pressure hull of the submarine survives, although it is badly damaged in places and open at the stern. This is likely to be due to the salvage of the stern torpedo tube, which is not present. There is a large, partial circumference hole immediately forward of the gun mount. There is no sign of the crew accommodation below, suggesting heavy internal damage to the submarine at this location, although the cause is unknown. The bow is also reported to be damaged and open. Small holes in the pressure hull observed elsewhere are likely to be the consequence of plate thinning caused by corrosion. Evidence of active corrosion was seen on the edges of the hole forward of the gun mount.

UB-107 off Flamborough Head. Active corrosion of the damaged hull above the Forward Battery Compartment. The corrosion layer formed by fouling and oxide has spalled off, possibly as a result of a recent impact. This has exposed the surface of fresh steel, which has begun oxidising and is an orange colour in the diver's torchlight.

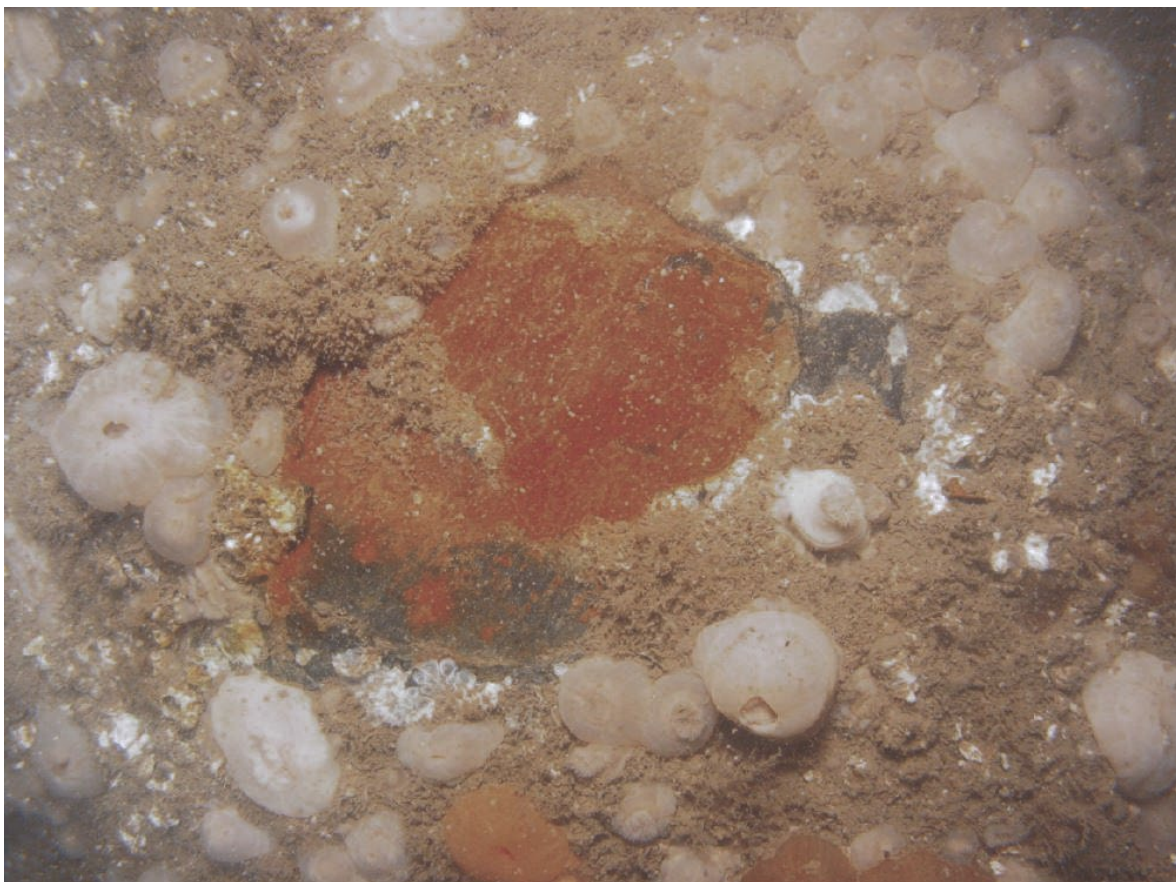
Fresh corrosion on the pressure hull of the early submarine Resurgam observed in 2006. Like the UB-107, it is not clear whether the concretion has spalled off naturally or has been knocked off by an impact.

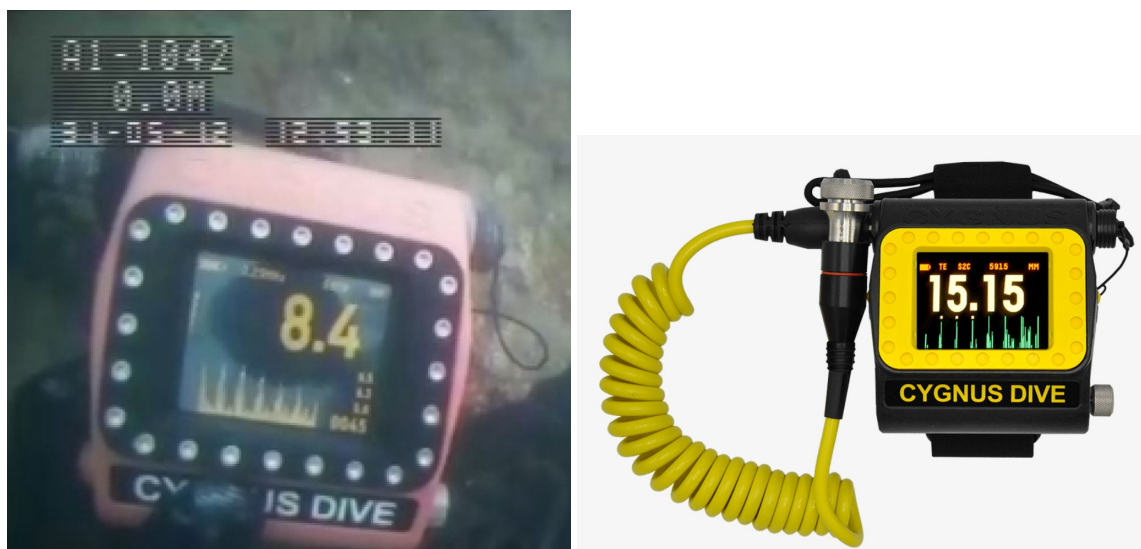
Thickness measurement of the pressure hull of the A1. The probe is being held against the bare metal of the hull plating behind the wrist monitor. The image on the right shows a similar gauge and probe on the surface.

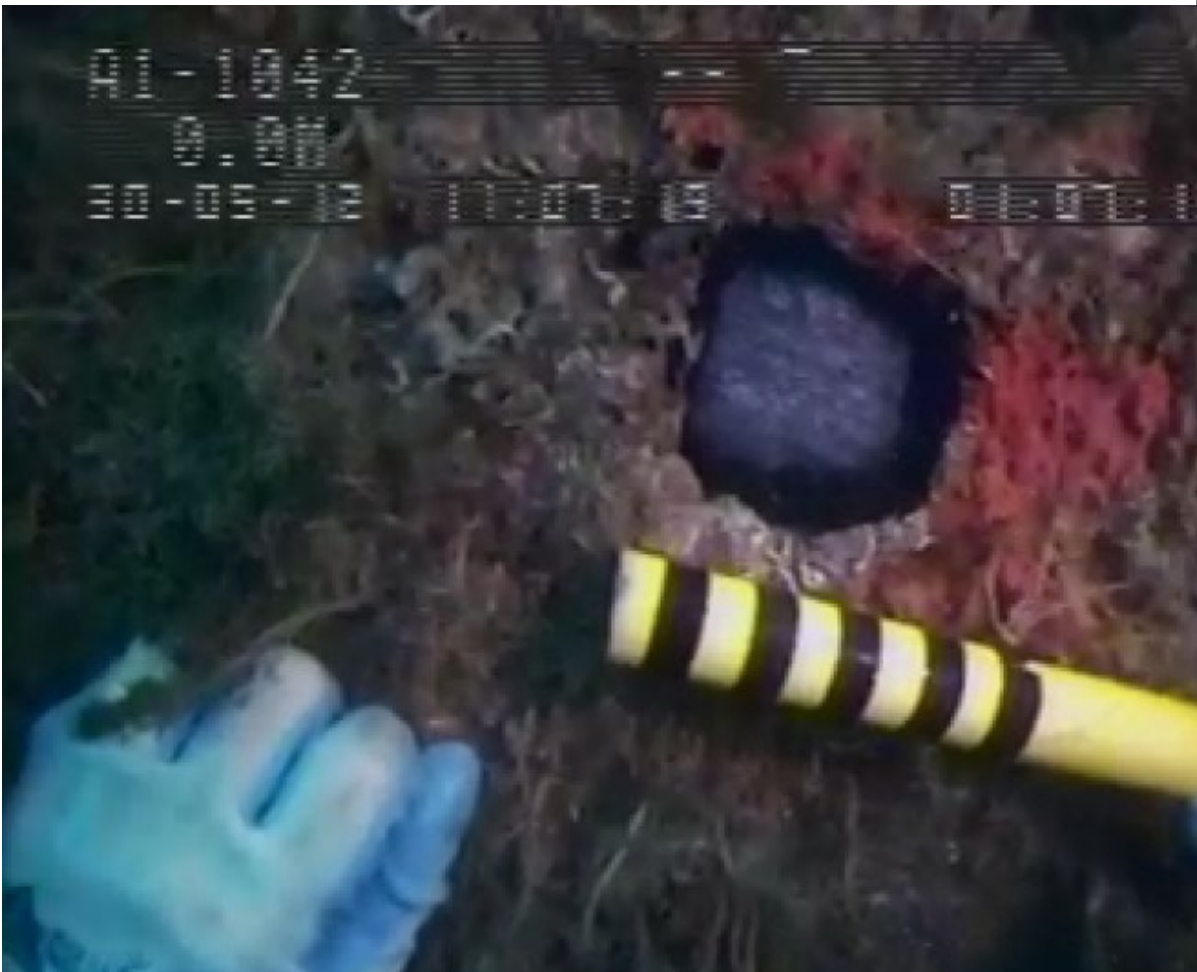
Hole in the concretion adhering to the pressure hull made to allow access for the UT gauge probe. It is important to record the process to verify that it has been done correctly. Note the roughened surface of the pressure hull plating below – this is the result of wasting caused by corrosion. Scrubbing the bottom of the hole allows this to be seen.

Immediately after taking the measurement, the hole was also filled with a waterproof underwater epoxy resin. This comes in two parts as a putty and can be mixed underwater by kneading the parts together (it is best to use pH neutral resin).

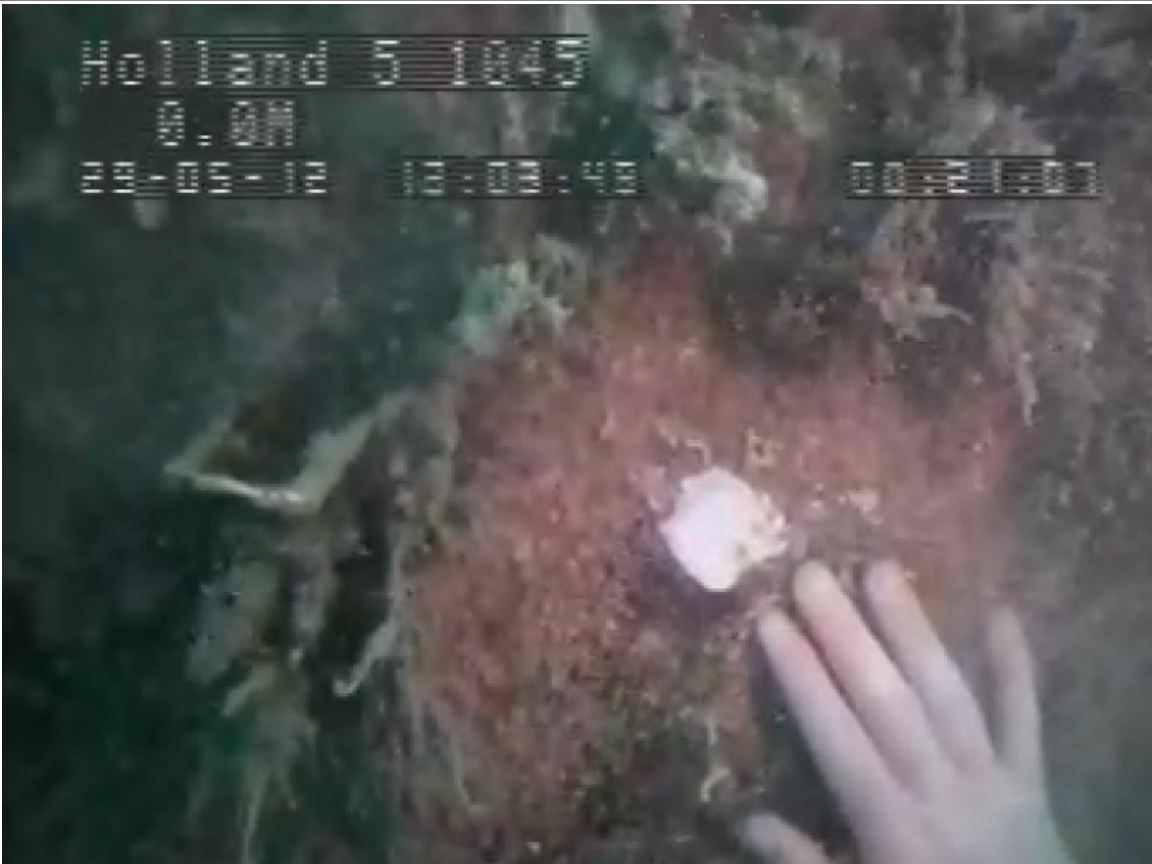
Another test hole filled with epoxy resin. The reddened area is where marine growth has been scrubbed away. Videoing this allows you to prove that the hole made for testing has been repaired properly.

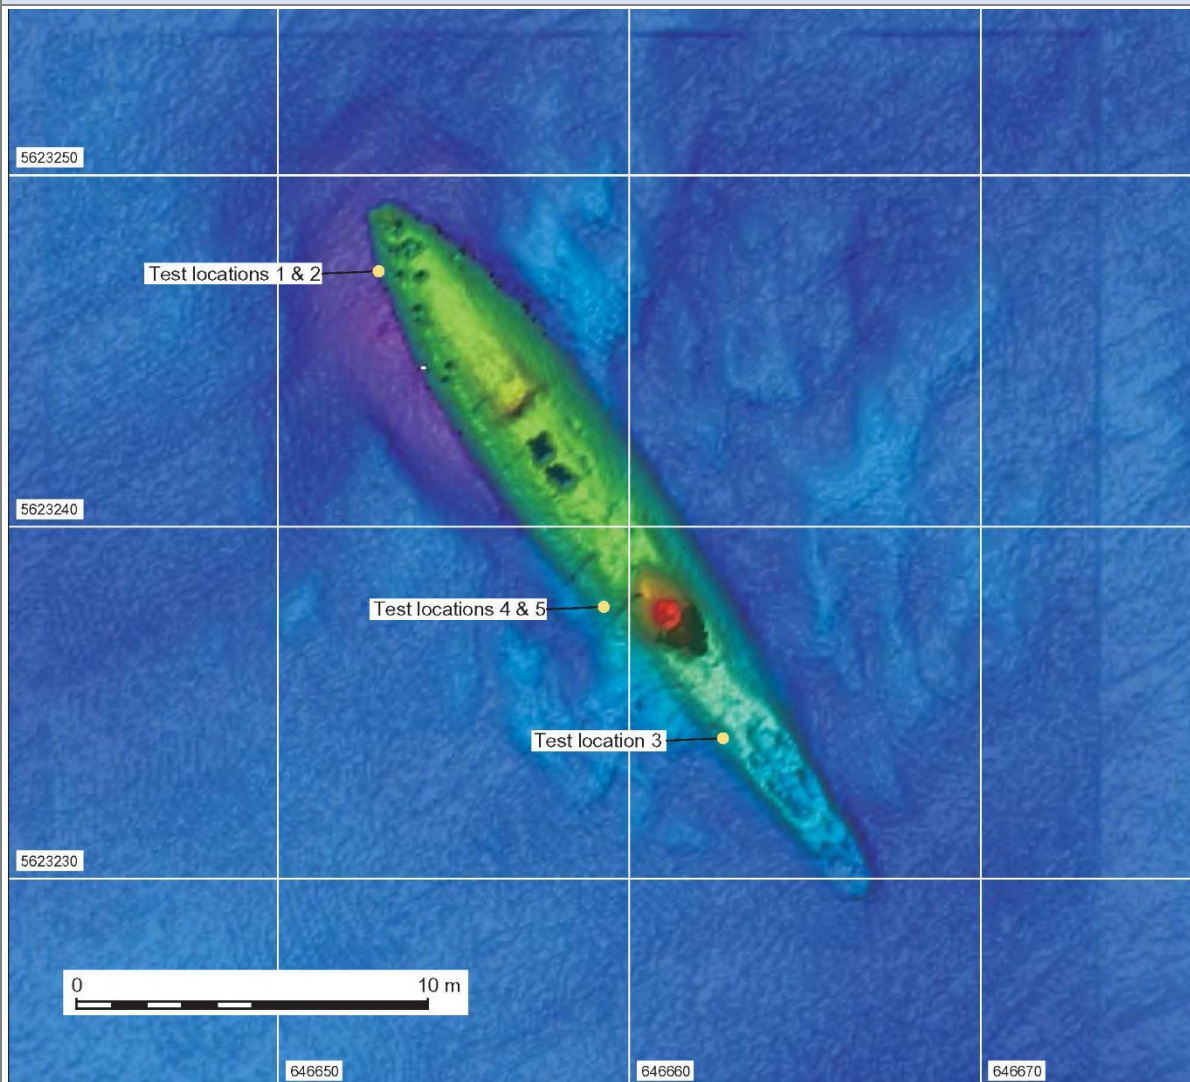
Test locations. Two test holes were made at each location, 10-20 cm apart. The locations chosen for testing were 1 m aft of the bow, 3.85 m aft of the conning tower and in line with the conning tower. Ideally more locations would have been chosen, but the number chosen had to balance the benefits of the information acquired against the intrusive nature of the survey.

The results of the survey were as follows. The gauge was first tried without removing the concretion, which varied between 9-20 mm thick. It is important to know how thick the plates used to build the submarine were. The records of the Director of Naval Construction state that the shell plating of the pressure hull was $\frac{1}{2}$ in (12.7 mm) thick, although the records of the builders, Vickers, record that the outer and inner plates were $\frac{7}{16}$ in (11.1 mm) and $\frac{1}{2}$ in respectively (the plates were arranged in alternate raised and sunken strakes or rows). The measurements taken suggest that there has been significant wasting of the plates due to corrosion, with the loss being 44-66% or 50-76%, depending upon the original thickness.
