# *Sainte Apolline's Chapel St. Saviour's, Guernsey*

## *Conservation Plan*

*Ref: 53511.03*

*December 2003*

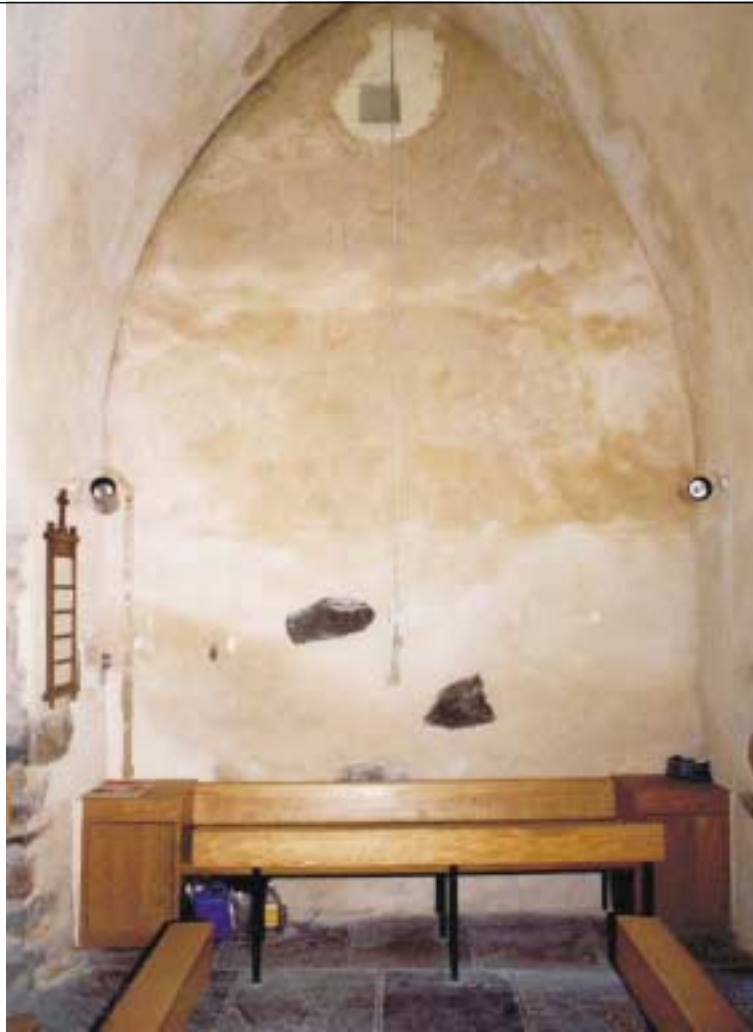
The west wall is badly stained by water ingress

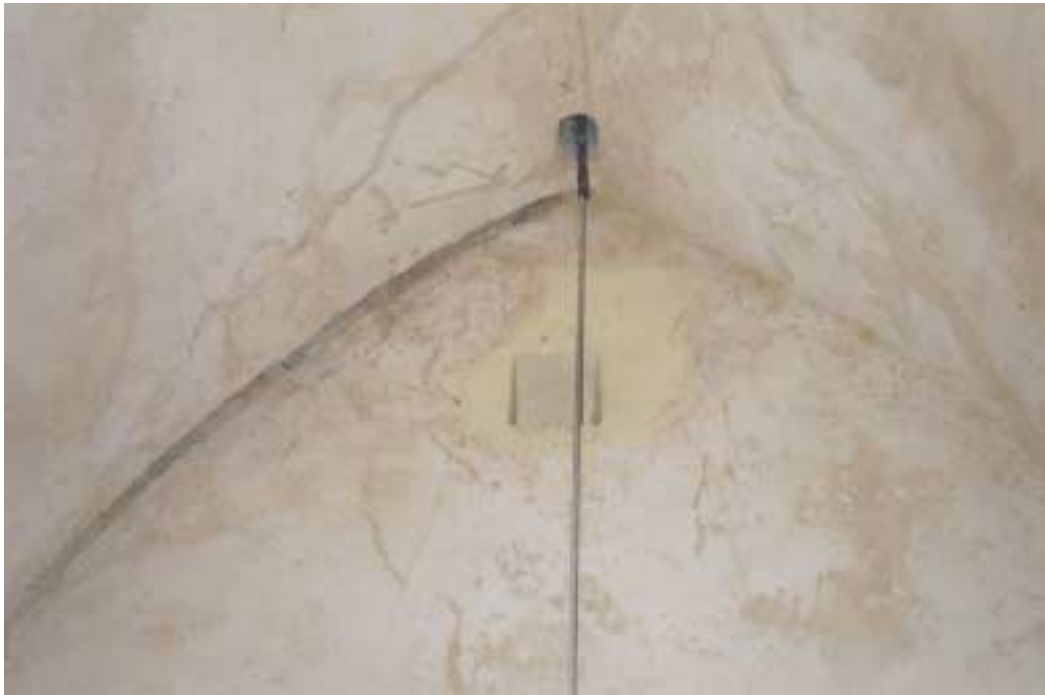
Water may be entering the chapel at the west end through the bell rope hole

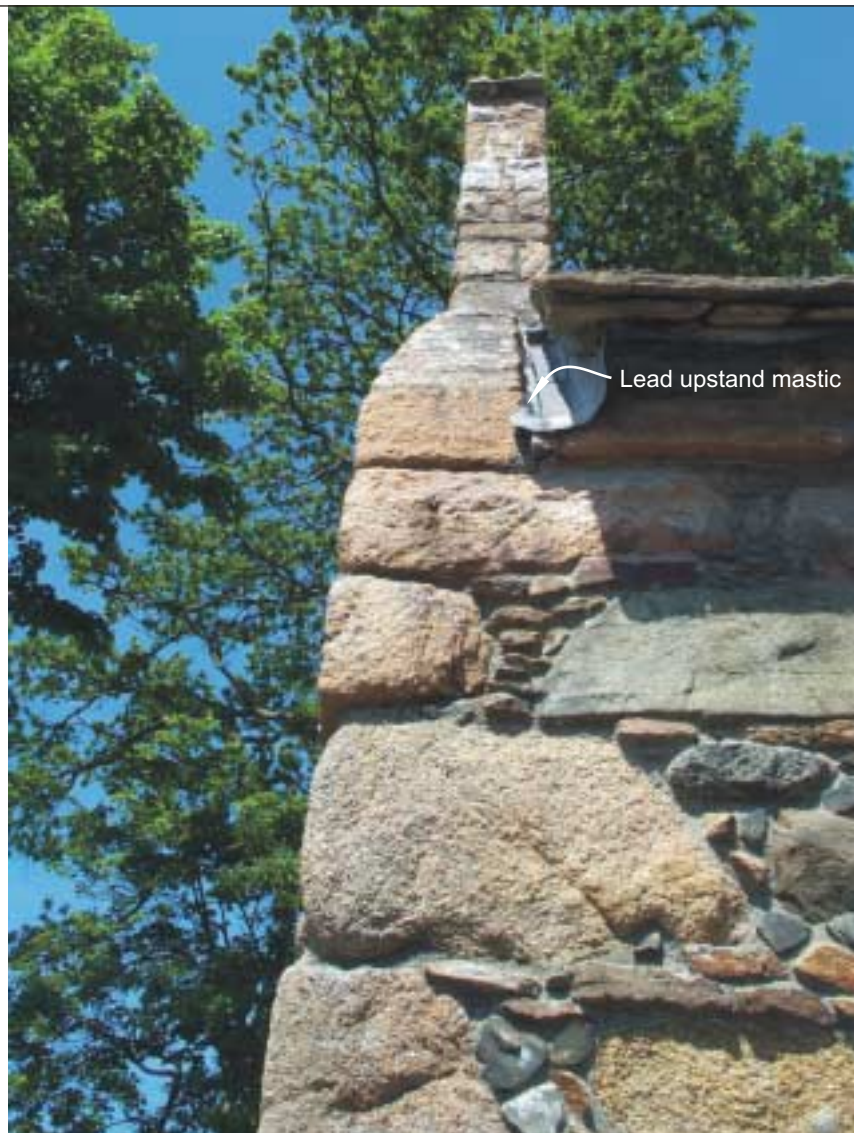
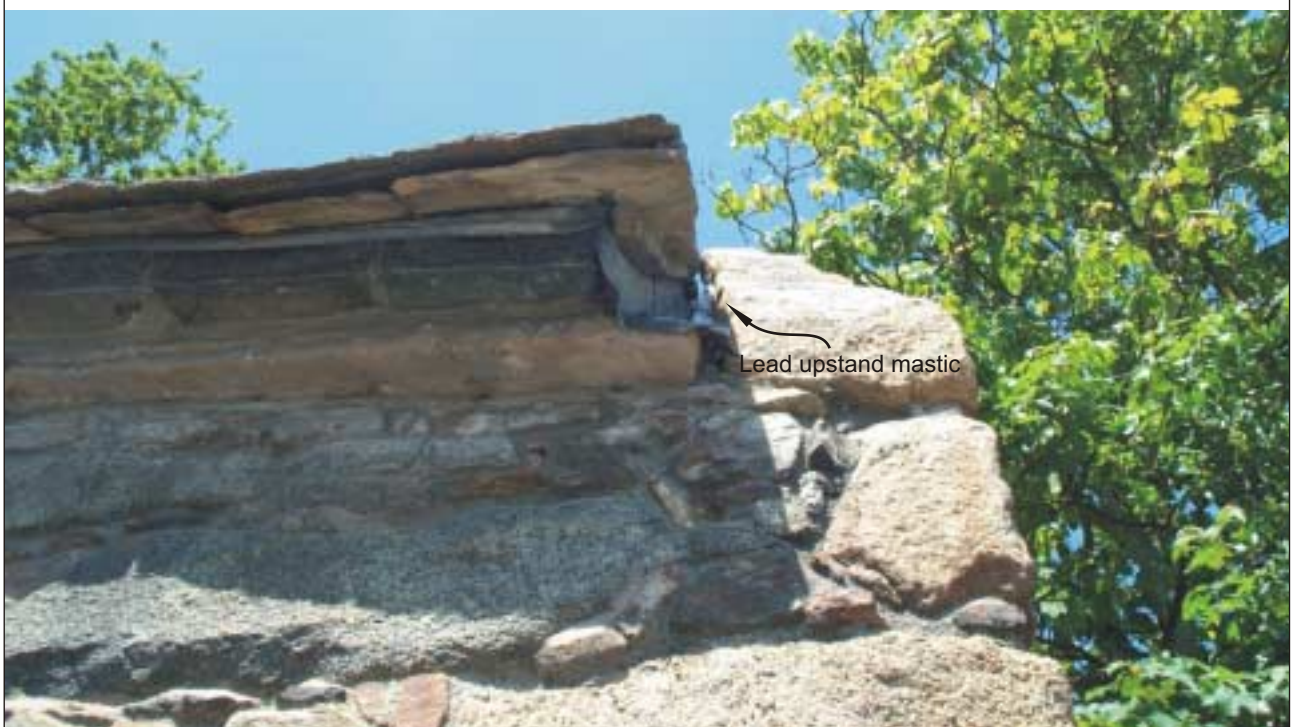
One of the lead-lined gutters a potential source of water ingress.

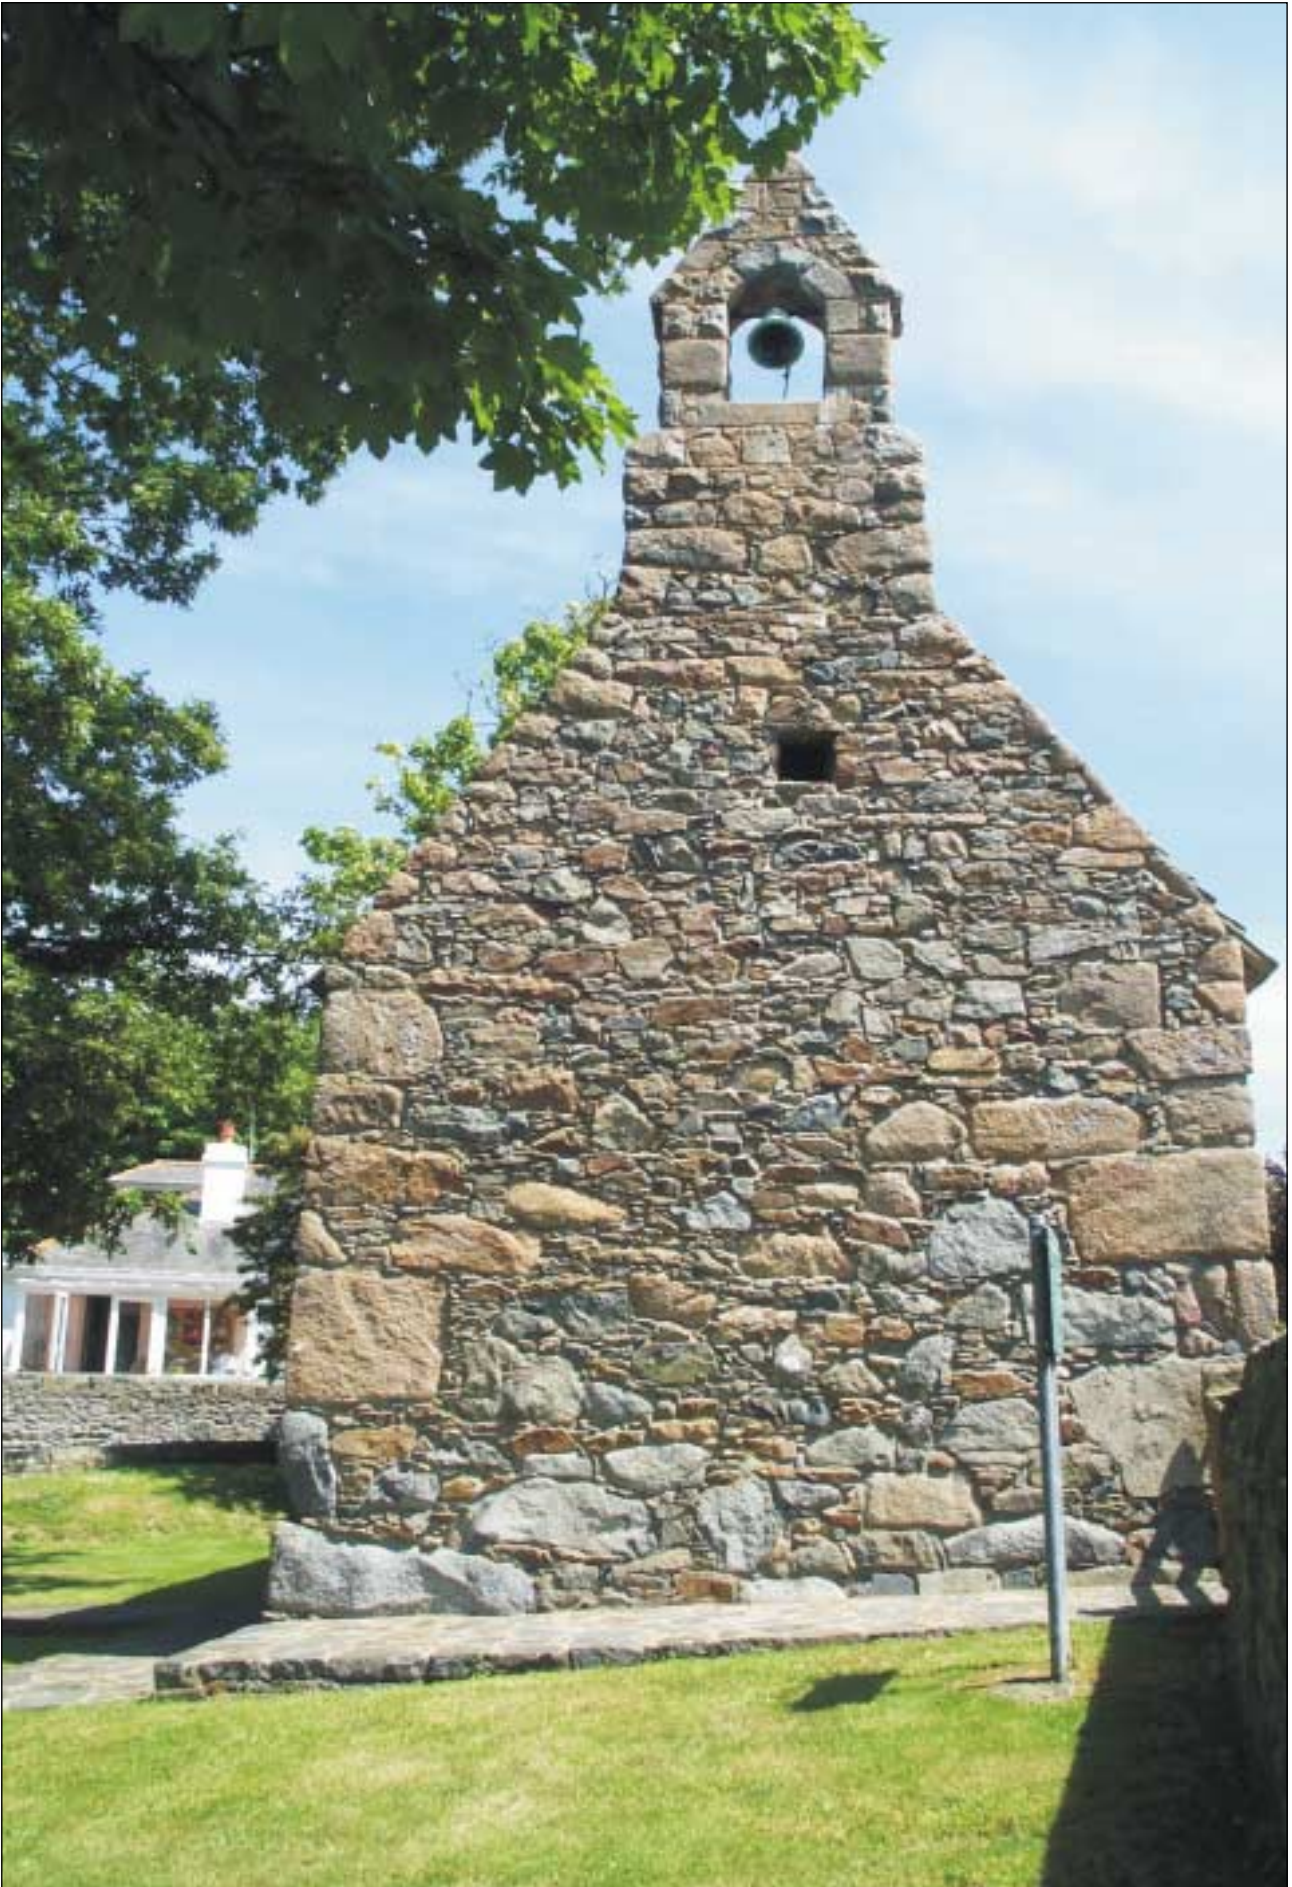
The west end of the Chapel, here the change in ground level from north to south is obvious.

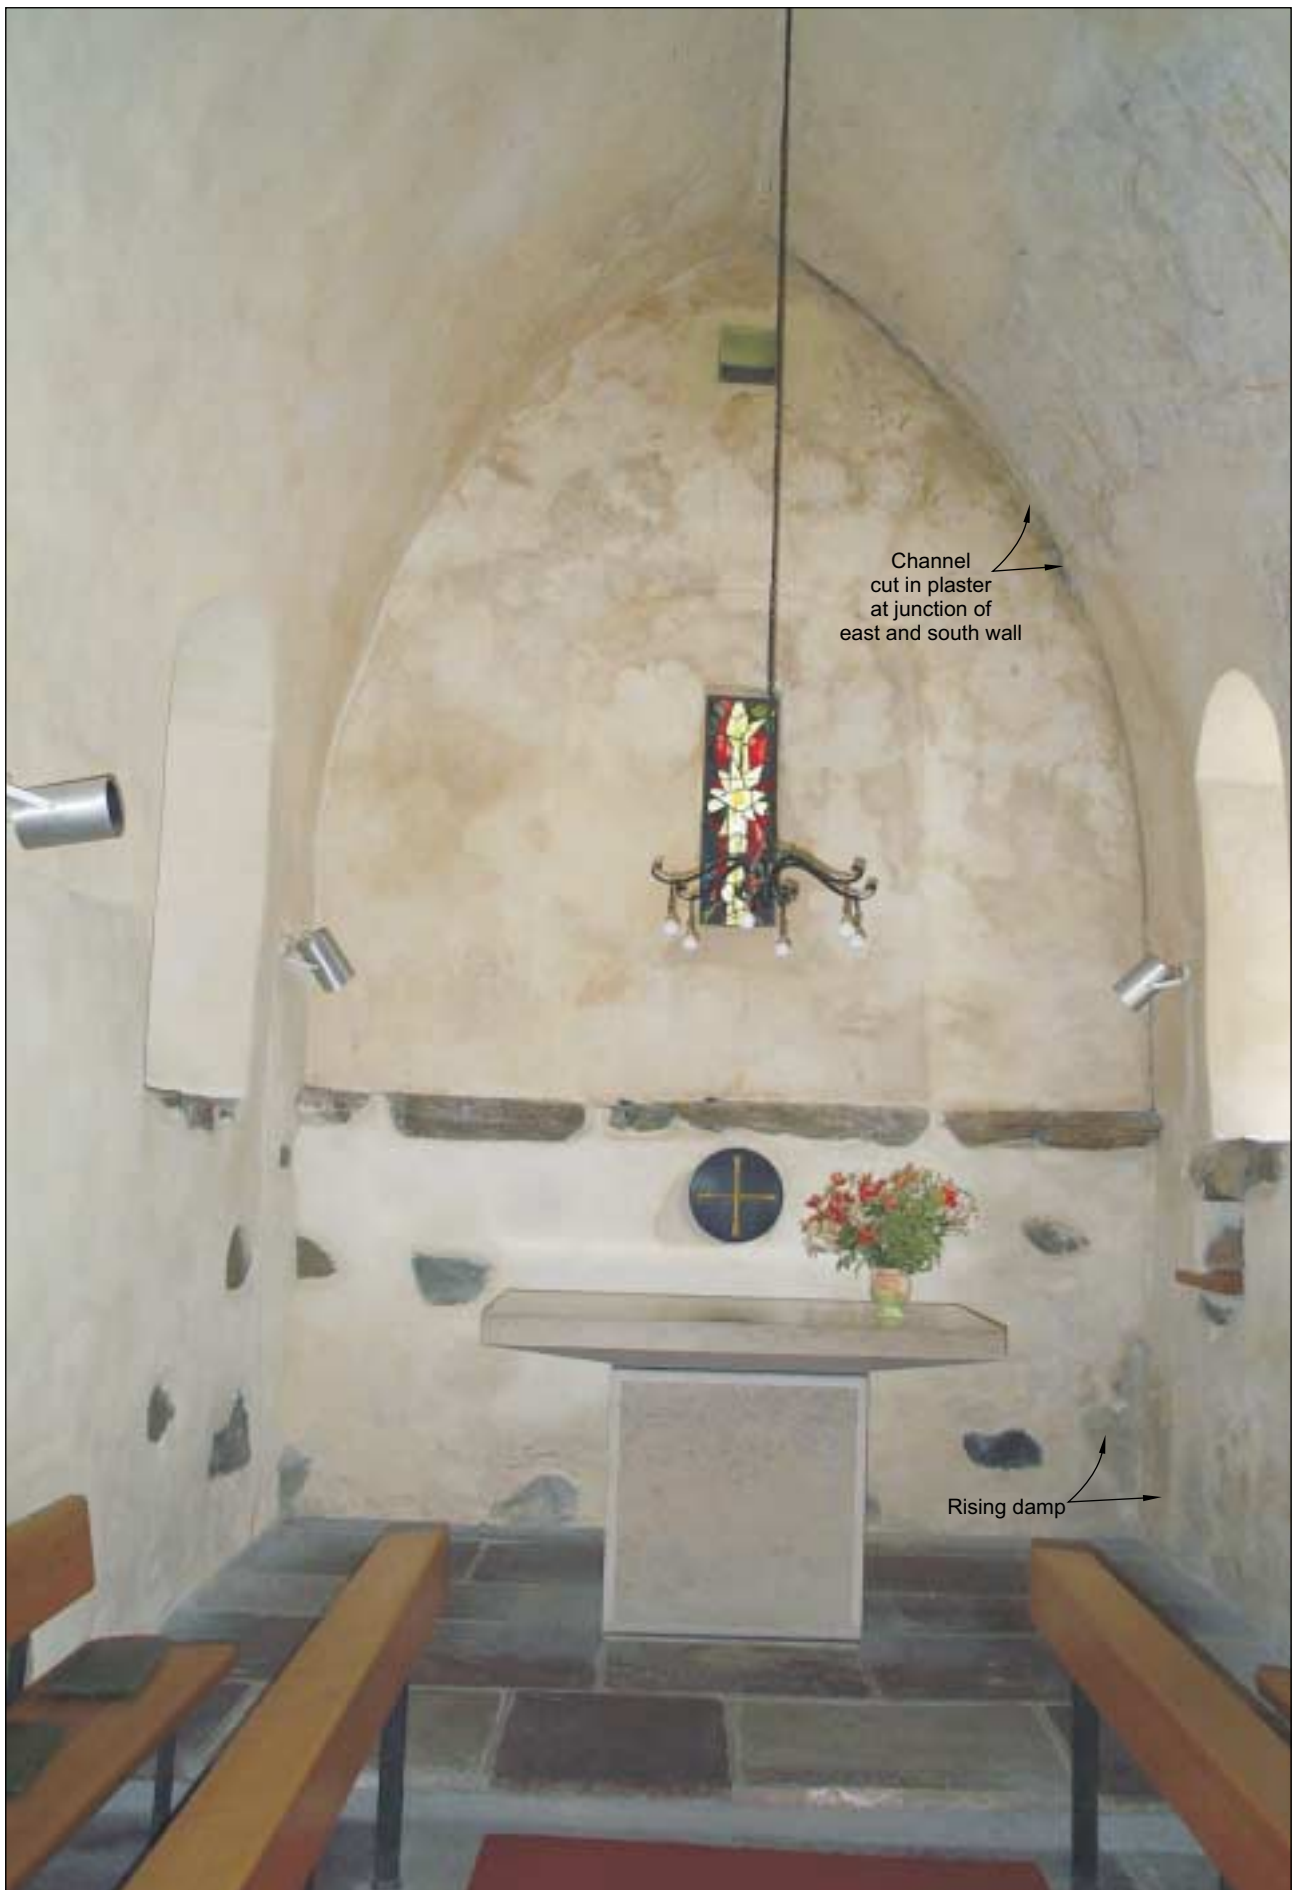
Patches of damp are visible on all interior walls, here seen on the east wall.
