Iona II, Lundy

Designated Site Assessment:

Full Report

Ref: 53111.03z

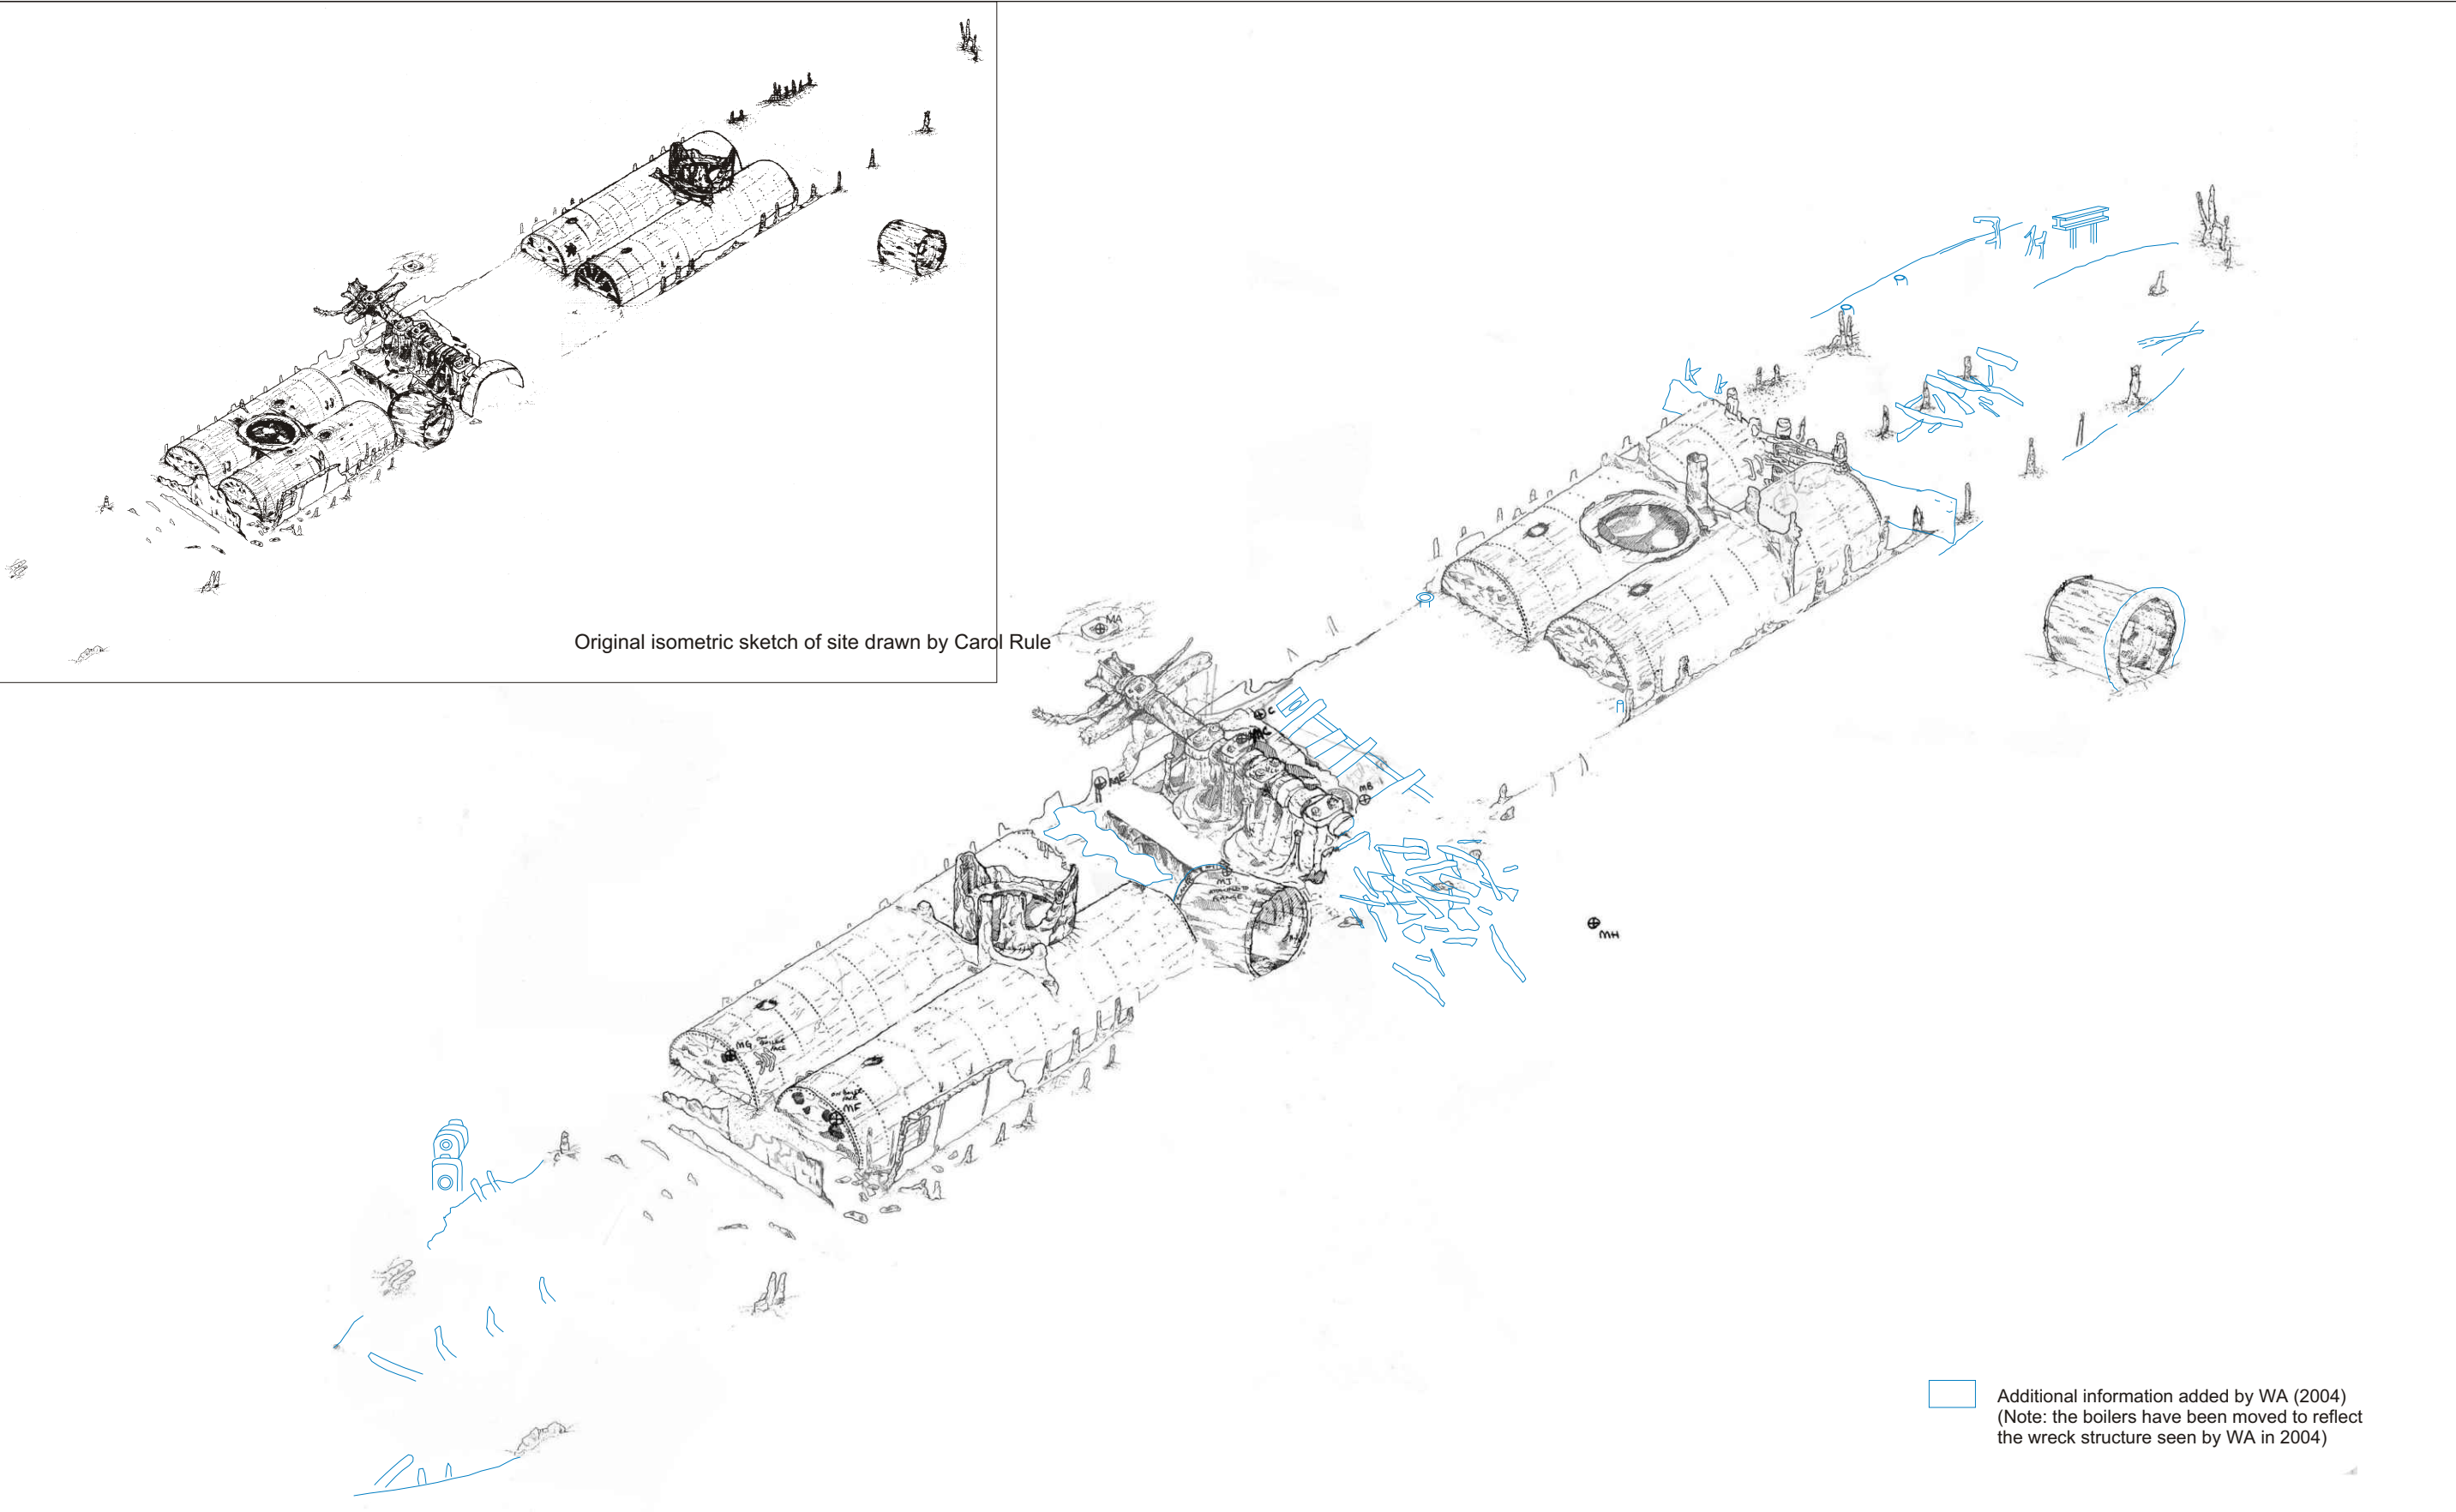
Figure 5

- 5.5.10. The boilers themselves are constructed by means of shaped iron plates riveted together. Both sets of boilers have an area that would have once held the smokestacks. These smokestacks are no longer in place (**Figure 5**) and so it is now possible to see into the boilers through the apertures, although silt has largely obscured the features within them. The bolt-holes for attaching the funnel bases can still be seen, although the funnels are now largely missing.

- 5.5.15. Griffiths (1997 p.21-22) states that the *Iona II* had an oscillating engine, i.e. an engine whose cylinder oscillates on trunnions instead of being permanently fixed in a perpendicular, or other direction. allowed for the construction of a more compact engine and the system was found to be reliable. By the 1870s the technology had been superseded and very few examples of oscillating engines survive. A contemporary drawing of the engine assembly (Griffiths 1997 p.22) shows that the piston assembly was situated below the crankshaft. Sections of this structure are visible forward of the crankshaft (**Figure 5**), more remains should lie buried in this area.

Updated isometric sketch plan of site produced by WA

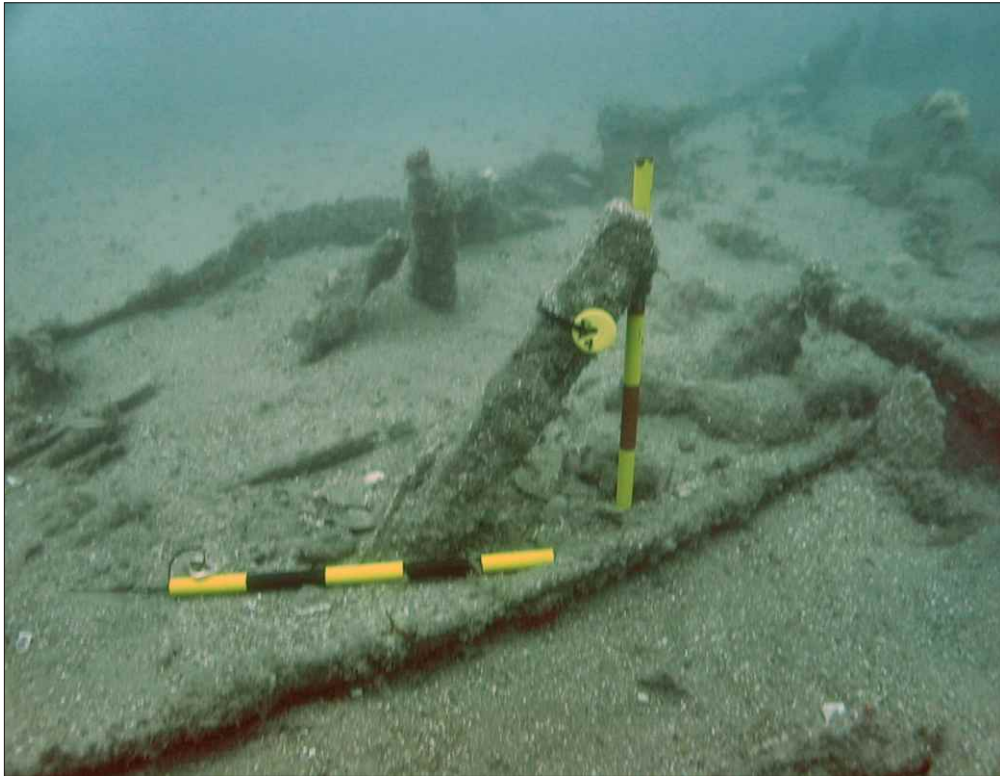
Plate 1: Frame (MP4)

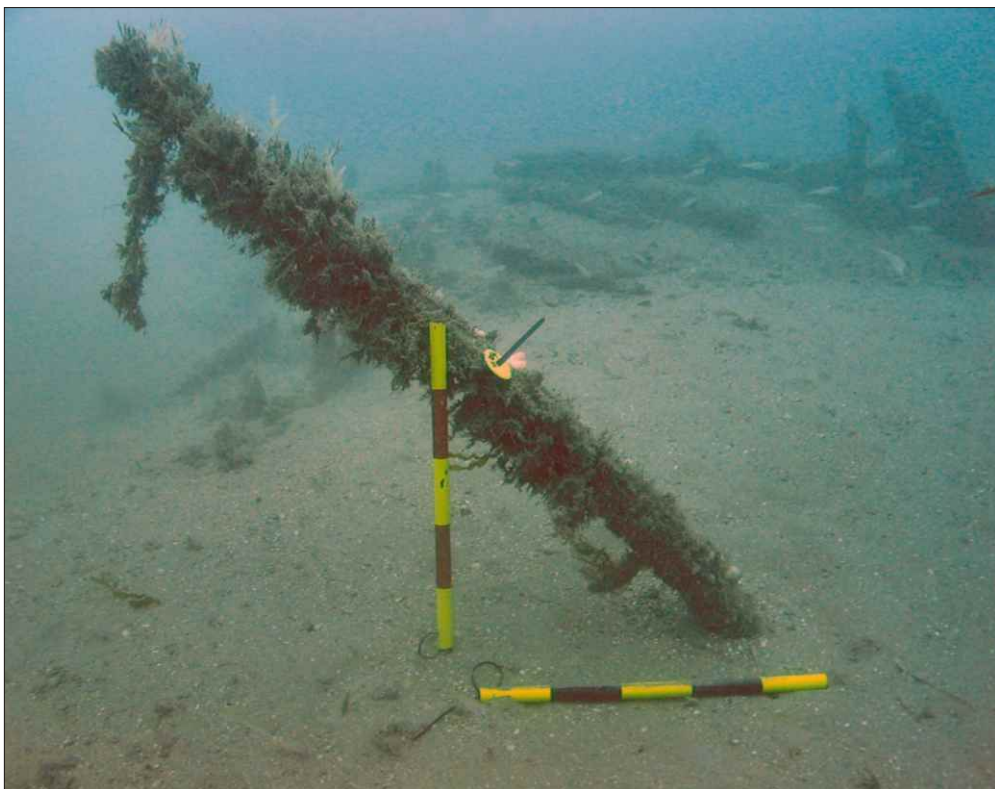
Plate 2: Frame (MP5)

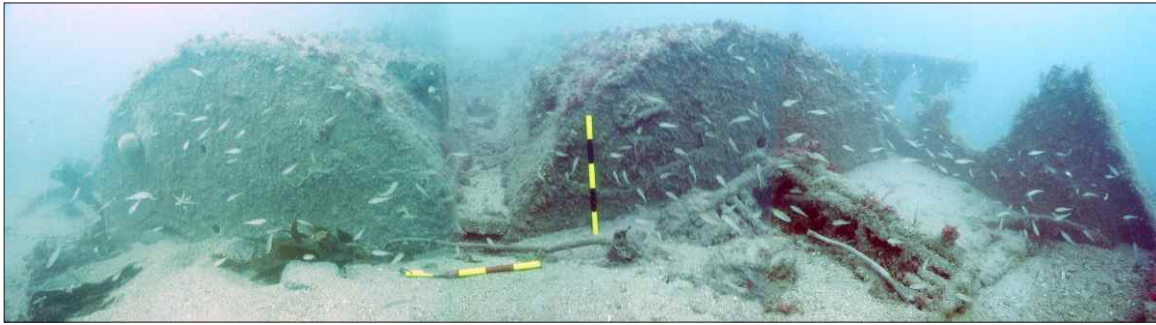
- 5.5.9. The boilers have a layer of concretion on them, but some of the fixtures that were part of their original construction are still visible. The lower third of the boilers are buried under silt (**Plate 3**) and the interiors of the boilers are filled with silt to various degrees. The starboard stern boiler shows signs of deterioration, as noted in the 1996 report to DCMS. The plating of this boiler has corroded leaving small holes in the boiler in areas. It is possible to look into the interior of the boiler through these apertures and the fireboxes are just about discernible through the silt.

- 5.5.12. The remains of a bulkhead forward of the forward boilers, which was noted in the 1990 survey (Rule 1991), have now largely collapsed (**Plate 3**). The only significant section of the hull that remains is an area running alongside the port side forward boiler that stands proud approximately two metres above the seabed and runs for approximately four metres (**Plates 4** and **10**).

Plate 3: Forward boilers (MP6)

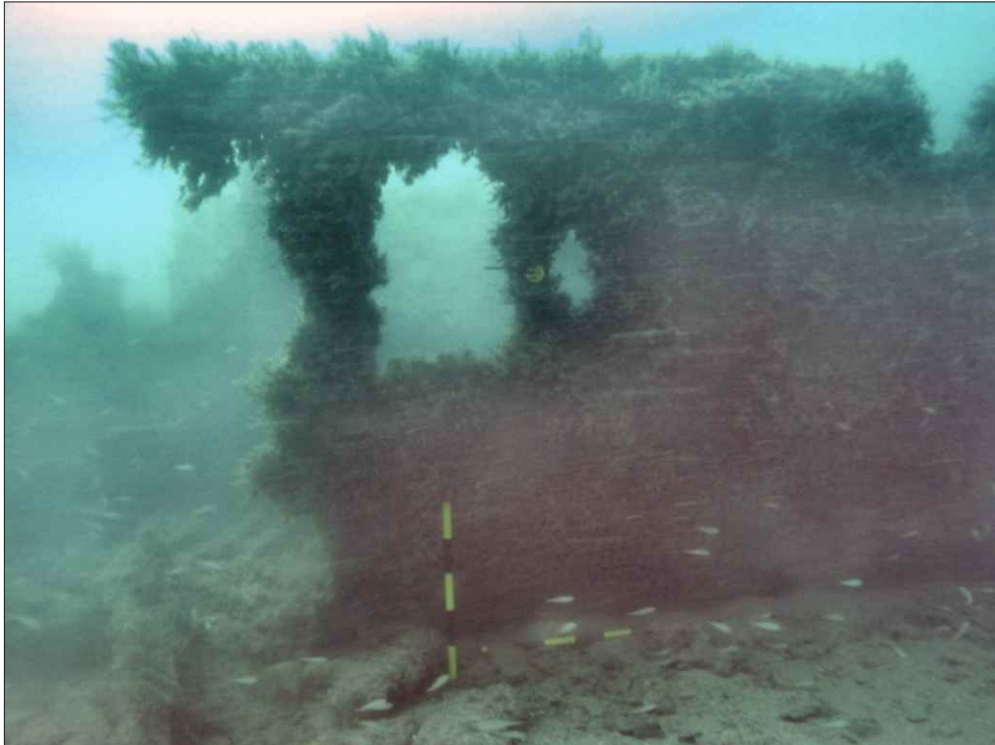
Plate 4: Side structure (MP7)

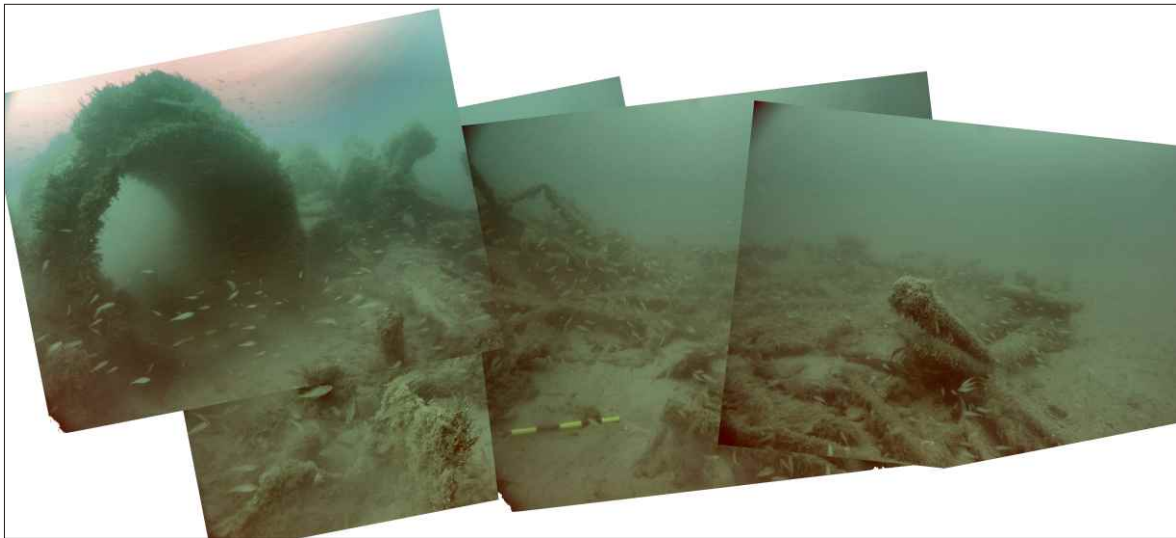
Plate 5: Funnel (MP8)

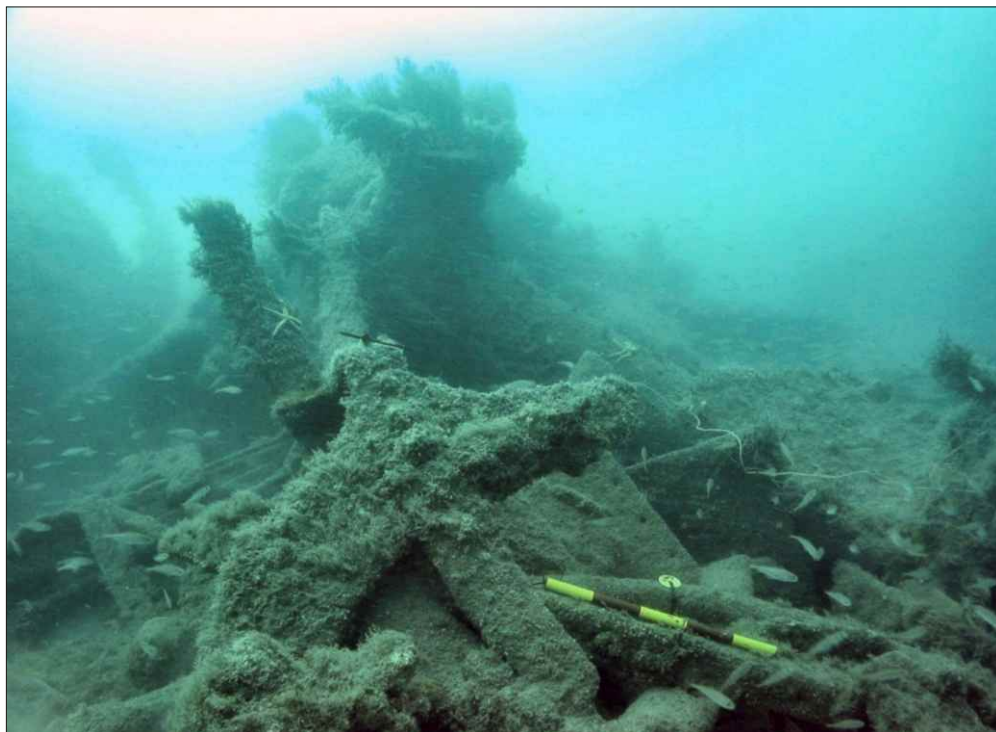
- 5.6.8. The most obvious change since the site was discovered was that the port side paddle wheel, which according to ADU records was largely intact in 1989, had collapsed. It is understood that this happened during the winter of 1990/91 and by 1996 had disintegrated. Due to the distribution of material from this paddle wheel it may be conjectured that an outside influence, such as a visiting boat anchoring into the *Iona II*, caused the damage. Natural deterioration is less likely to have caused such a traumatic disintegration.

Plate 6: Broken paddle wheel at end of crank shaft (MP9)

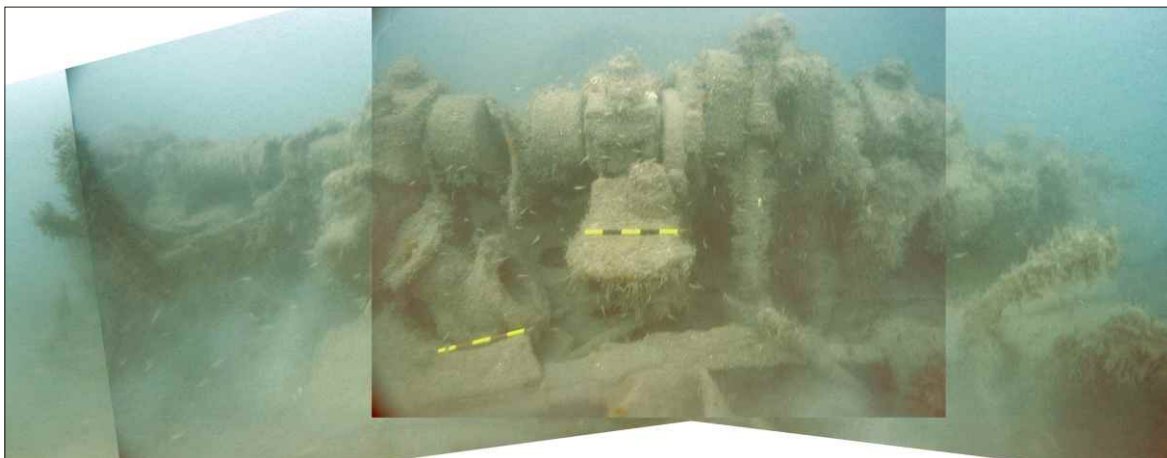
Plate 7: Crank shaft (MP10)

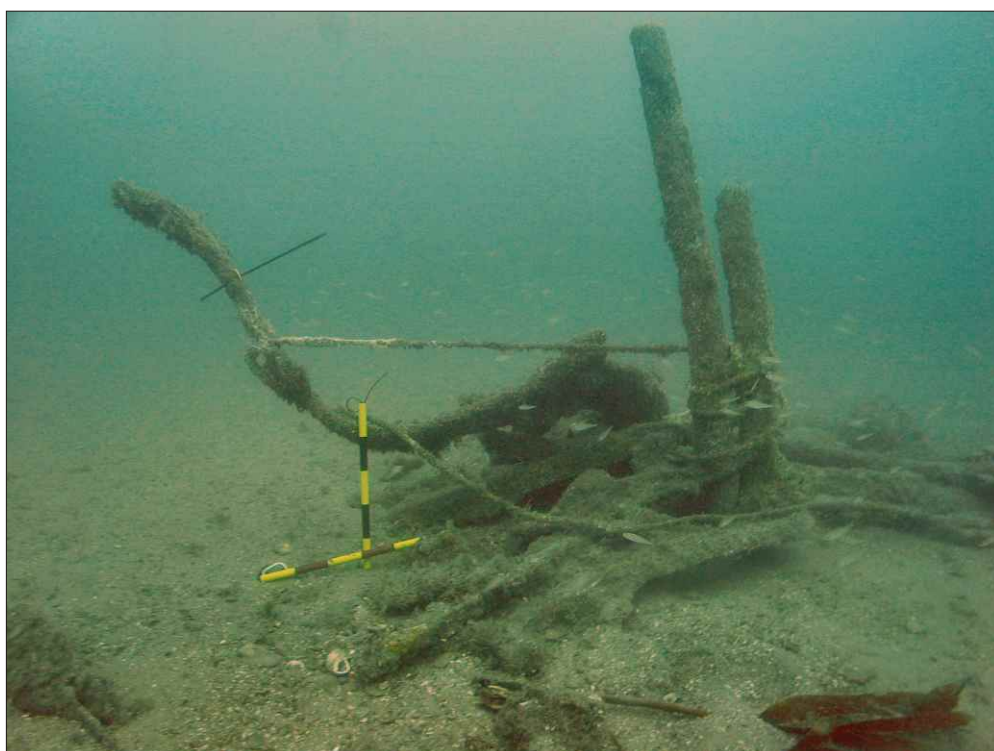
Plate 8: Stern post (MP14)

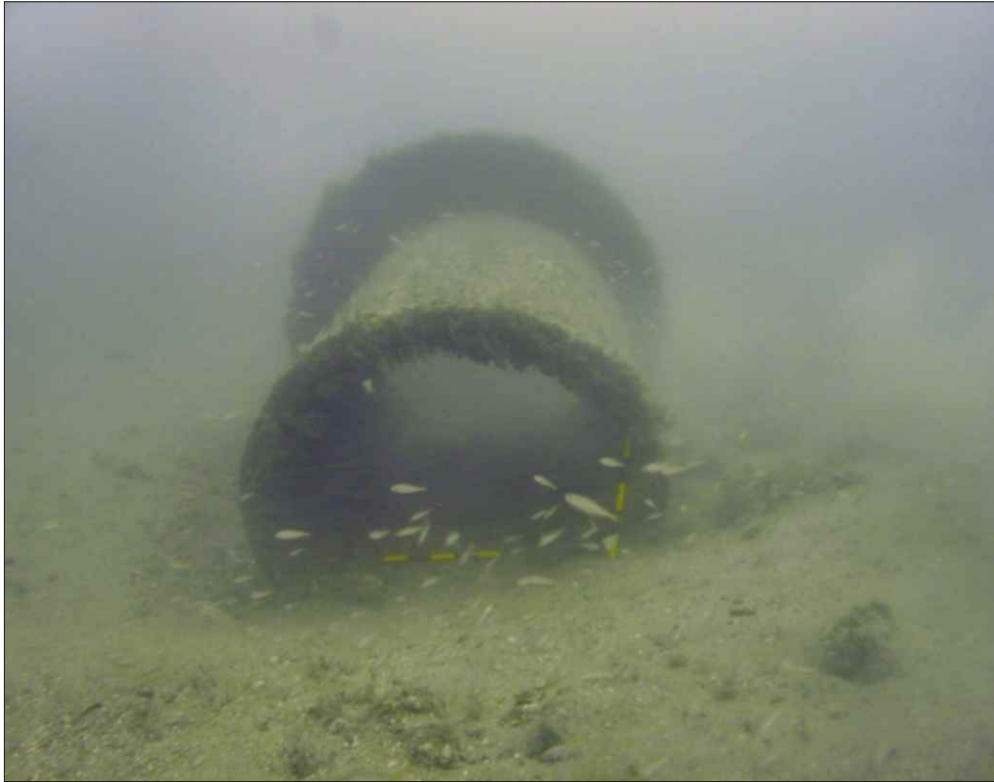
Plate 9: Funnel (MP17)

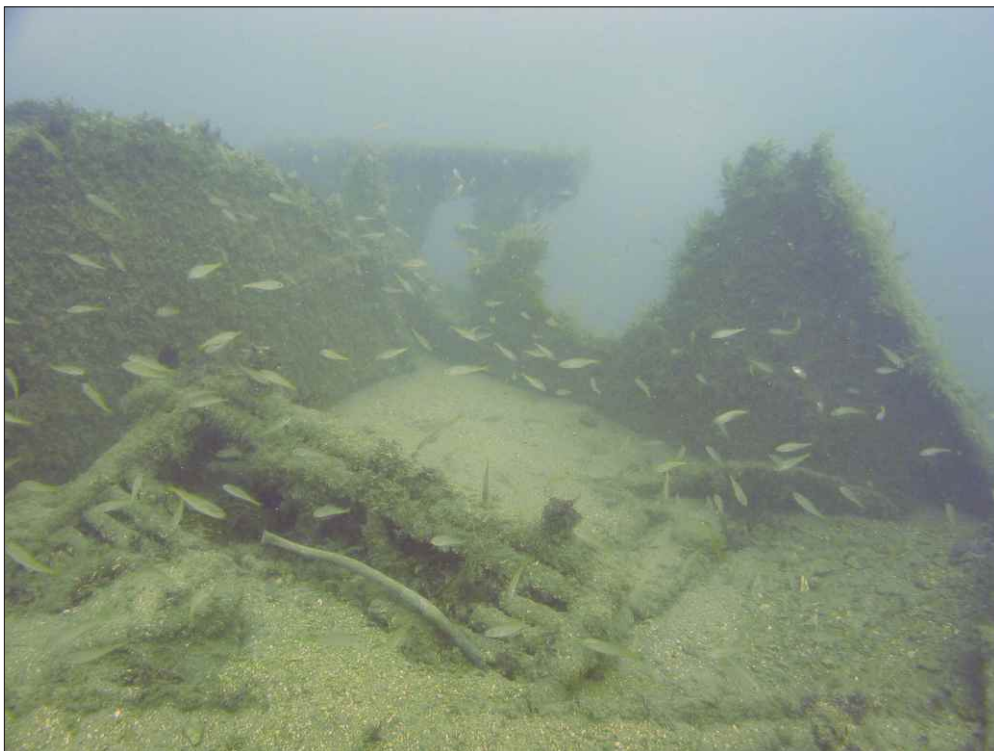
Plate 10: Side structure on portside near bows
