Withington, Gloucestershire

Archaeological Evaluation and Assessment of the Results

Ref: 59468.01
May 2006

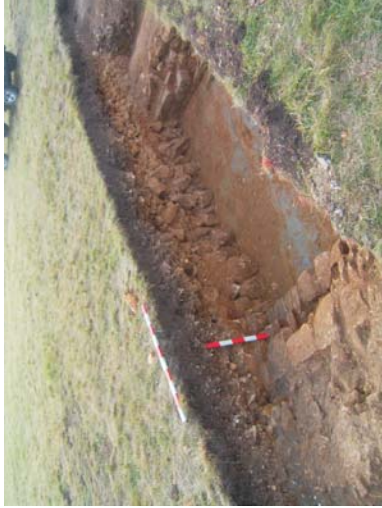
Plate 5: Trench 5 from south
(1m & 0.5m scales)

- 3.2.31 Two clear channels could be seen formed by three distinct limestone block constructions. The first channel was aligned roughly north-east – south-west, bounded by wall (506) to the west and wall (505) to the east. The second channel was of similar dimensions and was bounded by walls (505) and (504). The channel fills - (503) in channel 1 and (511) in channel 2 - were very similar deposits which contained fragments of limestone blocks and broken CBM; no dating evidence was recovered.

- 3.2.32 Although only partially excavated the structure was clearly identifiable as a stone-lined hypocaust system of ‘Union Jack’ style, such as those found within the *tepidarium* or warm room of a bath-house. No evidence of walls or floor surfaces remain and it is likely that a certain degree of robbing and recycling of material had occurred.

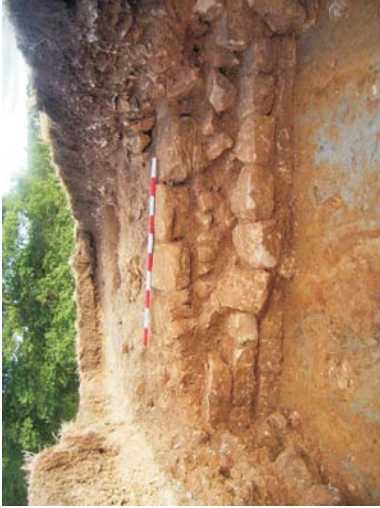
Plate 6: North facing elevation of Wall 406
(1m scale)

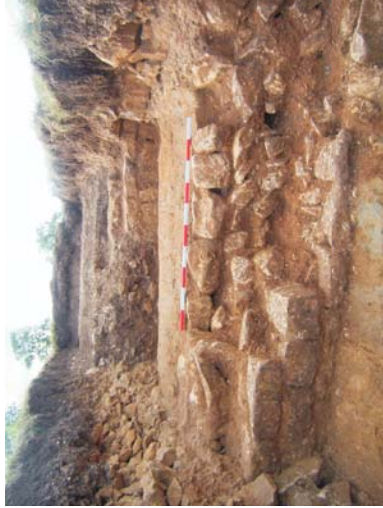
Plate 7: South facing elevation of Wall 408
(1m scale)

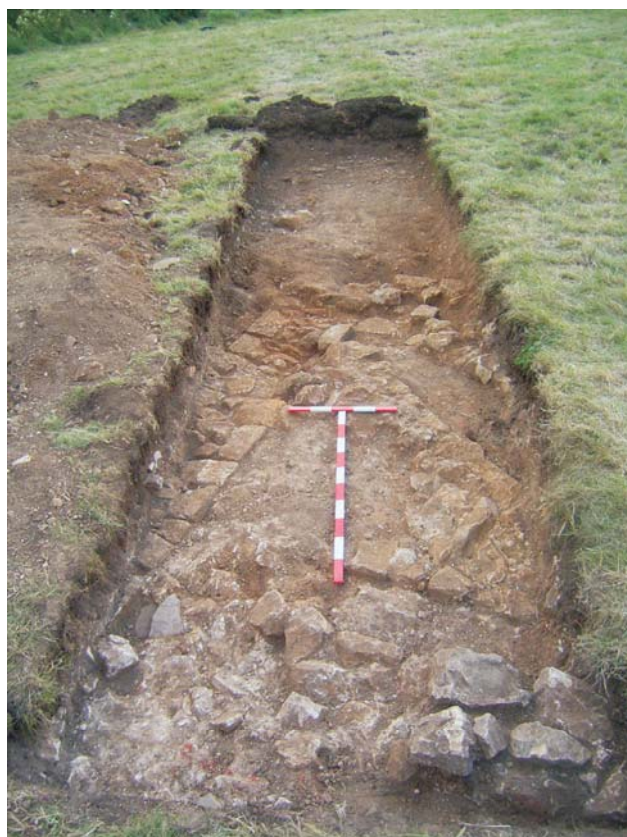
Plate 8: Trench 5 from east
(1m & 0.5m scales)

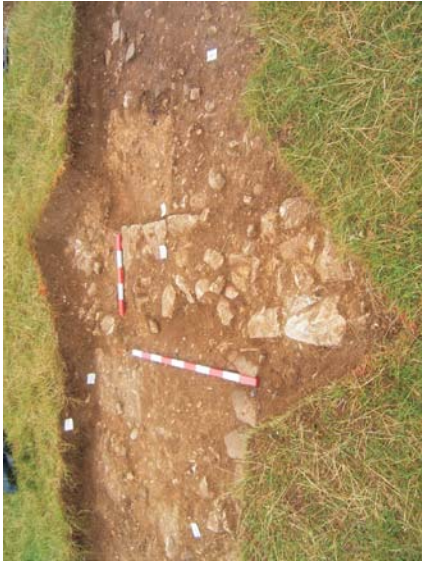
Plate 10: Trench 3 from north (1m & 0.5m scales)

- 3.3.14 Below the subsoil, two features cut the natural geology (303). The first was a possible domestic rubbish pit (304). The upper fill (305) produced Malvernian limestone-tempered pottery of later 1st century AD date. The pit was not fully excavated, but the date of the pottery suggests that it might pre-date the construction of the villa. The second feature, (306), was again unexcavated and its date and function are unknown. The upper fill (307) contained common flecks of charcoal and showed evidence of burning which may be indicative of industrial activity.

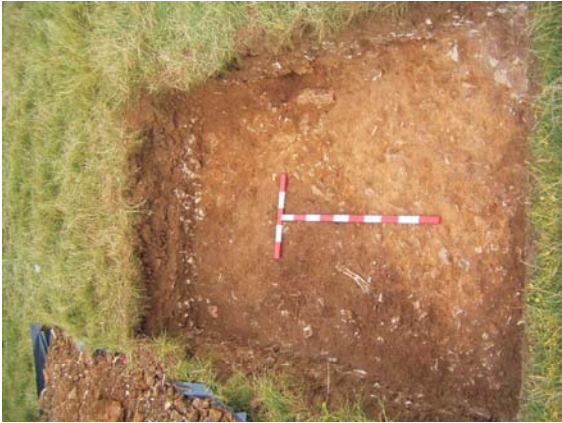
Plate 11: Trench 3 from south west (1m & 0.5m scales)

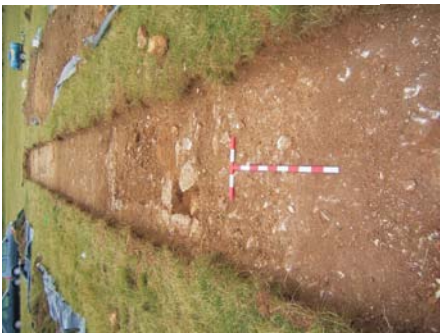
Plate 12: Trench 6 from west (1m & 0.5m scales)

- 3.3.15 The backfill deposits (602) from Lysons' excavations were encountered beneath the turf and topsoil (601) of the pasture field, concentrated towards the eastern half of the trench. Both topsoil and backfill deposits were very loose and friable; both contained Romano-British and post-medieval material including seven 4th century coins.

- 6.3.4 Trench 6 was positioned over an area of the villa complex instantly recognisable from the plans and paintings of the 1811 excavations. The exposed rooms and walls could be related to Lysons' plans of the site. There was clear truncation damage to the mosaic and walls of Lysons' Room 'F' which had occurred since their excavation. Lysons recorded the room as approximately 6.10m square with the mosaic intact (**Figures 2 & 3**) but it became clear that walls Lysons had recorded as upstanding had been subsequently truncated at the eastern end down to foundation deposits. The mosaic itself only survived for 3.20m - almost half of the floor had been destroyed.

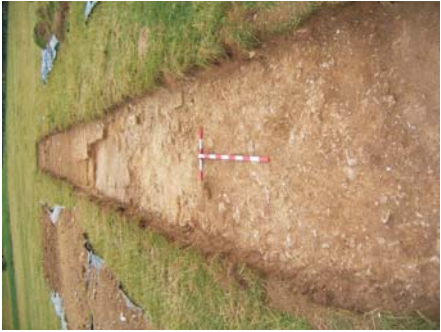
Plate 13: Trench 6 from east (1m & 0.5m scales)

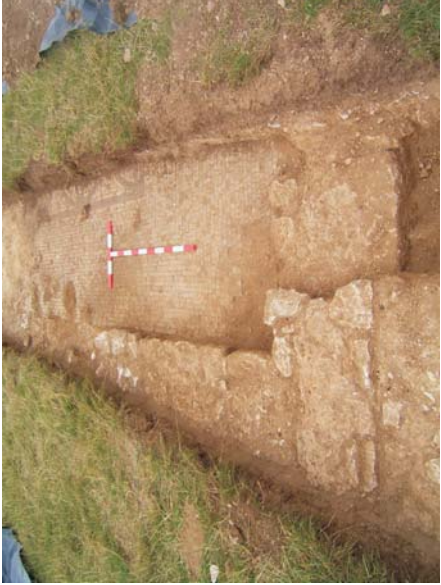
Plate 14: Close up of Wall 609, step in wall 608 and mosaic 610 from the west. Recorded as Room F by Lysons in 1811 (1m & 0.5m scales)

- 3.3.21 This truncation was also clear from the remains of the mosaic floor within Room 'F'. Mosaic (610) was constructed from a background of 30mm square white limestone *tesserae* with the design in dark red Pennant sandstone *tesserae*. An area of approximately 3.30m by 1.20m survived. The mosaic was set into a limestone mortar bonding deposit (611), clearly seen where the mosaic was truncated towards the eastern end. Deposit (611) was also truncated at this point and could be seen to overlie make-up, foundation deposit (612).

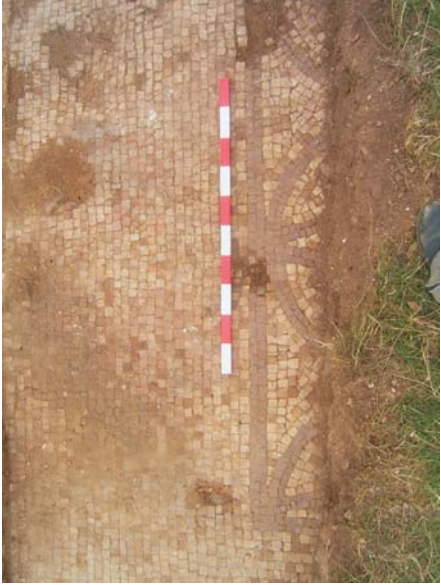
Plate 15: Close up of mosaic 610, in Lysons' Room F (0.5m scale)

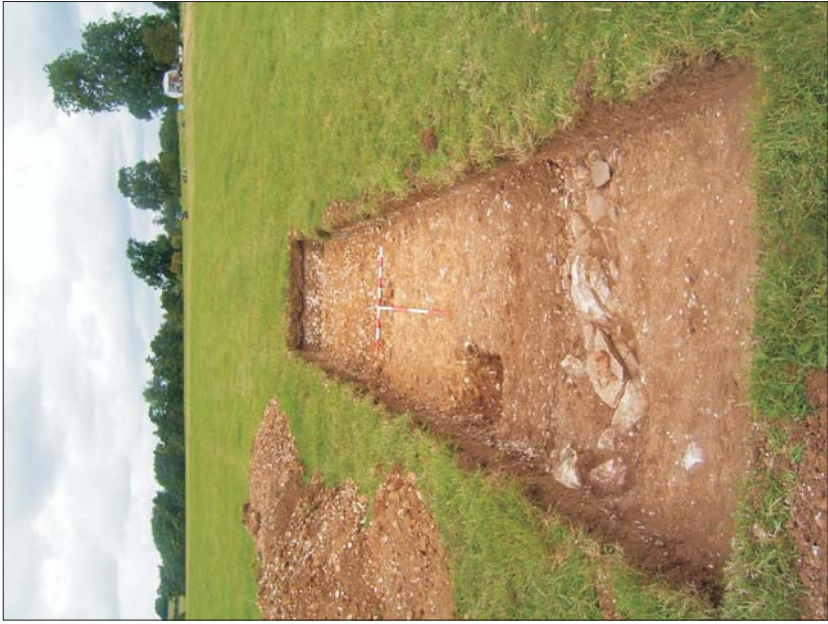
Plate 16: View of Trench 8 from south
(1m & 0.5m scales)
