## Arkwright's Mill, NCP Car Park, Miller Street, Manchester

### Archaeological Evaluation and Assessment of Results

Ref:59471.01

April 2006

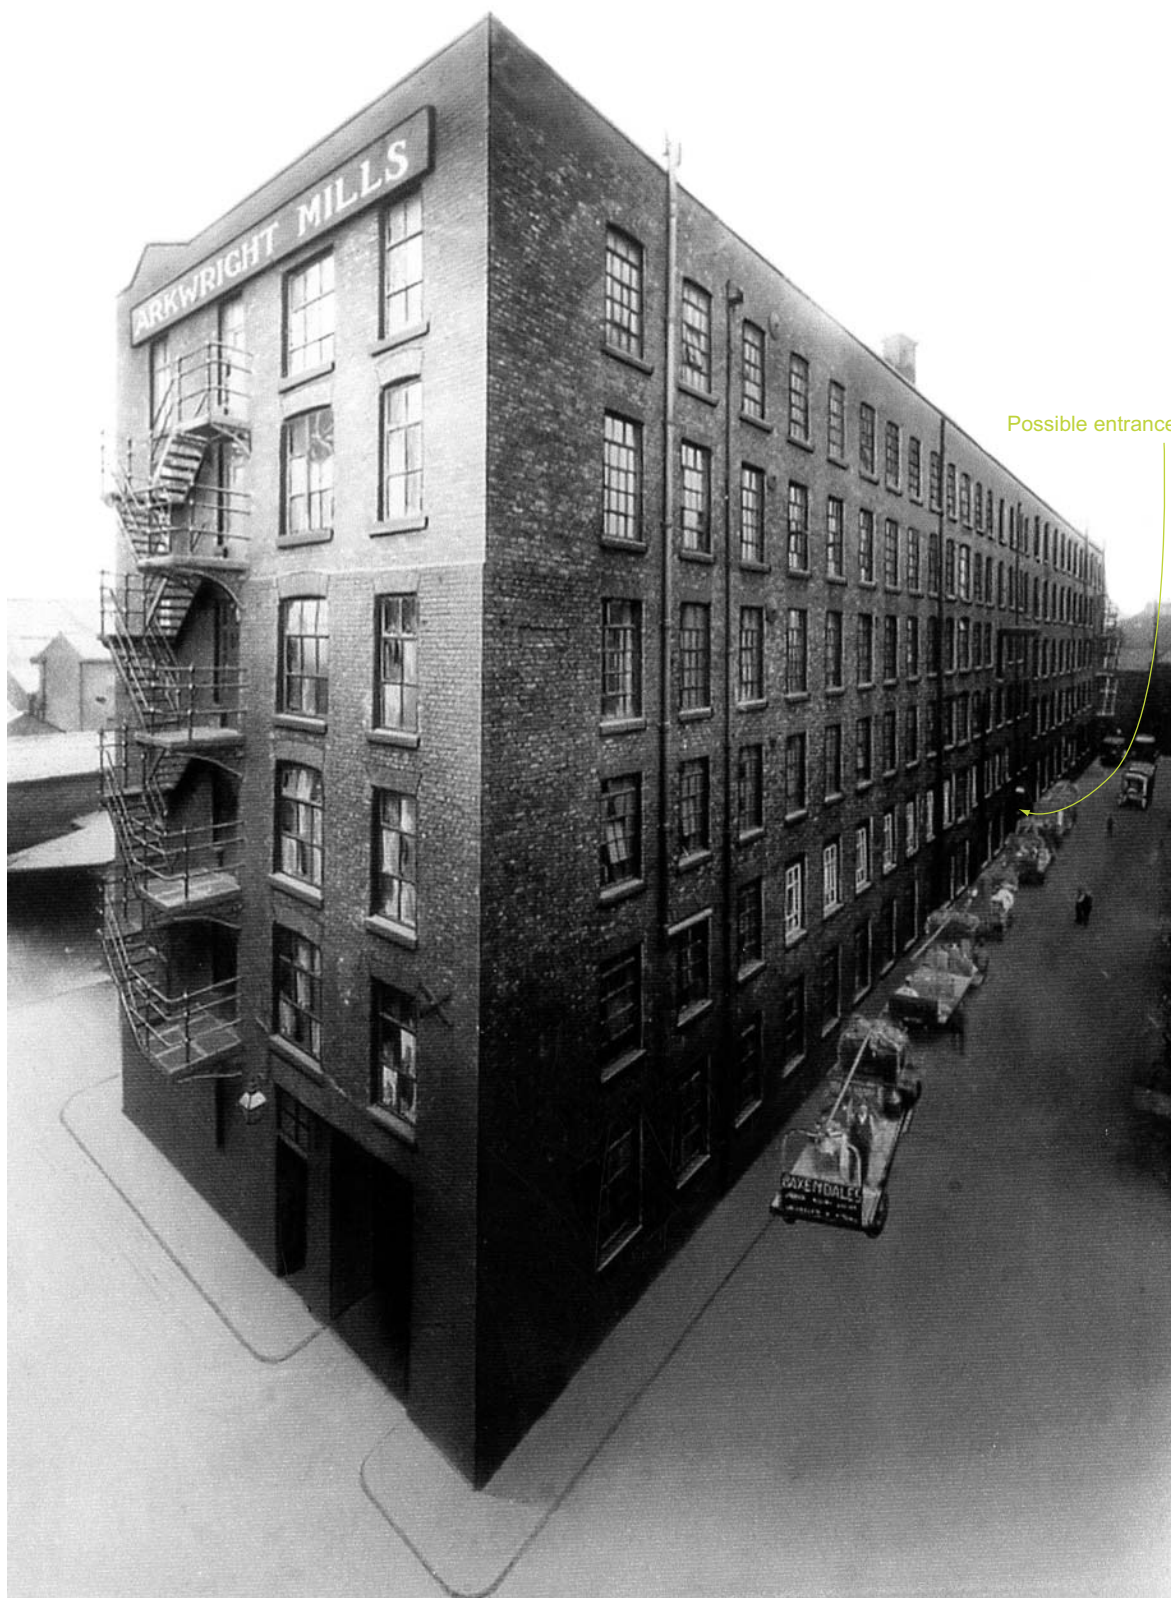
Photograph of the southern and eastern elevations of Arkwright's Mill, following the takeover by Baxendales. Figure 3 The post-1854 addition of two upper floors can be clearly seen, also a possible entrance in the eastern wall.

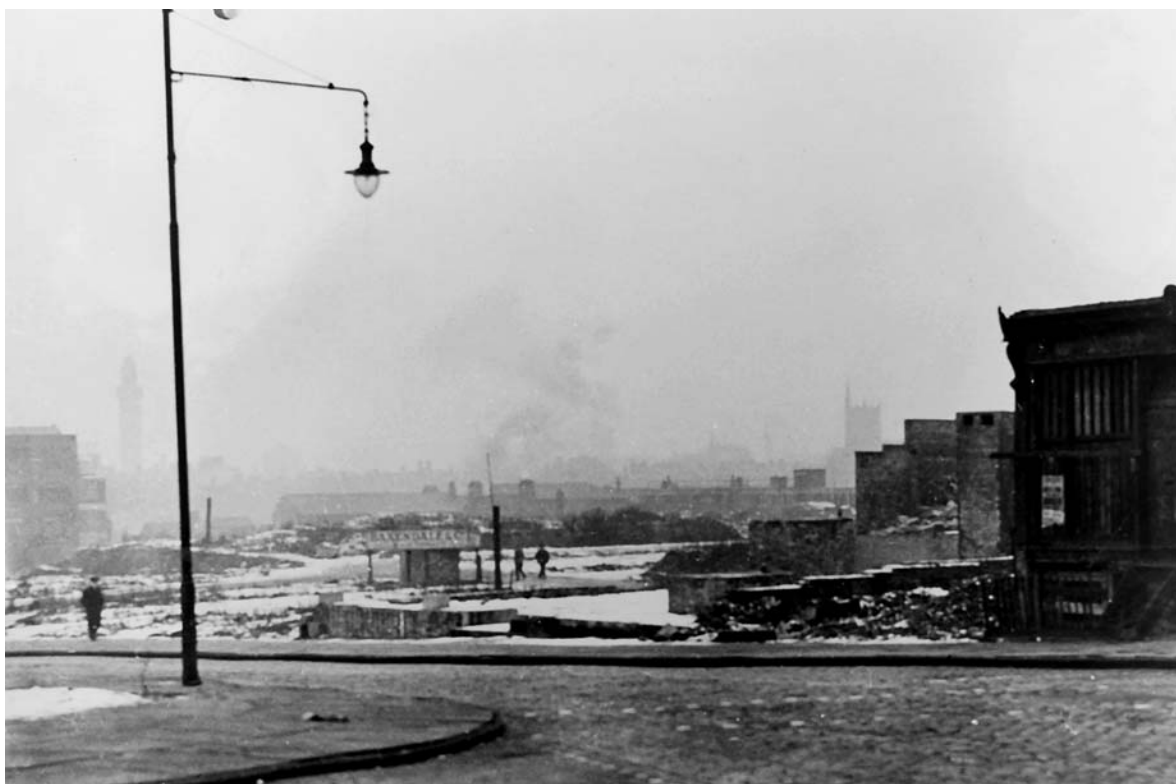
Figure 4

Photograph of the site of Arkwright's Mill following the Blitz in 1940.

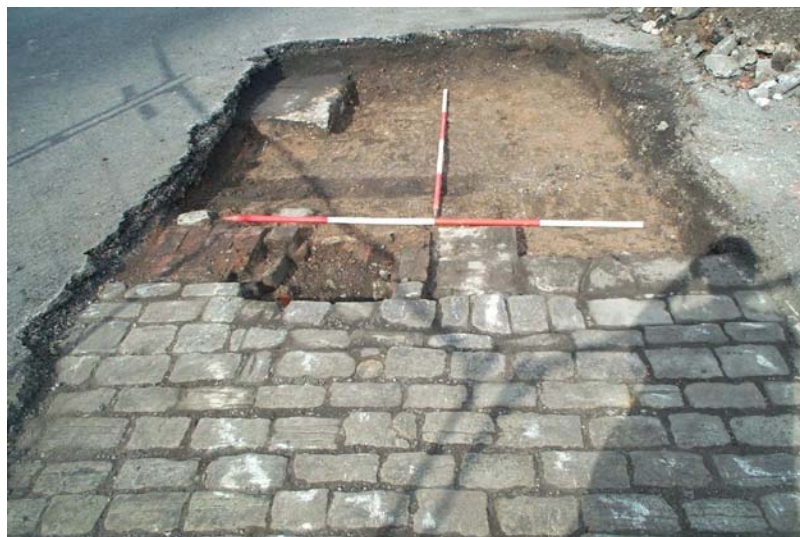
Trench 2 from the south

- 3.3.19 Structure (204/211) is likely to be the upper foundation course for a now demolished wall. It was cut through by a number of later intrusions of 19<sup>th</sup> and 20<sup>th</sup> century construction. These later intrusions, and the nature of the bricks and mortar within 204/211 indicated that this was the foundation for the southern wall of the 18<sup>th</sup> century mill.

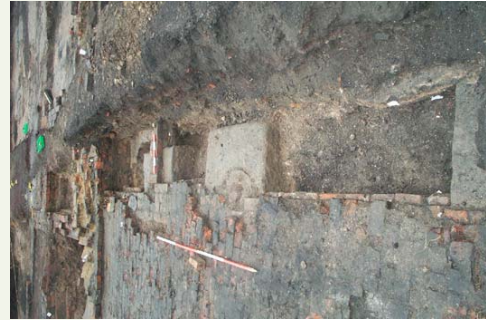
Excavation of 18th century tank group (354), below later retaining arches (311) and (312), from the east

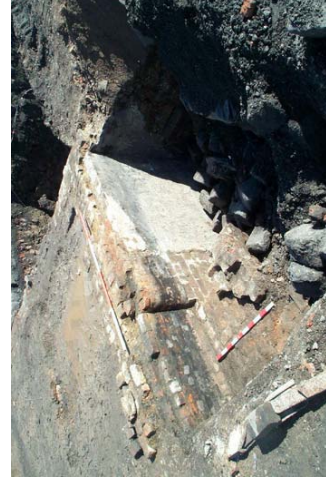
Wheel pit and doorway blocking wall (333), from south

- 3.3.37 After the failed attempt to power the machinery of the mill using only steam power there was a need to find an alternative mode of driving the looms, and so the factory resorted to the tried and tested water wheel. The next phase of building within the factory therefore relates to this period of alteration, with the construction of a wheel pit and associated structures.
- 3.3.38 The wheel pit was identified towards the eastern side of the mill and housed within the main building itself. The water wheel was described as 30 ft long by 8 ft wide (9.15m by 2.40m) (Videotext 2005, 2). The wheel pit was only partially exposed to a length of 1.80m; the width was 2.40m and so the wheel would have fitted tightly within it. The pit was excavated to a depth of over 3m.

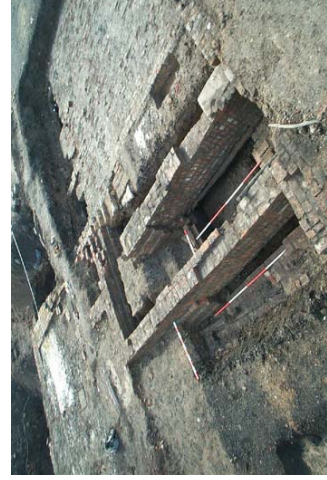
Retaining arches (311) and (312), and associated structures, from the north west

upper course of headers. The arch was bonded into buttress (313) at the eastern end, from which the arch could spring, and could be seen to butt against the earlier wall (304) at the western end. Buttress (313) was 1.15m long by 0.50m wide, recorded to a height of 0.54m and constructed from reused machine-made brick bonded with charcoal rich mortar, laid in English bond. The buttress sat upon a four-course stepped foundation consisting of two steps each of two bricks laid in stretcher bond.

- 3.3.71 Arch (312) was constructed in an identical fashion to (311) and was of the same dimensions. It did not spring from a separate buttress but continued to the east where it merged into a wall. This was recorded as 2.40m long by 0.36m wide and 0.85m in height, constructed of three courses of stretchers set on a six-course stepped foundation consisting of three steps of two bricks. Arch (311) also butted earlier wall (304) at the western end and was bonded and keyed into contemporary wall (314) at its eastern end.

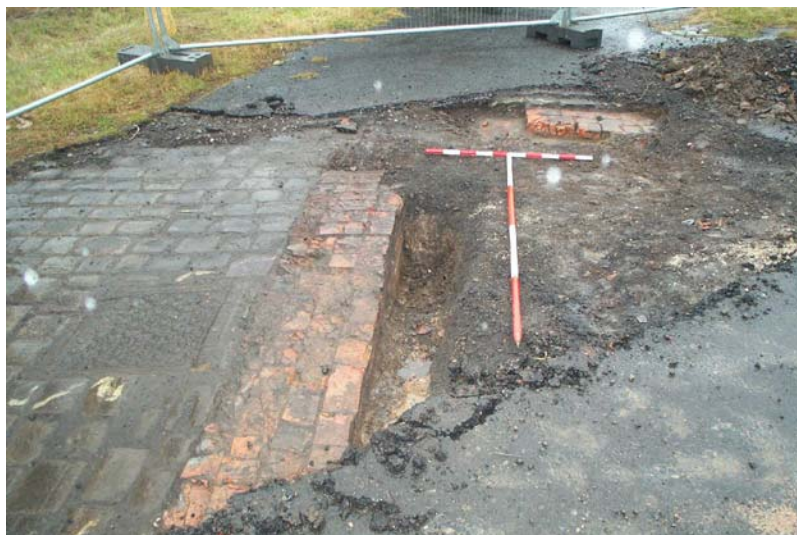
Trench 5 from the east

- 3.3.94 Below (502) were two walls. Wall (503) was 2.80m long by 0.50m wide and recorded for 0.32m high, three courses in stretcher bond, bonded with lime mortar with a broken brick rubble core. This is the continuation of the southern wall of the factory (204) as identified in Trench 2 (see above).

- 3.3.96 Wall (504) was the western wall of the mill, identified as (104) in Trench 1 (see above). However, examination of the bricks and mortar suggested that they dated to the 18<sup>th</sup> century and belonged to Arkwright's initial mill construction phase, whereas the wall foundations in Trench 1 were 19<sup>th</sup> century. It is clear that the southern end of the mill building has seen little alteration since it was constructed in the 1780s.

- 5.2.4 In Trench 5, 3m east of wall (504), there was likewise no evidence of a brick foundation trench butting 18<sup>th</sup> century wall foundation (503) (see **Figure 15**). Also, wall (504) was clearly identified as belonging to the original construction phase of the mill through analysis of the bricks and mortar.
