Shorncliffe Redoubt, Sir John Moore Barracks, Shorncliffe, Folkestone, Kent

Archaeological Evaluation and Assessment of the Results

Report reference: 62501.01

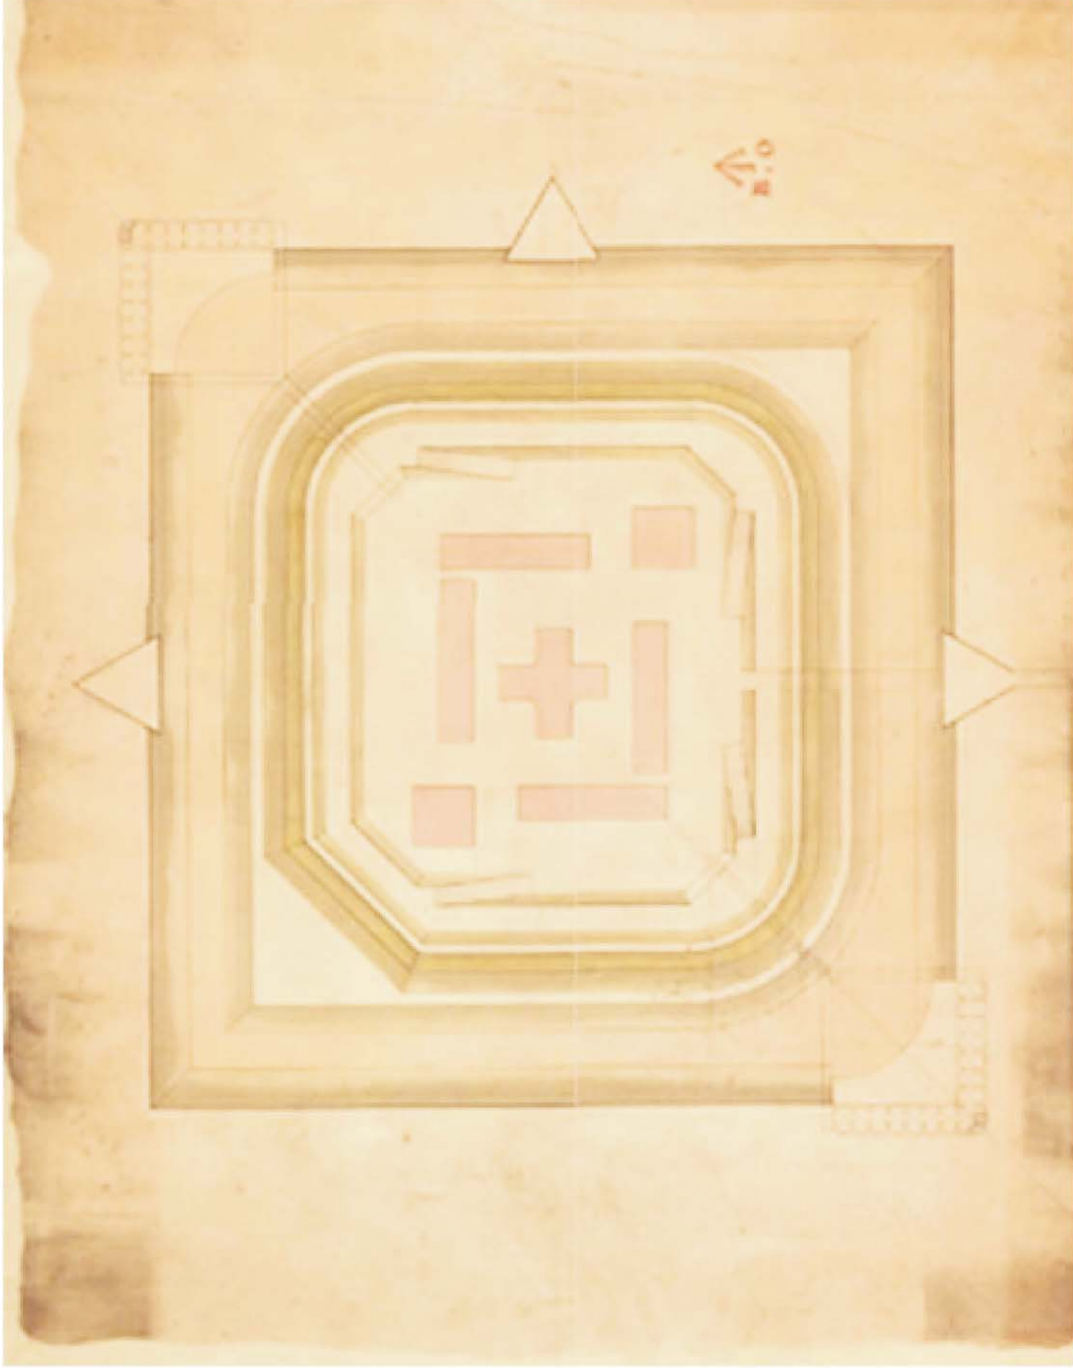
Figure 2

1794 plan of Shorncliffe Redoubt by Colonel William Twiss, showing earthen defences and magazines (Courtesy of the National Archives, PRO,MPHH/1/115 image ref.: 5)

- 1.3.8 The two Twiss plans of 1794 (**Figures 2 and 3**) appear to show the proposed plans for the layout of the redoubt, and it is believed that construction of the fort began in this year. The first plan (**Figure 2**) shows a square earthen rampart with rounded north-east and south-west corners and square north-west and south-east corners. Beneath the south-east and north-east corners are structures interpreted as buried magazines, with separate partitioned areas for the storage of ammunition and powder which appear to be accessed by tunnels. Within the earthen defences are a number of buildings set around a central cross-shaped building, with ramps leading away from the centre to the fire step around the inside of the rampart. The entrance appears to be on the southern side of the structure.

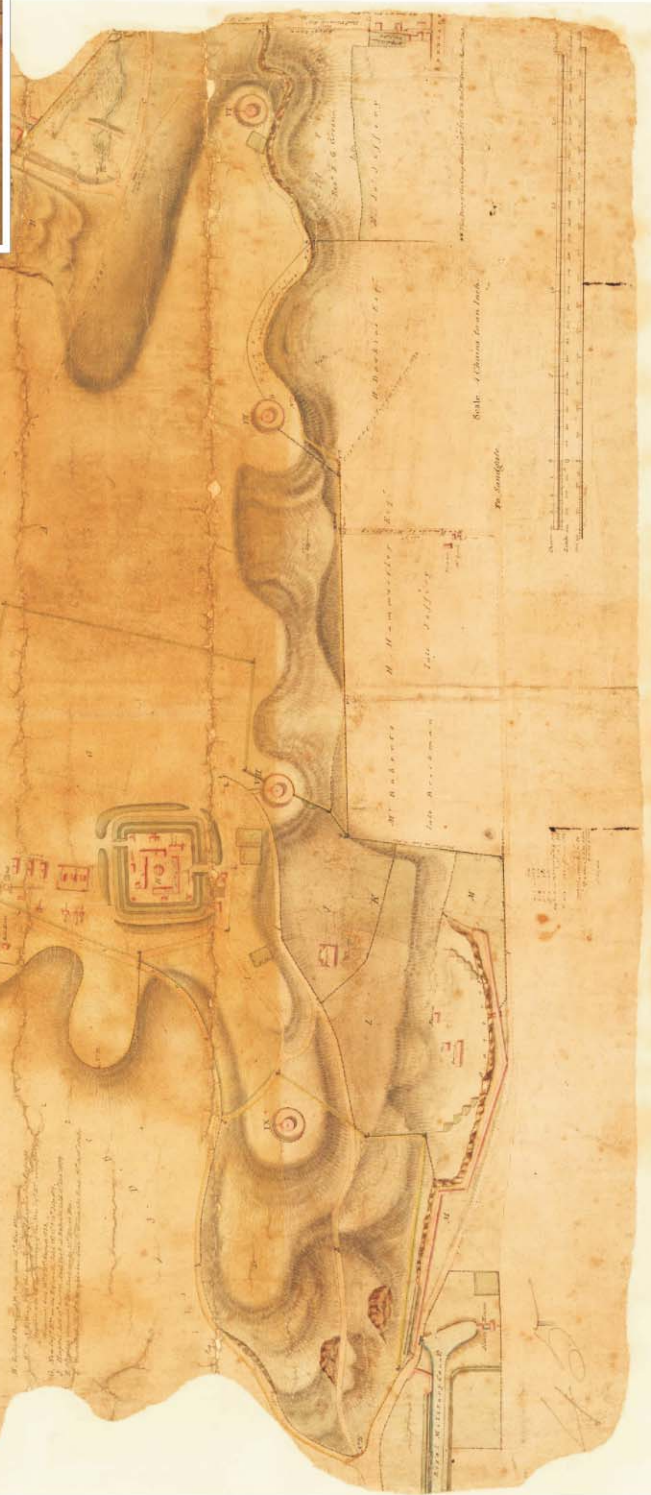
1834 Plan of Government Ground at Shorncliffe (Courtesy of the National Archives, PRO, ref works 43/1(13)) and the Shorncliffe Redoubt

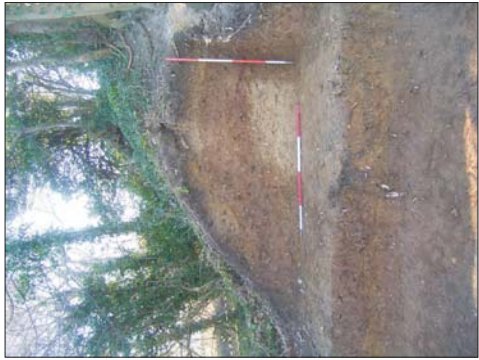
Plate 6: Eastern end of north facing section through eastern rampart of redoubt

- 4.4.13 Only one deposit revealed possible evidence of how the rampart may have been constructed. Deposit (306) was a very compact sand layer located towards the outer edge of the bank. It had clear vertical edges, implying that it had been held in place by some form of revetment, or contained within a gabion. Gabions were a tried and tested form of defence against musket and cannon fire; they comprised stacked baskets of earth. However, no evidence of decayed wickerwork or wooden revetment was identified here.

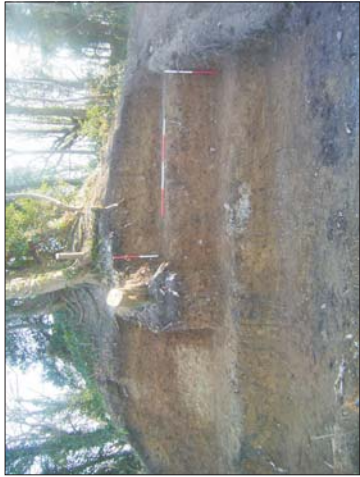
Plate 7: North facing section through eastern rampart of redoubt

6.4.3 There was no evidence of a stone foundation or internal stone walls used to hold in place the loose sand, but there was possible evidence for the use of gabions to create the bank, in the form of a compact sand deposit with clear vertical edges, tentatively interpreted as material packed within wicker baskets.

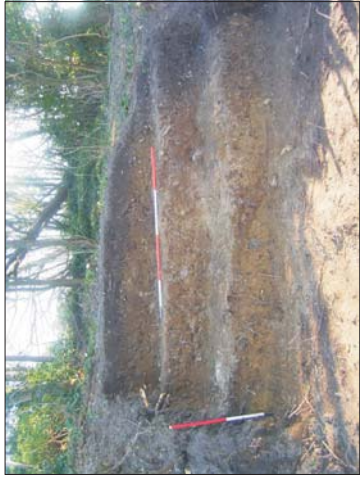
Plate 8: Western end of north facing section through eastern rampart of redoubt

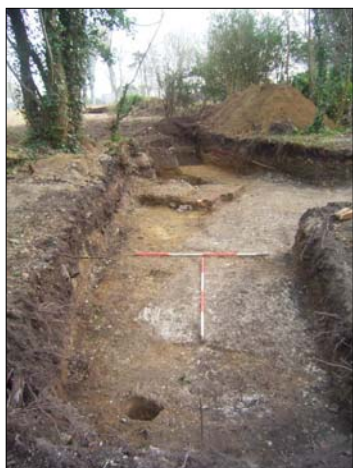
Plate 9: Trench 6 from the south west

- 4.4.25 The earliest phase of building was concentrated in the southern end of the trench where the partial foot print of a north-south aligned building comprising at least two rooms (Group 654) and a cellar (Group 652) was identified. The foundation trenches for the two rooms were clearly identified cutting into the underlying natural geology (626). Room 1 was approximately 3.75m long and 1.50m wide and bounded by two north-south aligned walls (613) and (614) and southern east-west aligned wall (615); no northern east-west wall survived.

- 6.10.3 In Trench 6 a number of rooms and a cellar associated with Redoubt House were uncovered, although the true nature and the function of these rooms is unknown, as they had been robbed for recycling down to foundation level in most instances. Trenches 7 and 8 revealed evidence of the associated structures of Redoubt House, including the highly truncated remains of the stable block, and planting holes for shrubs from the formal garden.
- 6.10.4 These structures related to Redoubt House also suffered from the effects of later military activity during the First and Second World Wars, which resulted in the demolition of the house and the building of barracks and other military buildings subsequently demolished.

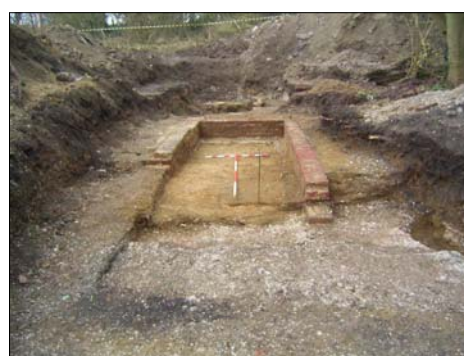
Plate 10: Trench 6 from the north

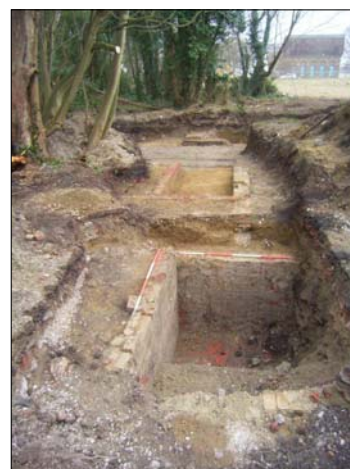
Plate 11: Trench 6 from the south

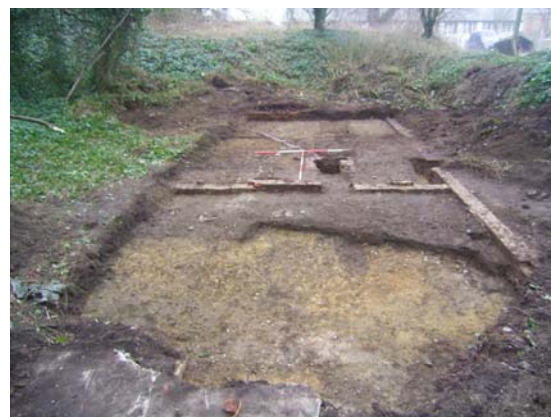
Plate 12: Trench 7 from the south
