Chesham Bois House, 85 Bois Lane,
Chesham Bois, Bucks. HP6 6DF

Archaeological Evaluation and Assessment of Results

Report reference: 62503.01

March 2007

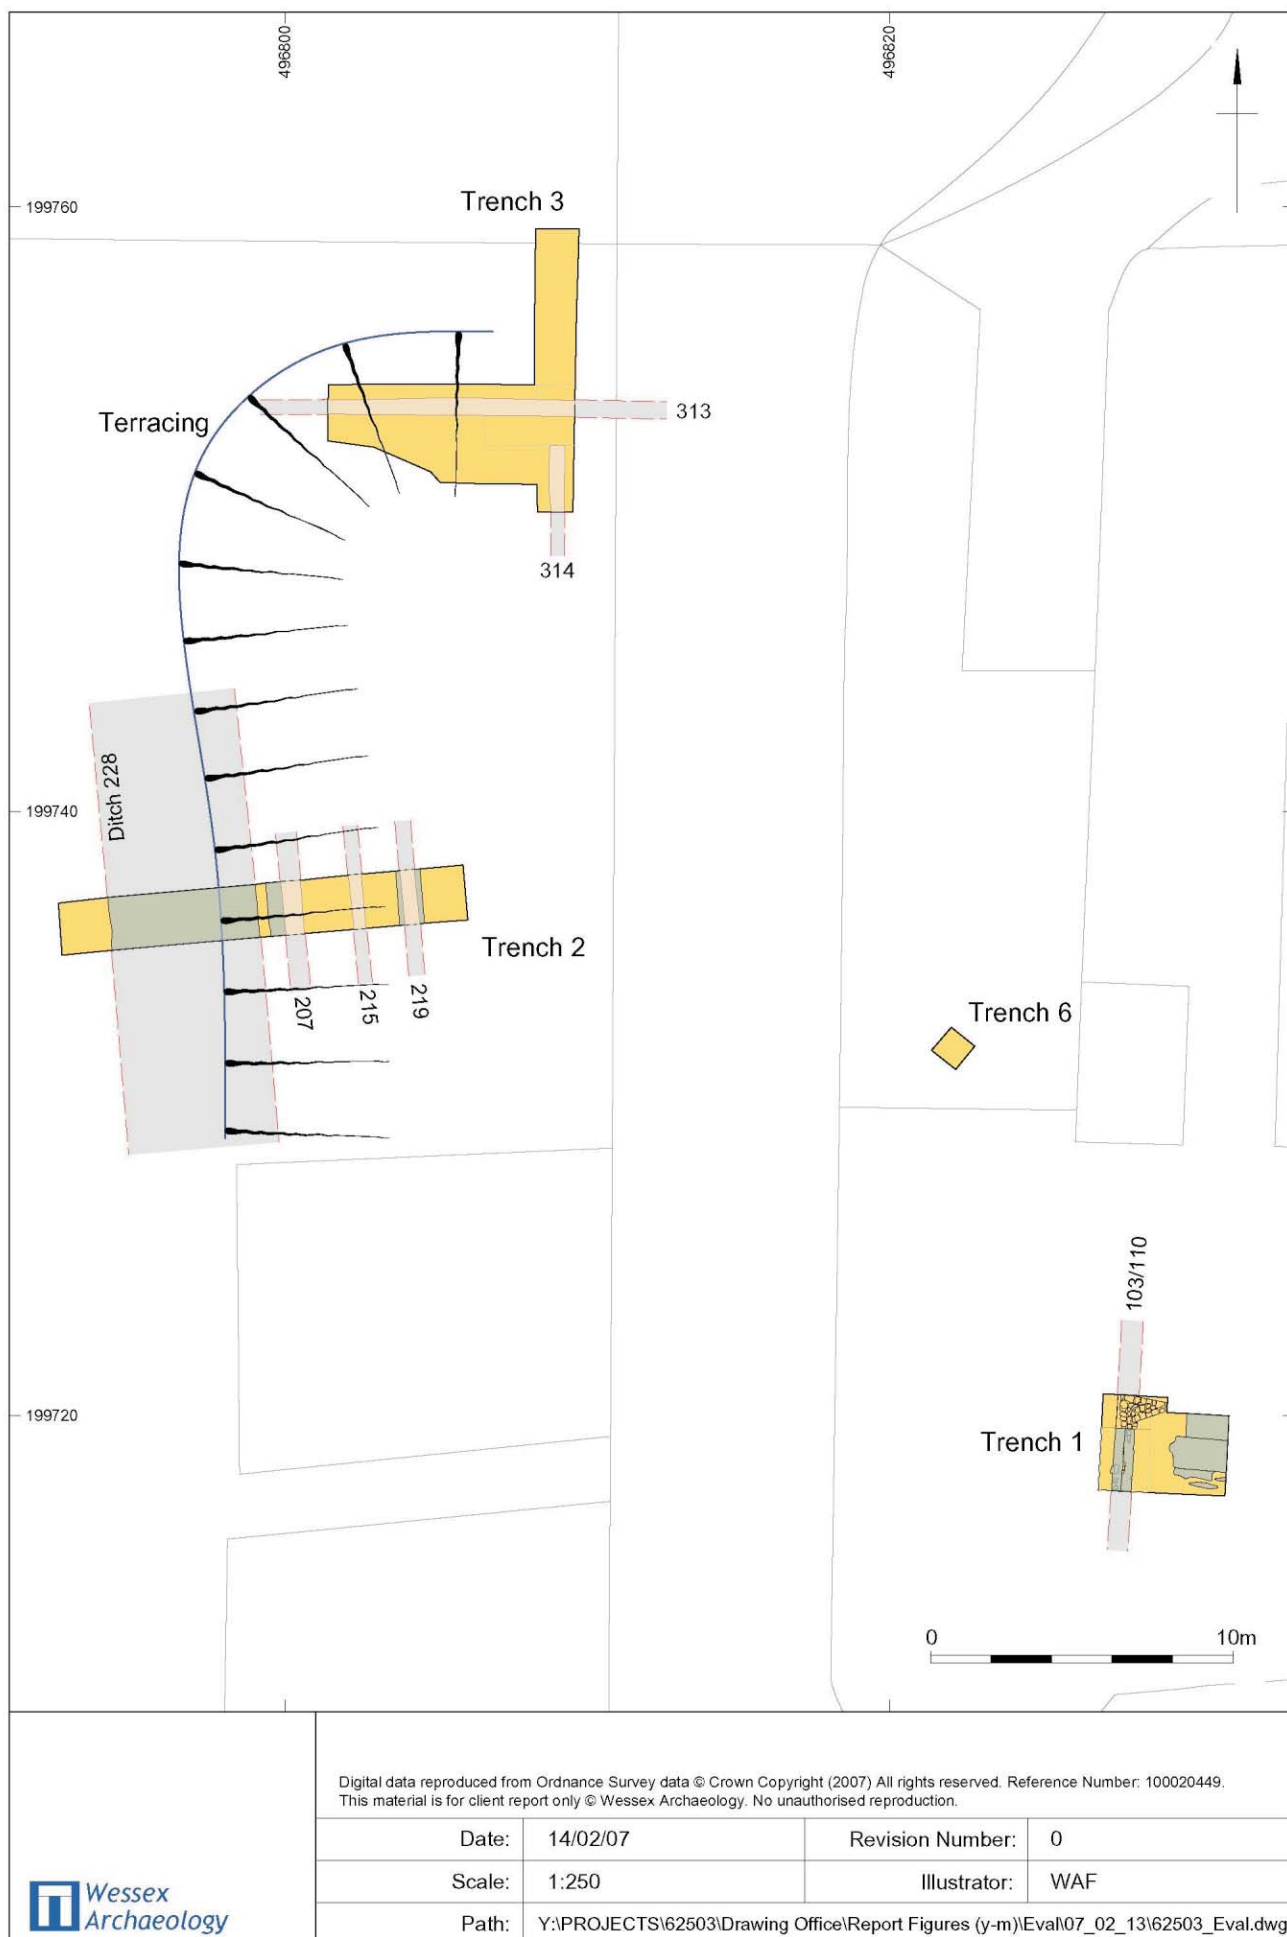
Figure 4

Plan of Chesham Bois House's Garden; trenches 1, 2, 3 and 6

- 4.3.1 Three machine trenches and a hand-dug test pit (**Figure 4**) were excavated in the gardens of Chesham Bois House. Only trench 1 located medieval remains; post-medieval walls and terracing were recorded in trenches 2 and 3, along with later garden features and trench 6 located a substantial rubble deposit, probably representing a backfilled cellar. Trench 1 (**Figure 5, Plate 1**) partially re-excavated the 2004 CVAHS trench that located a hearth, chalk floor and earlier remains and extended into a previously unexcavated area to the west that earlier results suggested would contain a further structure. Apart from cleaning and recording the hearth and floor located in 2004 were not disturbed as excavation

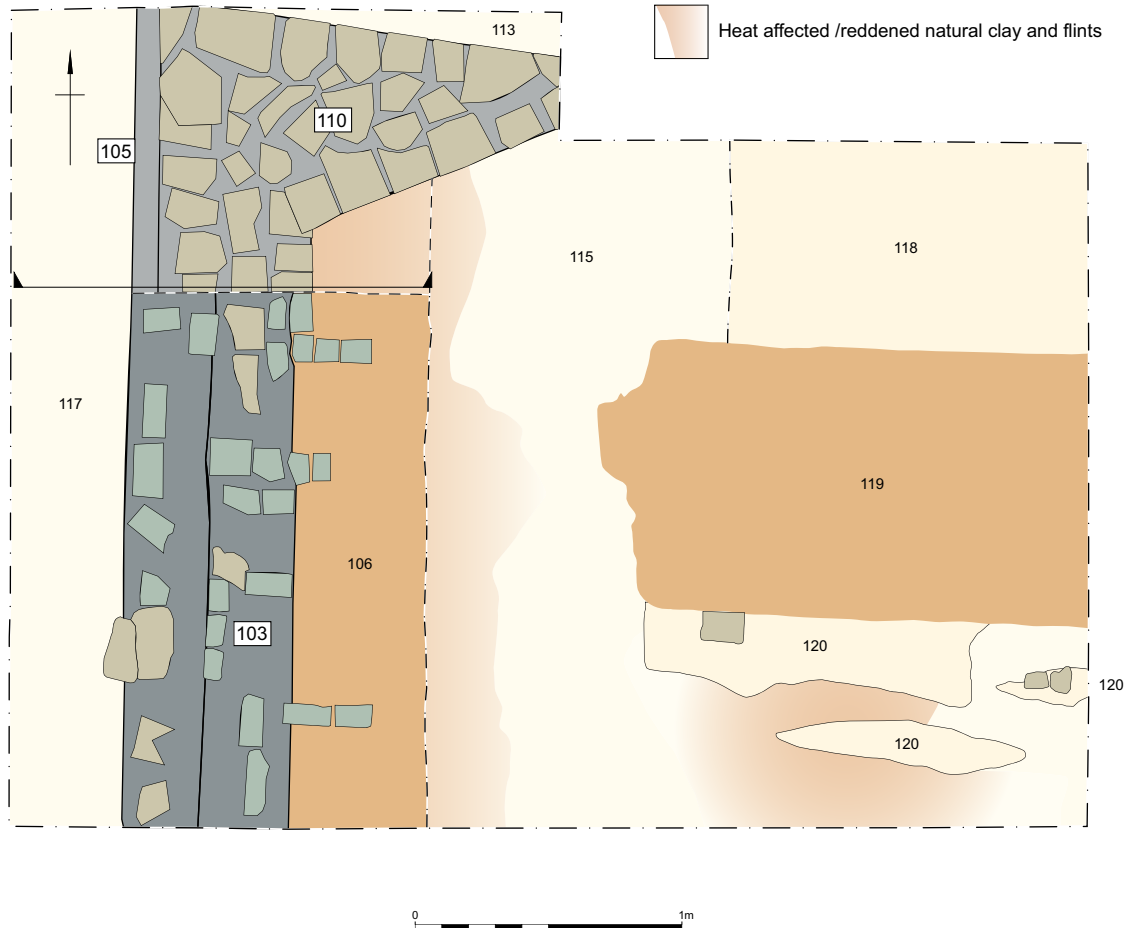
- 4.3.2 The earliest deposits recorded in trench 1 during this phase of evaluation comprised a thin occupation deposit (112/114) which directly overlay heat affected clay and flints natural. This appeared to be associated with the large pitch tile hearth (119) that was exposed during the 2004 excavations. An environmental sample taken from this deposit produced no charred plant remains and only fragments of wood charcoal including many that could be seen to be ring-porous, most probably oak. This deposit was sealed below the remains of a very calcareous mortar floor (111, 116, 118 and 120), which also partially overlay the hearth, and produced a single sherd of medieval sandy ware pottery. The laying of this floor was broadly contemporary with the construction of a mortar and tile footing (110). This was well-built, utilising peg tiles and peg tile fragments, and probable represents the foundations of a chimney breast. Aligned approximately north-south with a *c.* 45° returns to the east at its northern end, this probably formed an angular, crescent shaped structure. This structure probably overlay earlier structures and deposit, however, as it was preserved *in situ* no further excavation was undertaken. Although dated on the basis of a single sherd of pottery, this appears to represent the floor and chimney breast of part of a late medieval structure.

- 4.3.4 Deposit (109) was overlain by a sand bedding layer (108) which formed the base of a pitch tile hearth (106) constructed within chimney breast (110). A single sherd of post-medieval pottery was recovered from bedding layer (108), along with small quantities of animal bone, tile fragments and oyster shell. Hearth (106) was constructed of re-used tile and tile fragments, set at a *c.* 45° angle and bonded with sandy lime mortar, which also formed the surface of the hearth.

- 4.3.5 Following the construction of hearth (106), the chimney breast was re-built; the upper part of chimney breast (110) was removed (construction cut 105) and a new chimney breast (103) constructed of re-used brick and tile, bonded with pale grey calcareous lime mortar, above a layer of brick fragments and mortar (107) which was laid over the remains of (110) and abutted hearth (106). Chimney breast (103) was constructed partially above hearth (106) and narrow dividing walls, just one brick wide, appear to split the hearth into at least four small bays. A single sherd of post-medieval pottery was recovered from within mortar deposit (107).

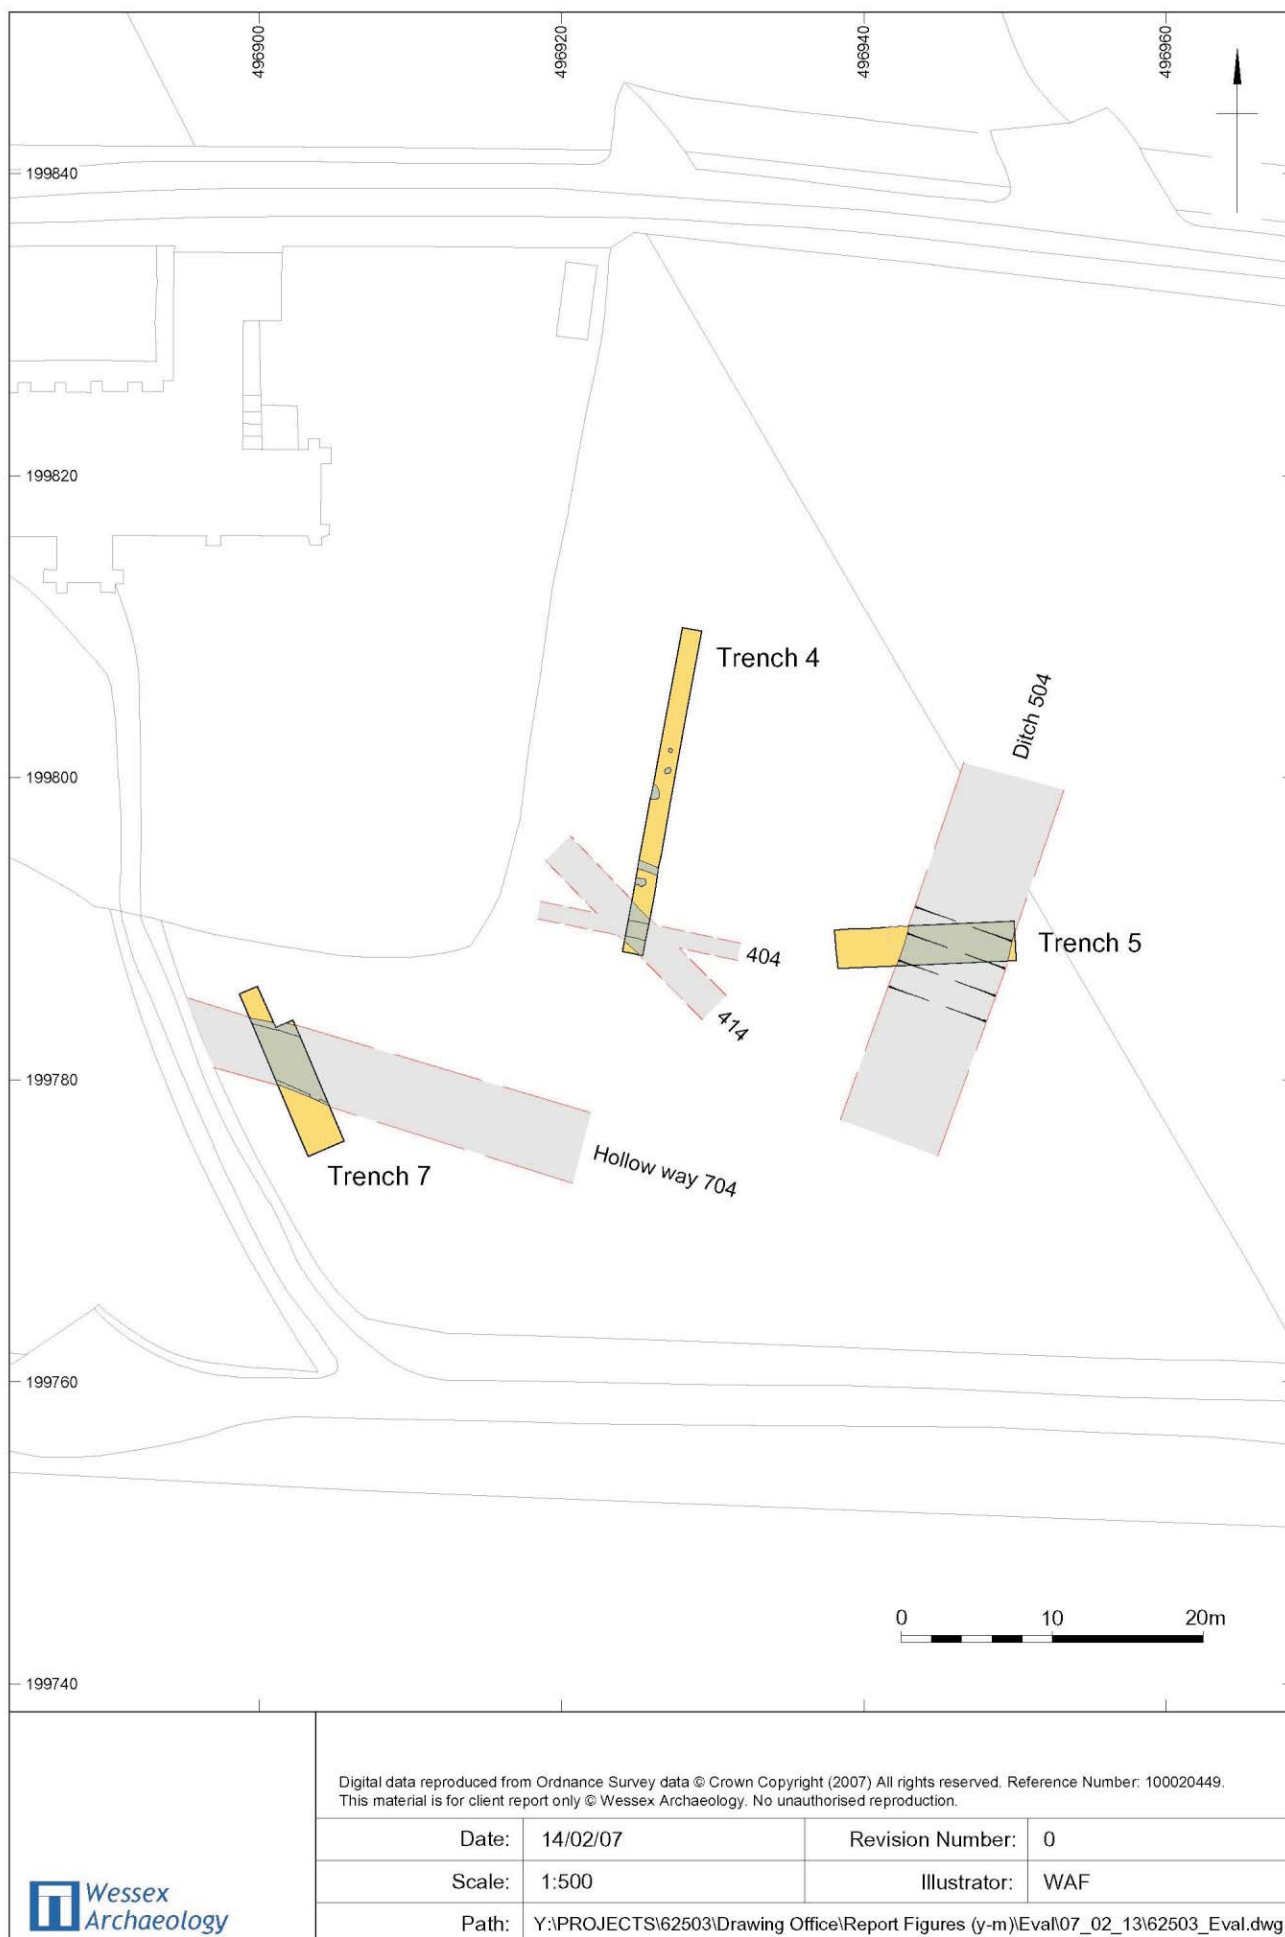
Figure 7

Plan of Church Field

- 4.4.1 Three machine-dug trenches were excavated in the Church Field (**Figure 7**); a single, substantial ditch, probably representing a boundary around the manorial complex was excavated in trench 5; two ditches of possible medieval or post-medieval date and a few root disturbances were recorded in trench 4, below later terracing deposits; and a possible hollow way, dated to the post-medieval period was excavated in trench 7.
- 4.4.2 The large ditch recorded in trench 5 (504) was aligned approximately north-south across the Church Field, where it was visible as a slight linear depression to the south of the trench, and probably represents a substantial property boundary around the manorial complex. This feature was also located during

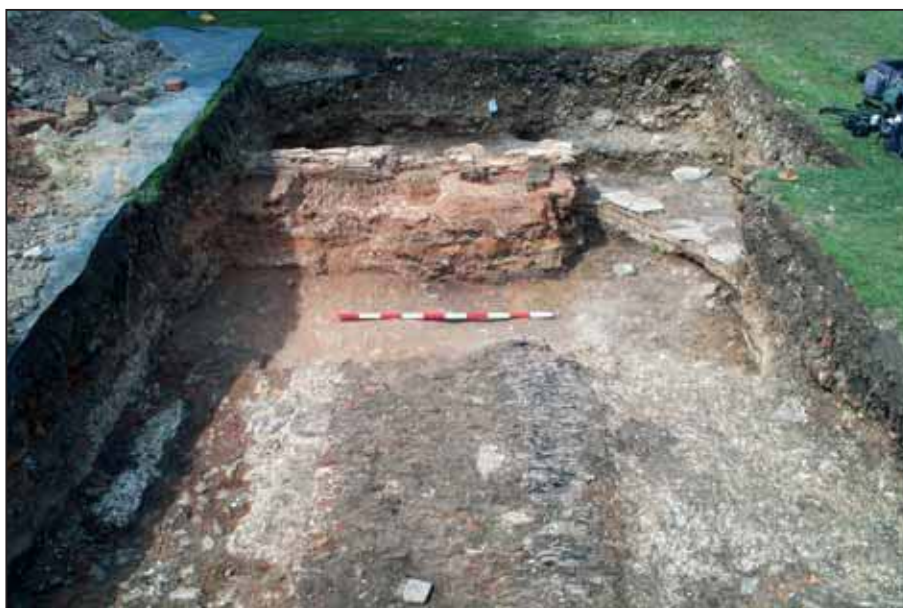
Plate 1: Trench 1 from the west

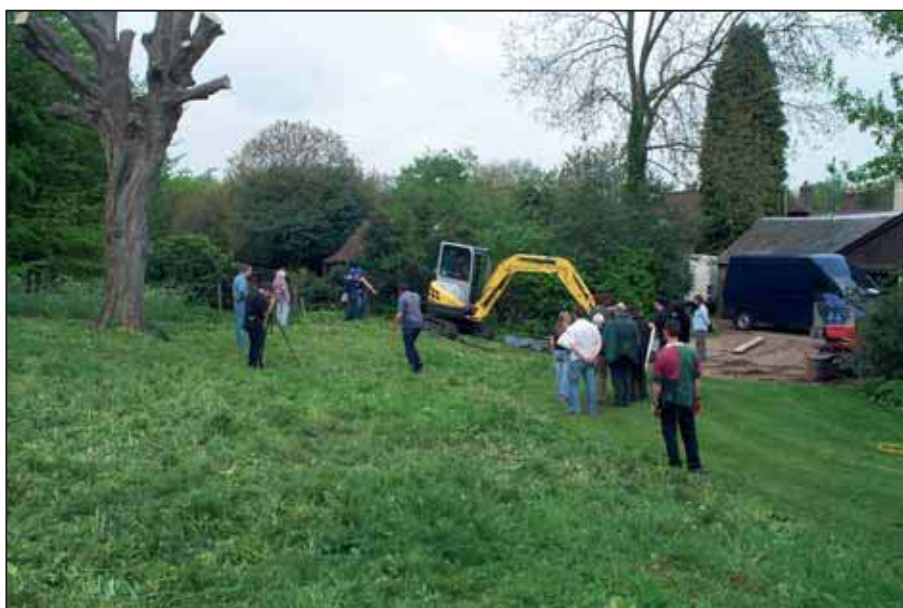
Plate 2: Terracing to the west of Chesham Bois House

- 4.3.9 The level of the clay and flint natural substrata to the west of wall (207) was approximately 1m higher than the level to the east, indicating that this was built as a retaining wall, probably at the same time as the ground level was reduced to form a terrace. The level of the natural substrata to the north of wall (313) was approximately 0.50m higher than the level to the south, again indicating its function as a retaining wall, although the construction cut was cut through deposit (312). All other features and deposits in trenches 2 and 3 post-date walls (207) and (313), which appear to form parts of the northern and western sides of a large negative terrace, probably constructed in the late 17th or early 18th century. Such terracing is likely to have completely removed, or at least severely truncated, any earlier remains in the area to the west of the present Chesham Bois House (**Plate 2**). Two re-used moulded bricks, possibly from window mullions, were recovered from wall (313) and their presence here suggests a level of architectural sophistication consistent with a high status manorial
