## Castle Farm, Scargill County Durham

Archaeological Evaluation and Assessment of Results

Report reference: 68732.01

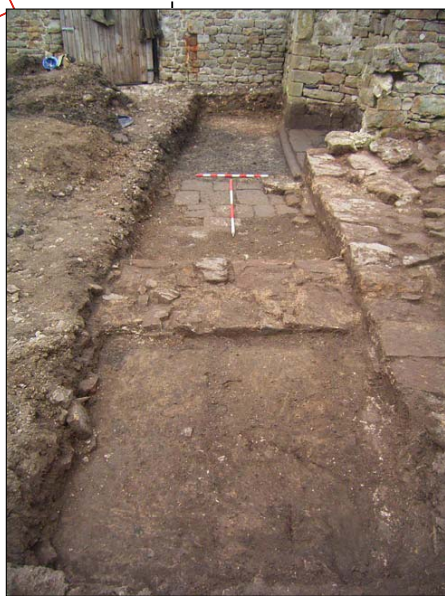
Plate 3: Western part of Trench 3, pre-excitation (from the south-east)

- 4.3.11 The archaeological features were covered by 0.40m of hardcore and demolition debris ((301), (302)). Removal of this revealed a mortar surface (304) on which remains of a flagstone floor could be seen (303). An area of trample or occupation debris (306) was found lying over the flagstones (**Figure 5, Plate 5**). Due to the large quantity of small artefacts and fragments of glass within it this deposit was subjected to 100% sampling for artefact recovery, a procedure which yielded a James I farthing and two bone dice as well as a variety of animal bones from a number of different species. This floor lay to the north of a south-west – north-east aligned stone built wall (314), of which only one course remained (**Figure 4, Plate 3**). This wall butted up to the wall incorporating the fireplace (327). As well as the known standing remains of the fireplace (**Figure 5, Plate 6**) this wall was shown to have continued to the south-east across the existing yard entrance and beyond the limits of the trench. The fireplace itself was seen to be an integral part of the wall rather than a separate or bonded structure.

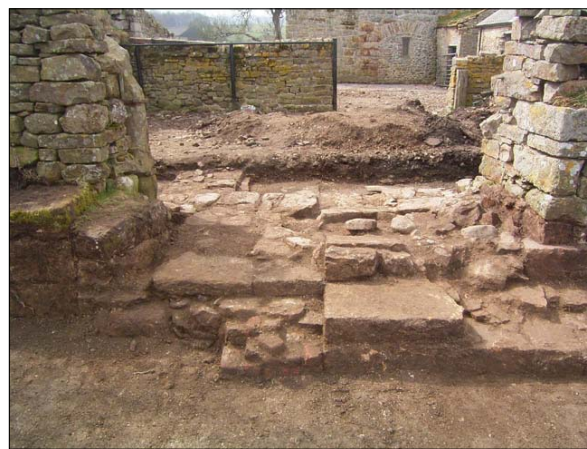
Plate 4: Central part of Trench 3 with gatehouse beyond (from the north-east)

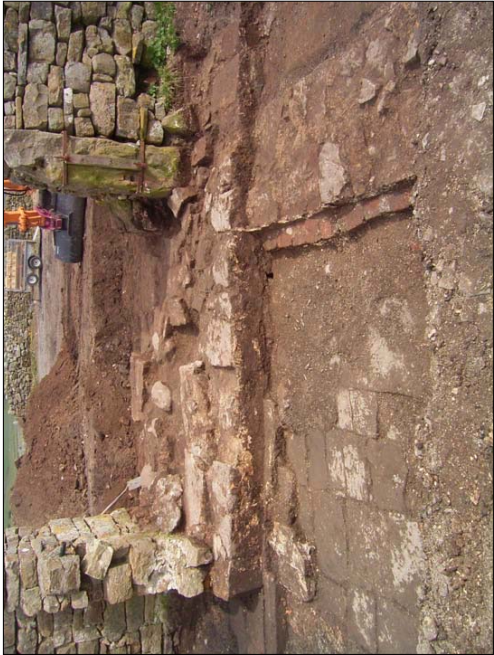
Plate 5: Pre-excavation view, gateway area, deposits 306 and 305 still *in situ* (from south-west)

- 4.3.17 The gateway threshold was at the same level as the yard surface, but archaeology was encountered at a significantly shallower depth within this area than in the parts of Trench 3 to the west and east. Once the overlying deposits (301) and (302) had been removed, a large amount of loose stone rubble was visible obscuring the archaeology, as well as a concrete pad with which the gate had been anchored. Amongst the loose stone rubble some horizontally laid slabs were uncovered (323) and (325); these overlay further stone rubble deposits (326) and (323). These flat slabs are likely to represent a later levelling of the gateway.

305	Layer	Dark blue-grey silt. Sooty deposit but also contaminated by diesel staining. No coarse components. Common small coal flecks. Common plaster/mortar flecks. Fairly friable. Lies within the hearth (328), stones beneath heat affected.			0.06m deep
306	Layer	Trample/occupation layer over floor (303). Mid grey-green sandy silt loam. 1% stone, sub-rounded; friable. Frequent plaster/mortar flecks.			0.02m deep
307	Layer	Mid yellow-grey silty clay, compact. Faint grooves filled with (331) suggests a possible bedding for flagstones. Overlies (330).			0.25m deep
308	Topsoil	Modern topsoil. Mid grey-brown silt loam. 2% stone, sub-angular – sub-rounded, 2-8cm. Friable and bioturbated. Overlies (309).			0.00-0.35m bgl
309	Layer	Demolition debris overlying eastern side of the trench. Mid brown silty clay loam. Mixed deposit. 40% stone rubble, sub-rounded – angular, randomly sorted. 5% mortar flecks. Fairly loose. Overlies (310).			0.52m deep

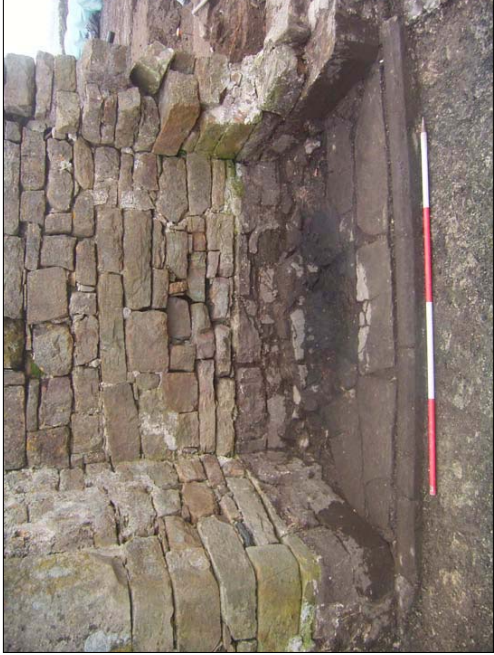
Plate 6: Fireplace 327 (from the south-west)

- 4.3.12 The flanking wings of fireplace (327) at the lowest course were shown to be of well dressed stone with chamfered corners and there were two carved stone projections at opposite sides of the fireplace. These may well have carried andirons to support the burning logs and to create an under-draught. The flagstones of the hearth (328) did not stretch to the back of the fireplace instead a crescent shaped area of rough rubble was seen, possibly the last traces of a fireback (a lining designed to protect the masonry at the back of a fireplace and to reflect heat into the room). The flagstones were bordered at the front by a stone curb. Excavation of the fireplace and hearth revealed a dark deposit with coal inclusions and a considerable amount of glass within the back hearth itself (305). Samples taken for artefact recovery contained a large quantity of window glass, and a single sherd of pottery dating to the 16<sup>th</sup> or 17<sup>th</sup> century.

- 7.3.3 The most obvious aspect of the later 16<sup>th</sup>-17<sup>th</sup> century remodelling is the large fireplace (327) in Trench 3. Although little remains, this is consistent with a 16<sup>th</sup> or 17<sup>th</sup> century date (Hall 2005, 173-6). Cutting across the earlier medieval wall (320) this fireplace, along with walls (314)/(505), must have belonged to one of the main rooms of the residence. The replacement of first floor halls with those on the ground floor was a 13<sup>th</sup>-15<sup>th</sup> century phenomenon that corresponded with more secure conditions and the need for less defensive structures (Wood 1994, 16). The suggestion from the position of the plaster surface (316) is that there were at least two phases of flooring within this room. The artefacts found within deposit (306), directly above the possible earlier floor, show the room to have been in use in the first part of the 17<sup>th</sup> century. This pattern of plasterwork at a slightly higher depth to the flagstones was also seen in Trench 5.

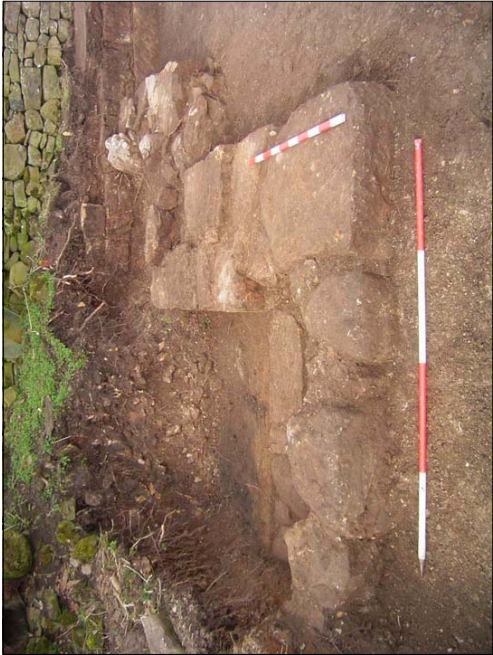
Plate 7: Walls 317, 318 and 319 (from the north-east)

319	Structure	Stone wall, south-west – north-east aligned. Squared stone blocks; no visible bonding agent; fairly regular jointing. Some galleting. Regular coursing; four courses including foundation course. 0.48m of width exposed by overlain by modern wall (329). Left <i>in situ</i> .	1.10m high
320	Structure	Stone wall, north-west – south-east aligned with south-west return. No mortar apparent appears to be bedded in a mid grey-green silty clay. Some sand and charcoal flecks. Fairly irregular jointing. Three courses remaining including a foundation course; unevenly coursed. 0.64m wide. Left <i>in situ</i> .	0.76m high
321	Structure	Three courses of stone blocks narrowing the gateway. Pale grey mortar with charcoal flecks. Regular coursed. Regular jointing. Overlies (324).	0.53m high
322	Structure	Roughly built brick pier. Bricks are reused and abraded with traces of pale white lime mortar from previous use. Size 140x100x60mm. No current bonding. Regular courses. Butts (320).	0.30m high

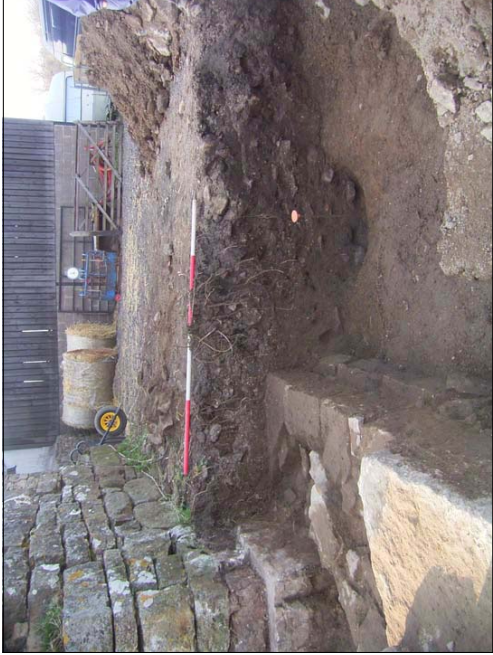
Plate 8: South-east facing section, wall 320, layers 312 and 313

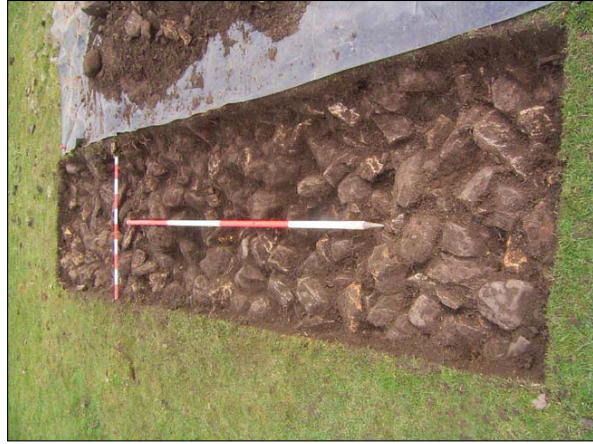
Plate 9: Pre-excavation view, Trench 4 (from the south-west)

- 7.2.3 The pond encountered in Trench 4 is likely to relate to the medieval period of occupation, but was not definitively dated.
- 7.2.4 This early period of occupation is likely to relate to the residence of the Scargill family, who were first mentioned in 1171. If the report of the visit of Edward II is to be believed then the family must have been resident here in 1323. The fortunes of the family appear to have been in the ascendant with Warin de Scargill (grandson of the original Warin de Scargill) being appointed Commissioner of Array in the wapentakes of Osgoldcross and Staincross sometime in the 1320s (Page 1914, 39-42). These are located in the West Riding of Yorkshire and it may be around this time that the family moved their main residence. We know that by Warin's marriage to Clara de Stapleton that the Scargill family now held land in the West Riding, specifically the manor of Saddleworth (Page 1914, 39-42), now located in Oldham on the outskirts of Manchester.

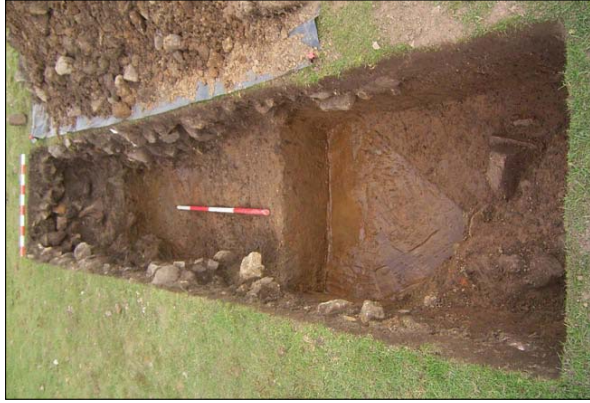
Plate 10: Post-excavation view, Trench 4 (from the north-west)

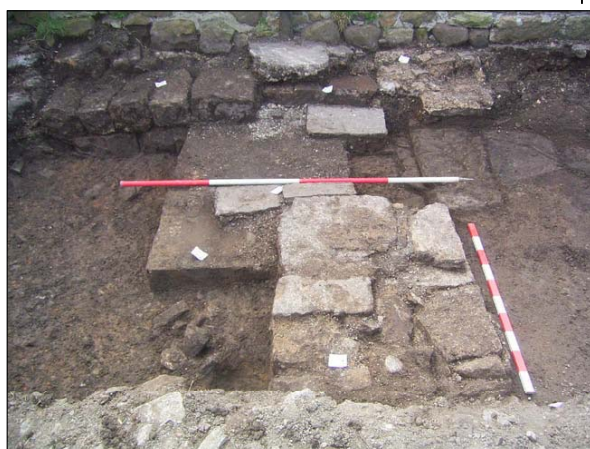
Plate 11: Wall 505 (from the north-east)

4.3.28 After removal of the yard surfacing (501) and subsequent demolition debris (502) the south-westerly extension of wall (314) was found (505) (**Figure 7, Plate 11**). In common with (314), traces of plaster were found on its northern face. A north-west – south-east wall (506) was also found to lie beneath and alongside the modern yard wall. Similar traces of plaster were found on its eastern face and lining (509), an alcove within it, a later modification of the wall. Wall (506) was cut through by (505) at the point of (508), which is probably the same as (505), the slight difference in width probably the result of seeking to build through the existing wall (506). Overlying part of wall (505) was fragments of a flagstone floor (507) bedded into layers (503) and (504), suggesting a doorway at this point. The plasterwork seemed to respect the level of this floor surface. Just to the north of the wall traces, of

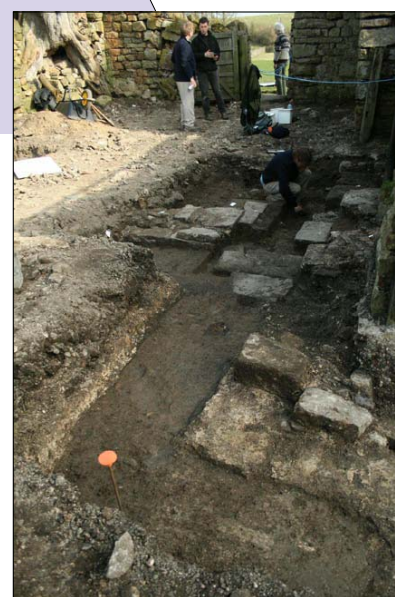
Plate 12: Trench 5, view from the north-west  
(image courtesy of Videotext Communications)

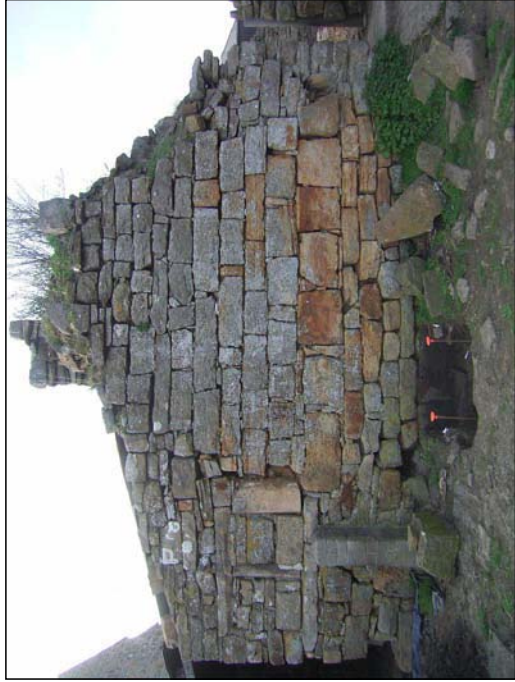
Plate 14: Position of Trench 7 and standing remains behind (from the south-east)

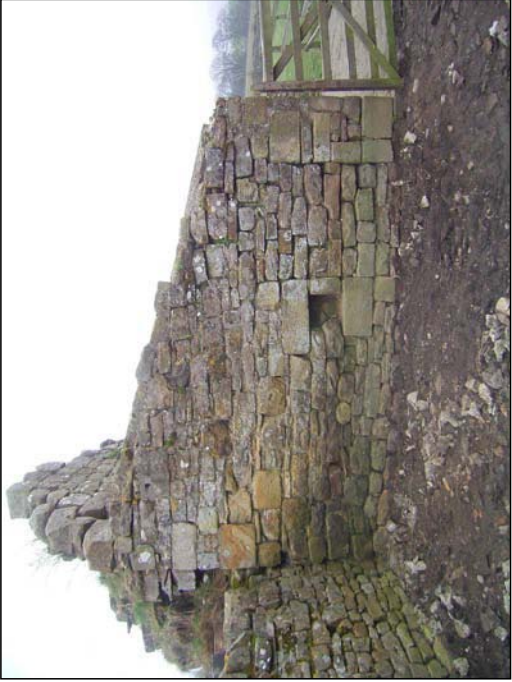
Plate 15: Standing remains (behind Trench 7) from the north-east

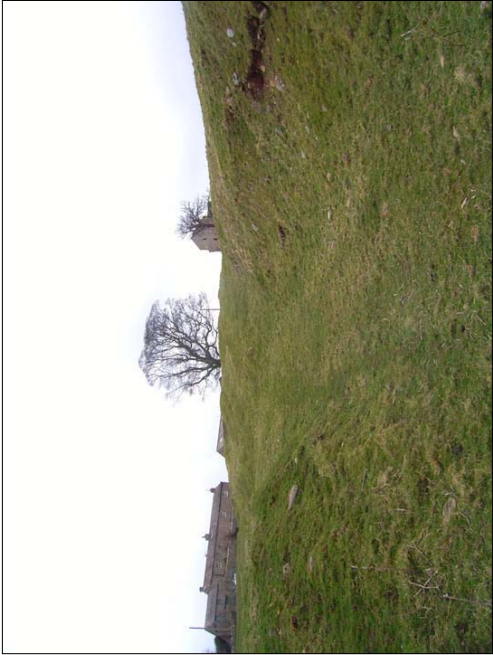
Plate 16: Holloway from Gregory Beck up to the gatehouse (view from south-west)

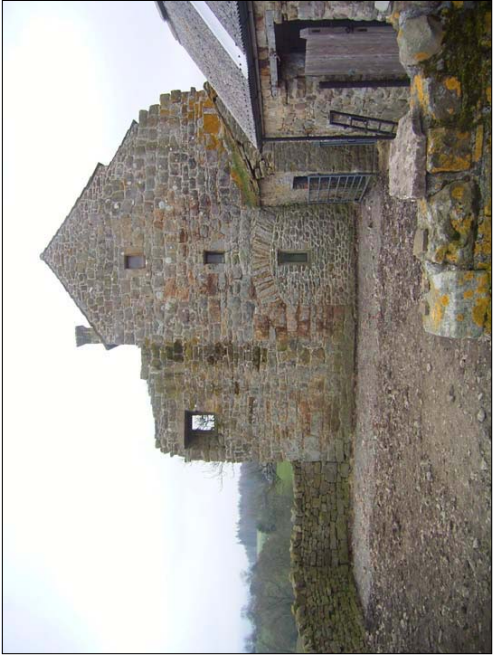
Plate 18: North-eastern elevation of gatehouse

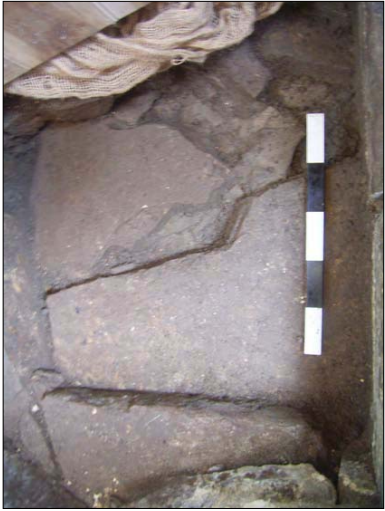
Plate 19: Flagstones revealed in gatehouse stairwell (view from south-east)

<b>THE GATEHOUSE</b>			<b>Type:</b>	Hand excavated
<b>Dimensions</b> 0.40x0.40m		<b>Max. depth:</b> 0.26m	<b>Ground level:</b> unknown	
<b>context</b>	<b>Description</b>			<b>depth</b>
	<i>Structure</i>	Flagstone fragments, the largest 0.35m long and 0.25m wide. Laid horizontally onto a mid grey-green sand. Very compact. Area 0.40 by 0.40m exposed. Surface is 0.26m down from the threshold step.		-
