Unit A1, Land at Cobdown House, London Road, Ditton, Kent

Archaeological Watching Brief Report

PLANNING REF. TM/05/00959/FL
NGR 571260,158657

WA Report reference: 72580.01

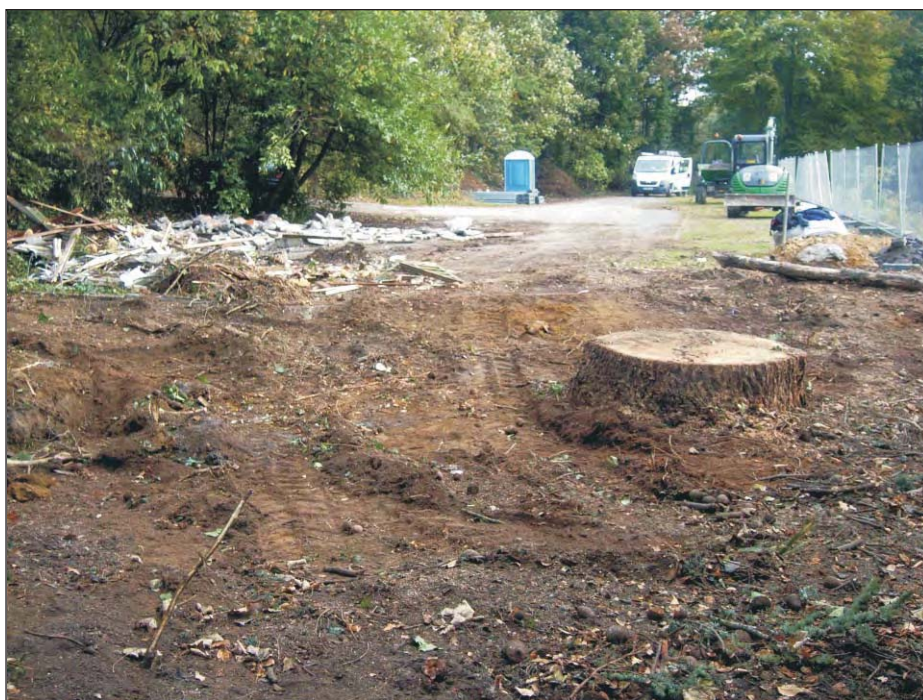
- 4.1.1 The watching brief began during clearance work (**Plate 1**), after the demolition of a small concrete structure to the north side of the tarmac hard standing for the car park and the stripping of vegetation to the west end of

Plate 1: Site after initial strip, facing north-east

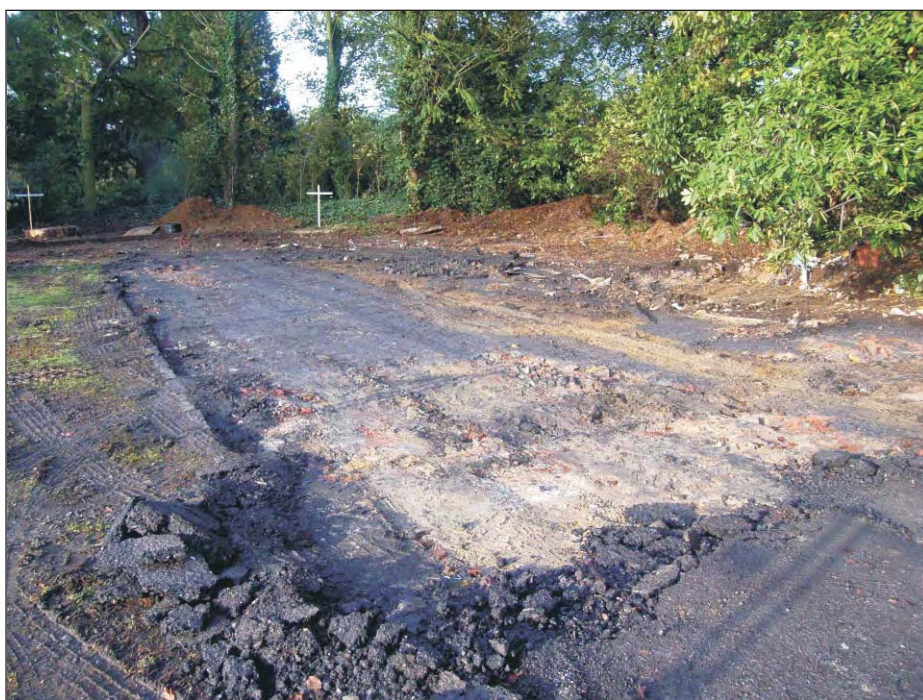
- 4.1.3 The tarmac hard standing was removed exposing the hardcore beneath (**Plate 2**). The machine excavated through this to uncover a large slab of concrete at foundation level, beneath where the tarmac had lain (**Plate 3**). When this was lifted to reveal the hardcore beneath (**Plate 4**), machine excavation of the foundation footings then begun. These layers of made ground and hard standing were only photographically recorded.

Table 1	Clearance layers	
Context	Description	Depth (m) below ground surface
001	Tarmac hard standing - for car park. Kerbed to the southeast side and southwest end of the Site. Plate 1.	c. 0m-0.10
002	Hardcore and sandy clay - the hardcore contains many broken fragments of red brick. It is often mixed within medium orangey brown sandy clay. A narrow strip of this clay is found to the north side of the area stripped. This mixed layer is stained black in places from the above tarmac hard standing (001). Plate 2.	c. 0.10-0.30
003	Concrete hard standing - Plate 3	c. 0.30-0.40
004	Hardcore - Plate 4	c. 0.40-0.50

Plate 2: Site upon removing tarmac hard-standing (001) down to hardcore (002): facing north-west

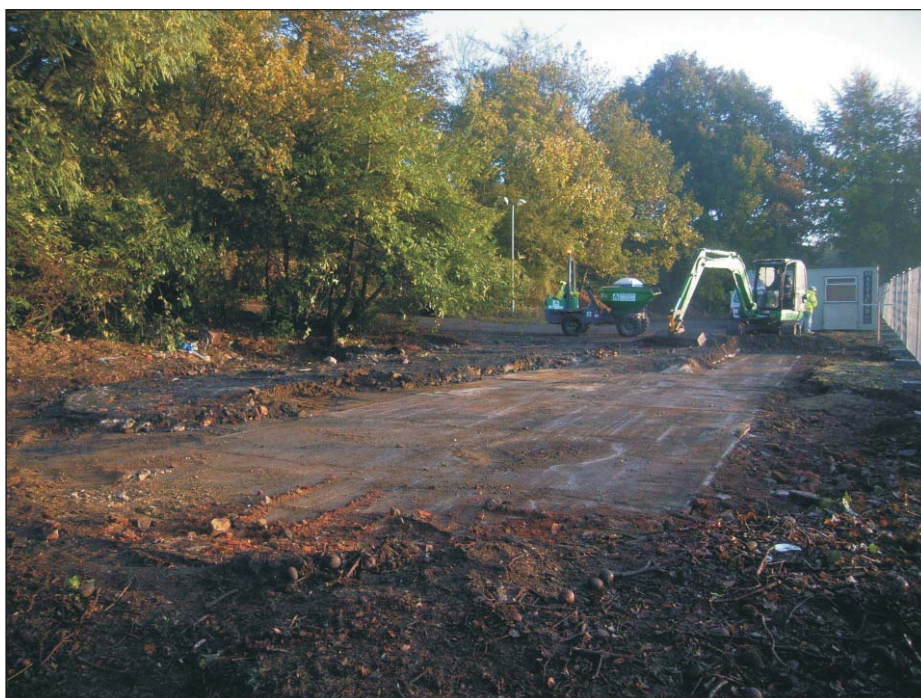
Plate 3: Site upon removing hardcore (002) down to concrete hard-standing (003): facing north-east

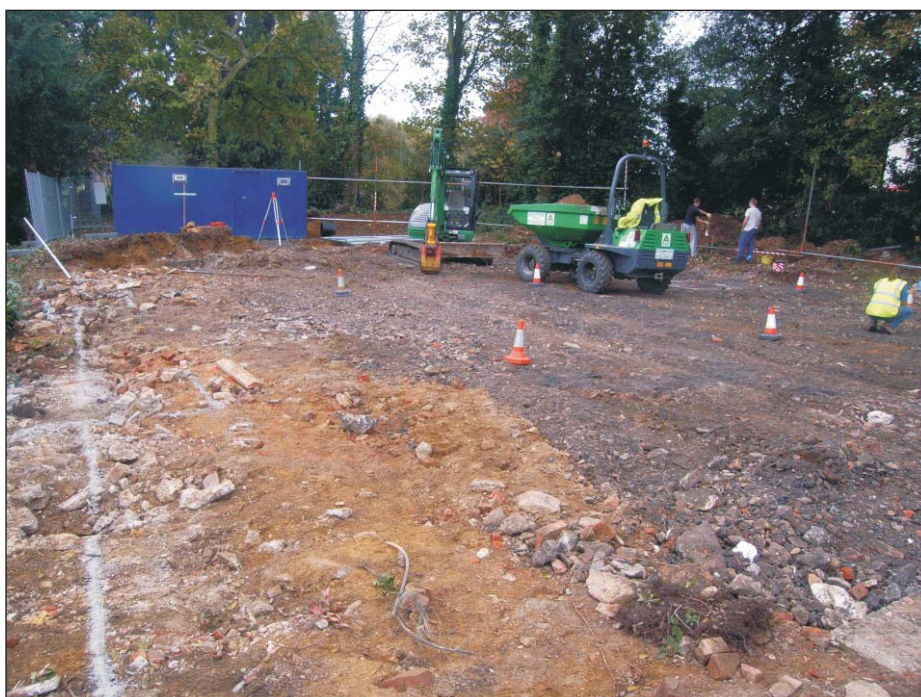
Plate 4: Site upon removing concrete hard-standing (003) down to hardcore (004): facing south-west

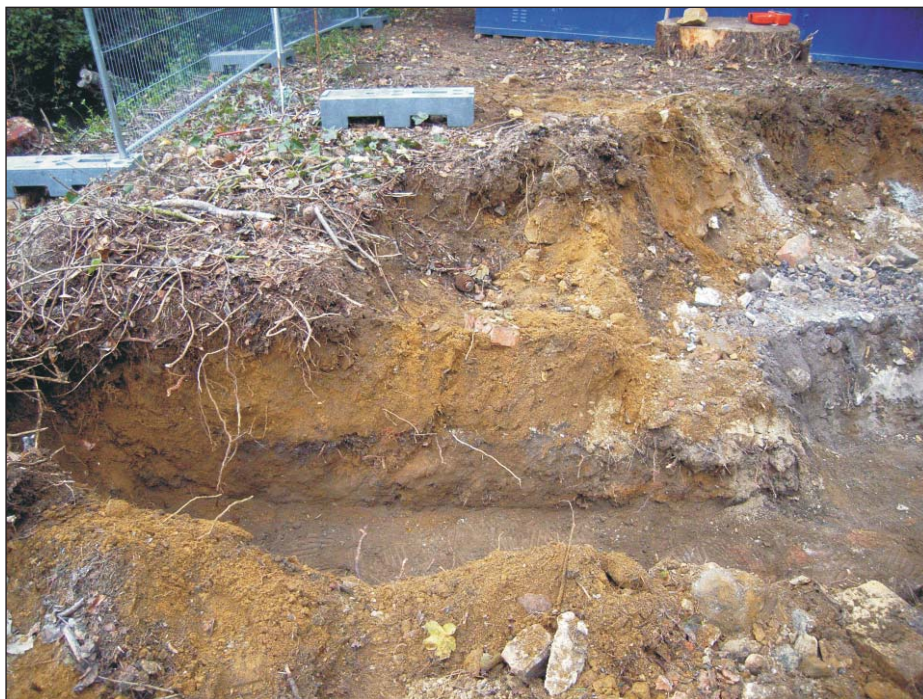
- 5.2.2 From the excavation of the first foundation footings to the southwest end of Unit A1 (see **Tables 2 and 3** in **Appendix 1** for relevant context summary tables), it was clear that much of the Site would be greatly disturbed by past construction work. At the south corner of the unit (**Plate 5**), where clearance work was less complete than elsewhere, a layer of mulch (**005**) overlay a thick layer of made ground (**006**). This relatively light orangey brown sand was deposited over hardcore (**004**), as well as a layer of medium brown sandy silt (**007**), which may be interpreted as a buried layer of topsoil or mulch. A subsoil of medium orangey brown silt (**008**) lay beneath (**004**) and (**007**). The natural (**009**) found within the south-west end of Unit A1 is a medium orangey brown silt with frequent small chalk inclusions (**Plate 6**).

Table 2	South corner (southwest end) of Unit A1 (Plate 5) (Natural not reached at point of recording. Foundation trench later deepened down into natural)	
Context	Description	Depth (m) below ground surface
005	Mulch - Loose. Medium brown. Dense matting of tree roots. Same as (010).	0-0.08
006	Made ground - Loose. Relatively light orangey brown. Fine sand. Occasional small sandstone (1.5cm x 1cm x 0.5 cm), small grit (under 0.5cm ³), and small fragments of Construction Building Material (1.5cm x 1cm x 1cm max.). Frequent roots, finer than in (005). Same as (011).	0.08-0.60
007	Buried topsoil/mulch - Friable. Medium brown. Sandy silt. Very occasional charcoal fragment. Rooted.	0.60-0.70
008	Subsoil - Friable. Medium orangey brown. Silt. Occasional small inclusions. Rooted. Same as (015).	0.70-0.78

Plate 5: North-east facing section at south corner (south-west end) of Unit A1

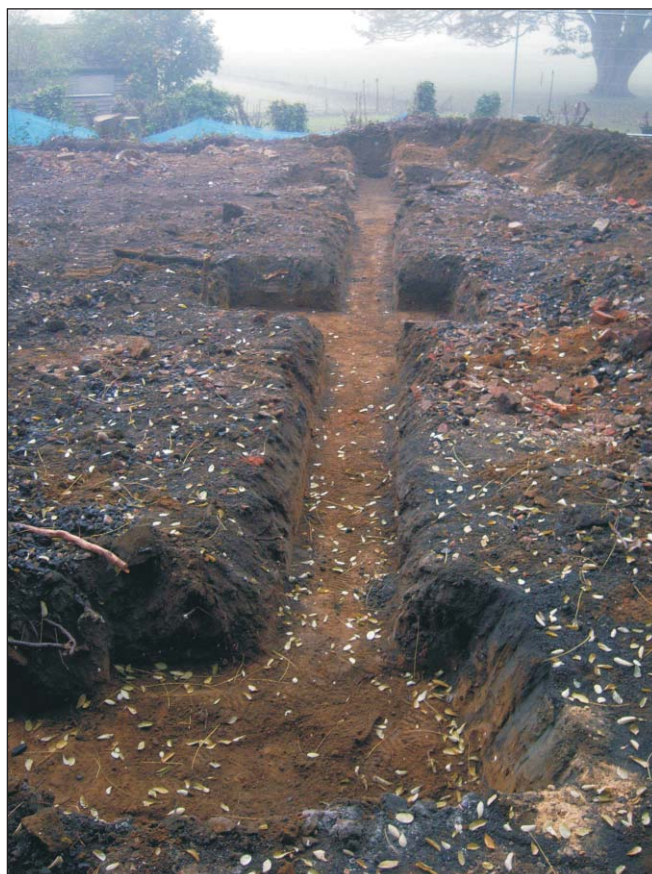
Table 3	Southwest end of Unit A1 (Plate 6)	
Context	Description	Depth (m) below cleared ground surface
009	Natural - Friable. Medium orangey brown. Sandy silt. Frequent chalk inclusions (a few mm ³ in size). Occasional charcoal flecks (several mm ³) and larger stones (c. 4cm x 3.5cm x 1cm). Occasional roots. Same as (016).	0.11-0.22

Plate 6: South-west end of Unit A1: facing south-east

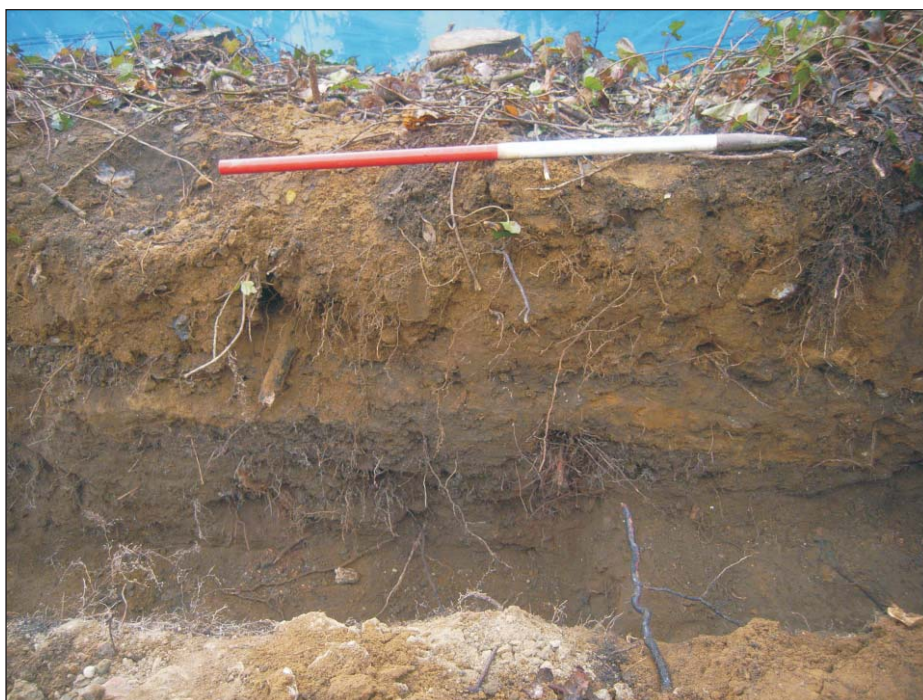
- 5.2.3 **Table 4** in **Appendix 1** is a summary record of the contexts found to the southeast side of Unit A1 (**Plates 7-9**). The top layer here is of mulch, which was partially cleared (**010**). To the very south, the underlying layer is made ground (**011**), which is the same as (**006**). This soon tails out to the north, at which point a short stretch of degraded red brick (**012**), one course thick, was observed to abut and run under the made ground (**011**). This brick layer was identified further to the east, where concrete slabs (**013**) lay over it. The layer of mulch (**010**) and brick (**012**) both overlie a layer of rooting (**014**). The subsoil (**015**), found beneath the rooting and the made ground (**006**), is the same as (**008**), and the underlying natural (**016**) is the same as (**009**).

Plate 7: North-west facing section at south corner (south-east side) of Unit A1

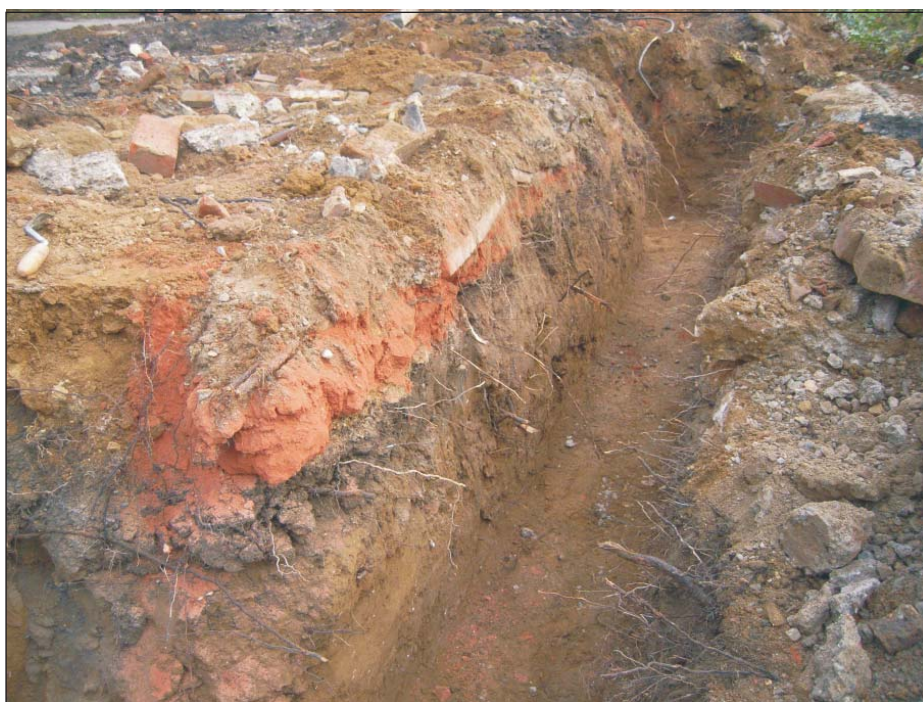
Table 4	Southeast side of Unit A1	
Context	Description	Depth (m) below ground surface (recorded at south corner)
010	Mulch - Loose. Medium brown. Dense matting of tree roots. Same as (005). Found above made ground (011) and layer of rooting (014).	-
011	Made ground - Loose. Relatively light orangey brown. Fine sand. Frequent small grit inclusions. Rooted. Located in the south corner of Unit A1. Tails out to the north within the southernmost footing 'pad'. Same as (006). Found below (010) and above subsoil (015). Plate 7.	0-0.59
012	Brick layer - one course thick within westernmost footing 'pad'. Very degraded brick. Found abutting and under (011). Possibly 13cm thick max. Less than 1m surviving. The same probable brick layer was identified further east above (014). Here, it is 0.31m thick max. Also found below (004) and (013) and above (014). Plate 8.	-
013	Concrete slabs - laid over the northernmost 2.5m long surviving stretch of brick layer (011). Plate 8.	-

Plate 8: South-east facing section at south-east side of Unit A1 showing the concrete slabs (013) and underlying brick layer (012)

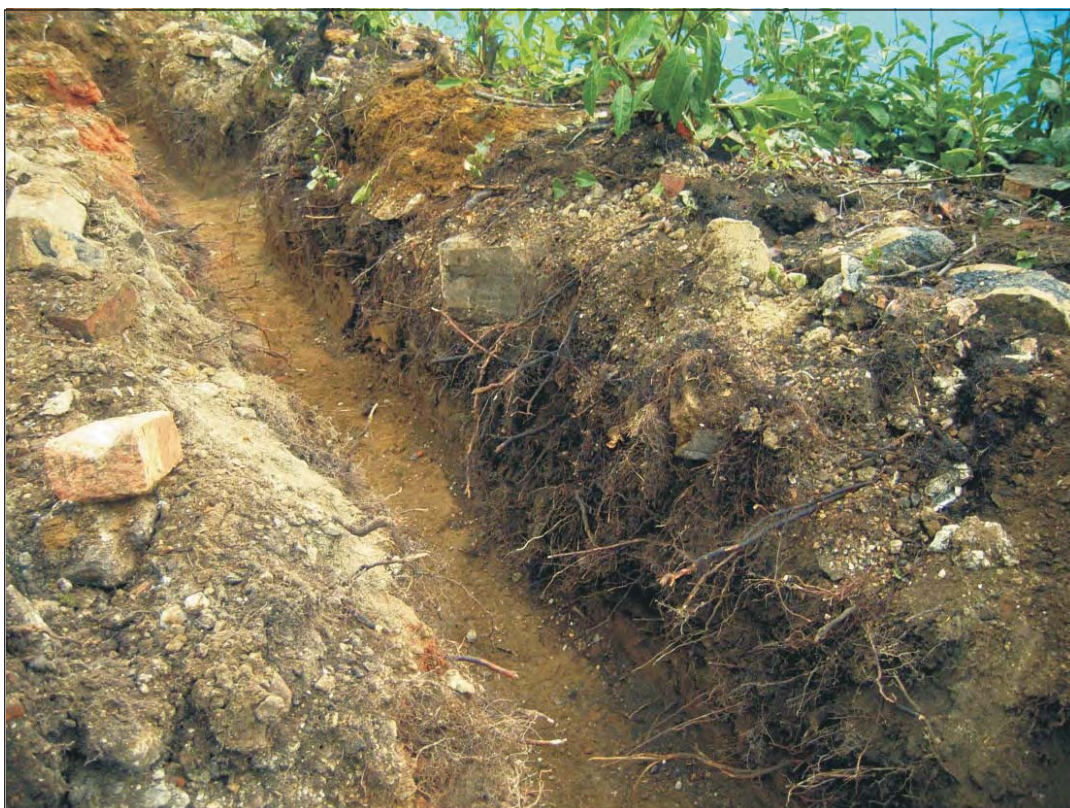
014	Rooting - layer of rooting present along the entire length of the southeast side of Unit A1. Loose. Medium to dark brown. Silt. Occasional flint (3cm x 3cm x 1.5cm). Layer is particularly thick in the section of the excavated footings beside the river, within the southernmost footing 'pad' and the footing trench to its north. Found above subsoil (015) and below the layer of mulch (010), red brick (012) and hardcore (004). Layer may be interpreted as extremely disturbed subsoil. Plate 9.	-
015	Subsoil - Friable. Medium orangey brown. Silt. Occasional small inclusions. Rooted. Same as (008). Found below (011) and (014). Plate 7.	0.59-1.11
016	Natural - Friable. Medium orangey brown, occasionally mottled with small patches of dark blackish brown. Silt. Frequent chalk inclusions (a few mm ³ in size). Occasional charcoal flecks (several mm ³) and larger stones (c. 4cm x 3.5cm x 1cm). Occasional roots. Like (015) except firmer. Same as (009). Plate 8.	1.11-1.17

Plate 9: North-west facing section at south-east side of Unit A1 showing the layer of rooting (014)
