## Land Adjoining 120 Fisherton Street, Salisbury, Wiltshire

### Archaeological Evaluation Report

Report reference: 65540.01

**April 2007**

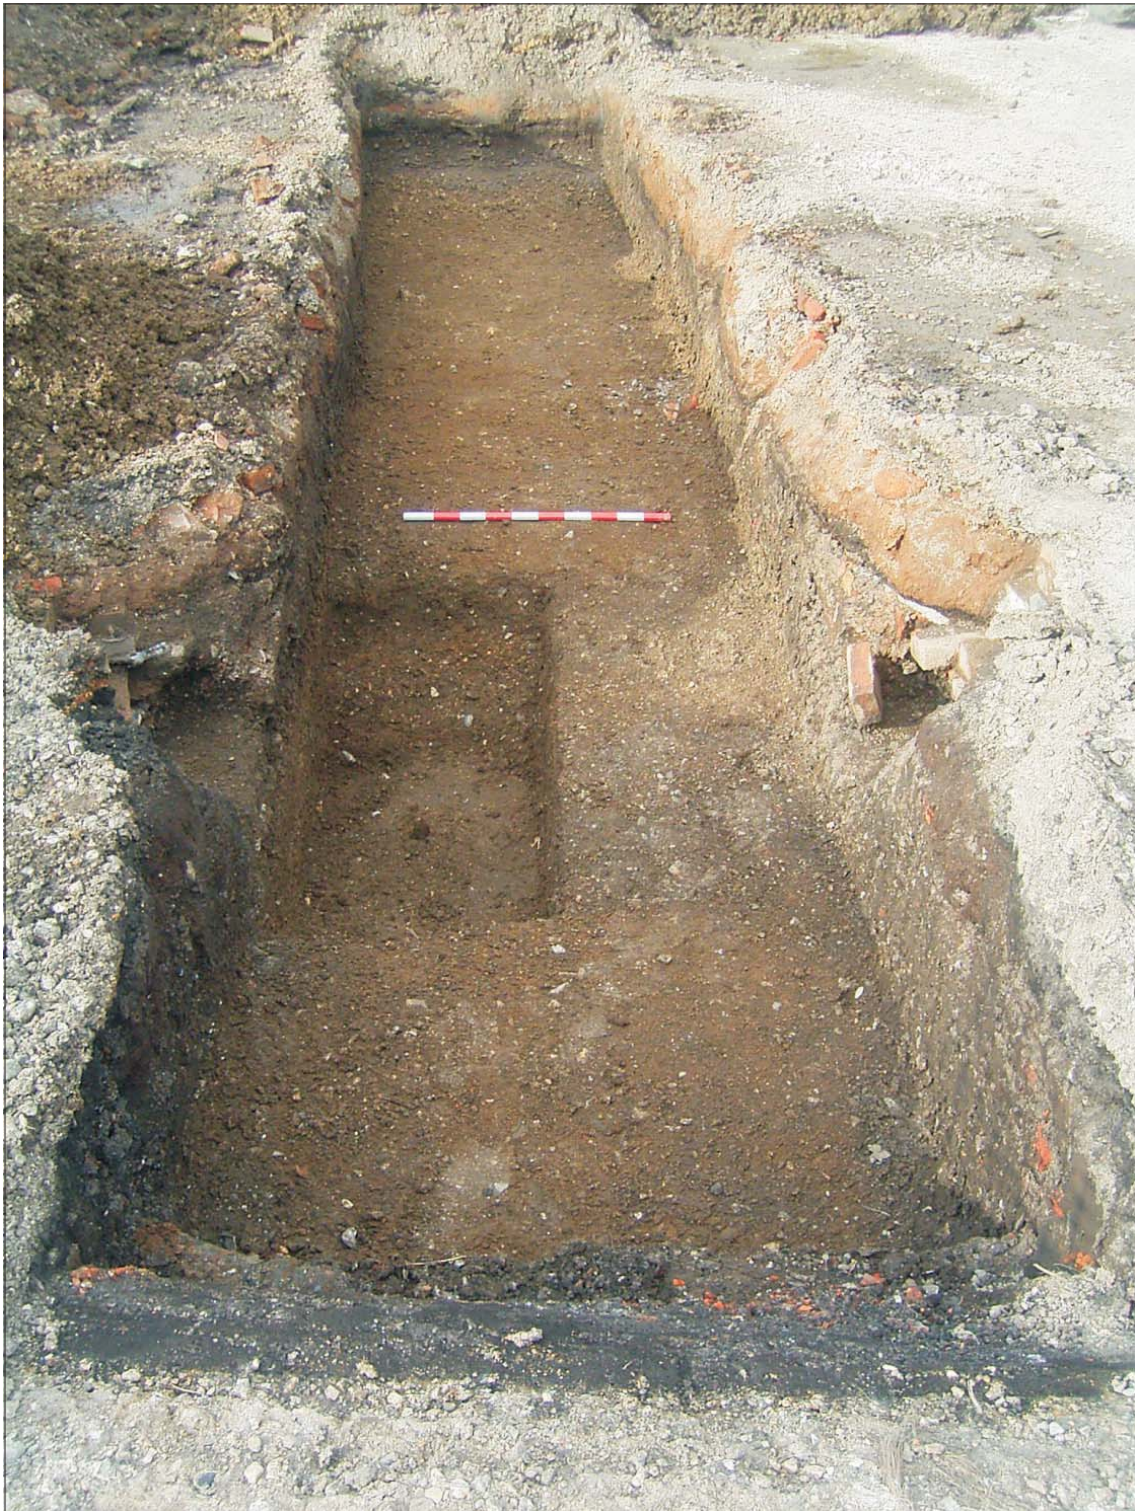
**Front cover - Trench 1 during evaluation**

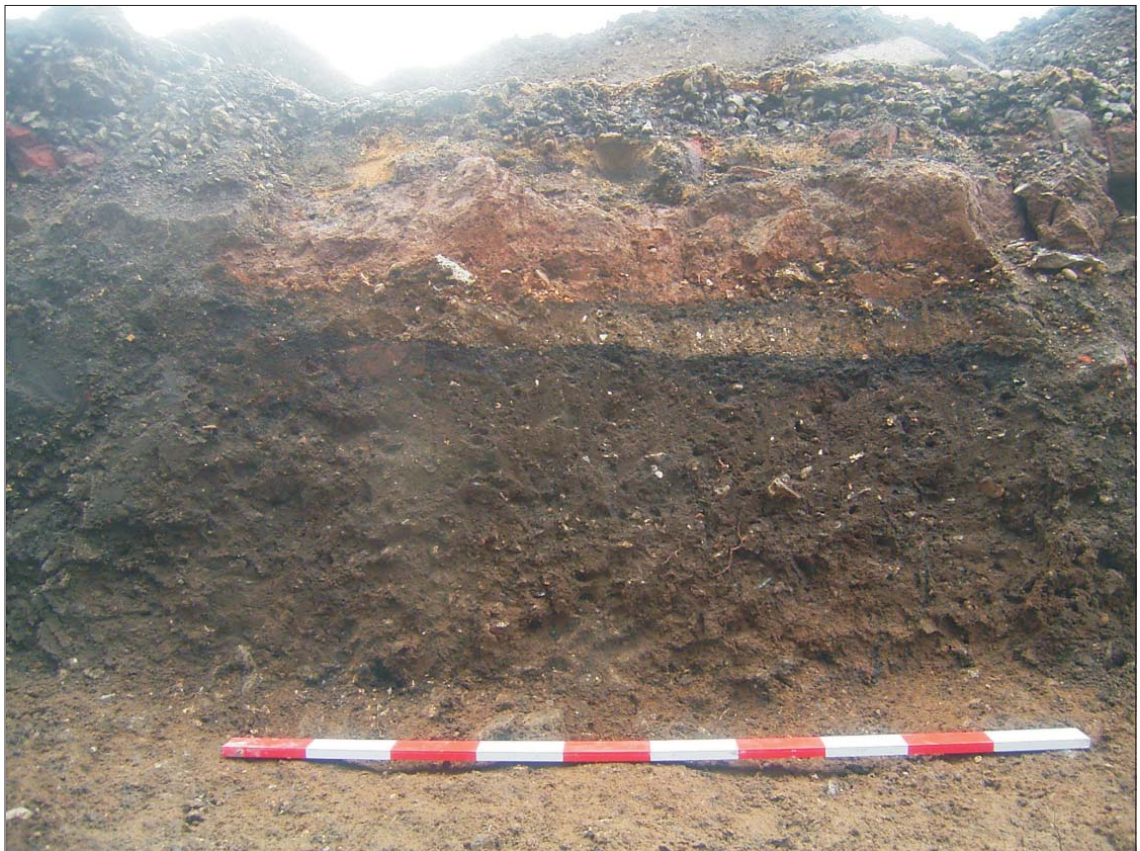
**Back cover - The soil profile and overburden, Trench 2**

5.1.1 Both trenches exposed the same sequence of deposits comprising 0.45m of overburden laid over a former topsoil on river gravels.

- 5.1.5 The relic topsoil was between 0.25m and 0.30m deep. It had an irregular, gradual boundary with the gravels below. There was a suggestion of some worm sorting to this layer as the top 0.1m contained few, small flints while the base was more stony with larger flints. The sandy clay texture was similar to that of the highest layer of gravel and was presumably derived from it.
