## Fingringhoe and Middlewick Ranges and Friday Wood DTA Colchester Training Area DTE East, Essex

Archaeological Desk-Based Assessment and Monument Condition Survey

Report reference: 68560.01

**March 2008**

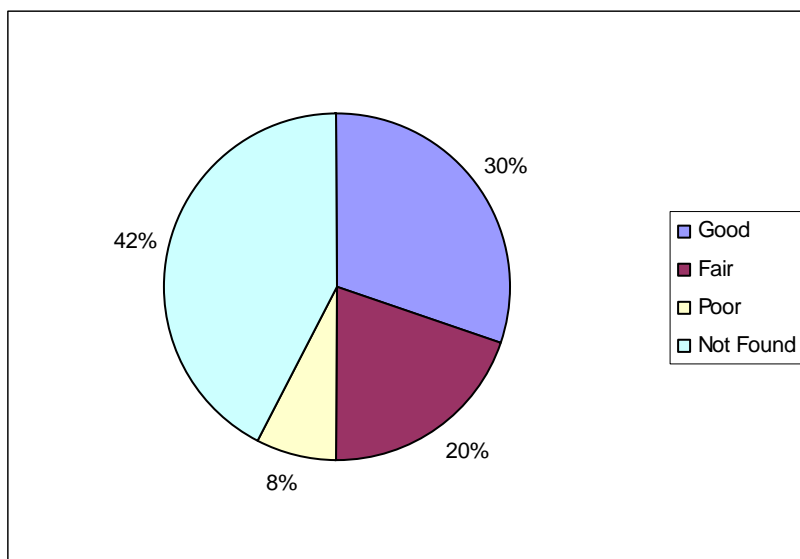
Chart 1: Percentage Monument Condition

- 4.2.1 As shown in Chart 1, 50% of the monuments surveyed were either in Good or Fair condition. Only 8% of the monuments were recorded as being of Poor condition. However, 42% of monuments were recorded as Not Found. The majority (61%) of the Not Found monuments relate to either cropmarks, previously excavated features or temporary military features (e.g. gun emplacement, slit trench) which are no longer extant within the landscape. If the Not Found monuments are not considered, the percentage of Good, Fair and Poor monument condition is 53%, 34% and 13%, respectively.

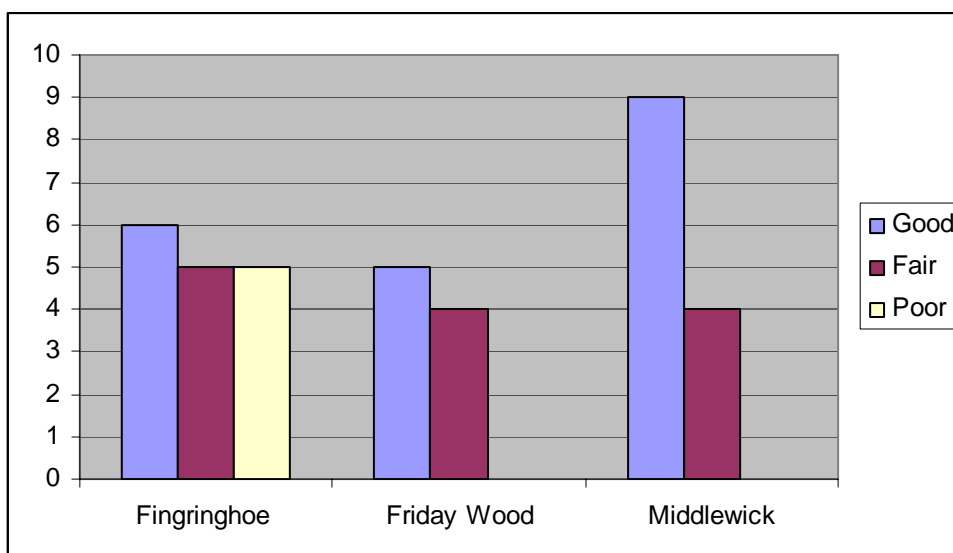
Chart 2: Monument Condition by Training Area

- 4.2.3 The monuments recorded as being of Poor condition are all located within Fingringhoe Range (Chart 2). Four of these monuments are red hills which are under active and extensive erosion from burrowing animals and a WWII pillbox which is incorporated into the sea wall and the concrete structure is collapsing (WA63).
- 4.2.4 In contrast, the three listed buildings within Middlewick (WA38, 46, 52) are all considered to be in Good condition and the Scheduled Monument of Berechurch Dyke (WA12) is assessed as being in Fair condition (**Plate 2**).

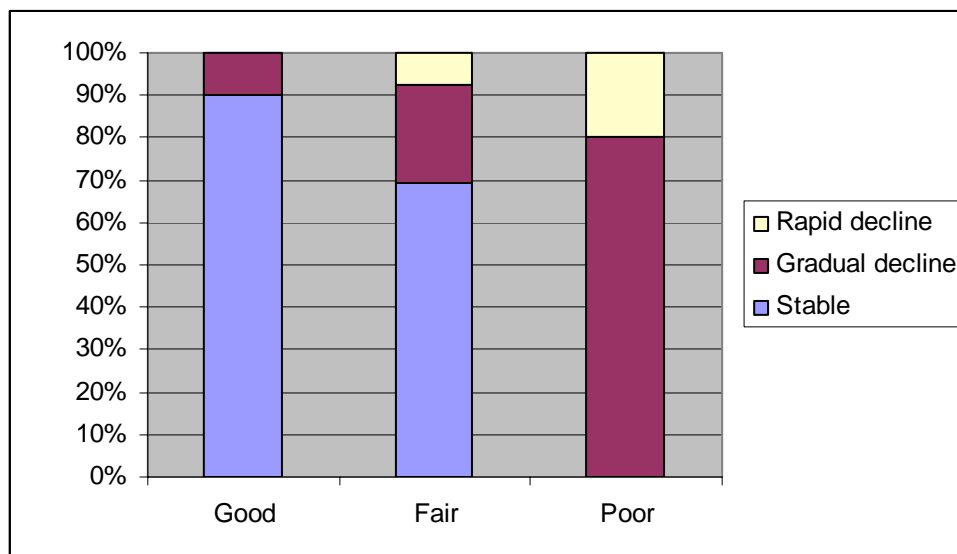
Chart 3: Stability and condition of monuments

- 4.3.1 The majority (71%) of the recorded monuments are considered to be Stable, with 24% recorded as Fair and 5% as Poor. The stability of the monuments are compared to condition in Chart 3.

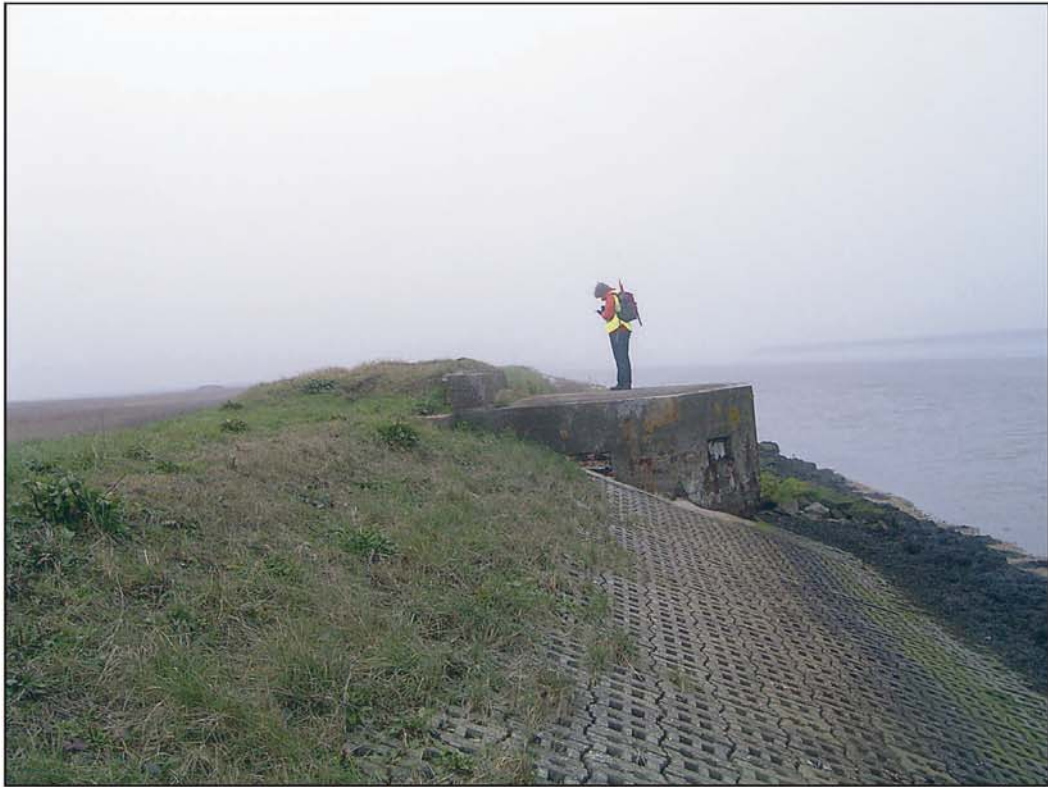
Plate 1: Pillbox **WA 63** and sea wall, Fingringhoe Ranges, view north-west

- 4.3.2 Only two monuments of Good condition are considered to be in Gradual Decline. Both are WWII pillboxes, in Fingringhoe (WA63) and Middlewick (WA 78), but are declining due to different impacts. WA63 has been built into the current sea defences and is declining through natural weather and tidal conditions whilst WA73 is being vandalised through burning and graffiti.

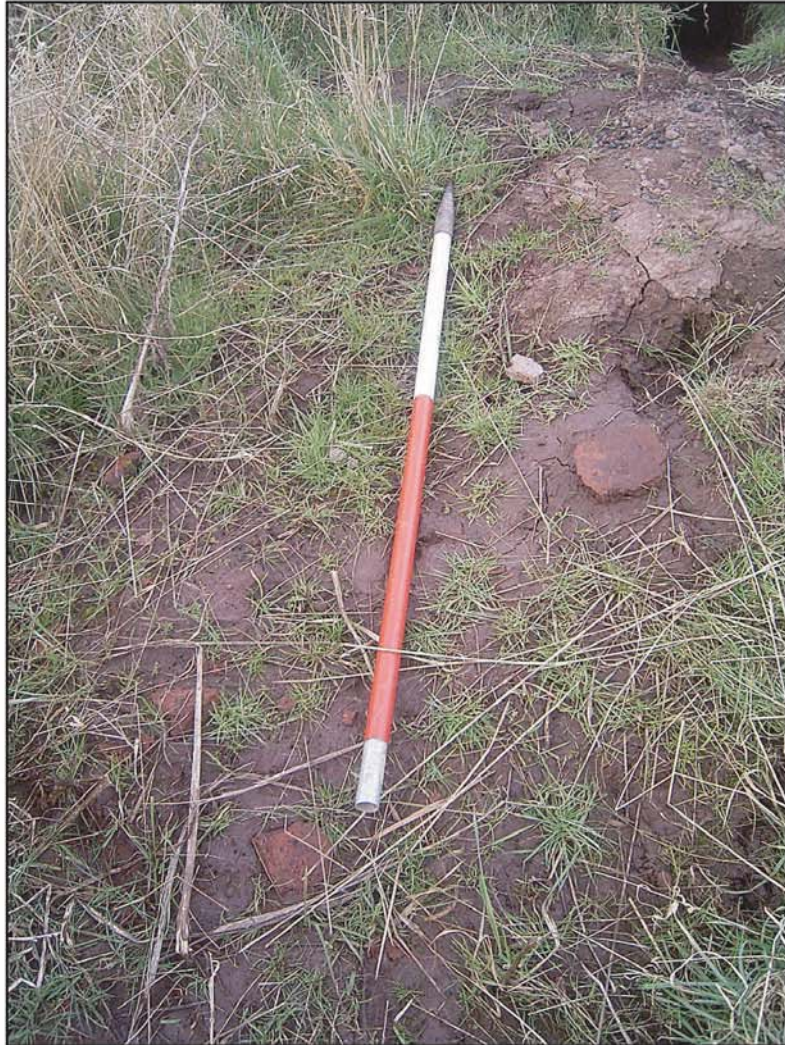
- 4.3.3 A red hill monument (WA92) of Fair condition is considered to be under rapid decline in Fingringhoe due to the excessive animal burrowing which is revealing large fragments of briquetage (**Plate 3**). The earthwork monuments of the Iron Age Berechurch Dyke (WA12) in Friday Wood and post-medieval 'The Fort' Redoubt (WA55) are considered to be in Fair condition but are of Gradual Decline. On the Iron Age monument this is due to burrowing animals and the encroachment of scrub whilst pedestrian and cycle erosion as well as fly tipping is affecting the redoubt (**Plate 4**).

Plate 3: Redhill, **WA 92**, Fingringhoe Ranges showing briquetage and animal burrowing , view north.

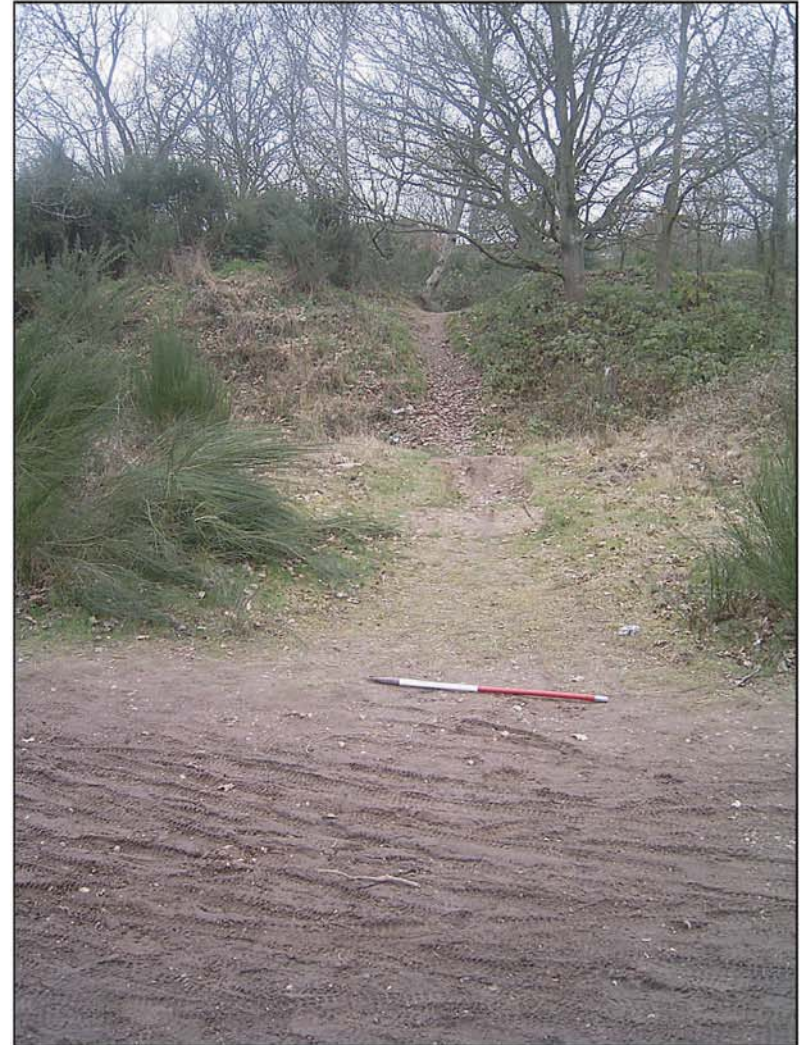
Plate 4: 'The Fort', Civil War redoubt, **WA 55**, Middlewick Ranges, showing cycle and footpath erosion, view north

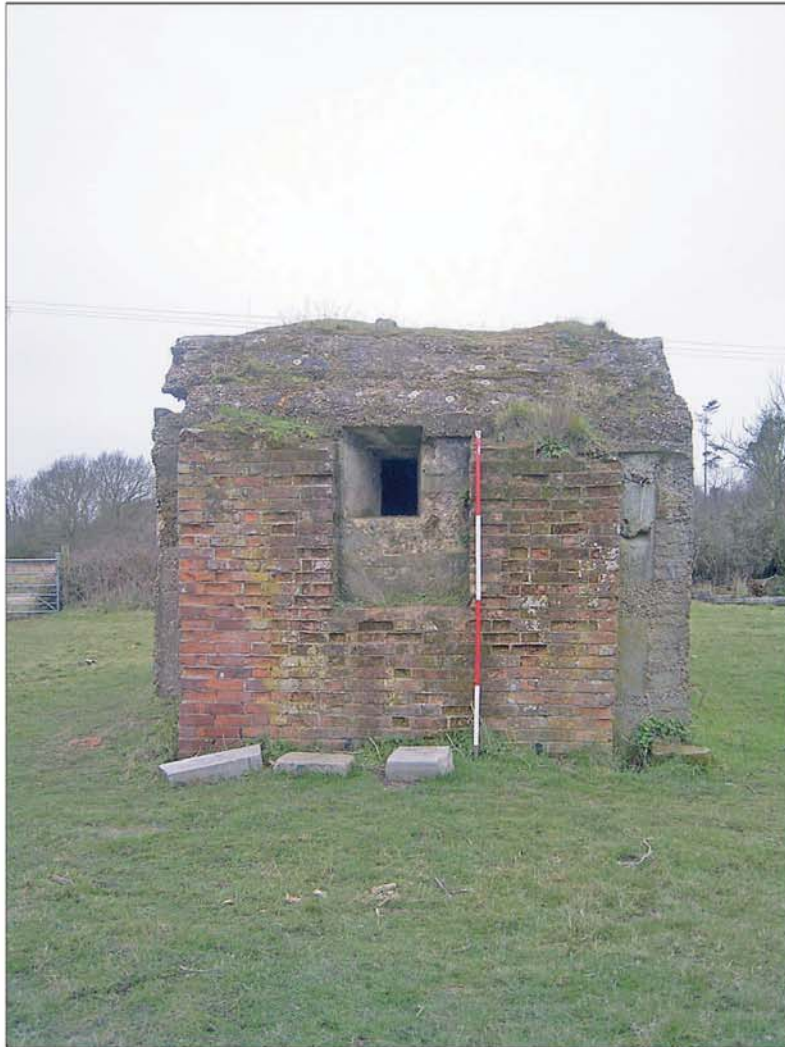
Plate 5: Military bunker, Rock Farm, Friday Wood Training Area, **WA 203**, view south.

- 3.12.2 During the condition survey, low earthworks were noticed north of Rock Farm and north-east of bunker WA 203 in Friday Wood. These were given a WA no 204 and are considered to be the remains of farm buildings showing on the OS 1881 (Figure 11) and 1924 maps (not reproduced).

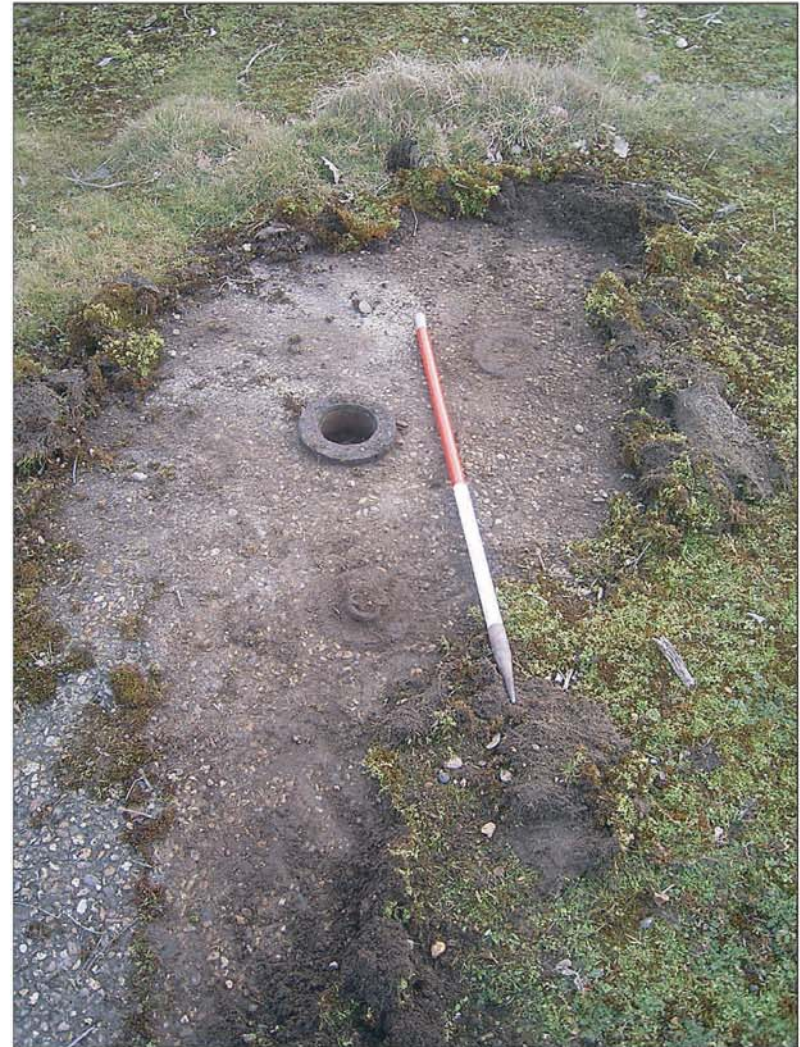
- 3.11.7 An anti-aircraft battery (WA69) was positioned west of Friday Wood Farm (**Plate 6**). An RAF aerial photograph taken in March 1945 shows four square gun emplacements, each with four internal ammunition recesses. They are in a rough semi-circle facing south. There is no sign of the command post. The same photo shows fields to west and north-west criss-crossed with anti-glider ditches (WA70). The area of the gun emplacements is now a rough meadow of gorse and grass with some of the concrete bases of the emplacements still visible. At the site of the eastern-most emplacement, at NGR TL 9832 2119, part of the pattern of holdfast fittings can be seen. These consist of the acceptance ring for the mounting plate locating spigot, flanked by four of the levelling nuts which are screwed onto the holding-down bolts. There is another reported site of a gun emplacement east of Rock Farm (WA205). This is not listed on the HER or UAD and was reported to the author by a Landmarc member of staff. Nothing could be seen on the ground at the spot and the location remains conjectural.

Plate 6: Holdfast fittings for gun emplacement, part of WW2 anti-aircraft battery **WA 69**, Friday Wood Training Area, view south
