**A DETACHED ROMAN BATH-HOUSE AT TRUCKLE HILL
NORTH WRAXALL
WILTSHIRE**

**Assessment Report on an Archaeological Excavation, Recording
and Outreach Programme**

**WA Document Ref. No. 58521.01
(EH ref. 5418 Truckle Hill)**

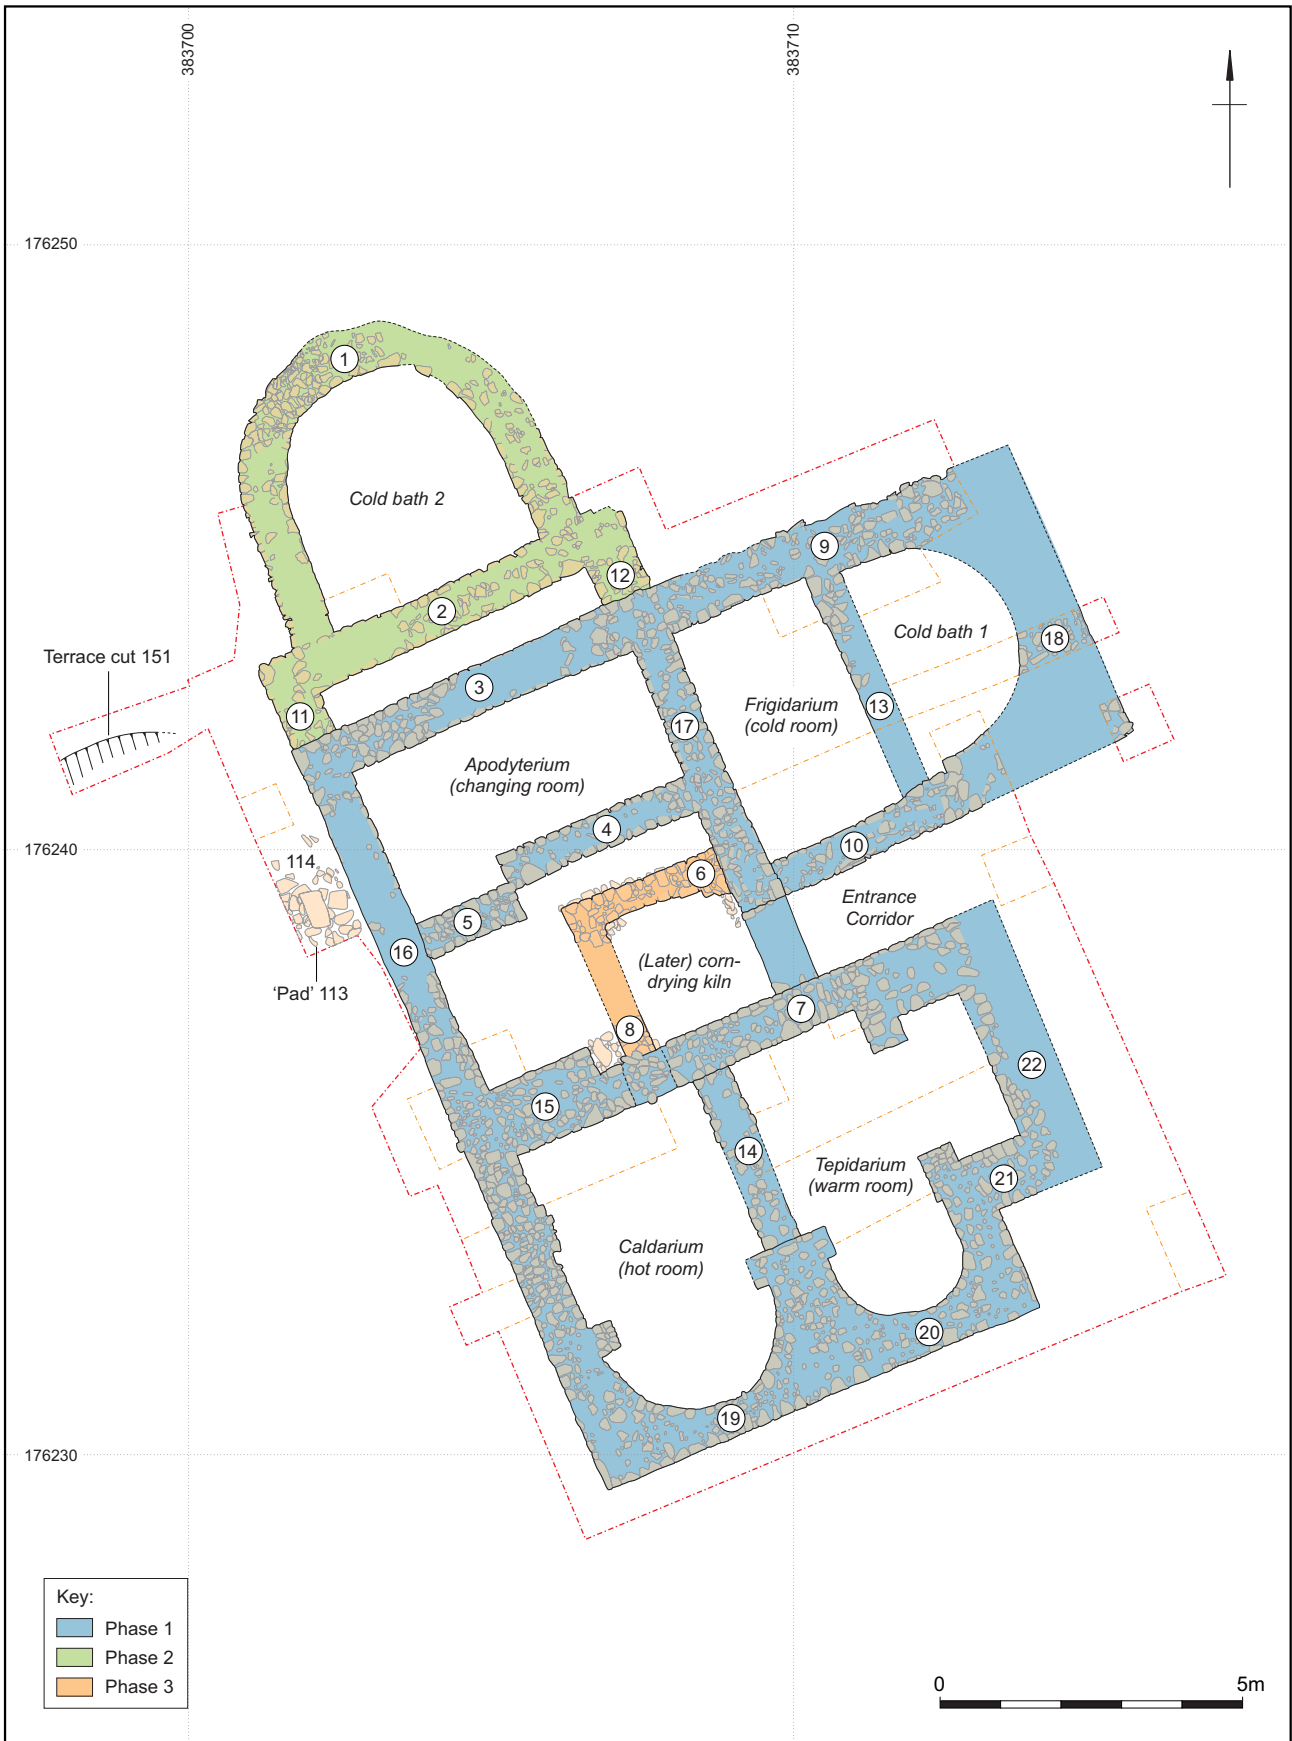
Figure 2

Plan of bath-house, as recorded in October 2007

5.1.5 The bath-house is described by individual element below, followed by the evidence for external features, the later agricultural use of the building and, finally, antiquarian investigations. (Note: Although all wall numbers appear on **Figure 2**, the majority of layer numbers referred to in the text below are not shown on this figure. Further details may be found in **Appendix 1**).

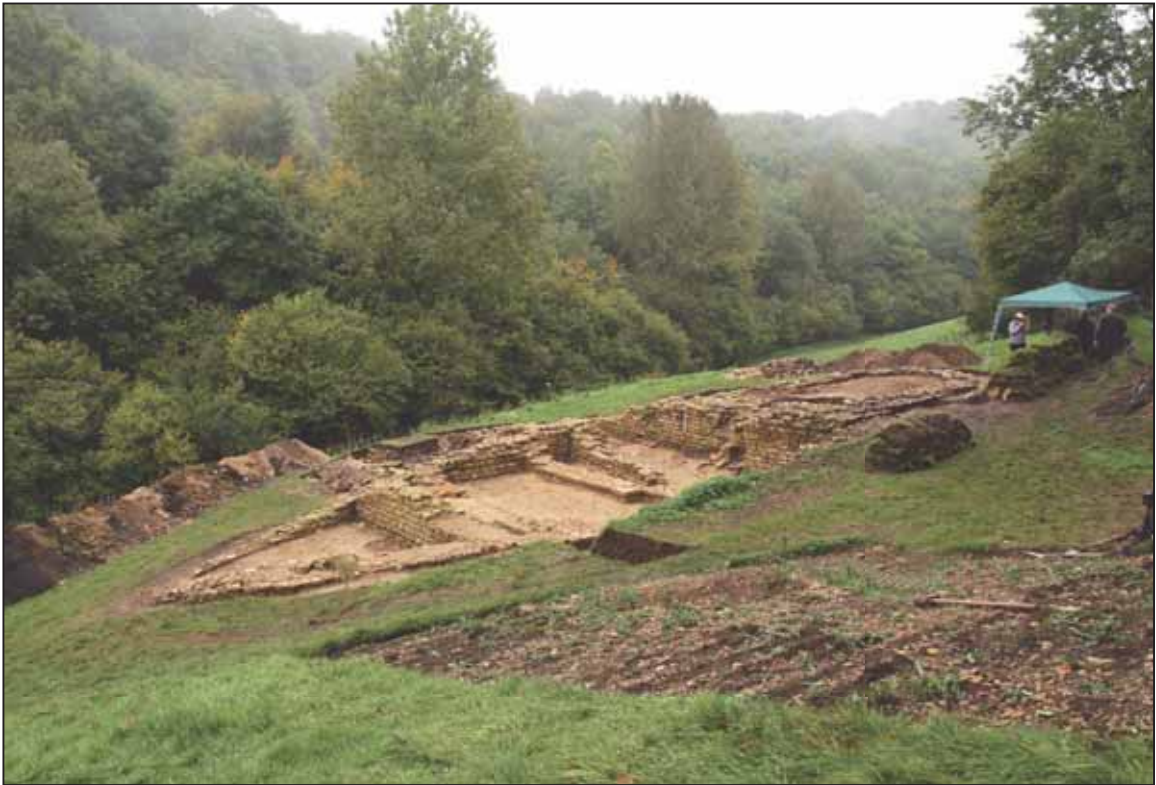
Plate 1. Bath-house following completion of excavation (scale = 1m; view from north-west)

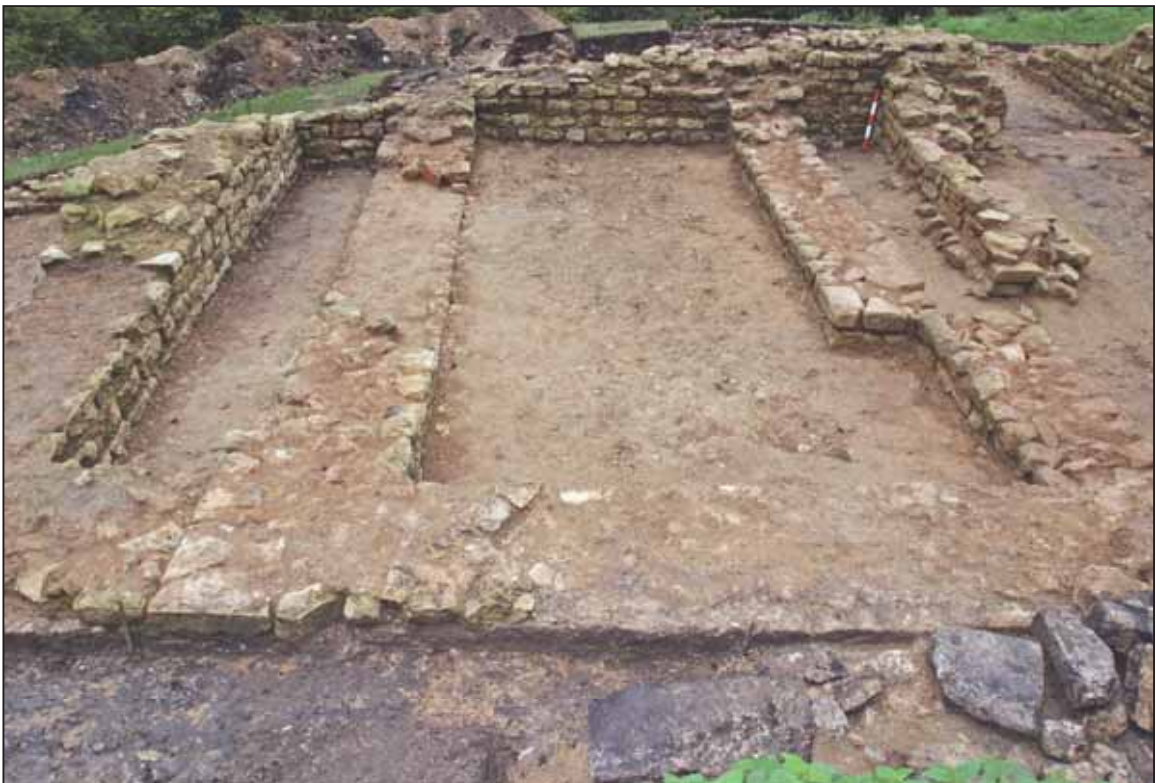
Plate 2. *Apodyterium* (changing room); later extension to left, offset dividing walls right, entrance corridor upper right. Note also wall of later corn-drying kiln to right of offset dividing walls (scale = 0.5m; view from west)

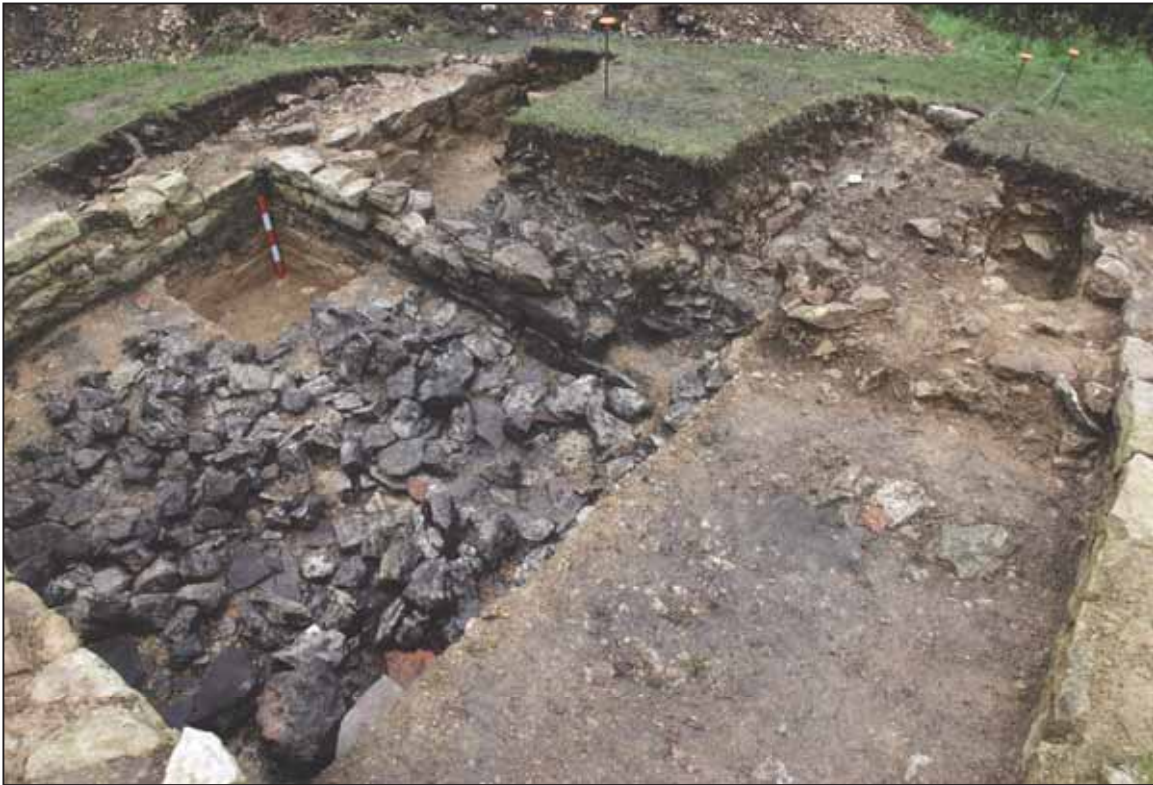
Plate 3. *Frigidarium* (cold room) / cold bath 1; collapsed rubble (127) in upper half of room in foreground, apsidal bath (largely unexcavated) in background (scale = 0.5m; view from south-west)

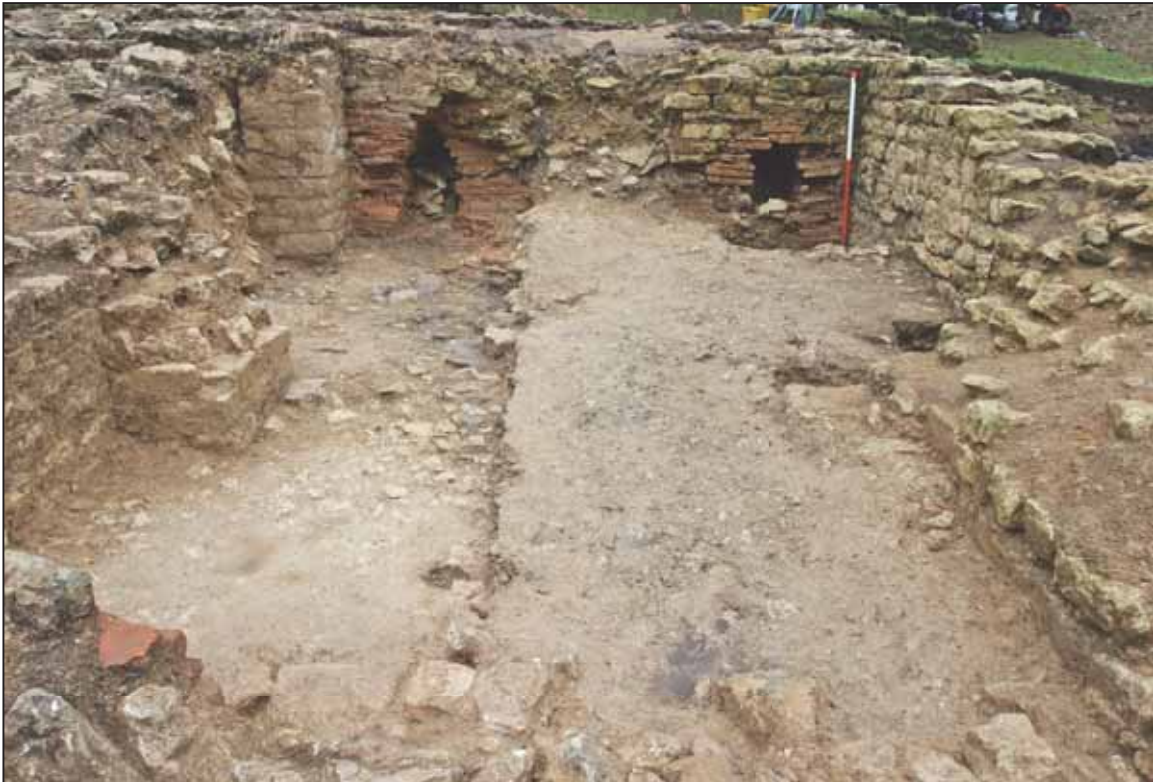
Plate 4. *Tepidarium* (warm room); annexe in foreground, flues between hot room and warm room in background (scale = 1m; view from east)

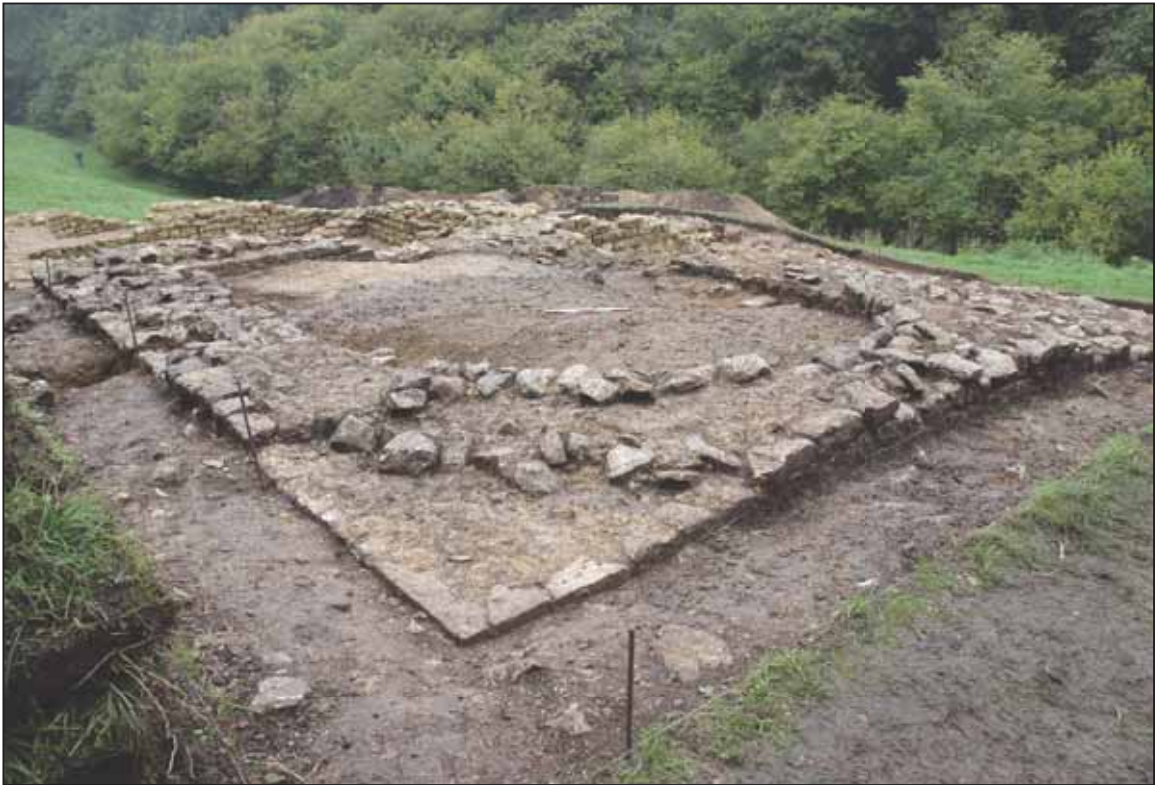
Plate 5. *Caldarium* (hot room); apsidal / square south end exposed (scale = 0.5m; view from south-west)

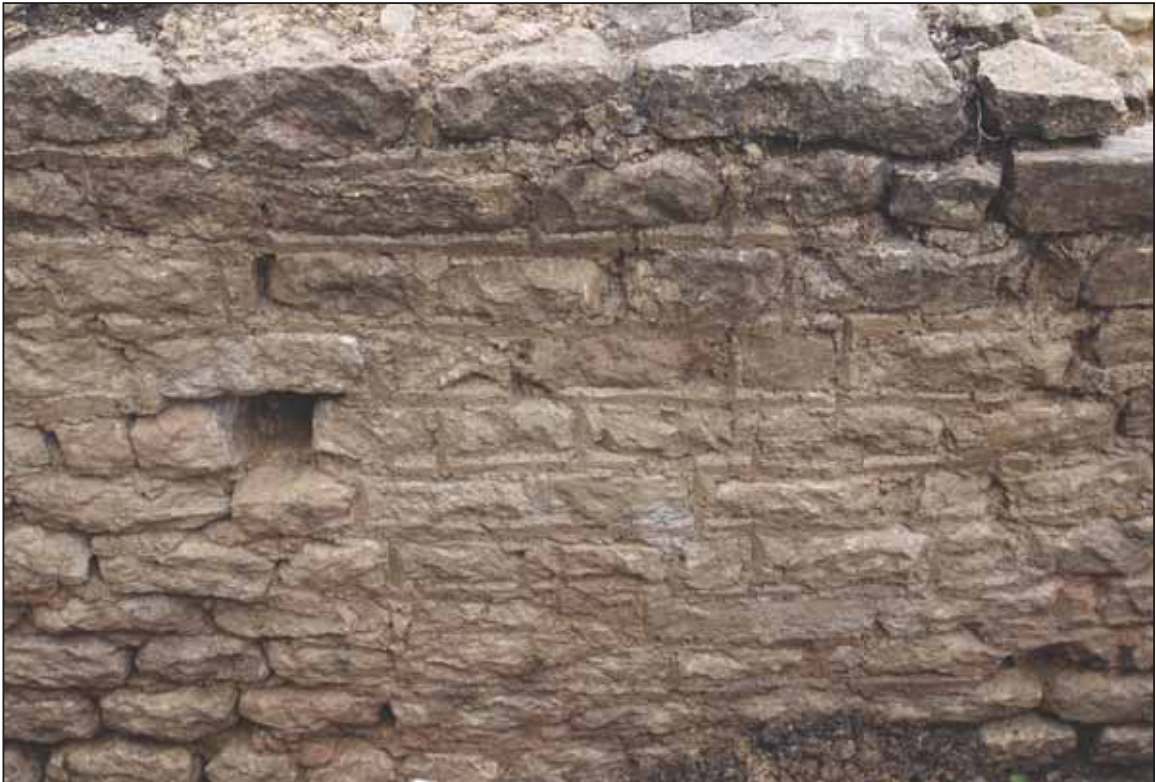
Plate 6. *Caldarium* (hot room); north wall (west end) showing struck pointing (no scale; view from south)

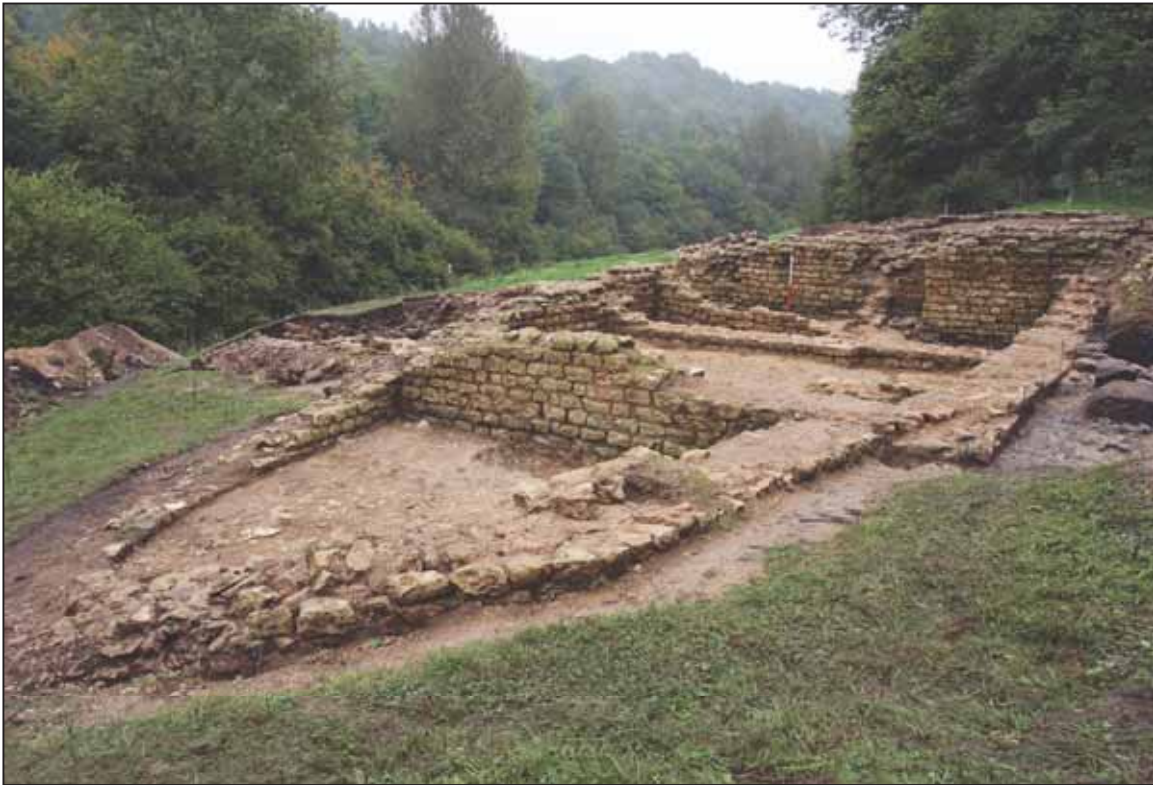
Plate 7. *Frigidarium* (cold room) / cold bath 2; cold room / bath 1 centre left, changing room centre right (scale = 1m; view from north-west)

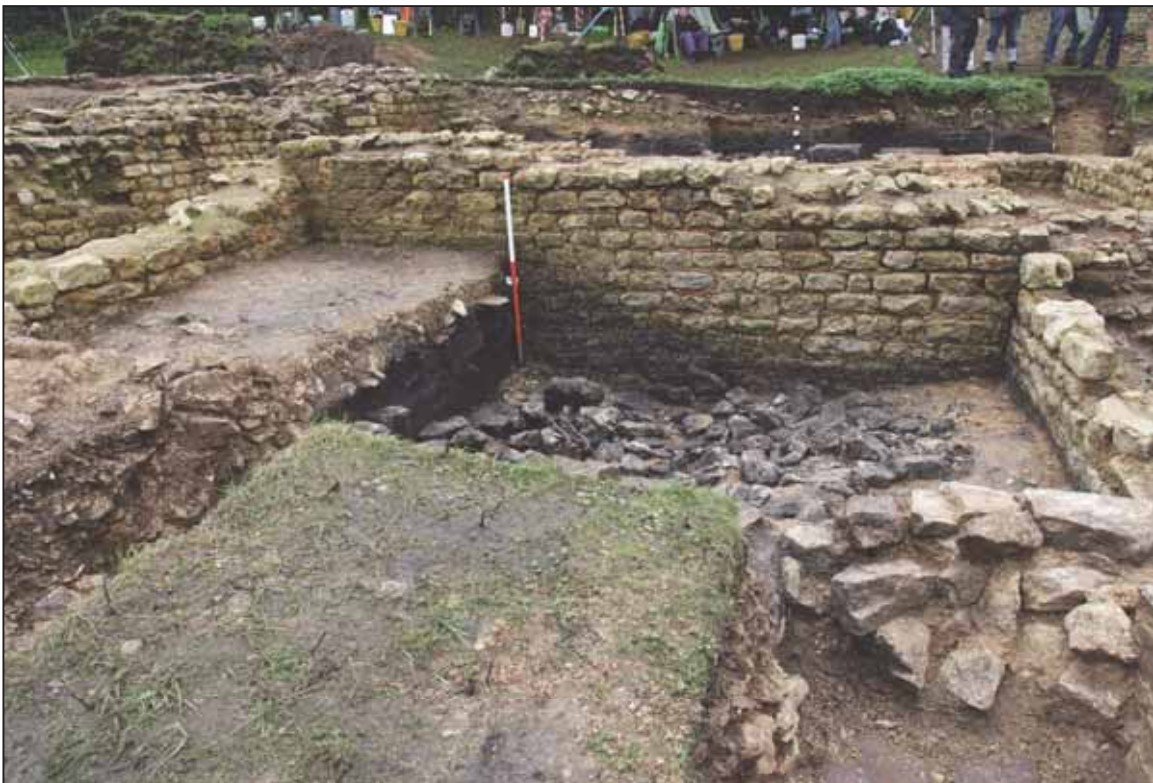
Plate 8. *Frigidarium* (cold room) / cold bath 1; collapsed rubble in upper half of room overlain by burnt cereal deposits (108) derived from later corn-drying kiln. Note a further layer of burnt cereal deposits (112) exposed at base of section behind (to west) of bath-house (scale = 1m; view from east)

- 5.9.3 Overlying the demolition / collapse rubble (127) within the *frigidarium* and extending eastwards across the rubble infill in cold bath 1, was a substantial, black deposit (108) extremely rich in charred cereal remains (**Plate 8**). This was up to 0.45m thick where it had been dumped against wall 17 and presumably represents spoiled debris from the corn-drying kiln. Layer 108 was sealed by layer 126 which largely comprised loose mortar probably derived from subsequent weathering and erosion of the extant bath-house remains, prior to them becoming buried beneath colluvial deposits.
