A Possible *Nymphaeum* At Truckle Hill, North Wraxall, Wiltshire

Interim Report on the 2010 Archaeological Excavation
and Outreach Programme

WA Document Ref. No. 74690.01

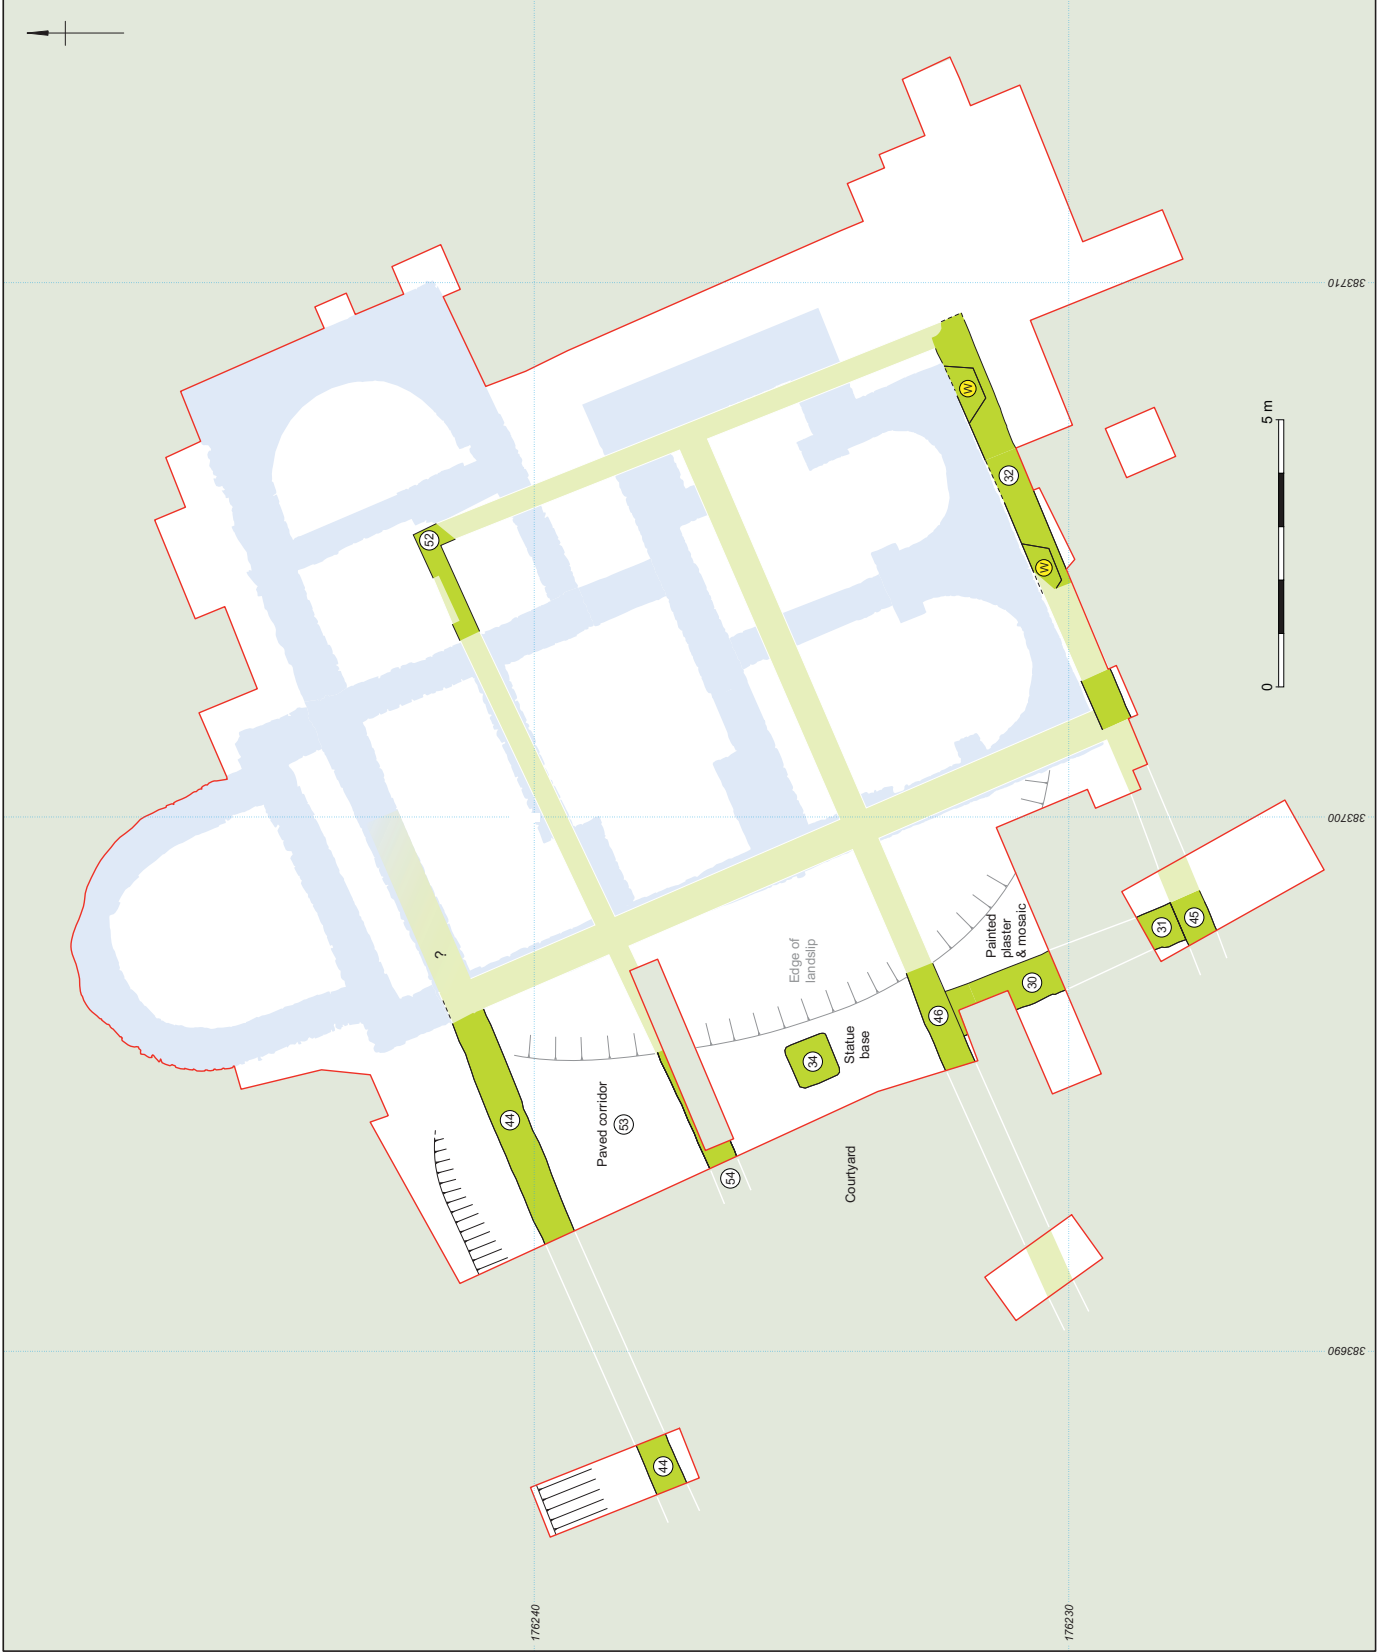
Figure 3

Plan showing details and projected extent of period 1 building

*North side (Trench BB. **Figure 3; Plate 8**)*

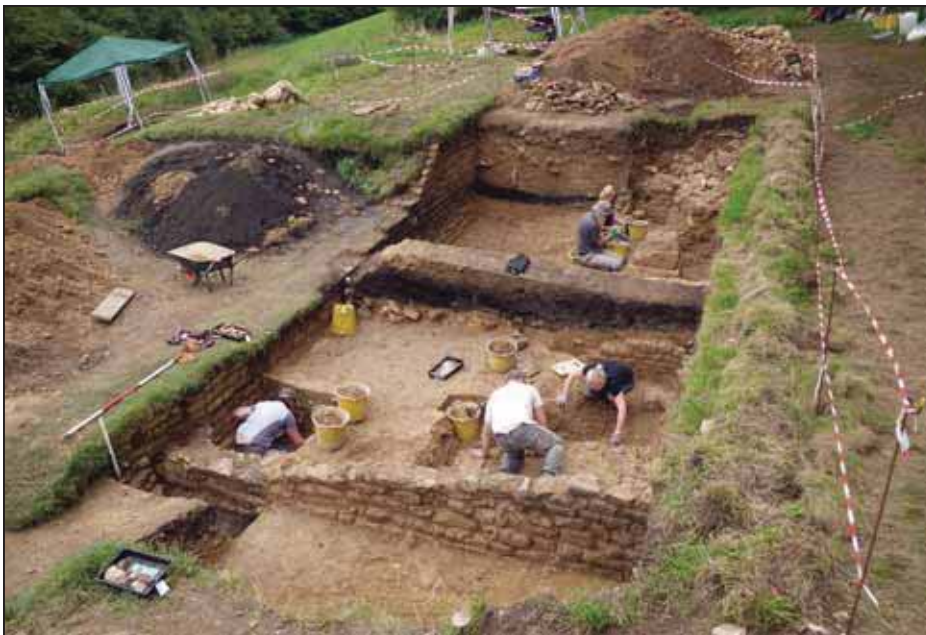
Plate 2: Advanced stage of excavation (Trench AA): Period 1 walls 44 and 54 in the foreground (with paved corridor 53 between) and statue base 34 and wall 46 in background (view from north-west)

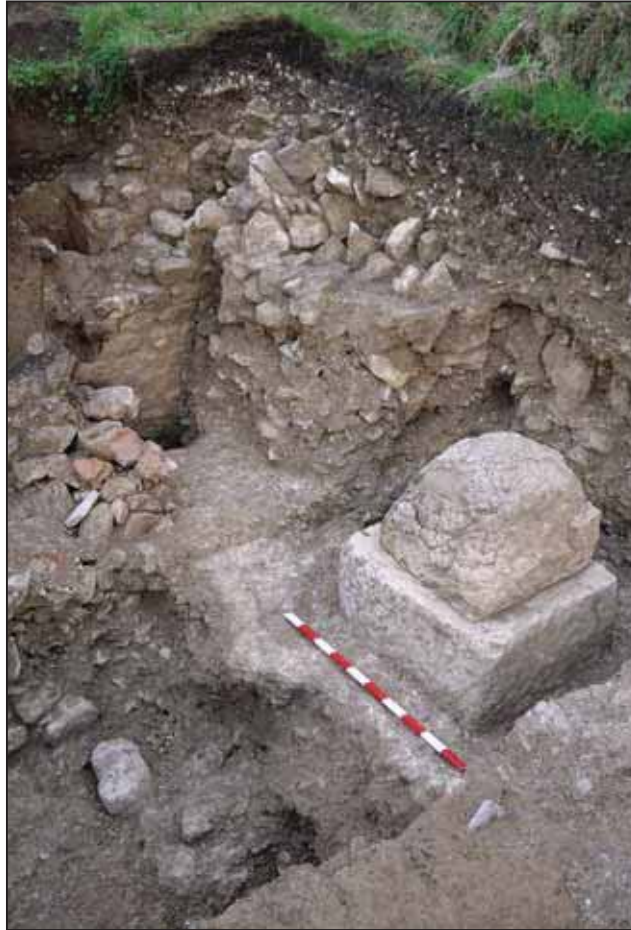
Plate 3: Period 1 building, courtyard (Trench AA): statue base 34 and partly tumbled wall 46 to the south. Note the edge of land-slip, lower left (scale = 1m; view from north-east)

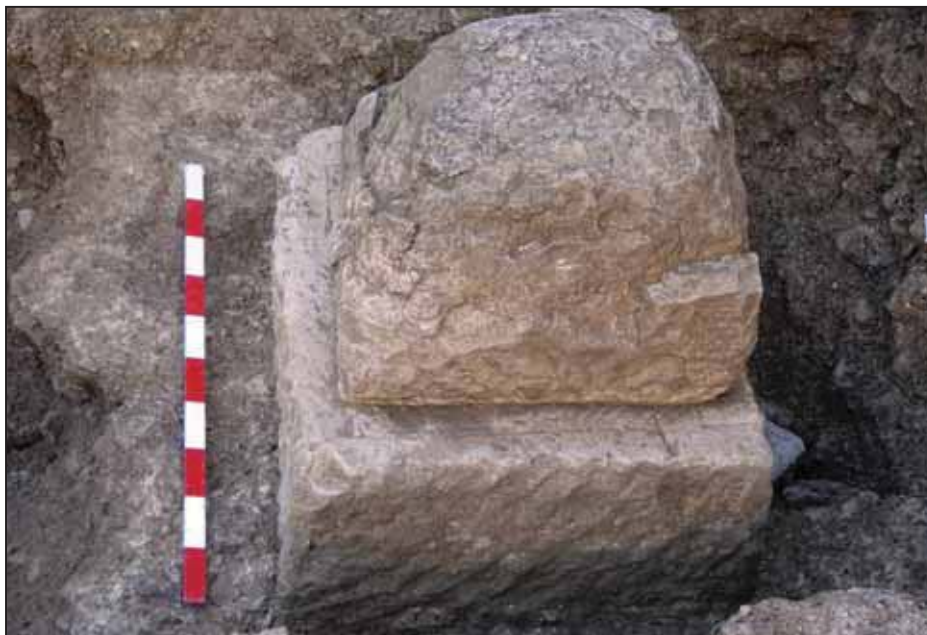
Plate 4: Period 1 building, courtyard (Trench AA): statue base 34 - note tooling marks and marking-out lines on upper surface of lower block; the scale rests on the associated bedding layer 443 (scale = 1m; view from north)

- 4.2.4 As recorded previously, statue base 34 comprised two elements, the upper part being a block of limestone 0.60m square and 0.40m high, of which the top and upper faces had suffered some degree of exfoliation as a result of exposure to frost action (in antiquity) (**Plate 4** and **Front Cover**). The lower, undamaged faces retained the rough tooling of what appears to have been a deliberately rusticated surface. Previous investigation had suggested that the upper part sat on a limestone slab, but excavation in 2010 showed this to be a substantial block measuring 0.80 by 0.75m and 0.45m high. Like the upper block, the sides of the lower block had been roughly tooled, apparently to create a deliberately rusticated surface, but the upper surface was more carefully finished. Here, shallow inscribed lines towards the north, south and east edges indicated where the upper block was to sit, slightly offset to the west and suggesting that the front (and therefore the postulated statue) faced east. Shallow tooling within the area enclosed by the inscribed lines provided keying for the upper block, whereas the surrounding margins had been smoothed, presumably as they would have been visible, and perhaps this surface was designed to contrast with the rusticated sides as there is no evidence to suggest that these faces had been clad in any way.

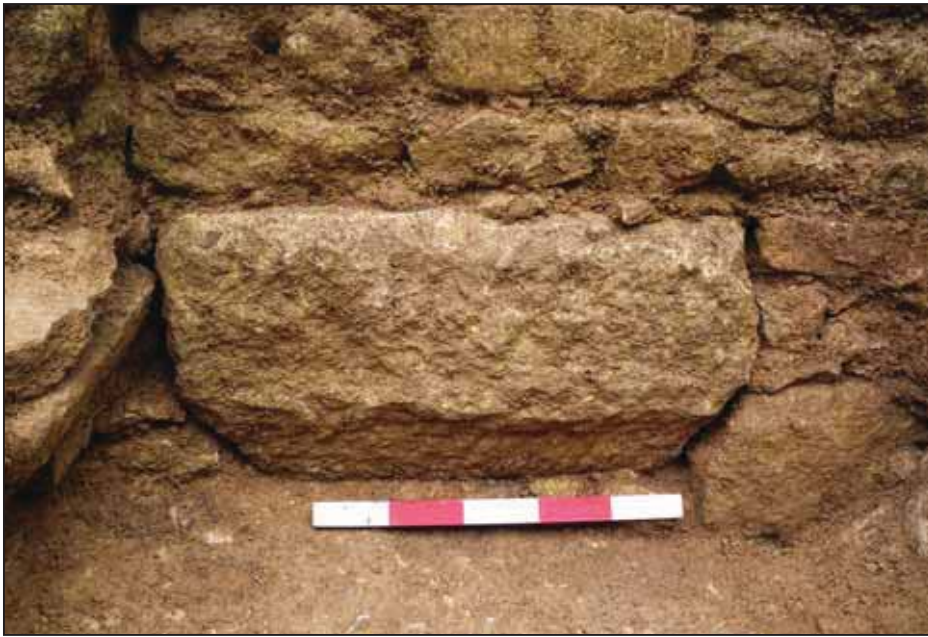
Plate 5: Period 1 building, courtyard (Trench AA): possible statue base or plinth, re-used (and inverted) as part of the foundation at the northern end of period 2 wall 48 (scale = 0.5m; view from west)

possible base for a statue or similar can be noted here, probably a period 1 architectural piece, inverted and re-used as a foundation at the north end of period 2 wall 48 (**Plate 5**). This 0.75m-wide block of limestone is likely to be square, and is 0.45m high with chamfered upper edges.

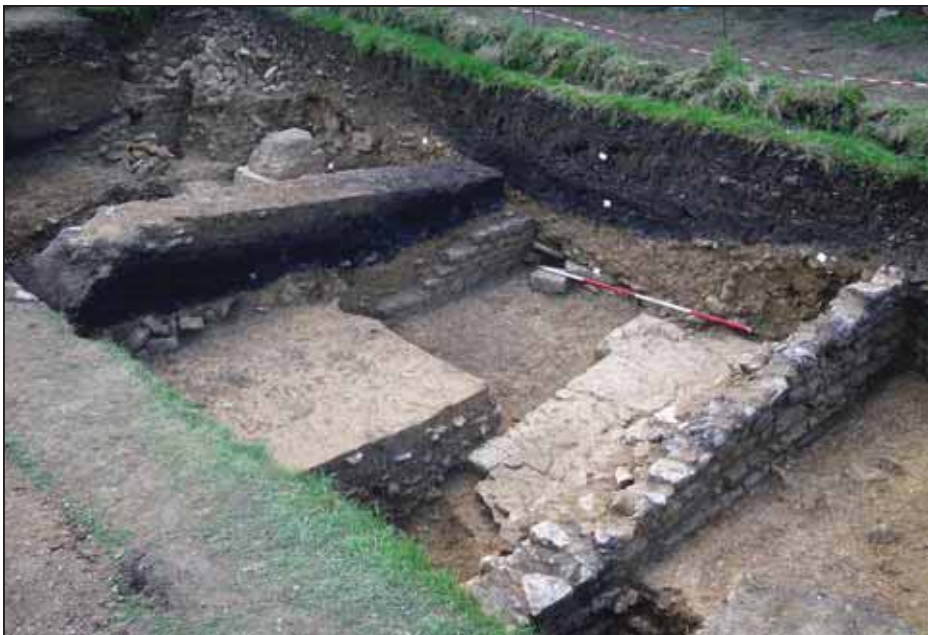
Plate 6: Period 1 building (Trench AA): Period 1 walls 44 and 54 (under baulk) with paved corridor 53 between, beyond which lies statue base 34 within courtyard and wall 46 (view from north-west)(scale = 2m; view from north-east)

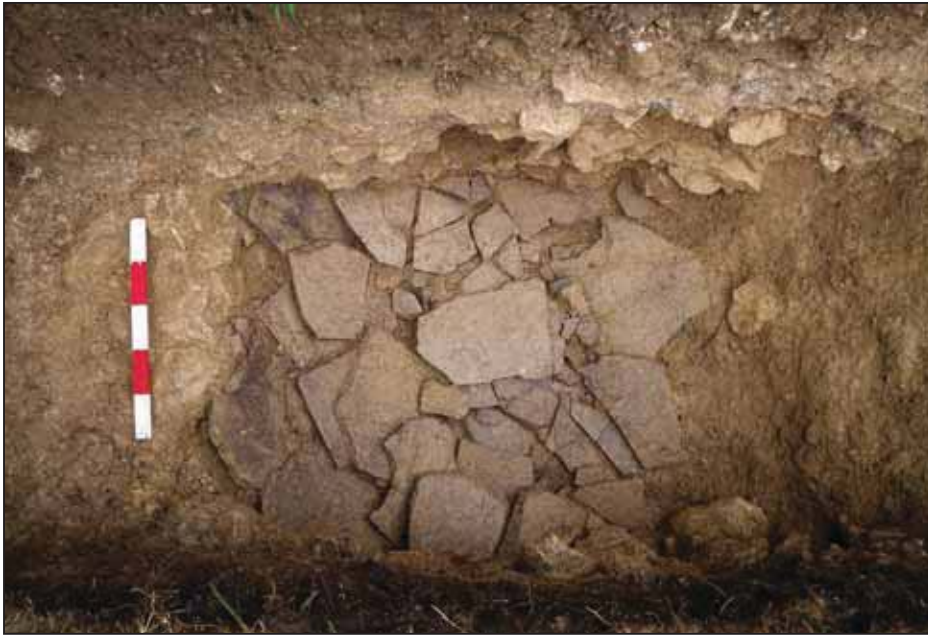
Plate 7: Period 1 building (Trench GG): wall 44, with collapsed roof tiles 433 lying outside corridor to the right (scale = 0.5m; view from east)

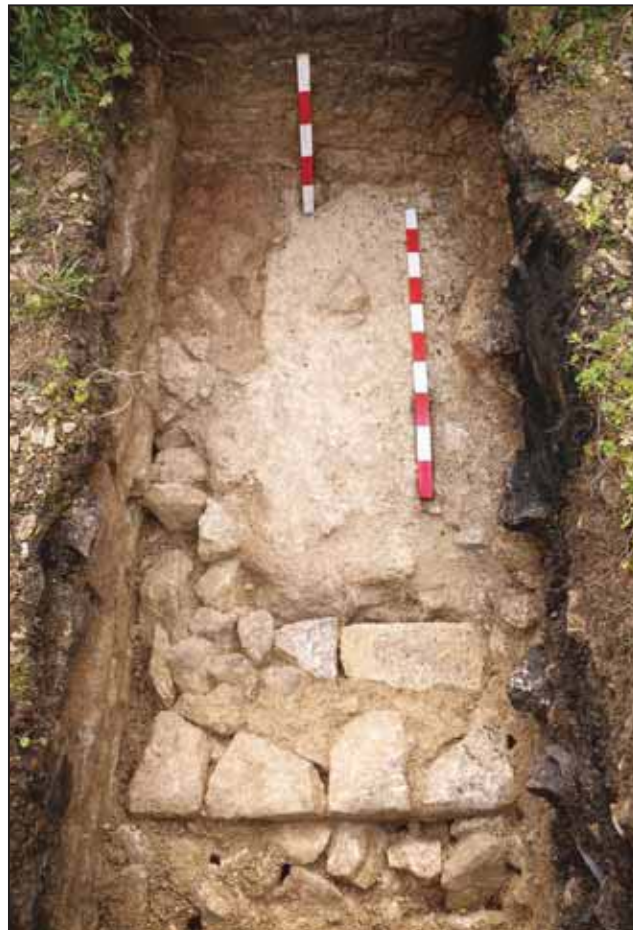
Plate 8: Period 1 building (Trench BB): wall 52, butted by period 2 wall 39 to the left; period 3 bath-house wall 10 to the rear. The scales rest on period 3 mortar surface 406 (scales = 0.5m and 1m; view from north-west)

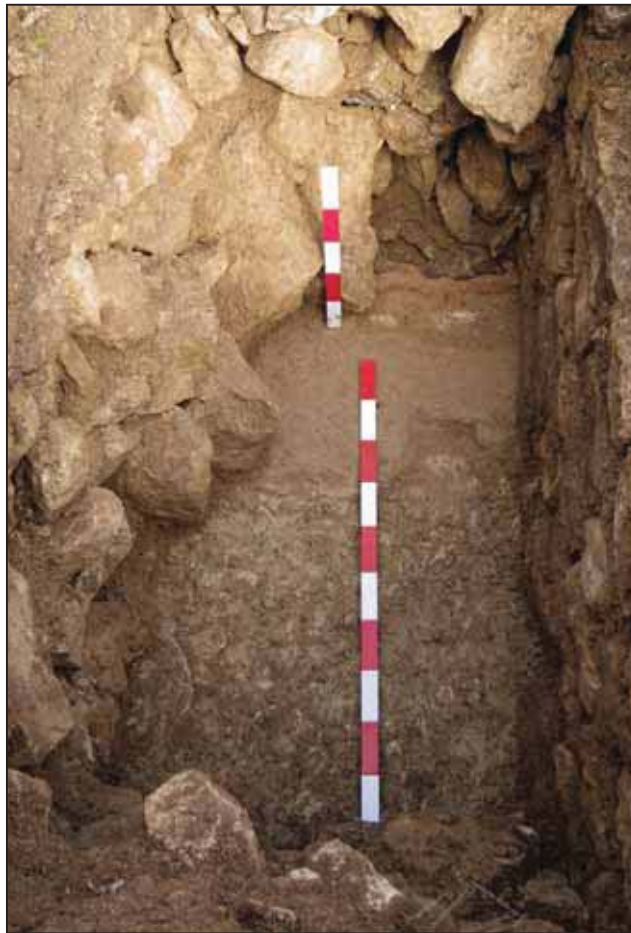
Plate 9: Period 2 building (Trench CC): tank/bath wall 51 with opus signinum on far face, and mortar bedding layer 409 in the foreground, overlain by period 3 bath-house wall 22 to right and rubble consolidation/make-up to left (scales = 0.5m and 1m; view from south-east)

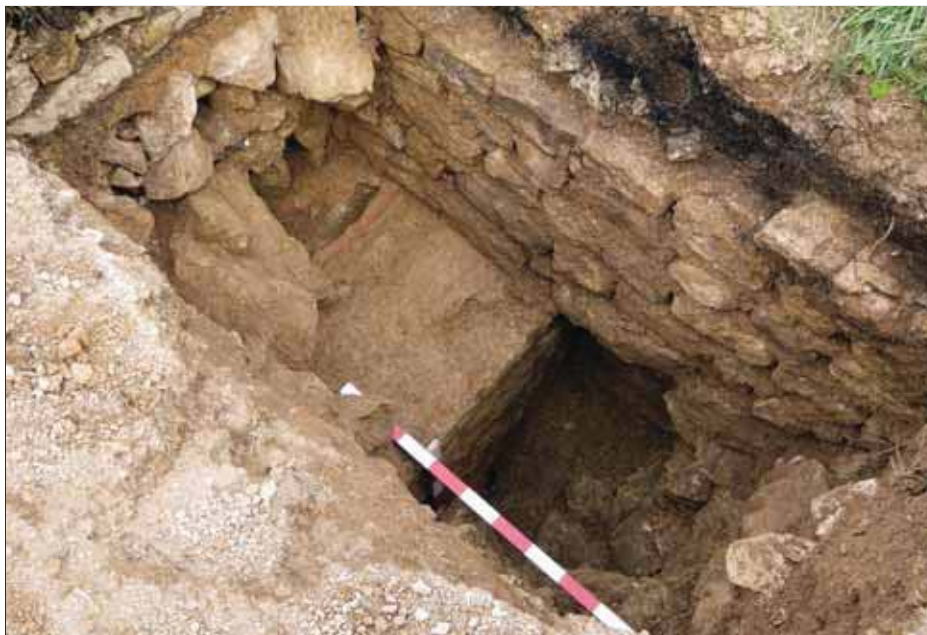
Plate 10: Period 2 building (Trench CC): tank/bath wall 51, with opus signinum on inner face; mortar bedding layer 409 to right has been removed exposing rubble make-up layer 410. Period 3 bath-house wall 7 lies to the upper left, above rubble consolidation/make-up, and bath-house wall 22 to the upper right (scales = 0.5m and 1m; view from south)
