Late Medieval consolidation Inland port and market centre (14th – 15th century)

The Town

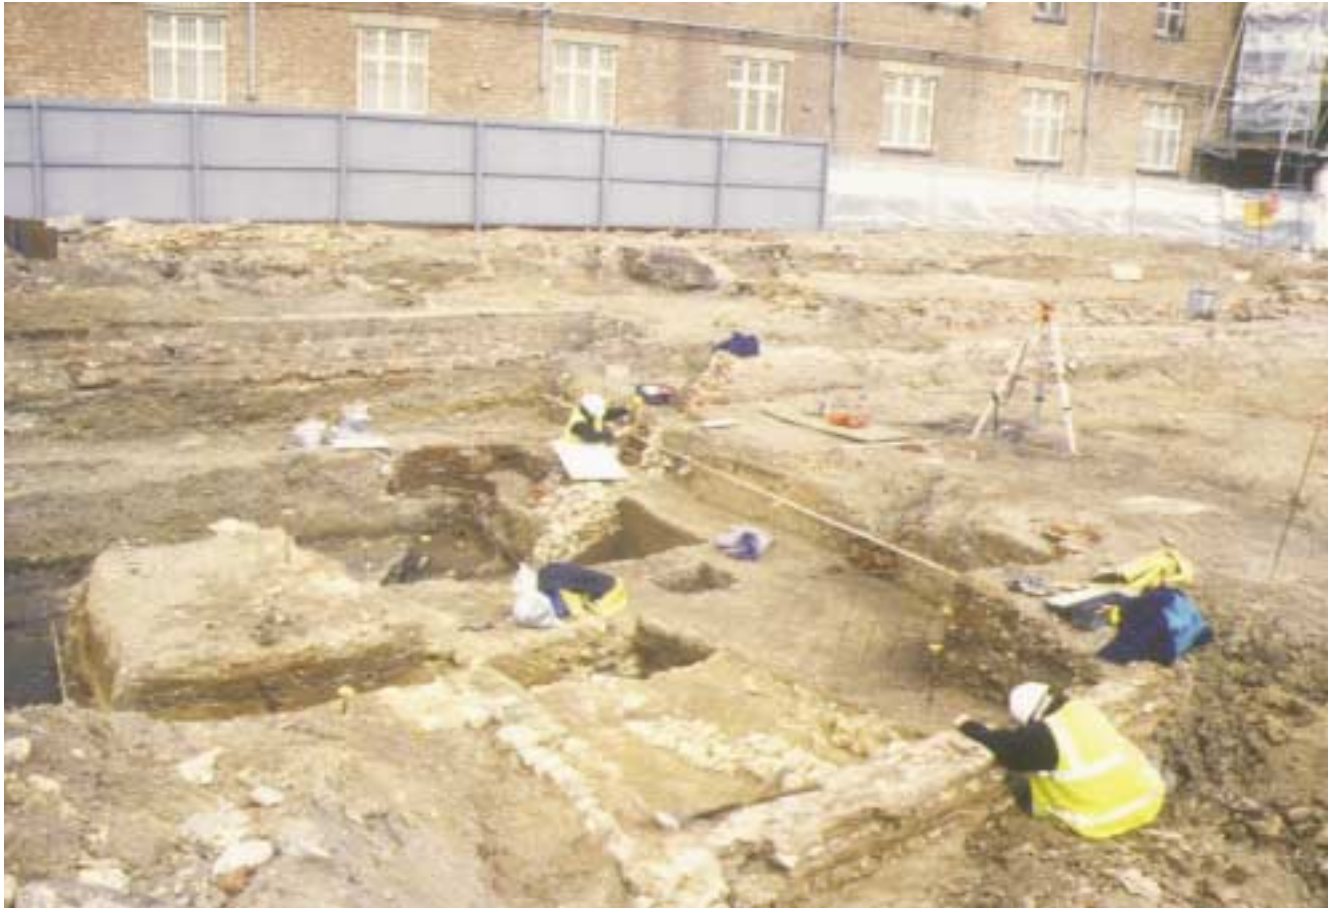
Figure 38: Excavating the foundations of a series of medieval buildings constructed over the edge of the infilled channel.

Buildings behind the market frontage were best preserved in the central two of the four properties excavated (corresponding to Nos 7–8 Market Place) (Fig. 38 & 39). By the late 15th century these had been extended to the west, although, where walls had been built over the now largely infilled Hogsmill channel, subsidence had caused structural problems. There was no building on the lower lying ground beyond it, and all that was found there were two ditches marking property boundaries, a few gullies and rubbish pits.

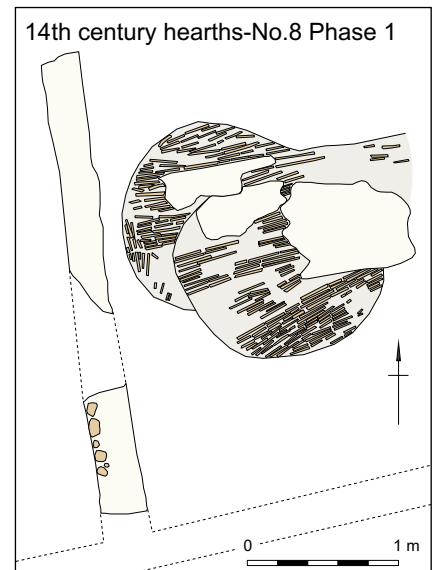
Figure 40: Plan of 14th century hearth.

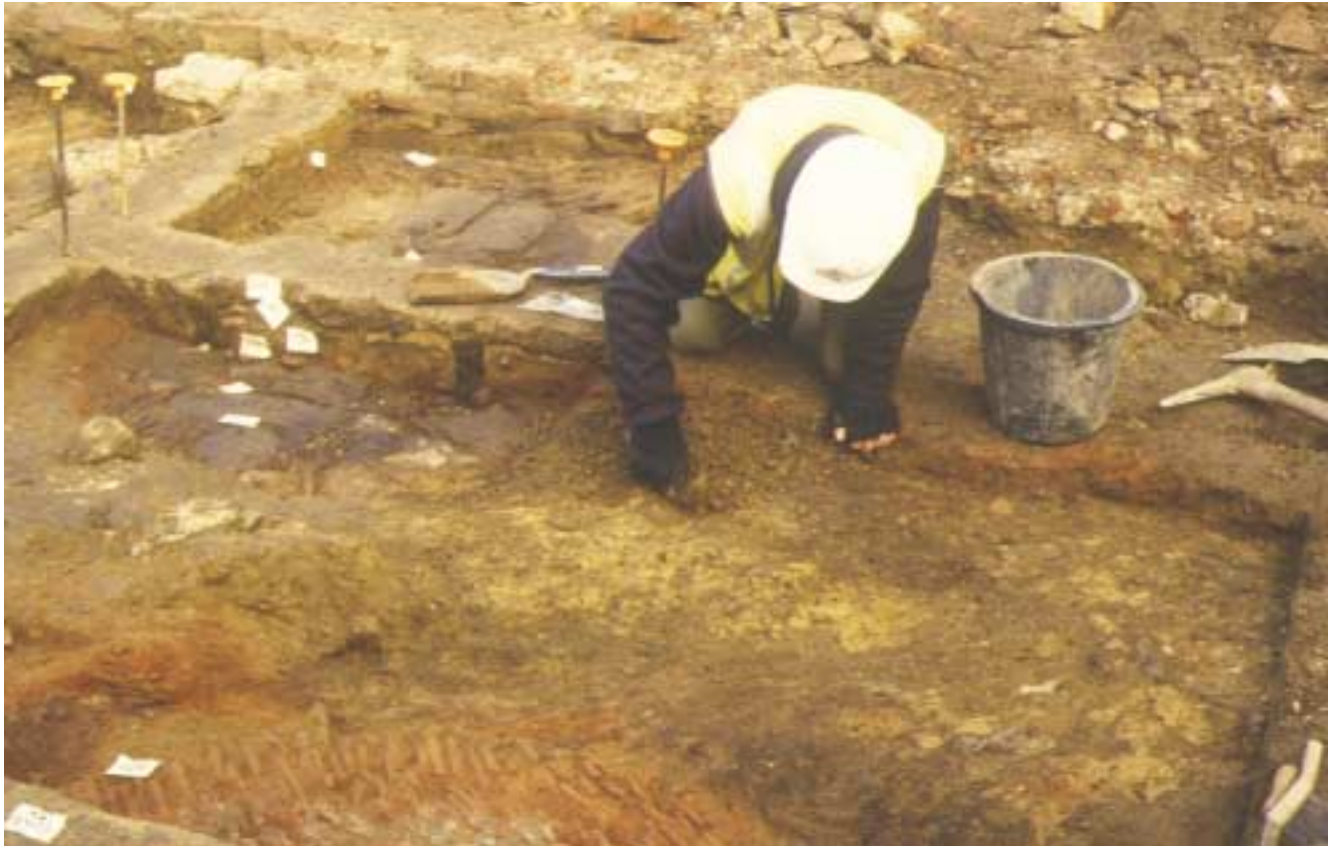
Figure 45: One of the hearths being excavated – possibly the base of a bread oven dating to the late 14th (or early 15th) century.

the 14th century occupiers of the High Street properties, trades there are known to have included iron smithing and possibly gold working. There is no evidence, however, that these hearths were associated with metal working, and baking (*Fig. 45*) or malting are again more likely uses.

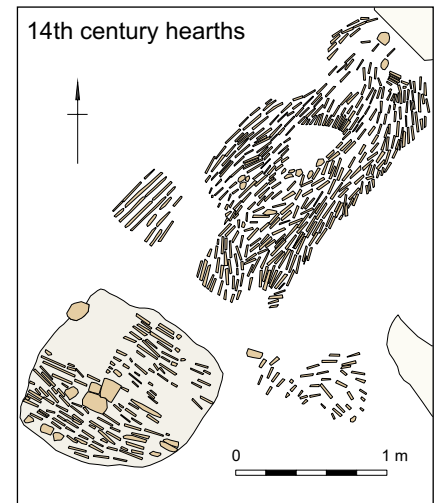
Figure 48: Plan of 14th century hearths.

The front of the High Street property north of Emms Passage contained a series of pitched-tile hearths, (*Figs 48-50*) all within 20m of the street (*Fig. 46*), one dated to c. 1375-1400, and its replacement to c. 1390-1410. Unlike those behind the market, these were out of doors, although several post-holes near them may indicate the presence of shelters. No clear floors were identified, there being instead a sequence of clay and mortar surfaces interleaved with dark ashy material containing a lot of charcoal. The ground may have been of beaten earth strewn with rushes or hay, although as it was probably still prone to periodic flooding, or at least damp, it may have been covered with wooden planking. (A similar sequence of hearths and deposits was recorded in 1990 south of Emms Passage.)

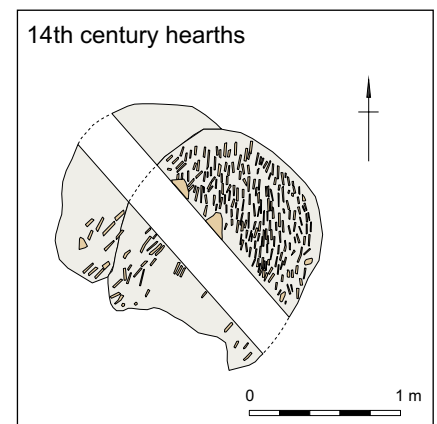
Figure 49: Plan of 14th century hearths.

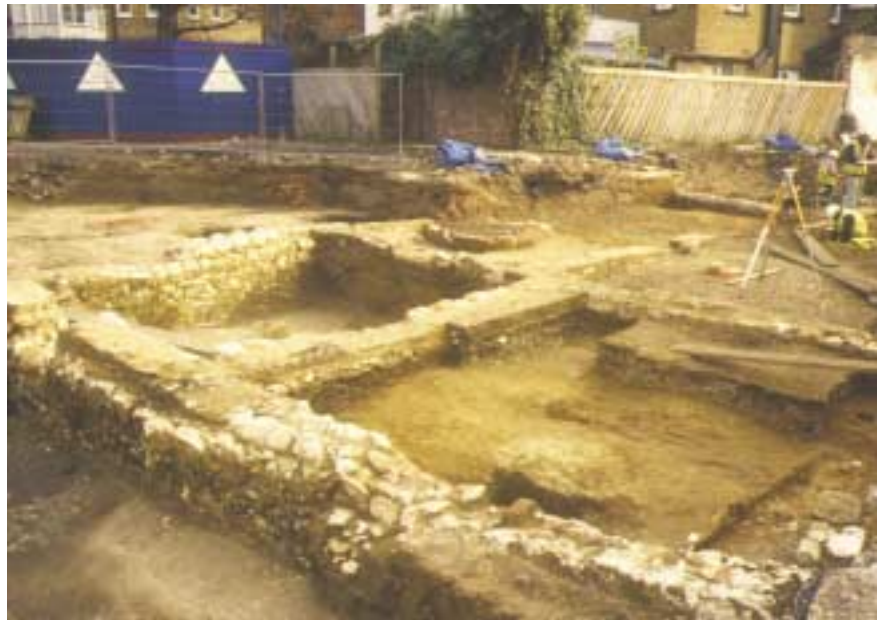
Figure 52: Foundations and bottom courses of a late 15th century building at 90° to Emms Passage – perhaps a precursor to the later maltings in this property.

At the same time a new property was laid out to the west, extending from Emms Passage to the Hogsmill, containing a large building, c. 10m long and 5m wide, lying at a right angle, and adjacent to, the lane (Fig. 52). Like the yard wall (the line of which was continued by the building's north wall) its externally visible walls were made of well-faced chalk and Reigate stone blocks. Its eastern wall butted the remains of the demolished 14th store, and its west wall corresponded approximately with the earlier, but now redundant, 13th century property boundary wall. There was probably a doorway midway along the east side, and traces of a mortar floor and floor joists survived inside. Immediately north of the doorway were three post-holes that may have held posts supporting a second storey.

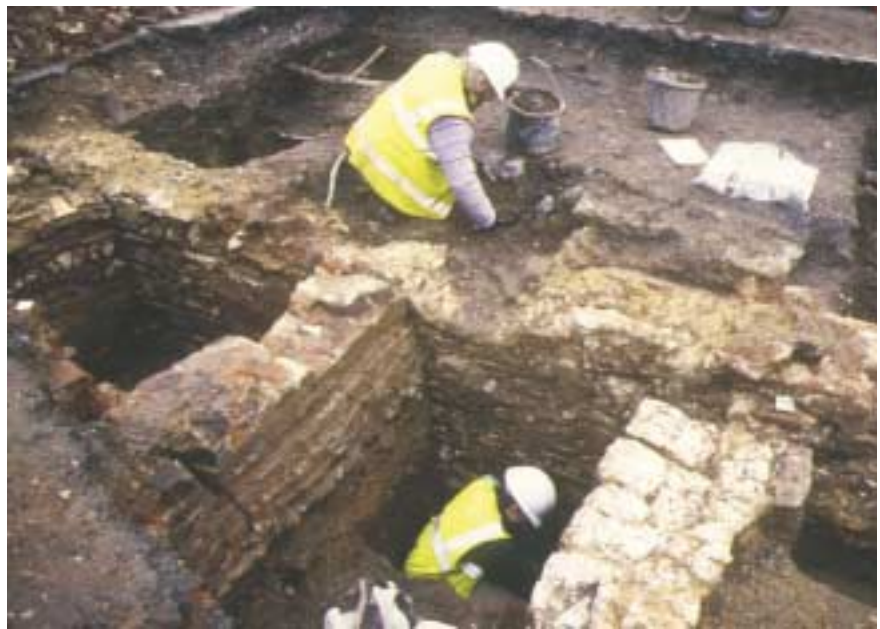
Figure 53: Late medieval cellared structure adjacent to Emms Passage – a later brick wall lies across the middle. The walls were carefully built of blocks of chalk and Reigate stone interspersed with courses of flint nodules and tile.

Behind the High Street buildings, beside Emms Passage, was a small (2m by 3m), 15th century cellar, 1.5m deep (Fig. 53). It was built of chalk, Reigate stone and flint with courses of tile, and with mortar on the walls and floor. There were no steps but access would have been from the building above. Charred remains of cereals (mainly wheat), peas and possibly field beans were found in the cellar, but more frequent were items preserved by mineralisation, including apple and grape. Duck and pigeon (probably domestic) were identified in the small quantity of animal bone.

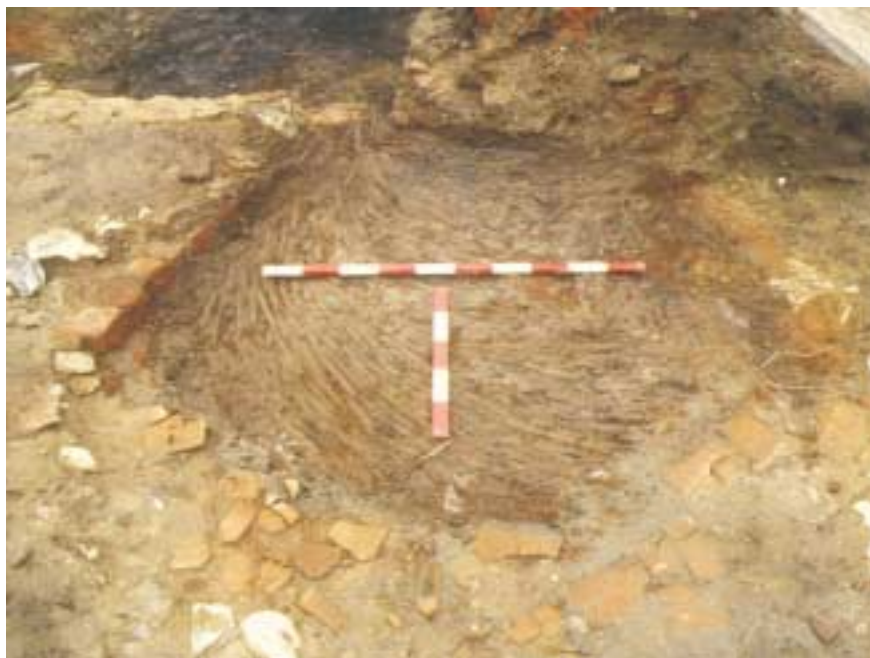
Figure 55: Probable malting kiln. The chamber floor, with the stoke-hole and rake-out pit behind.

On the north side of the yard was a length of wall running eastwards from the north-east corner of the extended building to the rear of the property (Fig. 47). Built into it was a large kiln or oven (Fig. 55). The chamber, on the south side of the wall, was slightly pear-shaped, with a floor of pitched roof tile fragments, and the remains of a clay dome surviving around its edge. The stoke hole was through the wall and a large, shallow, sub-rectangular rake-out pit extended to the north side. Several post-holes and gullies in the vicinity may have formed a shelter to cover the rake-out pit and the surrounding working area.

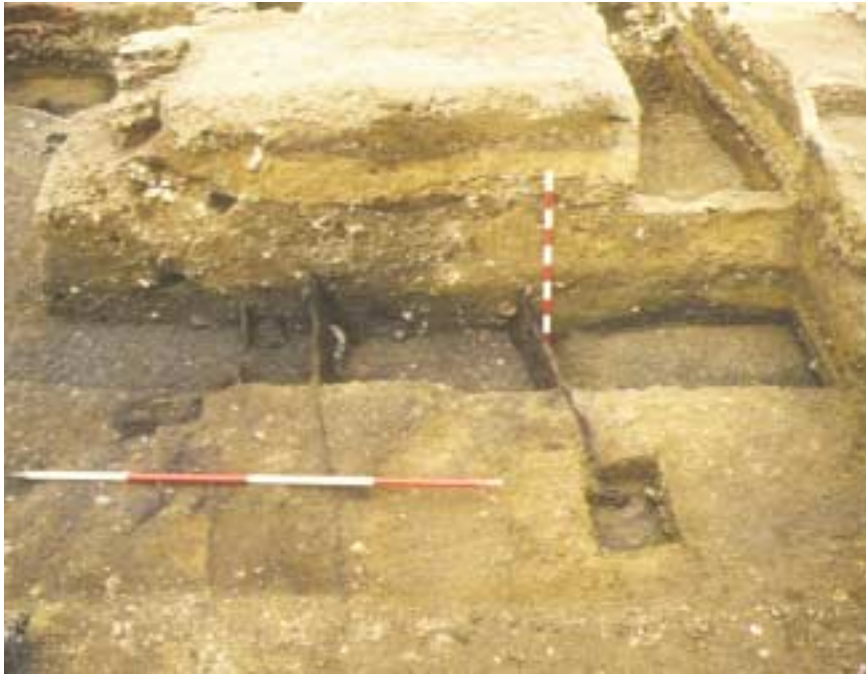
Figure 57: Silty flood deposits interleaved with dumps of gravel and domestic refuse infilling the former channel from the late 13th to early 15th century. Note the remains of three parallel revetments (centre) running across the channel and used to stabilise the infill deposits.

As in the 13th century, land was reclaimed within individual properties. At least three more revetments, of probable 14th century date, were found at the rear of the same market frontage property as before (Fig. 57), but unlike the earlier revetments, which were aligned north-south along the line of the channel, these ran east-west across it (Fig. 30). As the channel became shallower, the revetments would eventually have blocked it and so provided a 'bridge' across to the low gravel bank to the west, which could itself then be reclaimed. The reclamation of the channel would then have proceeded north and south in the adjacent properties, in due course to the edge of the River Thames and the Hogsmill. These revetments were poorly preserved and less substantial than the earlier examples, reflecting the decreasing depth of the channel as it was filled in. Some of their posts had mortise holes with pegs, indicating the re-use of building timbers (Fig. 58). These had been sharpened and driven into the ground to retain the horizontal pieces, of which little survived. The latter were made entirely of sections of planking from the hulls of broken-up boats.
