Butterley Spillway

BUTTERLEY SPILLWAY

Text by Ashley Tuck

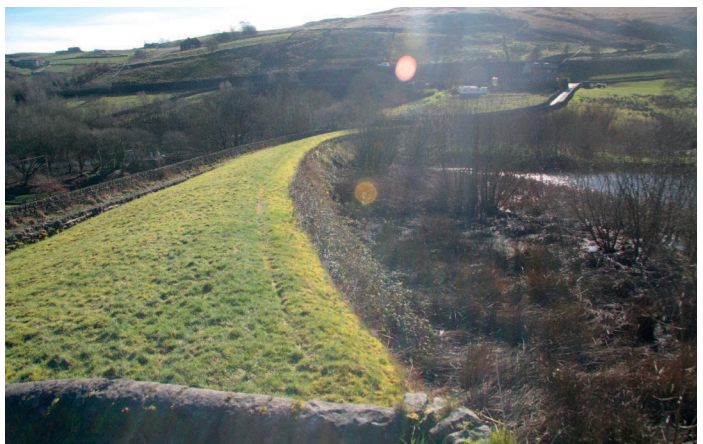
Historically, Marsden has suffered flooding events caused by dam failures. One of these events was linked to the construction of the Huddersfield Narrow Canal. The Tunnelend Reservoir had been constructed to provide water for the canal. In 1799 when the works were still under construction, heavy rain led to severe damage. The Tunnelend Reservoir was overtopped, devastating Marsden, and several stone canal aqueducts proved to be unable to cope with the unprecedented overflow and had to be replaced with cast iron aqueducts of a new design.

*Dam of Tunnelend Reservoir,
which failed in 1799*

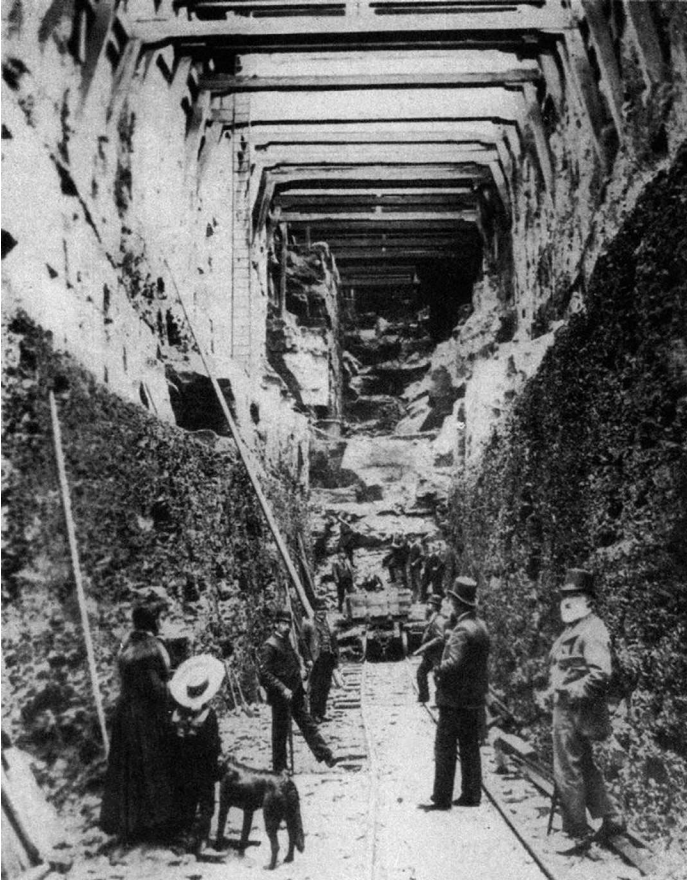
The puddle trench at Butterley Dam under construction

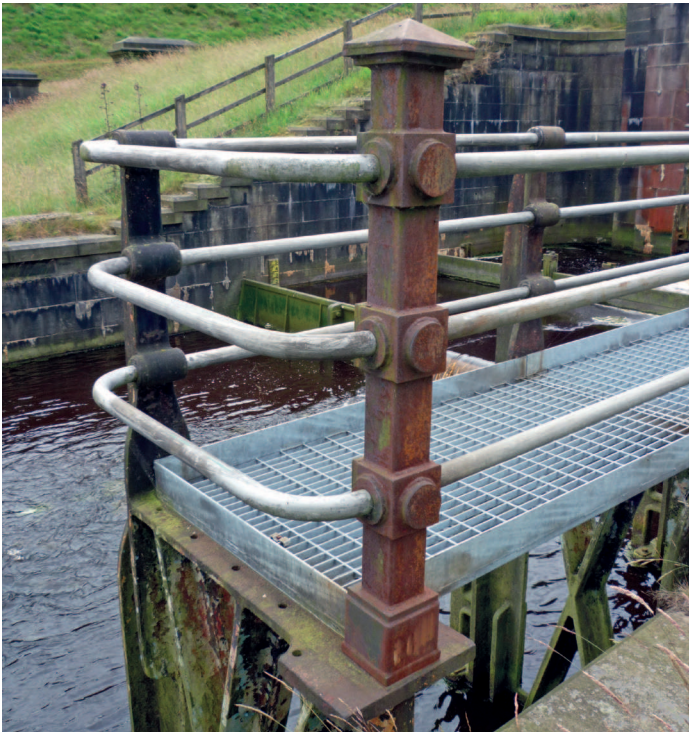
A curved cast iron framed bridge with oak planking was installed across the weir in 1907. This bridge was replaced in the 1980s but used the same castings as the original access platform at the scour portal, which largely survives *in situ* although with a modern walkway grid.

*Detail of Butterley Scour Portal
access platform*

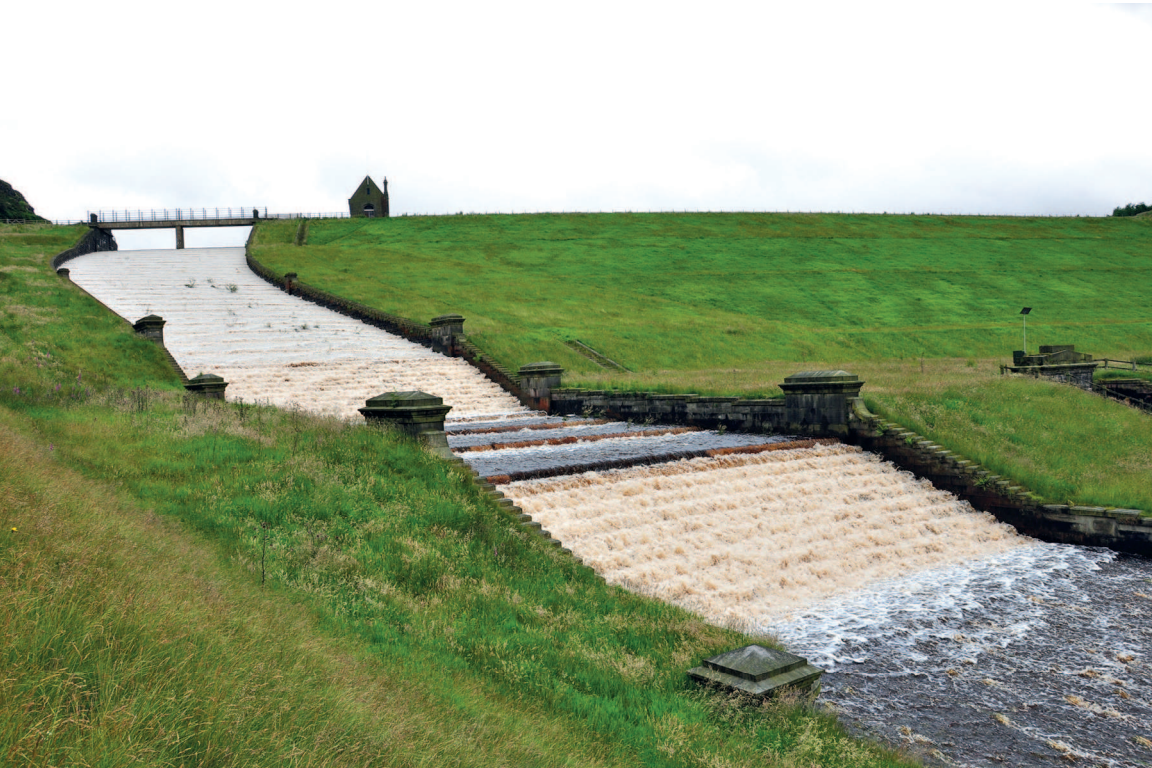
Butterley Spillway in full flow

A number of different designs of spillway are commonly used, but the Butterley Spillway is of the stepped type. Stepped spillways have been in use for around 3500 years, with the oldest known surviving example the stepped weir at Akarnania, Greece, which is still functioning. Roman examples survive in North Africa.

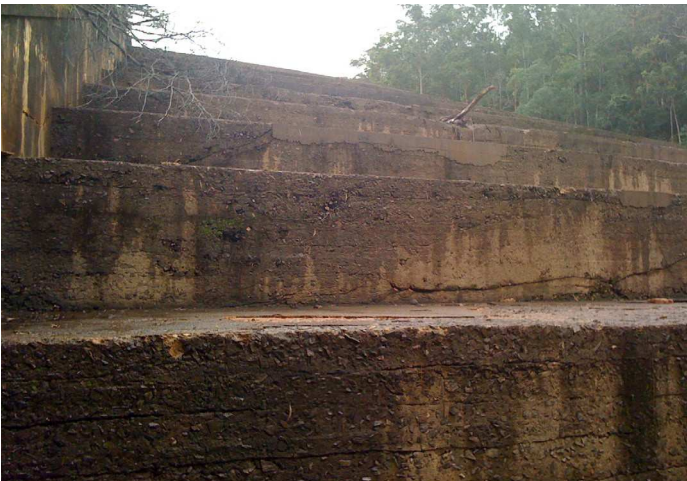
Gold Creek Dam in Australia

Although early stepped cascades were built in cut-stone masonry or timber, a wider range of materials were introduced during the 19th century. The 1890 Gold Creek Dam cascade in Australia was the first concrete stepped cascade. An 1885 unlined cascade at Gold Creek had been destroyed by a heavy scour, but the stepped version is still in use today.

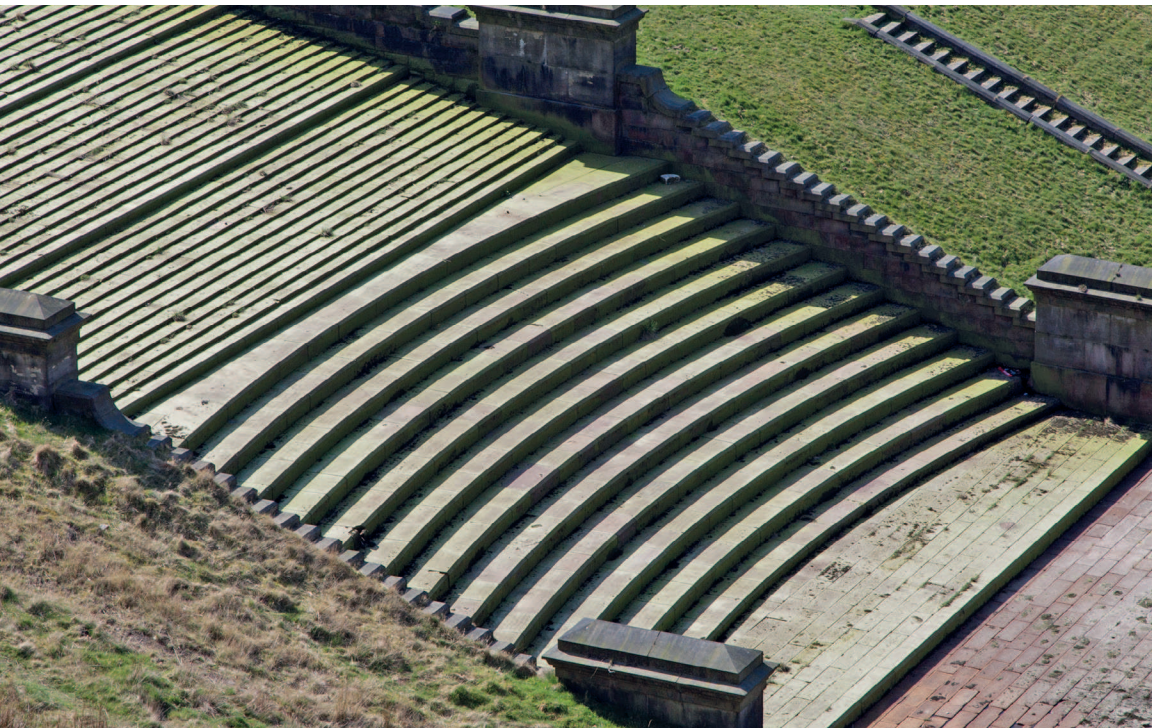
The original masonry of the spillway

The original spillway was constructed of local sandstone with a stepped base. The majority of the structure was constructed from ashlar blocks, and the side walls largely rusticated stone. Two curved stepped cascades were located where the gradient was steepest and were lined with ashlar walls. The walls were topped with interlocking coping stones. Five stone piers on either side of the spillway marked the major changes in gradient of the slope and match the terracing of the dam embankment. Each pier was set on a small plinth and was finished with pyramid-shaped coping stones.

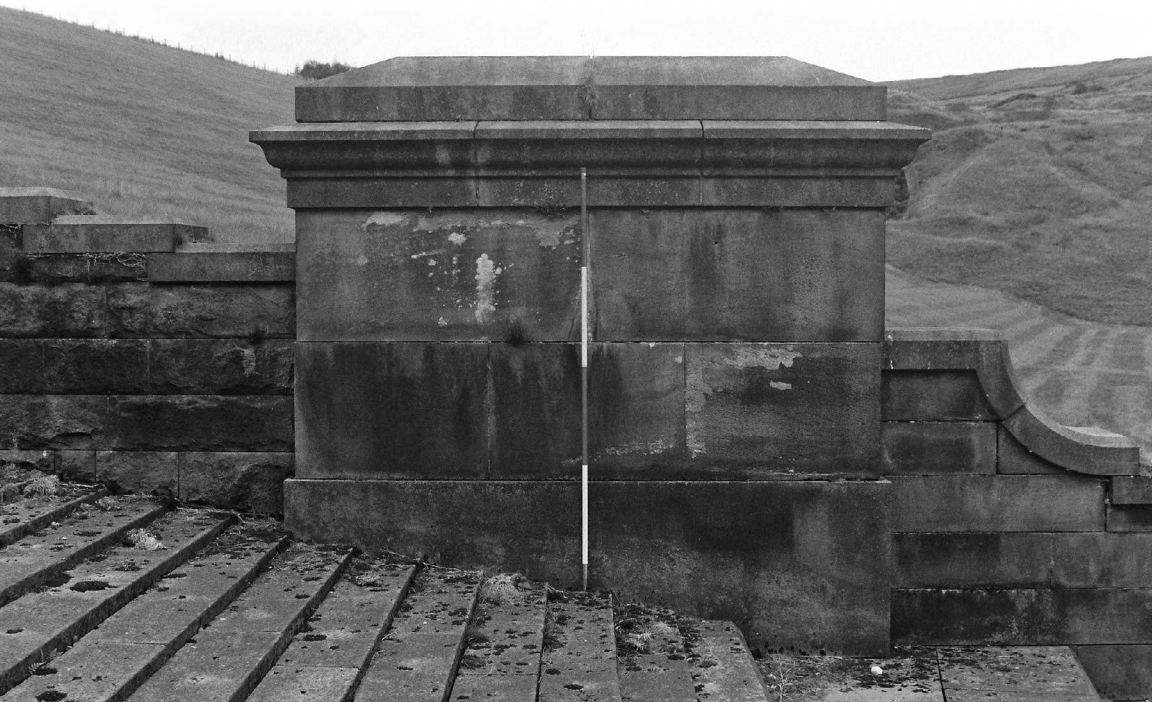
Ashlar stone is finely dressed and cut with flat faces. In contrast, a rusticated finish is one that is left rough on the visible face to mimic a natural, unworked appearance.

*Record shot of original stone
pier showing wall with ashlar
finish to right of the pier and
rusticated finish to the left*

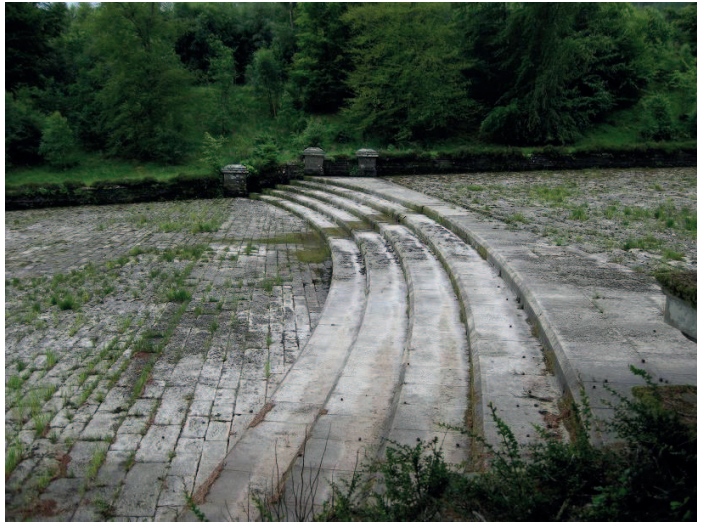
Comparable spillway at Cowm Reservoir, Rochdale, built by Thomas Hawksley

Butterley has design elements in common with numerous examples elsewhere. The upper section of the 1846 Naden Higher Reservoir near Rochdale bears marked similarities to the head of the Butterley Spillway, while the 1868–71 spillway at Cowm Reservoir, also near Rochdale, has two sets of stepped cascades with capped piers in the channel walls.

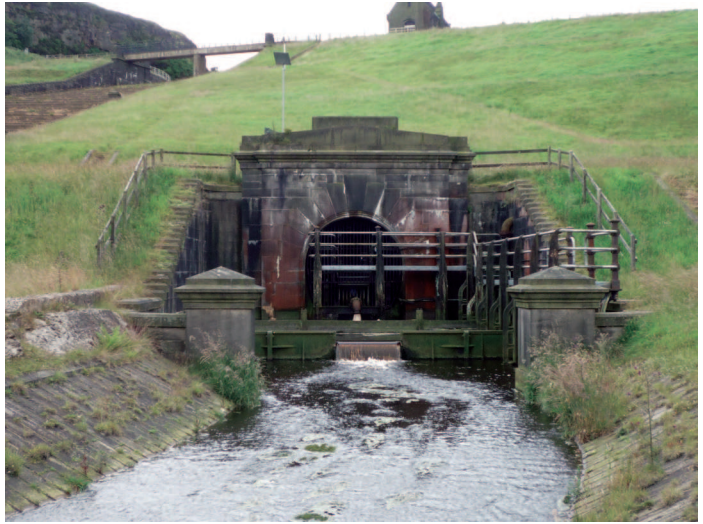
Butterley Scour Portal

Similarly, great care was taken with regard to the outward curving terminals of the channel walls, ending with square capped piers. These were identically detailed, and accurately aligned with the inward curving walls leading to the scour portal to the west.

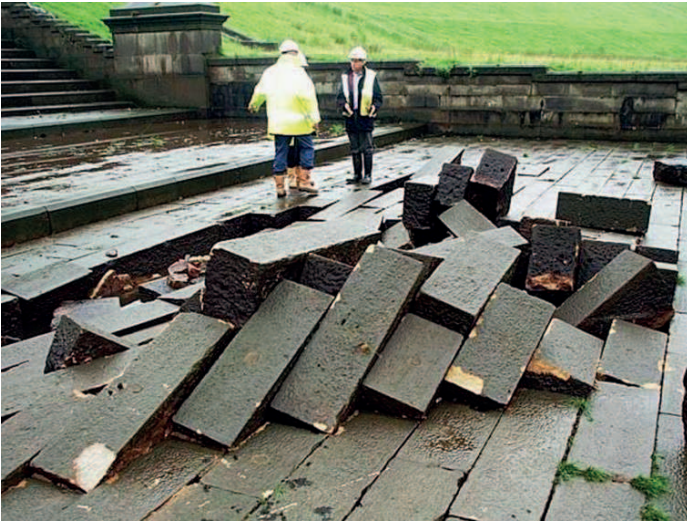
Severe damage to spillway caused by minor flood in 2002

In 2008 a statutory inspection by the All Reservoirs Panel found that Butterley Spillway had defects which represented 'a real risk of failure.' It was assessed that flood events likely occurring every 12–100 years would pose a danger if the current structure remained in the state it was in. Yorkshire Water was therefore required, under the Reservoirs Act 1975, to implement remedial works to remove any potential risk to public safety.

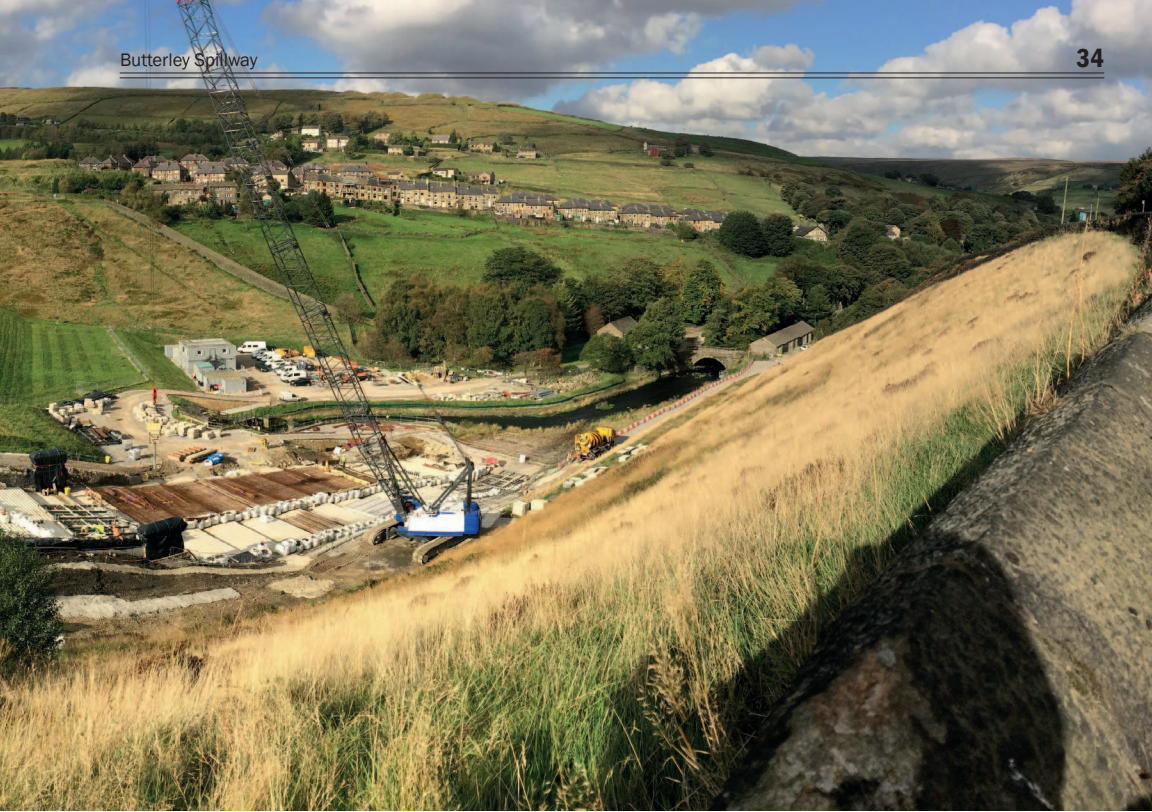
*Remediation works at
Butterley Spillway*

The necessary works to the channel included removing the curved cascades and some associated piers. Elements of the base of the channel and the walls were rebuilt in concrete. The height of the east wall was raised, re-using the original coping stones. The piers at the top of the former upper cascade were raised using re-used stone. Existing offset piers were cut back to make them flush with the channel walls. New fill material was brought in to raise the level of the embankment to the height of the raised walls.

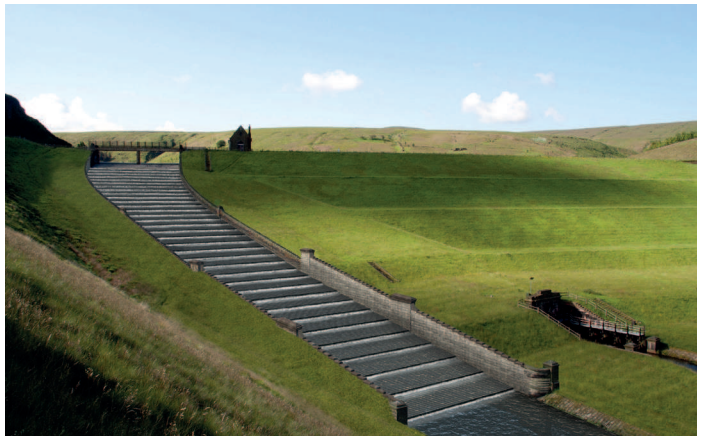
*Computer generated image
showing an artist's impression
of Butterley Spillway following
remediation works*
