Whitestaunton Manor House, Whitestaunton, Somerset

An Archaeological Evaluation and an
Assessment of the Results

Ref: 52568.12

May 2004

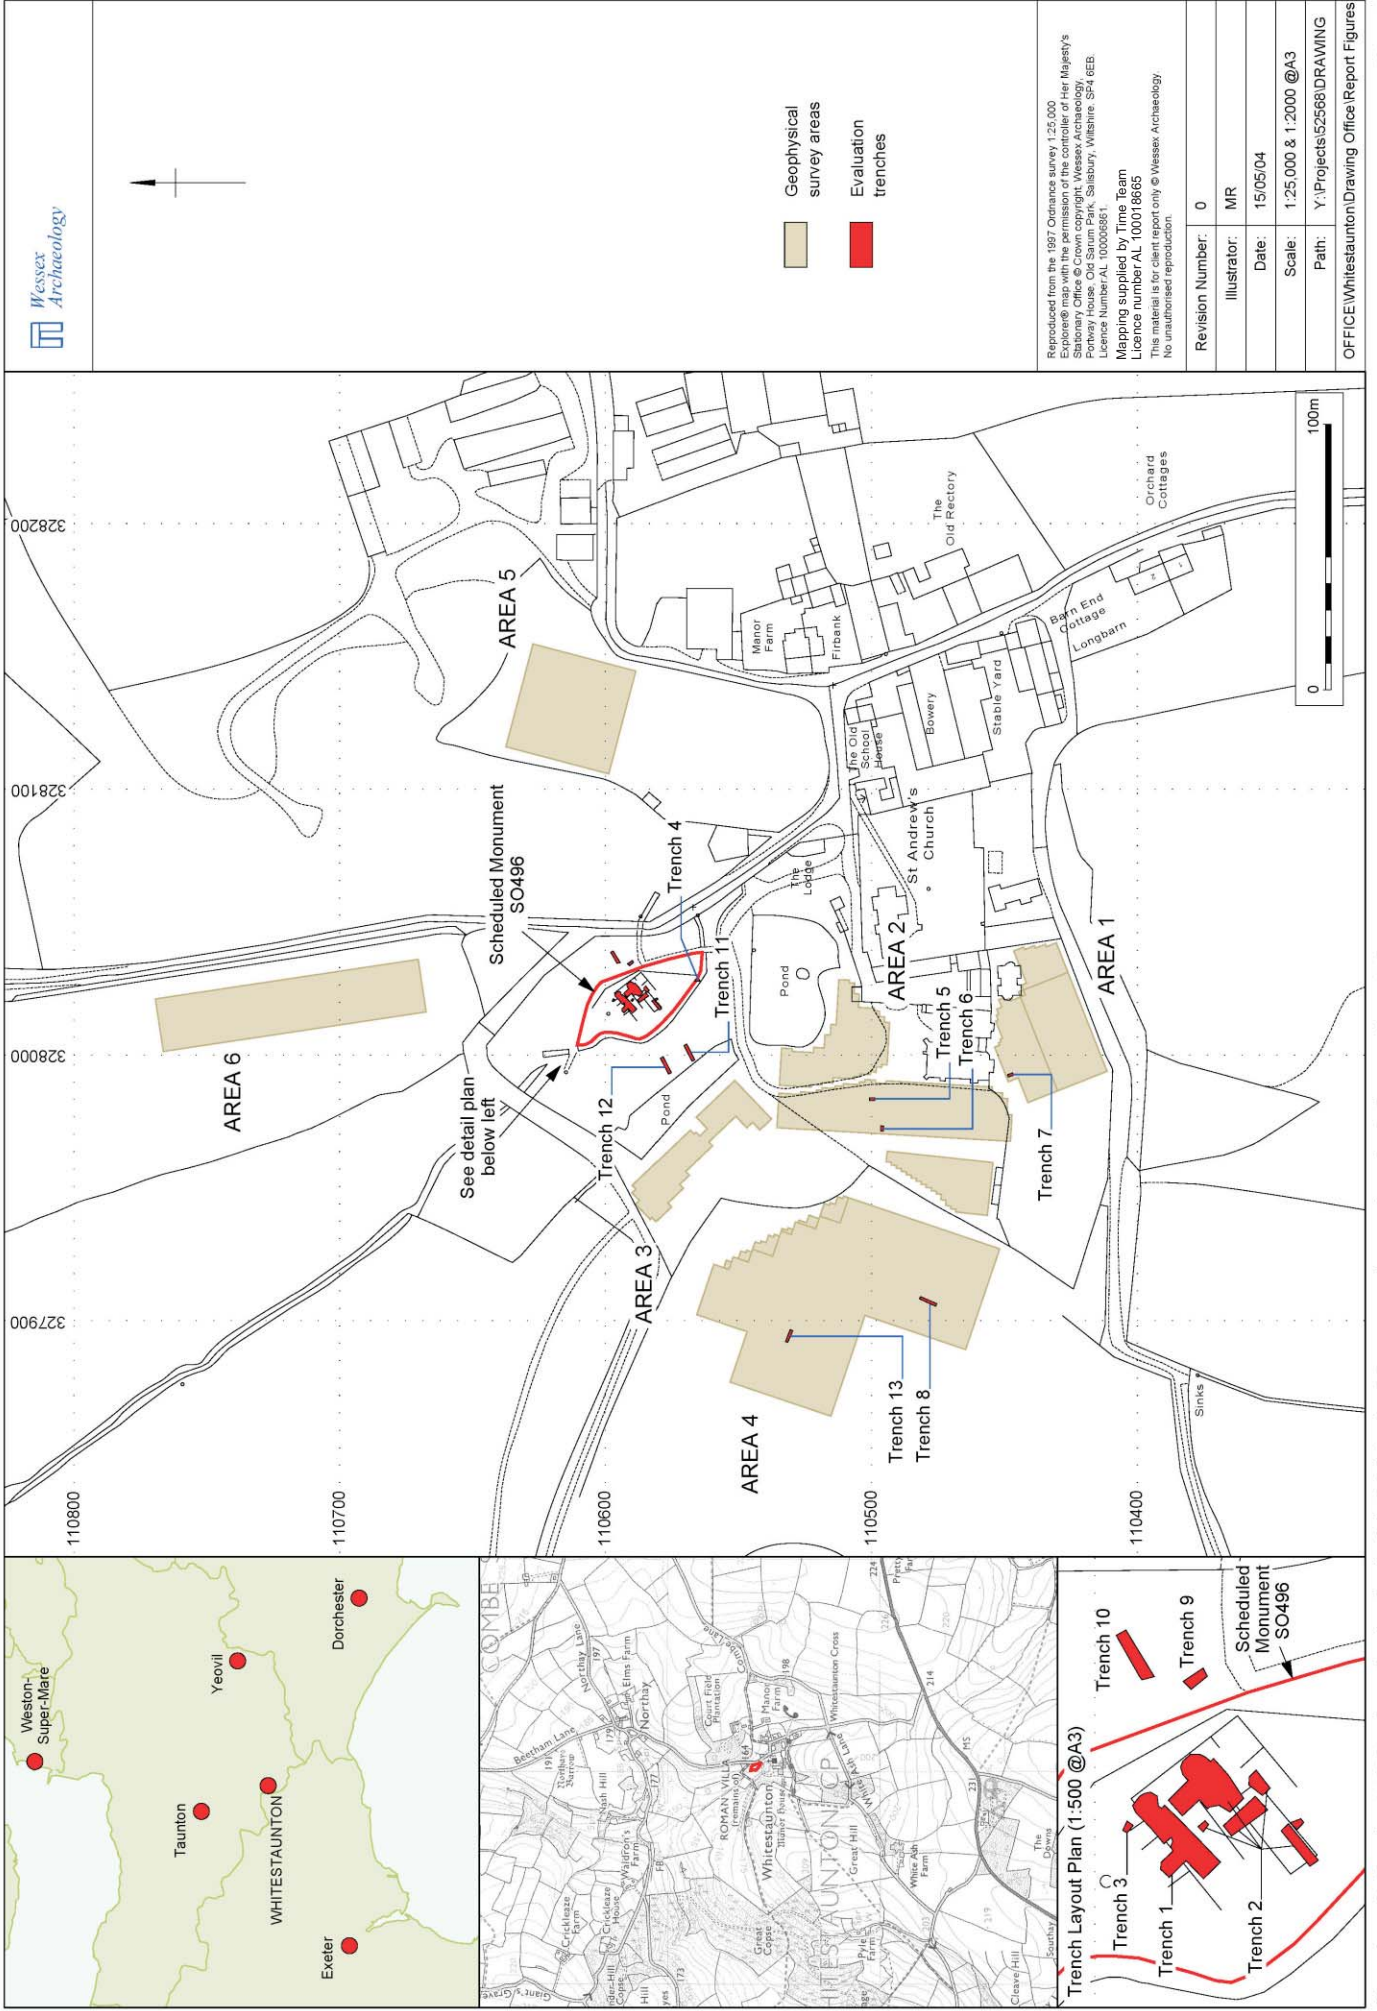
Site and trench (Trenches 1-13) location, also showing the Scheduled Ancient Monument and areas of geophysical survey (Areas 1-6)

1.1.3 The evaluation was undertaken in the garden and grounds of the manor house and in the fields beyond (**Figure 1**). The main focus of the evaluation was a Scheduled Ancient Monument (County No. SO496), excavated in 1882–3, and usually described as a Roman villa (below). A secondary focus was on a field to the west of the Manor, containing evident earthworks, possibly of Roman or medieval date (Videotext Communications Ltd 2003, 2).

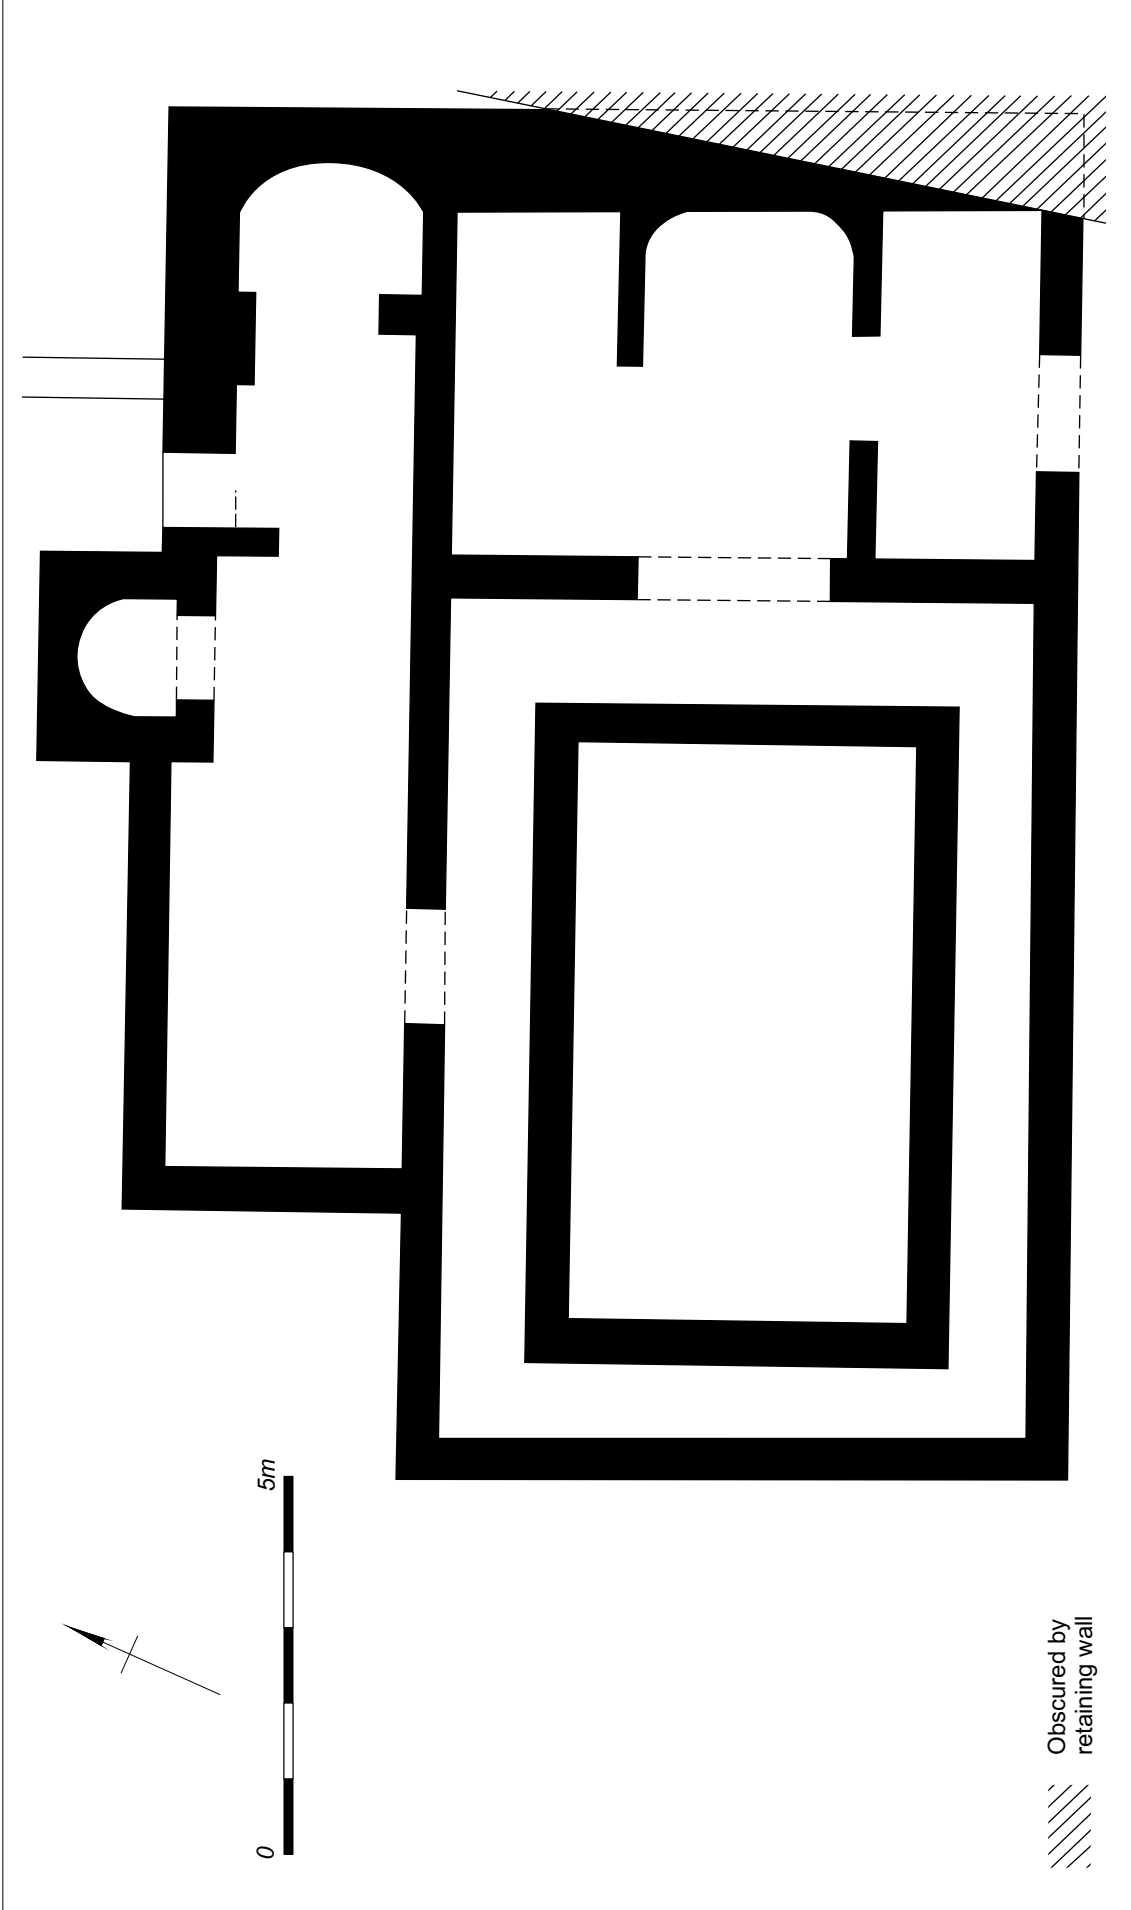
Figure 2

Outline plan of the Roman remains as displayed (after Bowles 1999, Fig 4.1)

- 1.3.4 Two plans of the remains exist, both apparently based on the remains as displayed and completed long after the excavation. These are an outline plan drawn in 1969 by Kings College Archaeological Society, Taunton (now in the Somerset Records Office; Bowles 1999, 42, fig 4.0), and a measured plan (idealised wall outlines only) surveyed by Freya Bowles as part of her undergraduate dissertation on the remains (**Figure 2**; Bowles 1999, 44, fig 4.1).

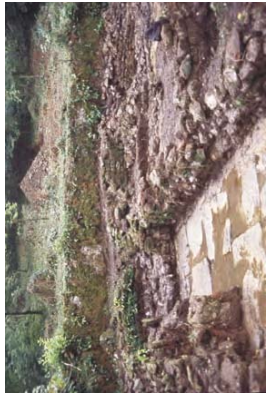
Plate 1: View of Trench 1 looking north-east, showing flagstone floor

3.3.3 The main room was floored with flagstones (context 103) each approximately 0.9m² and 0.15m thick, with a surface at around 158.80m aOD (**Plate 1**). In one place, a broken flagstone permitted the observation

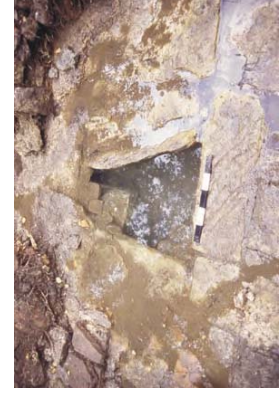
Plate 2: View of broken flagstone in Trench 1, showing pilae and water-filled hypocaust. Looking north-west, 1m scale

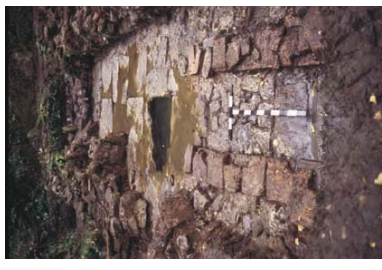
Plate 3: View of two alignments of reused Roman tiles in Trench 1: evidence of a later phase of Roman building or Victorian reconstruction? Looking north-east, 1m and 0.5m scales

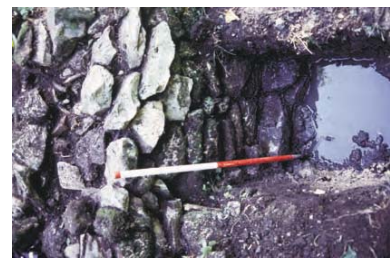
Plate 4: North-west facing external elevation of building in Trench 3, showing footing course and roughly faced Roman wall overlain by irregular Victorian masonry. Looking south-west, 1m scale

- 3.3.16 **Trench 3** was a small sondage measuring 1.0m x 0.7m in plan, located to investigate the external wall of the building. Natural gravel was encountered, but its level is not recorded. Assuming the wall was founded on the gravel, natural lay at c.158.37m aOD. The wall stood to a total height of 1.2m (including the foundation plinth), although the upper 0.5m was less regularly coursed and was interpreted as a Victorian rebuild (**Plate 4**). Against the footing, the only deposit excavated was a 0.6m thick dump of silty loam (context 301), probably Victorian excavation backfill and later soil accumulation.

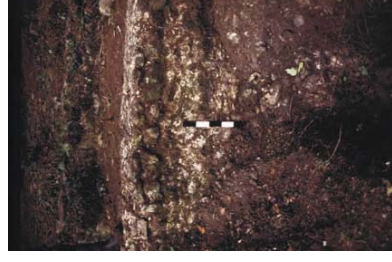
Plate 10: View of Trench 4 showing probably Victorian culvert wall. Looking east, 0.5m scale

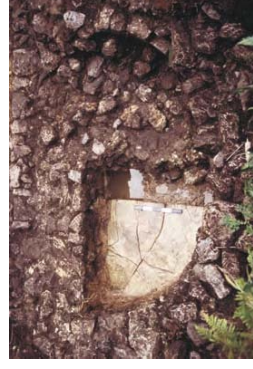
Plate 9: View of plunge pool with Victorian backfill partially removed to show stone floor. Looking south-west, 0.5m scale
