Governor's Green Portsmouth, Hampshire

Archaeological Evaluation Report

Ref: 71502
February 2010

Archaeological Evaluation

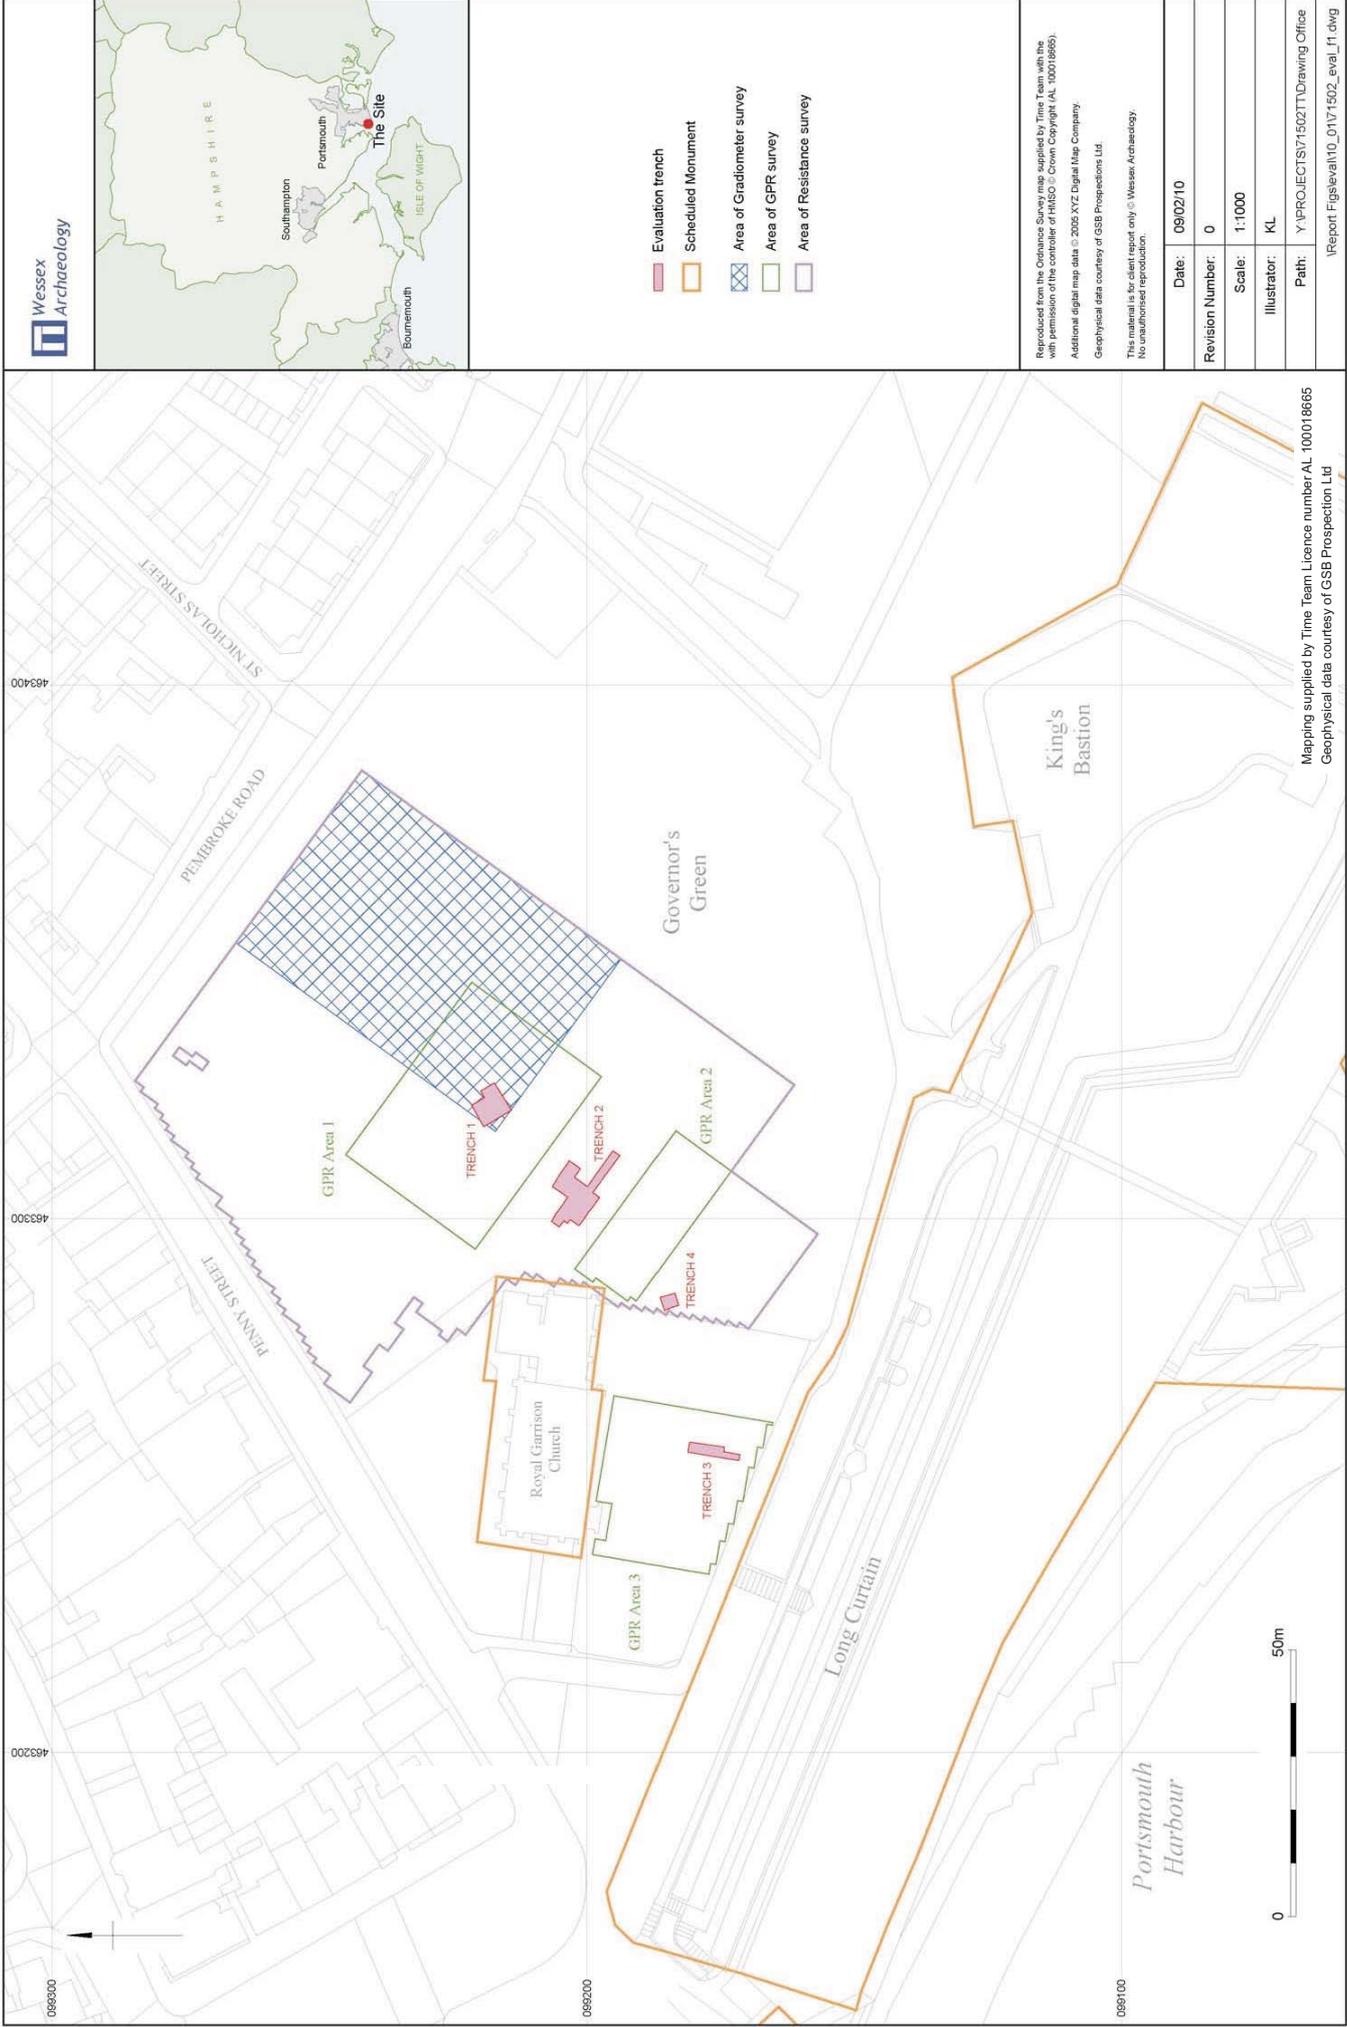
Figure 1

Site and trench location

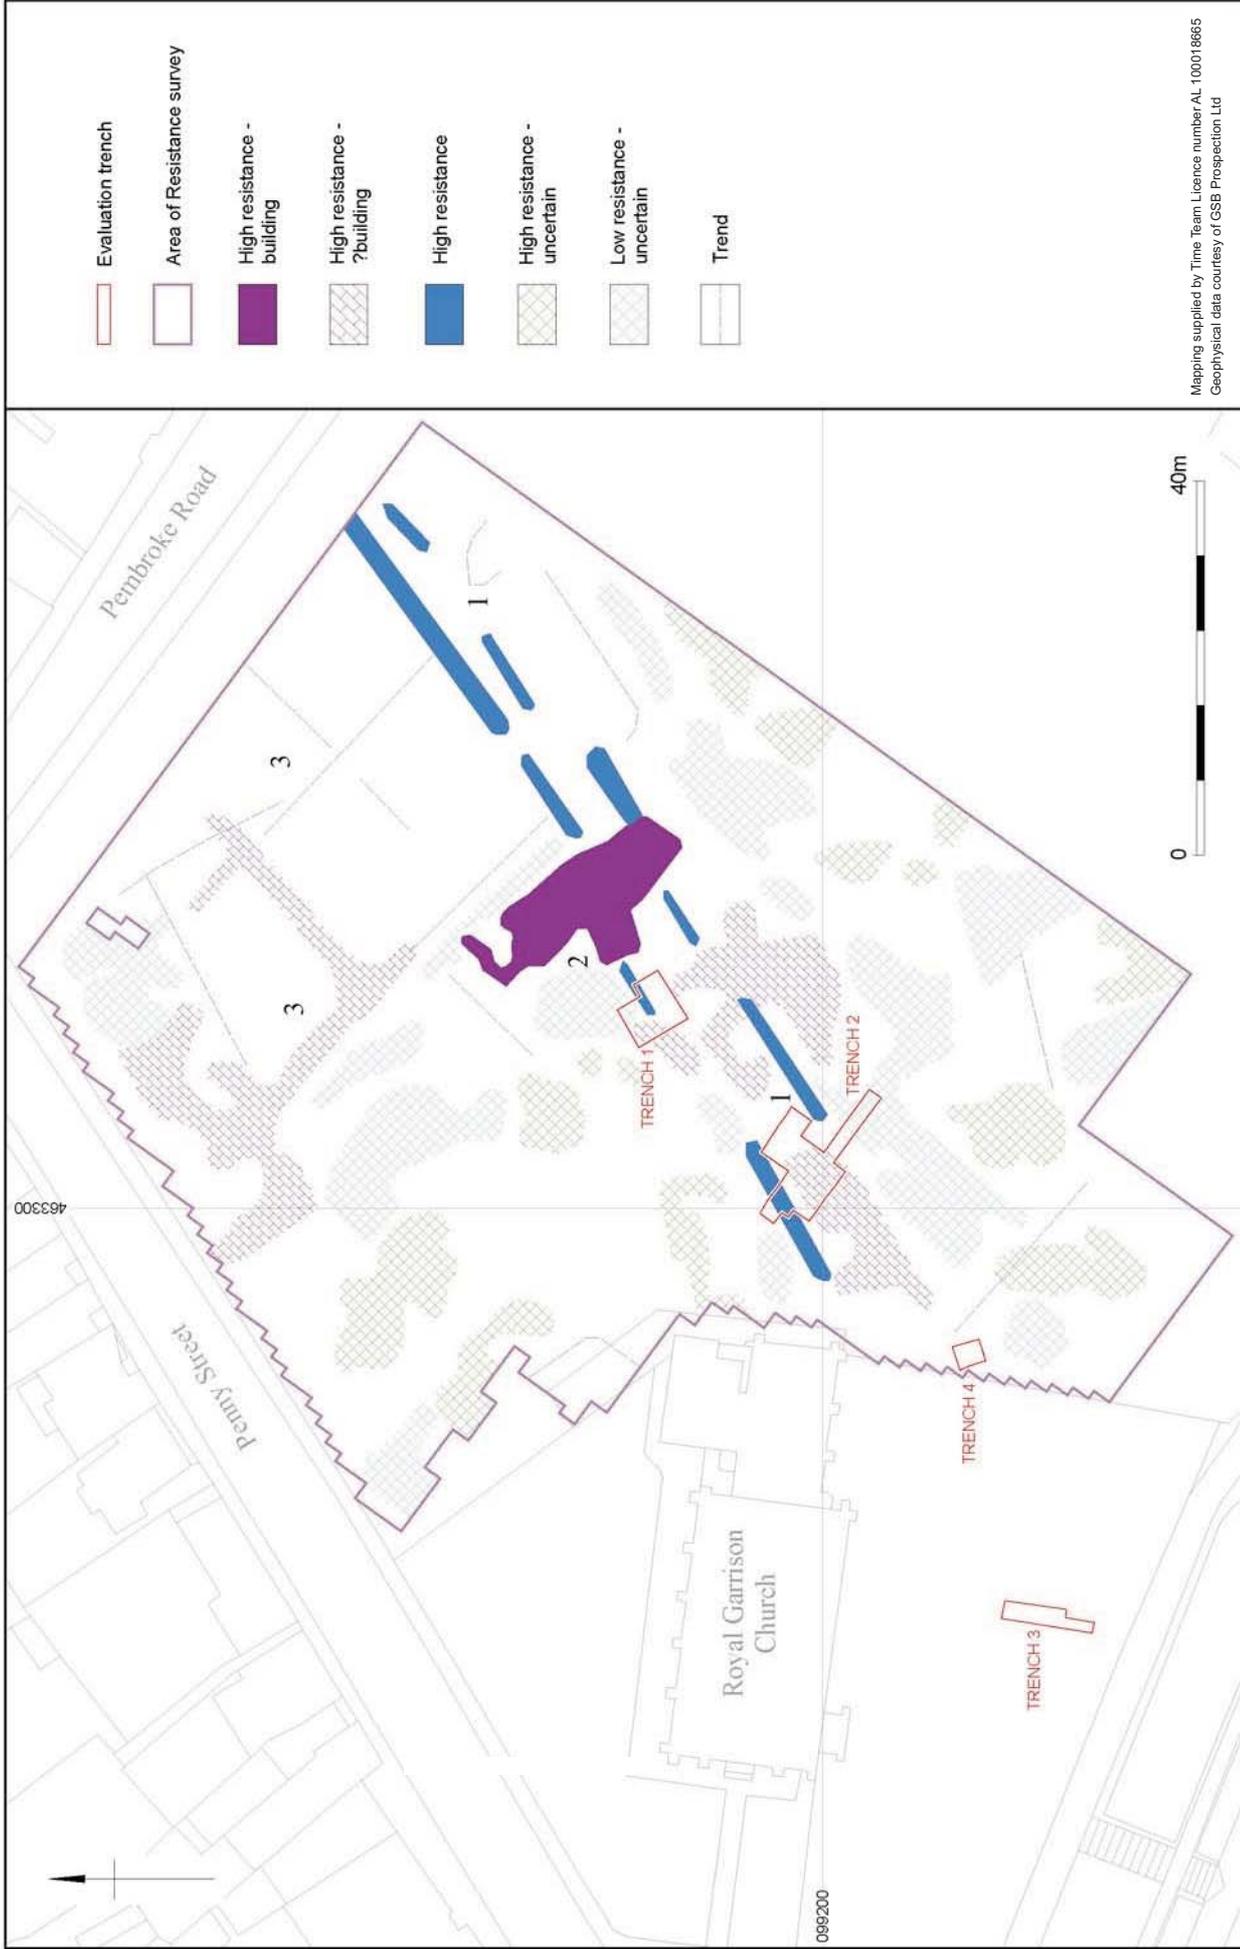
Figure 2

Results of resistance survey

4.2.3 A number of negative responses were presumed to be associated with wall foundations of one of the hospital buildings; they also corresponded well to parchmarks seen within the field and also the resistance and GPR surveys.

4.2.5 The line of an earlier road was barely visible in the magnetic data, and nor was it clear within the resistance survey. However, the main Domus Dei complex enclosure wall (or possibly a later replacement wall associated with the Governor's House) was identified as anomaly (1), this wall clearly fronted onto the gravel road as indicated in Trench 2.

- 4.2.17 All three survey techniques have detected wall foundations and disturbance associated with the 'Domus Dei hospital' – the data sets corroborate the previous interpretations which were based on aerial photographs of the Site. A former road crossing the field is also visible within the resistance and gradiometer data, and responses in the GPR largely appear to respect this line.
- 4.2.18 South of the Garrison Church, the GPR survey has identified some anomalies which seem to correlate with the purported position of buildings shown on a drawing dating to the 16th century. However, there is little definition within the anomaly spread and, to the south, excavation revealed a significant depth of made ground, which seems to be built on to natural gravels. It seems likely that the archaeological deposits in this area may have been destroyed.

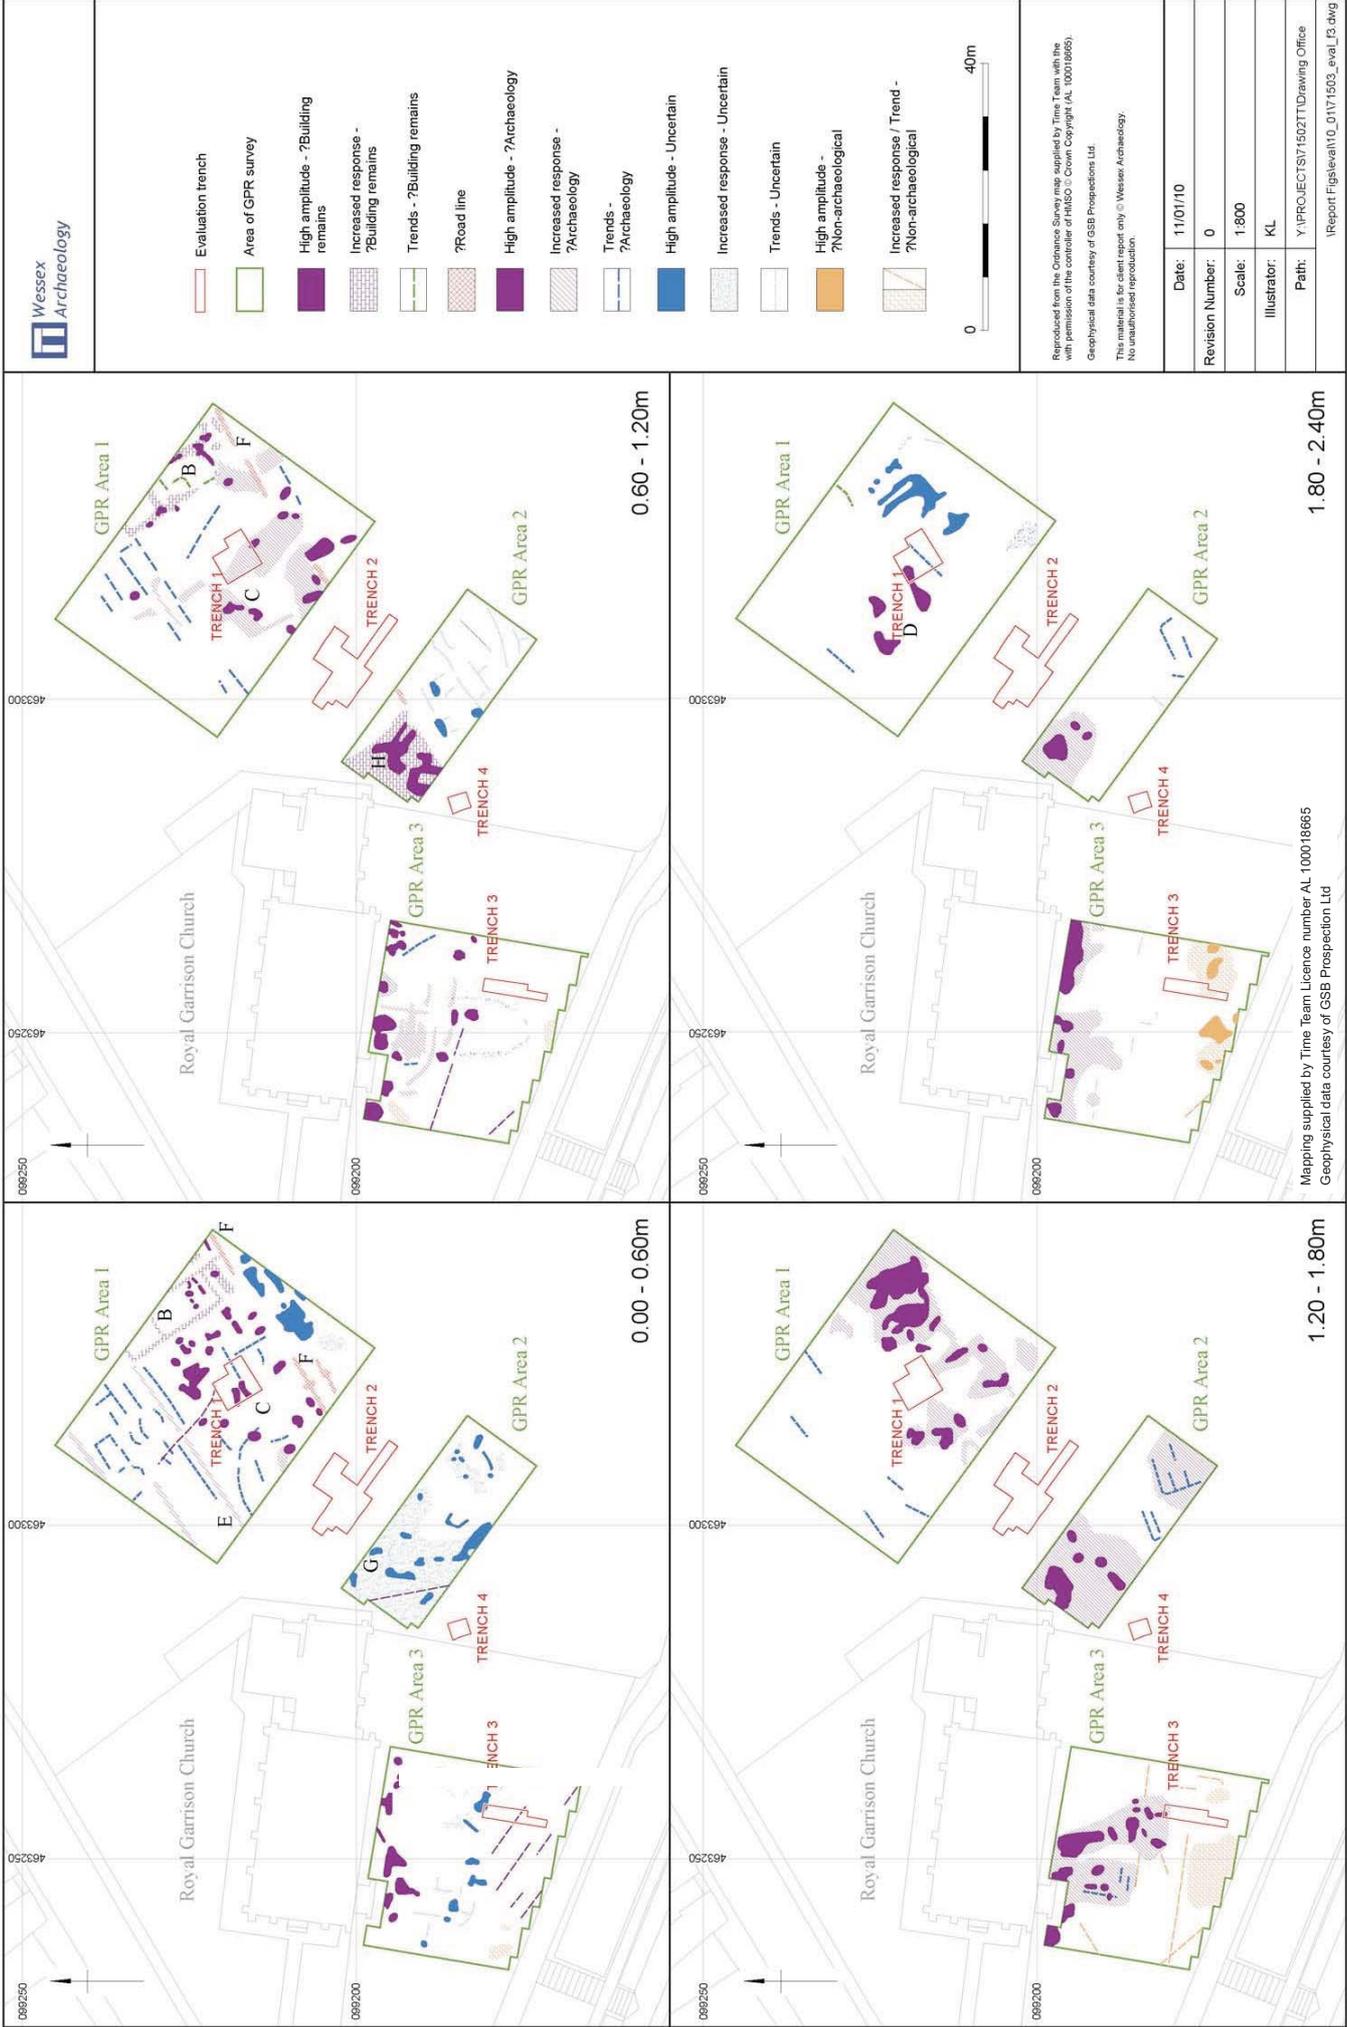
Results of GPR survey Figure 3

- 4.2.13 With increased depth, the spreads of anomalies (aside from the aforementioned group (D) which sits directly beneath known building remnants) are difficult to attribute an interpretation to as many of them lack any real defining form to their distribution but, in most cases, some kind of anthropogenic origin seems the most likely cause.

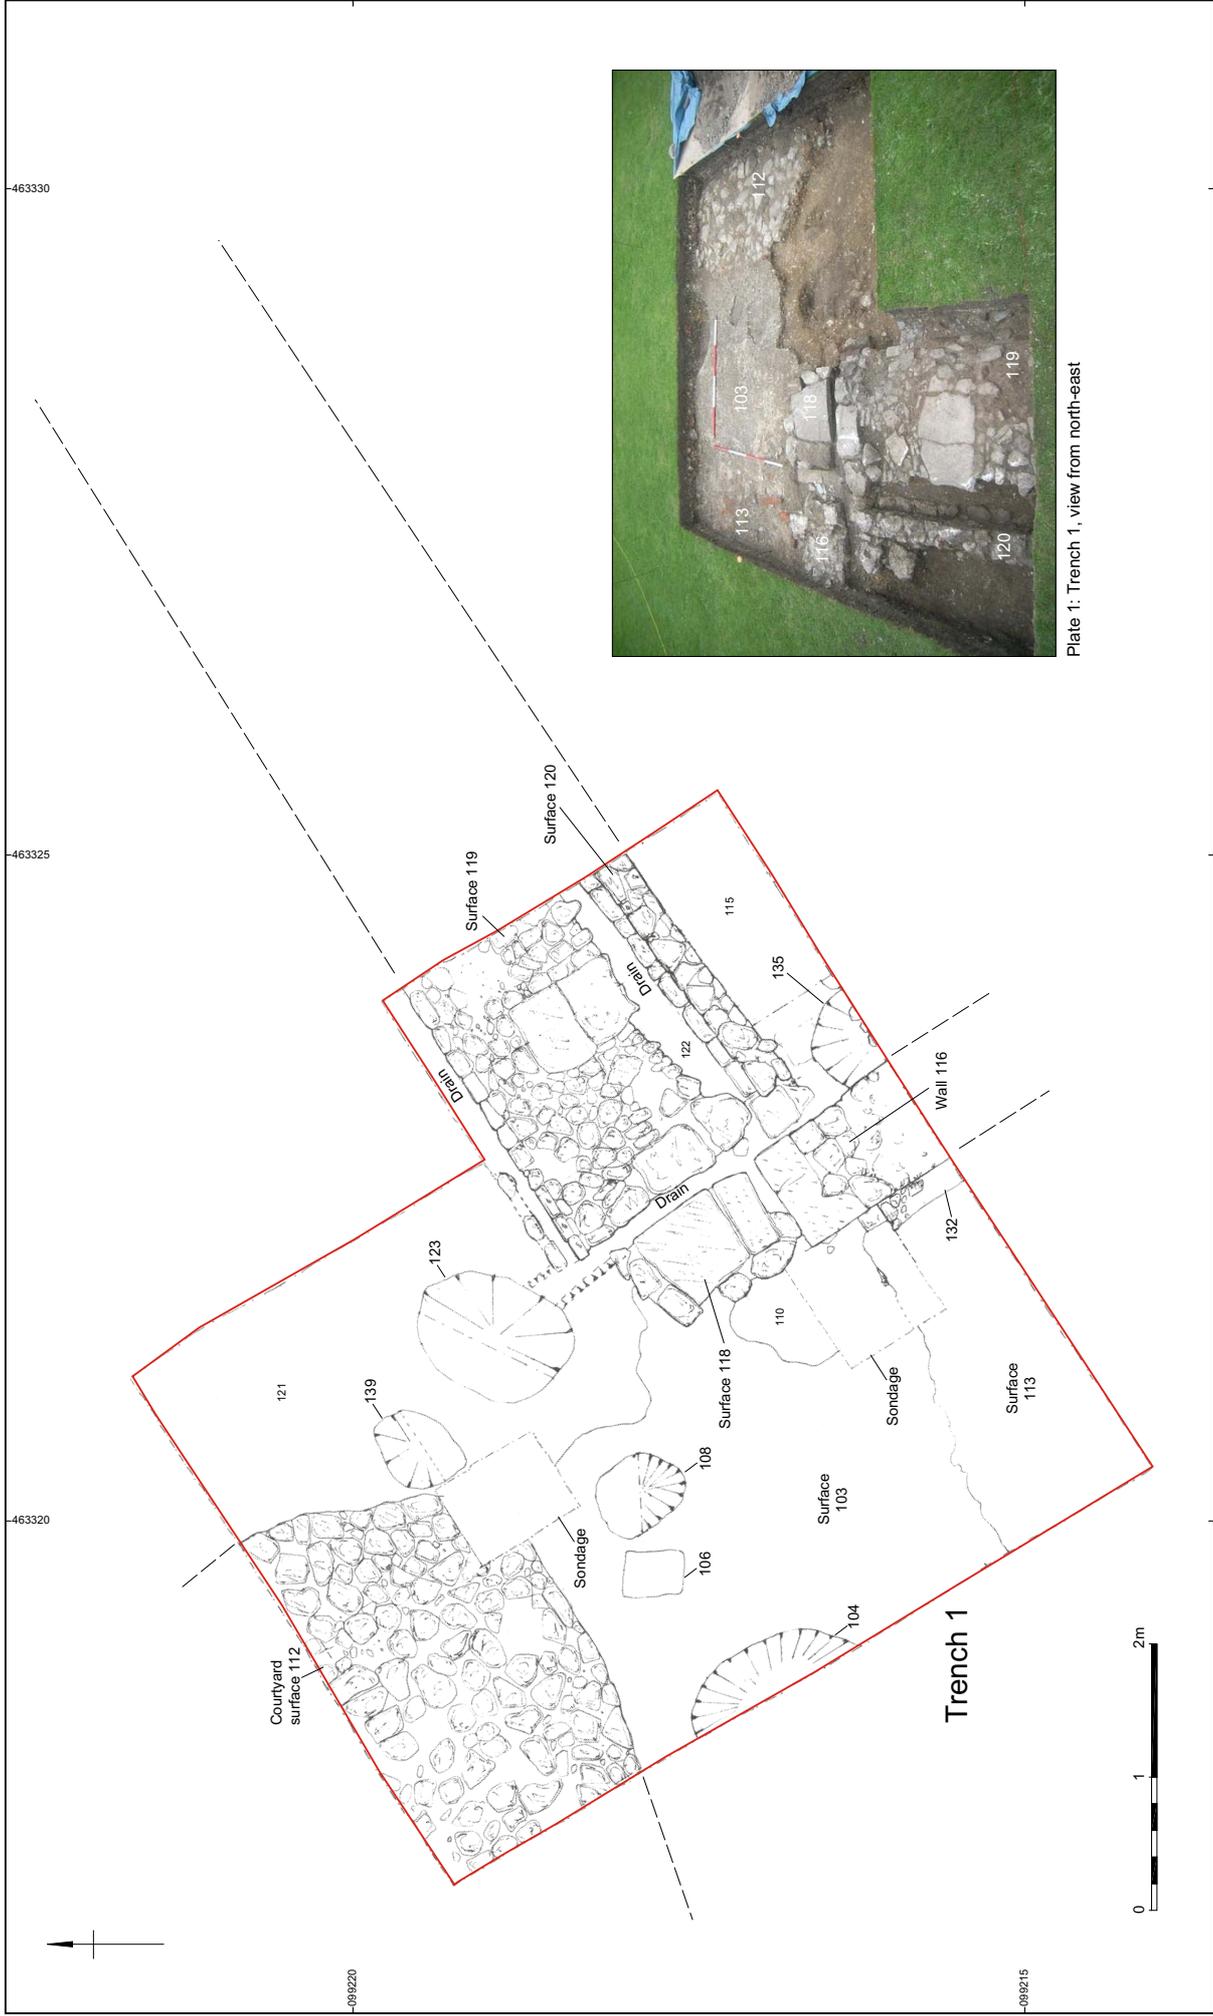
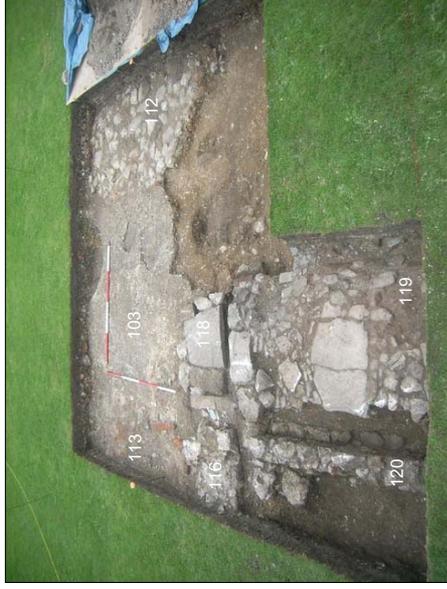
Plate 1: Trench 1, view from north-east

6.2.5 In Trench 1 the remains of a stable block and external yard surface were found. On the 1584 map and in the 1582 evaluation, stables were mentioned in this part of the Domus Dei complex, and it appears that the 16th century stables were built upon the foundations of the medieval stables.

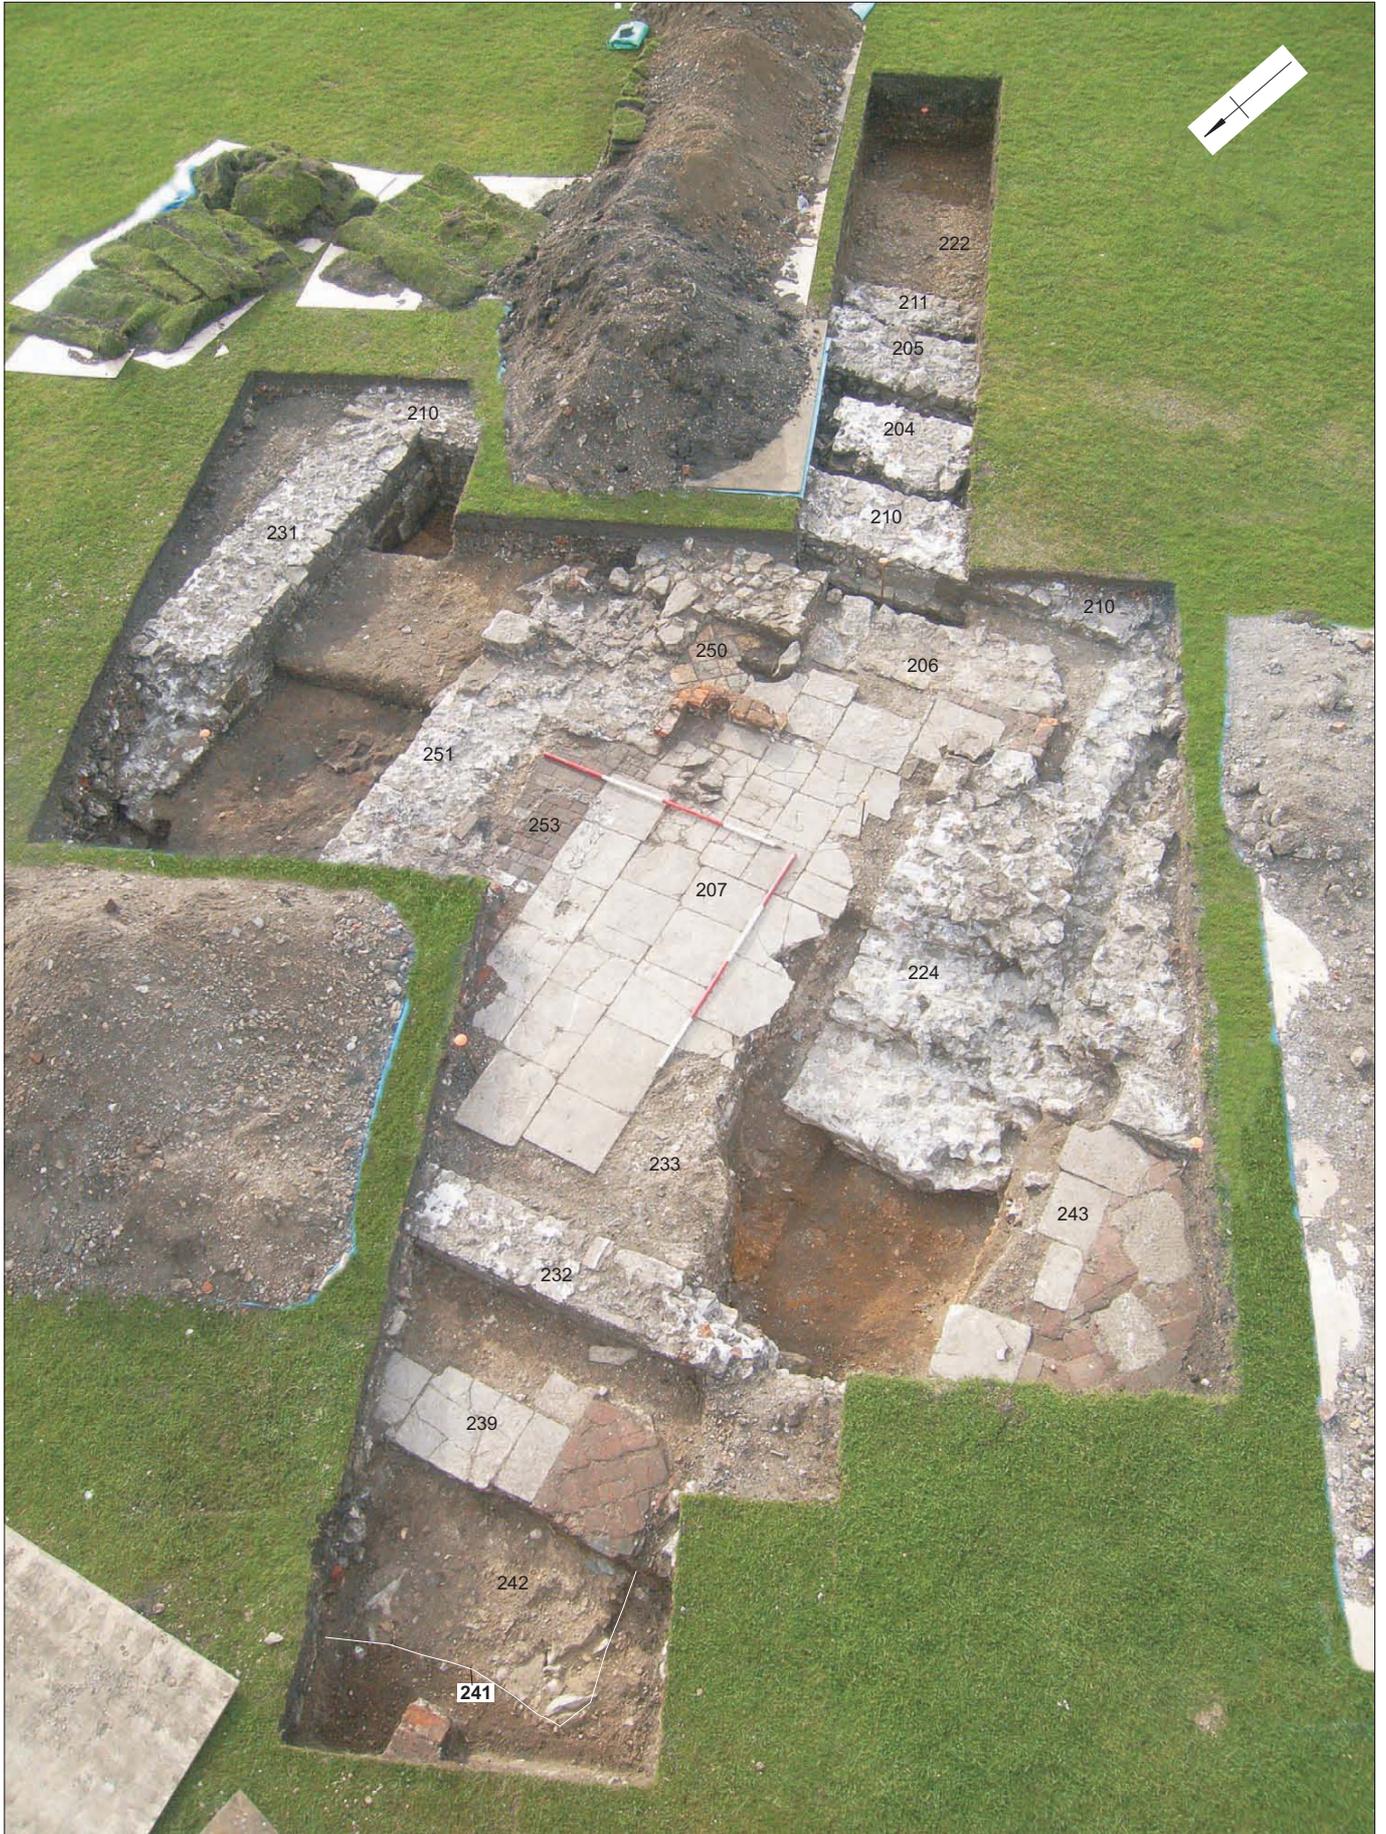
Figure 6

Plate 3: Trench 2, view from north-west

- 4.3.12 Wall (211) was exposed at the eastern end of the trench and this was interpreted as the perimeter wall of the Domus Dei complex, as it fronted onto the roadway (222). The latter comprised a metallated surface of water-worn pebbles, and would originally have joined St. Nicholas Street at the

- 4.3.15 The main 16th century structure in Trench 2 comprised a rectangular building formed of walls (231), (210), (232) and large masonry structure (224), within foundation trench (229/237) – the foundation trench truncated wall (206). Wall (232) was interpreted as a possible internal wall, while (224) was apparently a large, load-bearing wall. The foundation trench (229/237) clearly cut through the earlier flagged floor (207/239/243) and the underlying make-up layers, but certain of the stone flags had been re-set with the white lime mortar used to bond the 16th century walls. In the centre of the room, partly overlying and inserted into floor (207), was a fireplace (Group (261) with an associated spice cupboard formed by reused walls (206) and (249), and a setting of yellow and green glazed tiles (250) (**Figure 5, Plate 2**). The back wall (251) of the fireplace was a very substantial structure; an indication of a large chimney breast.

- 4.3.16 Parallel to wall (210) was wall (205) which replaced the earlier perimeter wall (211) of the Domus Dei complex; it clearly cut through the earlier build. The roadway surface (222) was still in use at this time and may have been repaired with a layer of redeposited natural gravel (221). This layer contained sherds of late medieval and early post-medieval (16th/17th century) pottery sherds. However, it is clear from the cartographic evidence for the later periods of the Governor's House that by 1750 the road had been removed, and only a small gate into Governor's Green from the north remained.

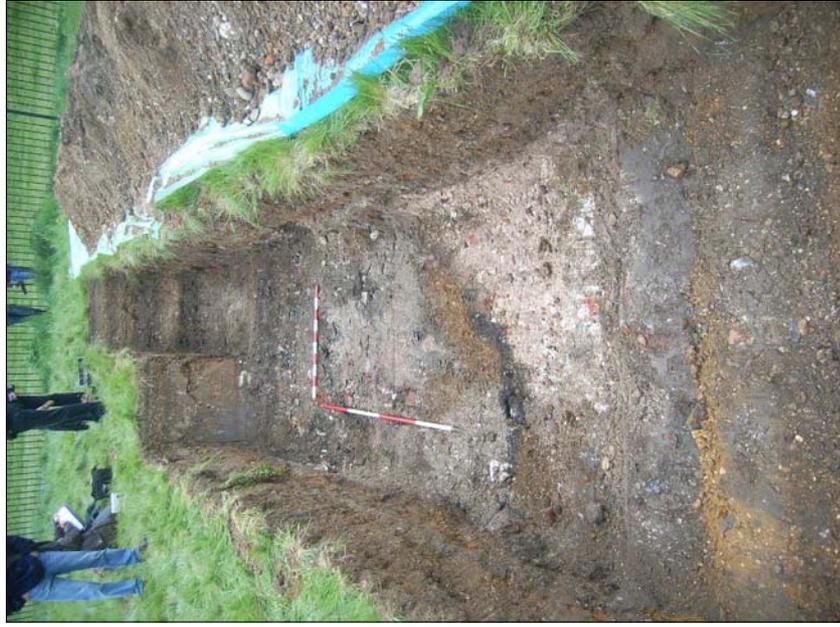
Plate 4: Trench 3, view from south

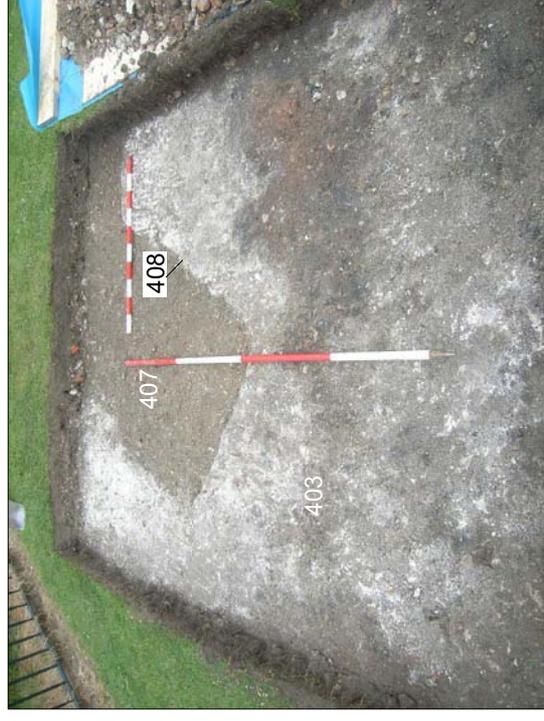
Plate 5: Pre-excavation plan of Trench 4, view from south-east
