# 3 Gladstone Cottages Wimborne Avenue, Southall

Building Recording

Ref: 54580.01  
MoLAS Site Code GCW03

*October 2003*

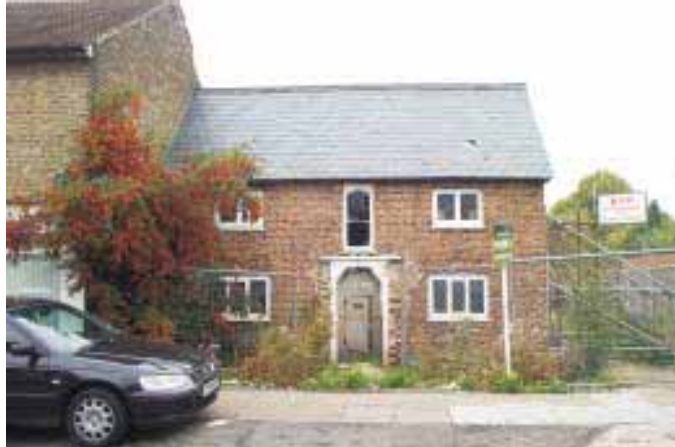
Plate 1: Front (south elevation)

3.1.2 The front (south) elevation of the building is symmetrical (**Figure 2: Plate 1**). The central doorway is flanked by windows and above it was a slim window, itself also flanked by small windows. The ground floor windows have flat brick arches above, while the first floor windows have a soldier course of headers above them. The windows are all replacement PVCu casements, except the central first floor light which is timber-framed and still contains some coloured glass. Internally this window frame bears the inscription *PG 1946* (**Figure 2: Plate 2**).

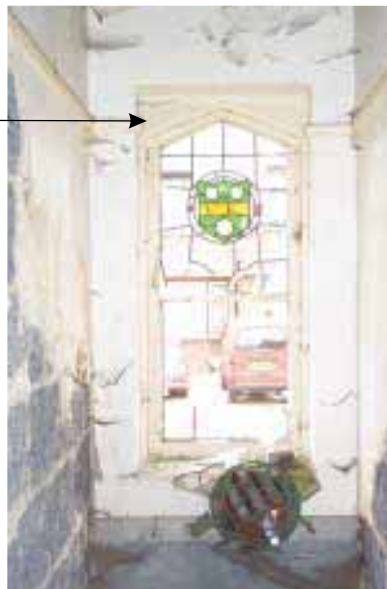
Plate 2: Stairwell window detail

Inscribed: PG 1946

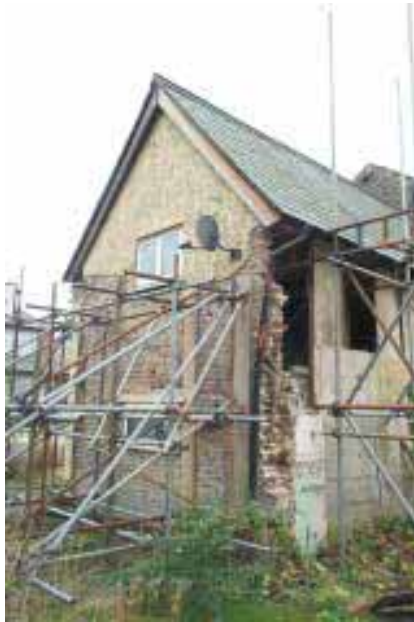
Plate 3: Side (east) elevation

3.1.4 The side of the building (**Figure 3: Plate 3**) is heavily shored. Again built of red brick, this elevation retains much of its cement render at first floor level. There are two windows in this elevation; one on each floor level and both centrally positioned. Both windows retain simple hood-moulds, that to the first floor window is still covered with cement render. To the right (north) of the first floor window is a small black satellite television receiver. The barge board protecting the gable end of the roof is unadorned.

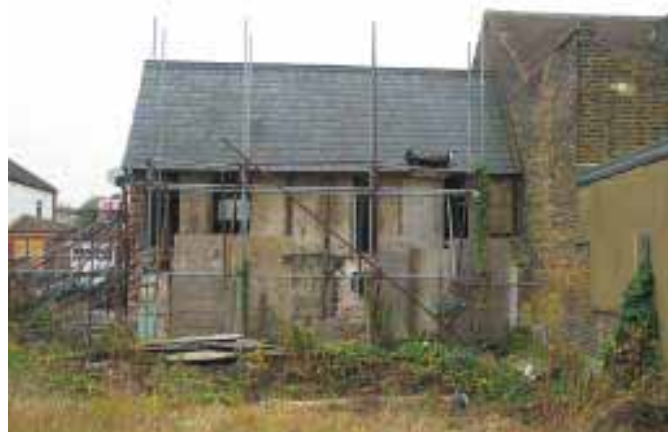
Plate 4: Rear (north) elevation

- 3.1.5 The rear (north) elevation of the cottage (**Figure 3: Plate 4**) has mostly been demolished. A small portion of wall remains in the centre of the elevation at ground floor level; this wall contains a small opaque circular window of probable mid-twentieth-century date. A second portion of wall survives at the east side of the rear (north) elevation. This portion retains a small section of ceramic tiles and nearby stands a water pipe with stopcock, suggesting that this part of the building was formerly the kitchen or bathroom.
- 3.1.6 In the eaves at the western end of this elevation are the remains of a lead welded back gutter, indicating the position of a chimney stack.

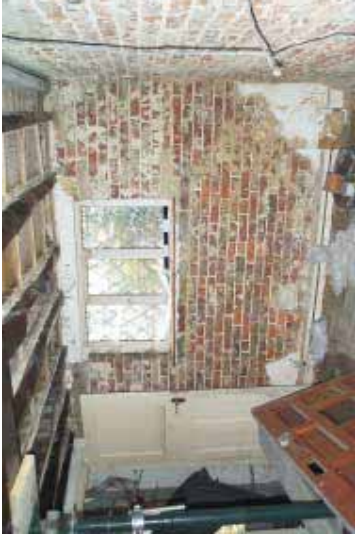
Plate 5: Western ground floor room - south wall

- 3.2.2 The western ground floor room (**Figure 5: Plate 5**) contains an opaque circular window (mentioned previously) in the former north wall, and a casement window in the south wall. The western wall is of nineteenth century brick construction and retains some plaster. The eastern wall of the room forms the stairwell and is constructed of twentieth century engineering bricks.

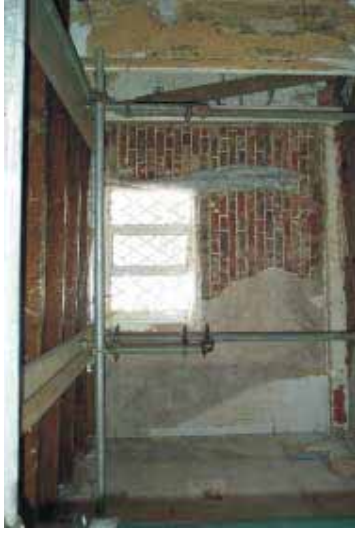
Plate 6: Eastern ground floor room - south wall

- 3.2.3 The eastern ground floor room (**Figure 5: Plate 6**) contains two windows; one in the south wall and one in the east. A built-in cupboard is located in the north-east corner, while in the north-west is an under-stairs cupboard. The west wall of this room forms one side of the stairwell and is fully plastered, but on inspection of the reverse side is constructed of twentieth century engineering bricks.

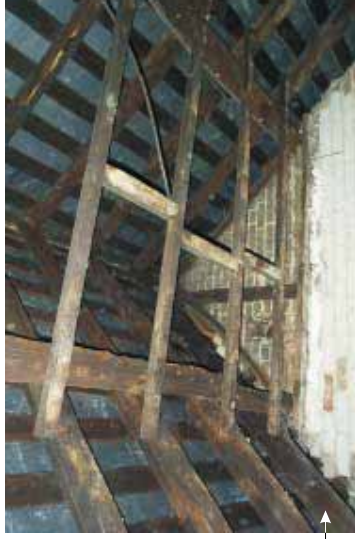
Plate 8: Western first floor room - roof construction

- 3.2.7 Although the roof structure is fully visible, lack of safe access prevented a detailed investigation. The tie beam in the western first floor room, and the wall plate visible in the eastern first floor room are both substantial hardwood timbers. The purlins are also of substantial dimensions, partially prepared to a rough square section and built in to the gables at either end. Cross-strutting has been added to the underside of the purlins, presumably to form the ceiling of each room. Rafters are of single section, running from the wall plate over the purlins to the ridge plate. The rafters are a mixture of square sawn and partially prepared timbers. Attached to them are large slating battens approximately 150mm wide. The size of these battens and the other roof timbers may suggest that the roof covering was originally of heavy clay tile, probably sourced locally. The roof is un-felted. The construction of the roof and the size of the timbers used indicates an early nineteenth century date for the roof.

Partially  
prepared  
timbers

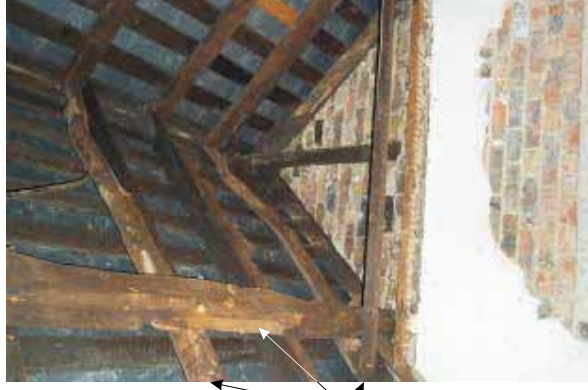
Plate 9: Eastern first floor room - roof construction

- 3.2.6 The eastern first floor room (**Figure 5: Plates 9-11**) has windows in the south and east walls. Again, the south window has two courses of bricks on edge above it. The demolition of the north wall has revealed a heavy wall plate, which, at a point near the stairwell, contains a scarf joint. Also in the north side of this room, some of the laths remain between the roof timbers. Packed behind the laths is an insulating layer of straw.

Partially  
prepared  
timbers
