203 HOLLAND PARK AVENUE LONDON W11 LONDON BOROUGH OF KENSINGTON AND CHELSEA

Archaeological Evaluation Report

Ref: 56920.01 July 2004

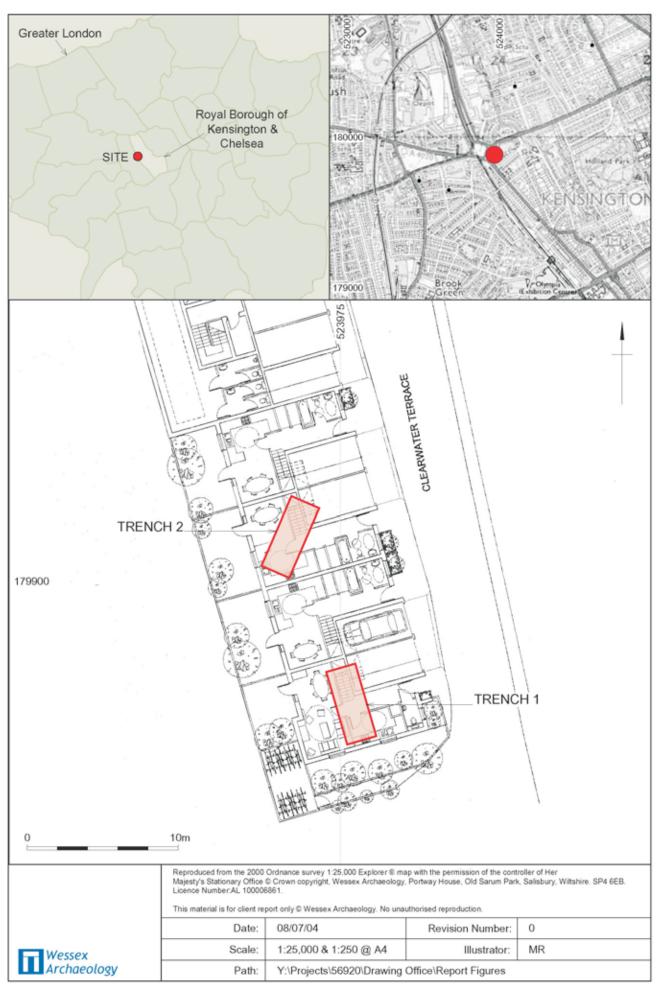
Figure 1 – Site and Trench Location Plan

- 1.2.1 The Site consists of a cleared area of land containing the former basement of the Duke of Clarence Public House to the north, which stood at 203 Holland Park Avenue. The remainder of the Site to the south had previously been occupied by ancillary buildings and gardens. (**Figure 1**).
- 1.2.2 The evaluation consisted of two machine excavated trenches, each measuring 5m x 2m which were positioned within the footprint of the proposed development towards the central and southern area of the site away from the exposed basement to the north.
- 1.2.3 Rubble and weeds covered the ground surface of the evaluation area. Natural geological deposits beneath the Site were found to comprise yellow London clay.
