**174-178 LONG LANE, SE1
LONDON BOROUGH OF SOUTHWARK**

Archaeological Evaluation Report

**London Site Code
LLB04**

March 2005

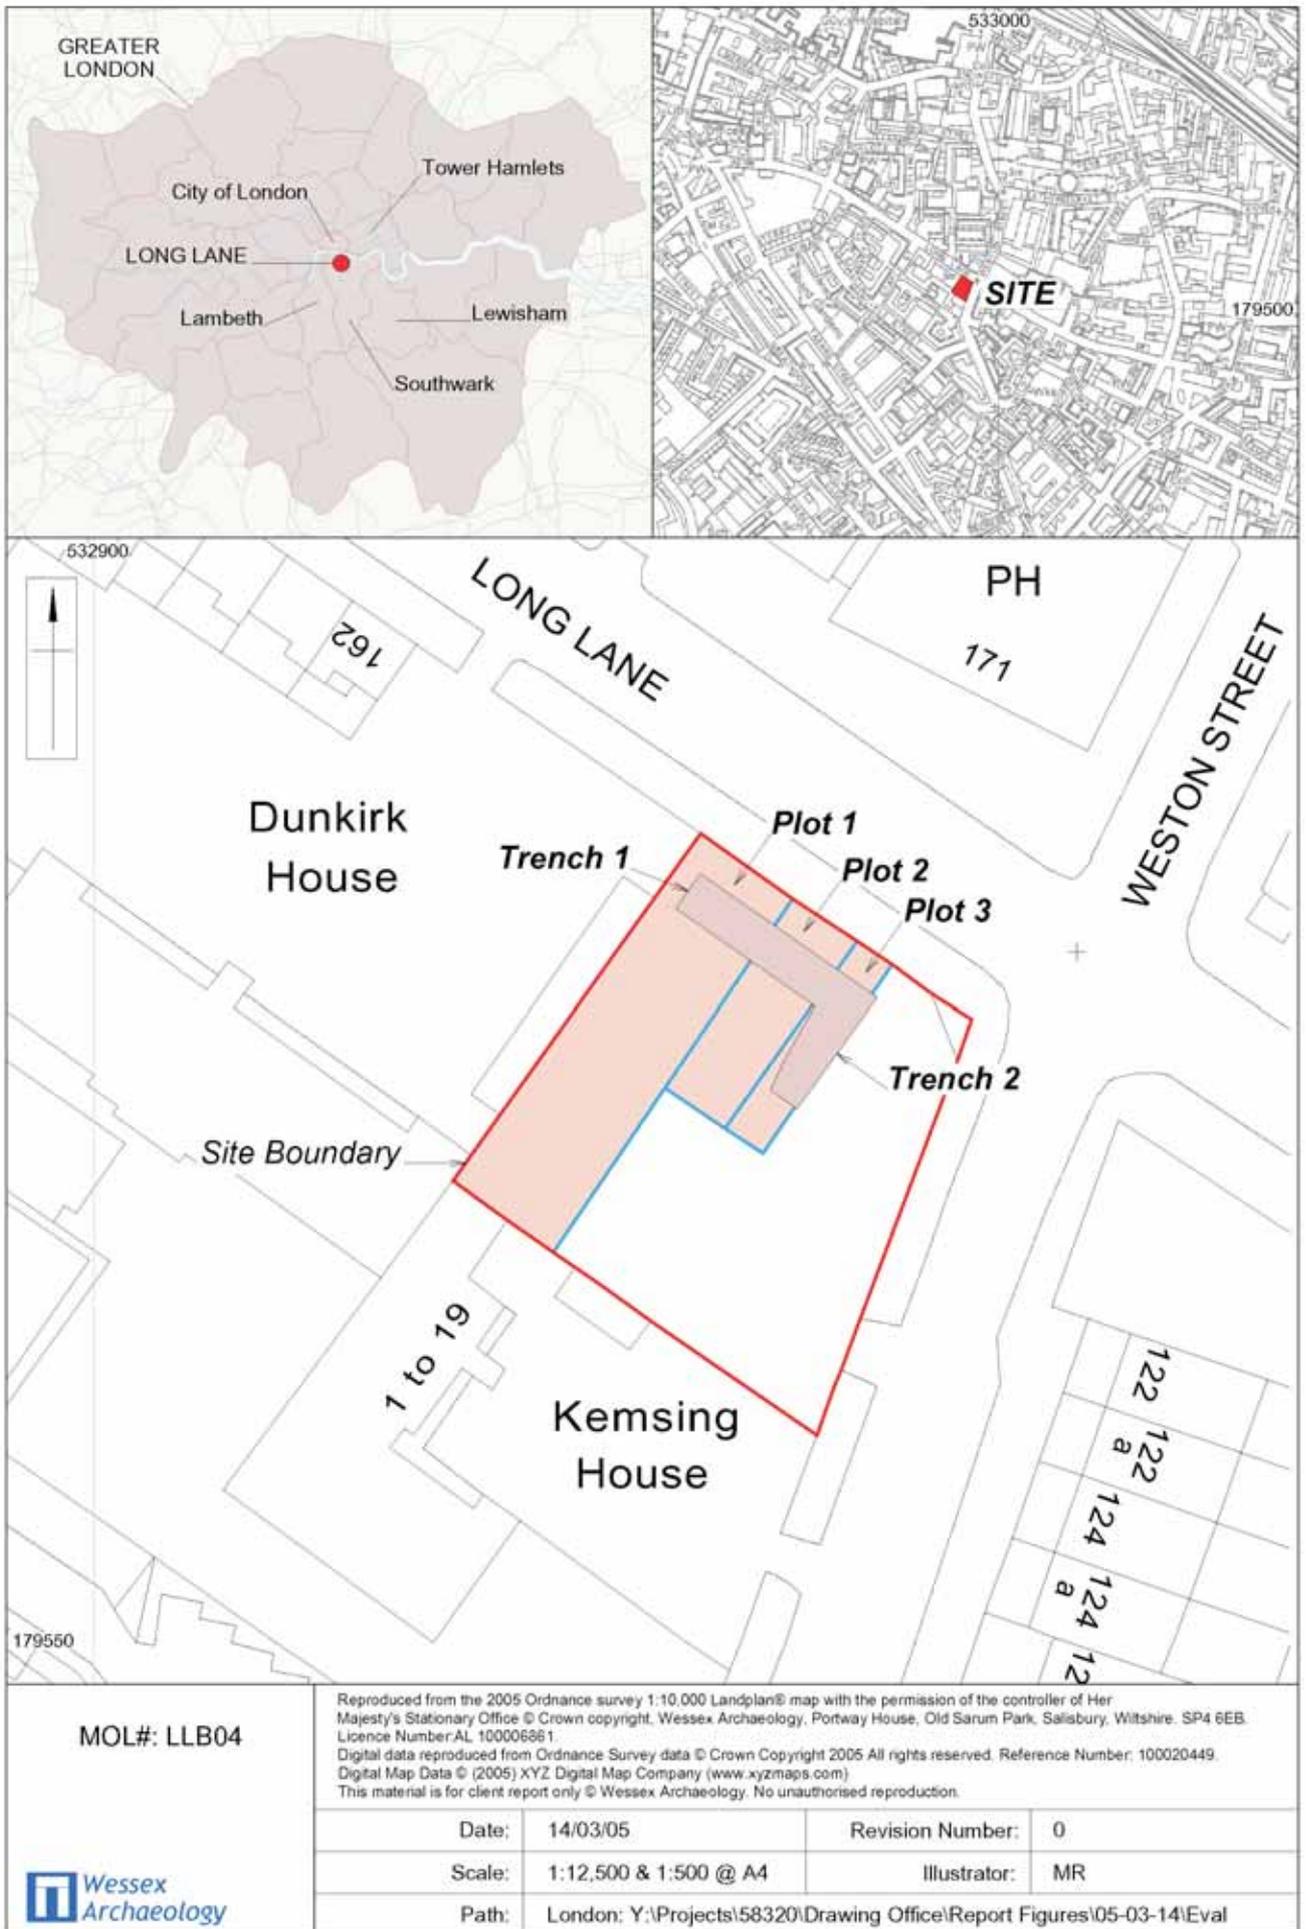
Figure 1

Site and Trench Location Maps

- 1.1.5 The evaluation comprised the excavation of two trenches in accordance with the Brief, one orientated east - west at the front of the property measuring 15m x 2.8m with a further trench at right angles to the first measuring 9m x 2.8m (**Figure 1**).

- 2.3.1 The evaluation comprised of two machine-excavated trenches, sited within the footprint of the proposed development (**Figure 1**).
- 2.3.2 Trench 1 measured 15m x 2.8m (42m²) and was oriented east - west to examine the northern frontage of the Site. A subsequent trench, Trench 2, was excavated at a right angle to Trench 1 to examine the sequence to the rear of the plot, it measured 9m x 2.8m (28m²).

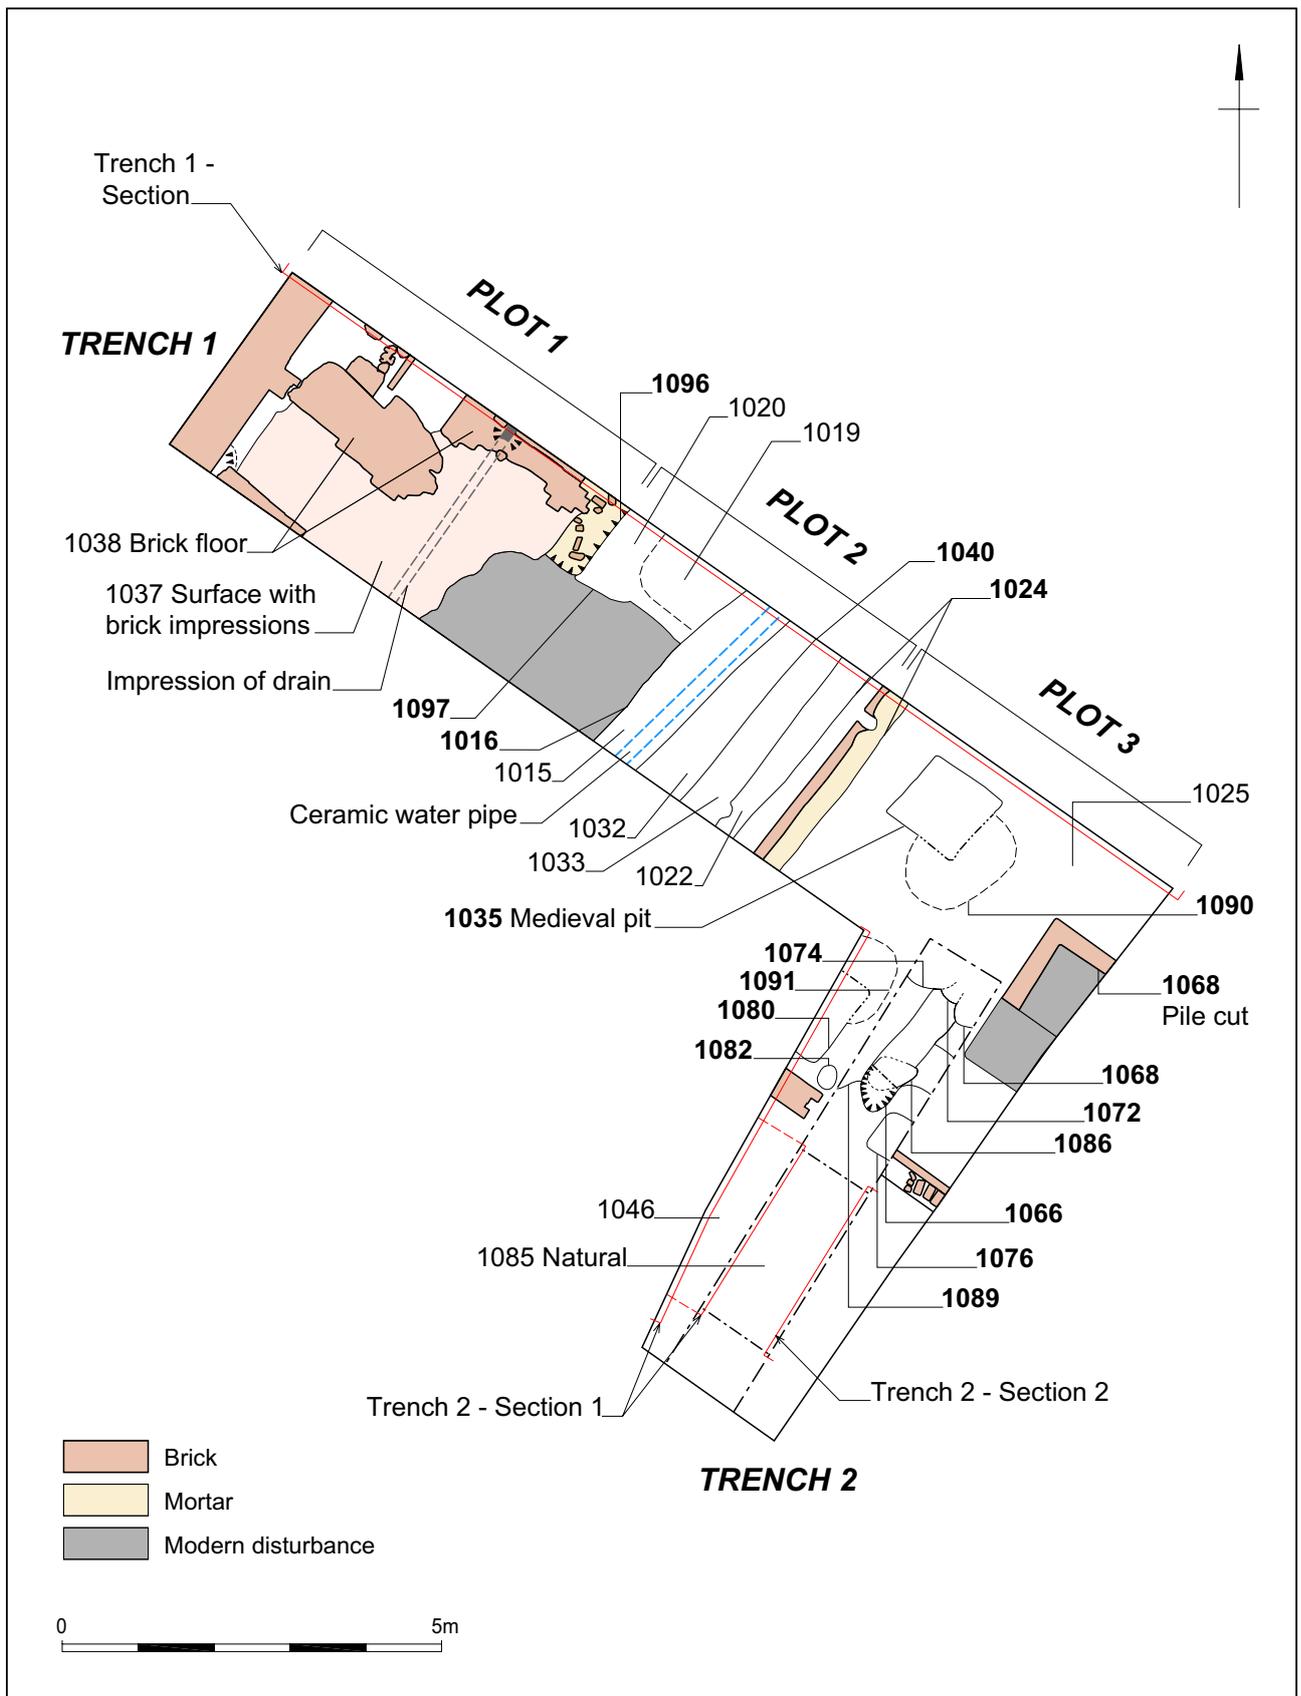
Figure 2

Plan of Trenches 1 & 2

- 3.3.1 In Trench 2, a ditch/gully [1066] (**Figure 2**) orientated on a north-south axis was truncated at its northern end by a series of pits. The finds from the fill (1067) of [1066] date to the medieval/early Post-medieval period and include fragments of shelly sandy ware and a single fragment of peg tile.

- 3.3.2 Cutting ditch/gully [1066], and stratigraphically earlier than (1025) were pits [1086] and [1072] (**Figure 2**) which date, on the basis of the stratigraphy, to the medieval period. Pit [1073] (**Figure 2**) was truncated by pits [1068] and [1074]. A further, sub-rectangular, pit [1076], was located to the southeast of gully [1066].

3.5.7 Evidence of the construction of the 20th century properties on site was also present in the form of pile cuts [1084, 1097] and a brick built soak away [1078, 1079] (**Figure 2**).

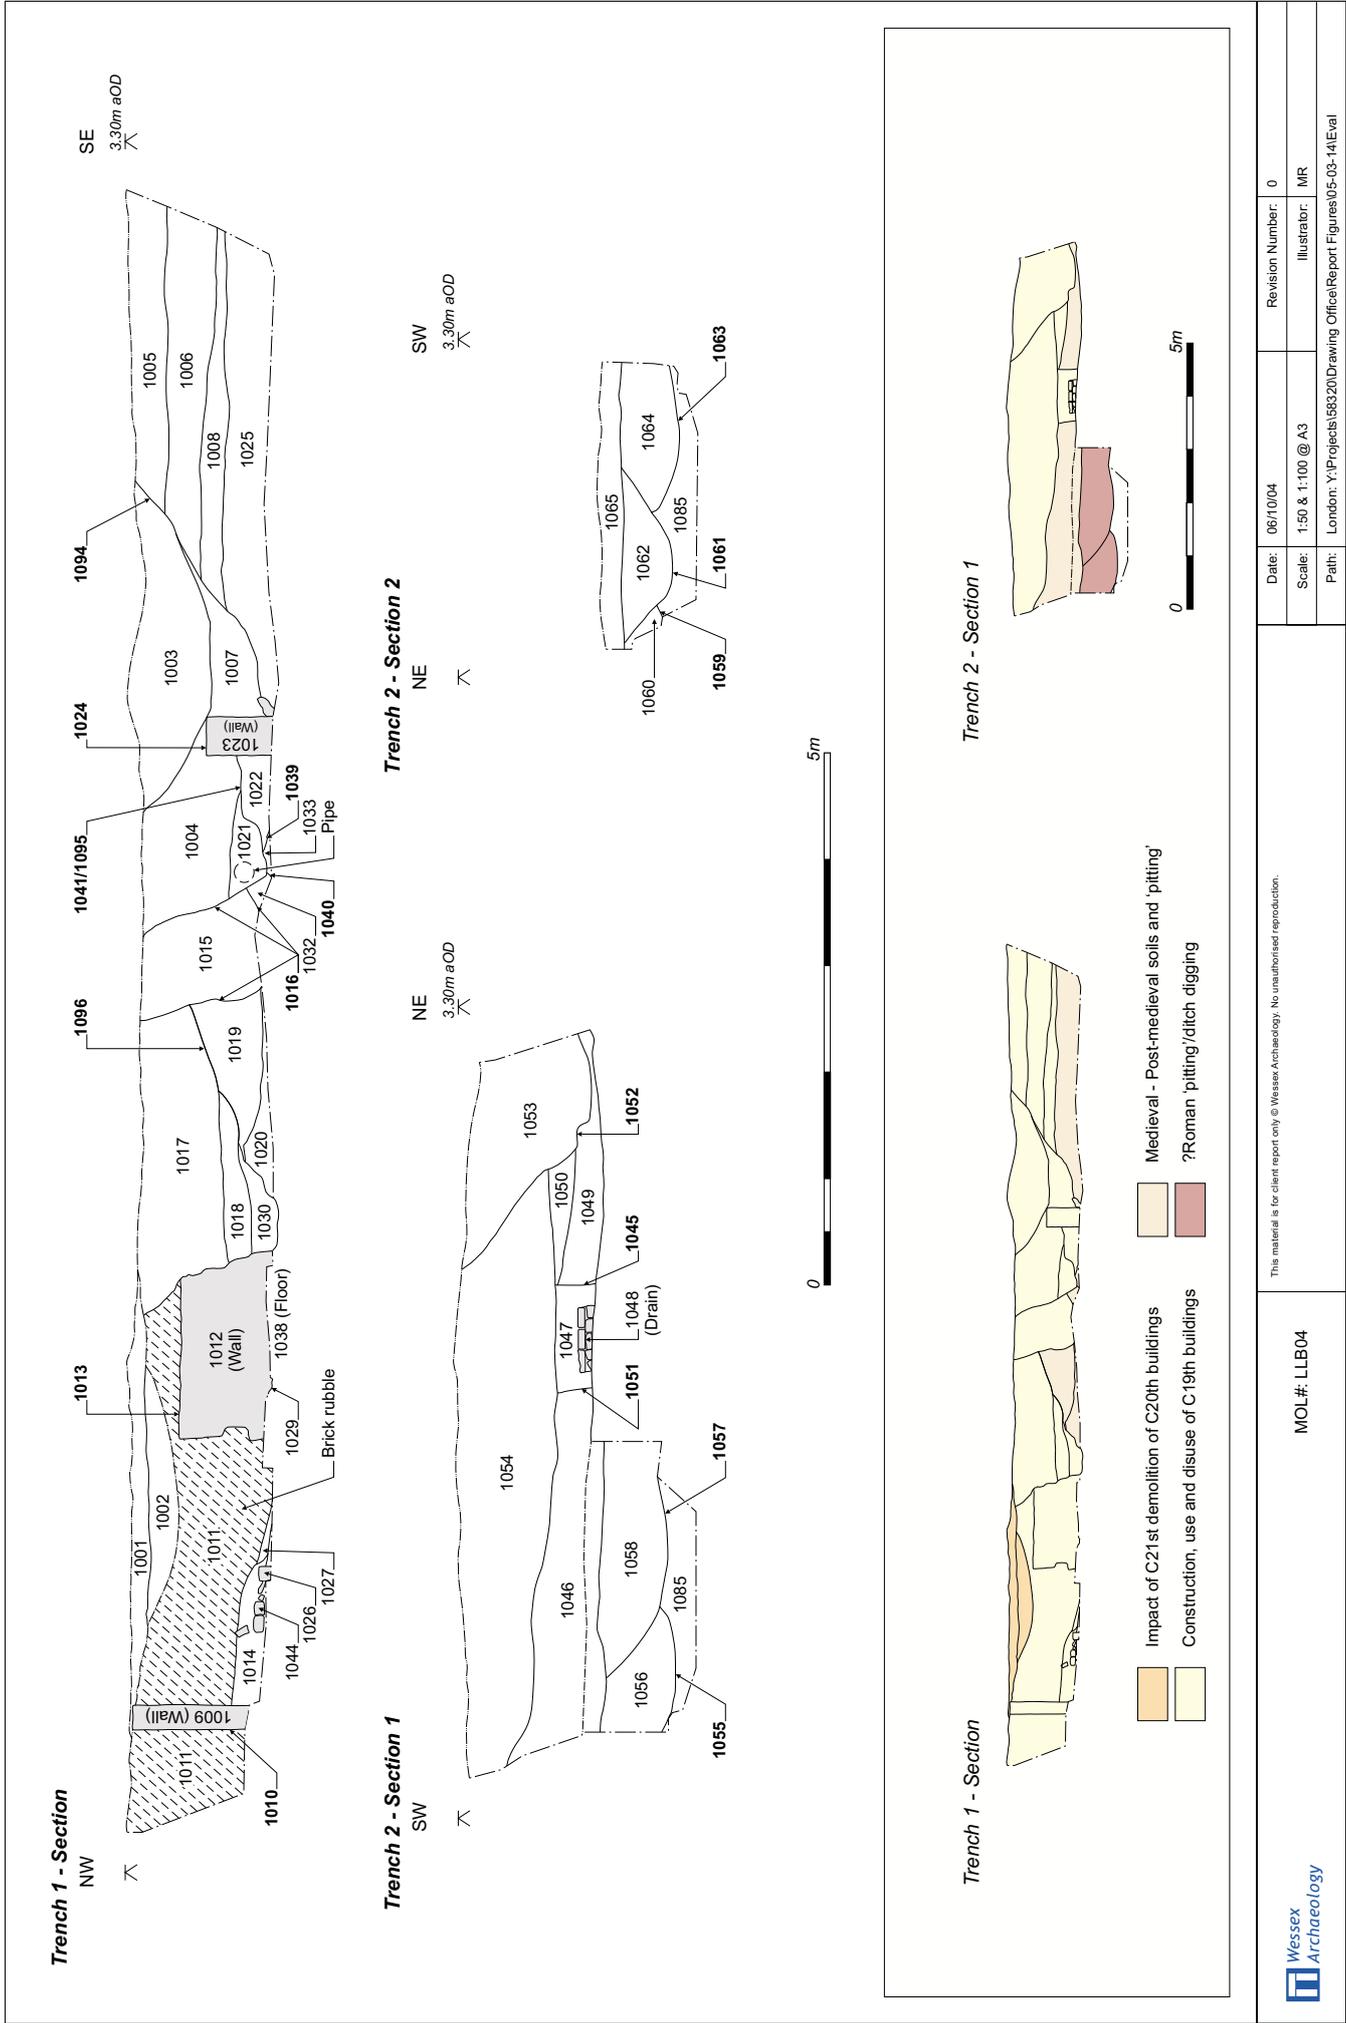
Section Drawings and Site Sequence Represented by Period

- 3.1.3 In summary this sequence can be broadly characterised as representing, from earliest to latest (**Figure 3**)
 - Roman pitting and ditch digging.

- 3.2.2 Of the three putative ditches observed in Trench 2, two [1063] and [1059] were cut into the natural sands and gravels and were in turn truncated by ditch [1061] (see Trench 2 section 2). Medieval and post medieval activity which horizontally truncated the upper extent of these Roman deposits is probably responsible for the introduction of two small fragments of intrusive pottery from fill (1064) (**Figure 3**).

- 3.3.3 To the north, in the southeastern end of Trench 1, a square pit [1035] measuring 2 x 2m was filled with (1034) which contained Tudor Green glazed pottery dating to the 14th /15th century in addition to quantities of animal bone, oyster shell and an iron object. This pit was cut through (1025) (**Figure 3**) a mid brown silty clay at the eastern end of Trench 1.

3.5.5 To the south, the remnants of a brick drain, [1045] within a foundation trench [1051/1045] and orientated on an east-west axis, was recorded within Trench 2 (**Figure 2 & 3**).

3.5.8 Demolition of the 20th century buildings, comprising the dismantling of the structures standing until March 2005 and the breaking out of the concrete slab is reflected in the horizon of horizontal truncation and demolition deposits (1001, 1002) (**Figure 3**).

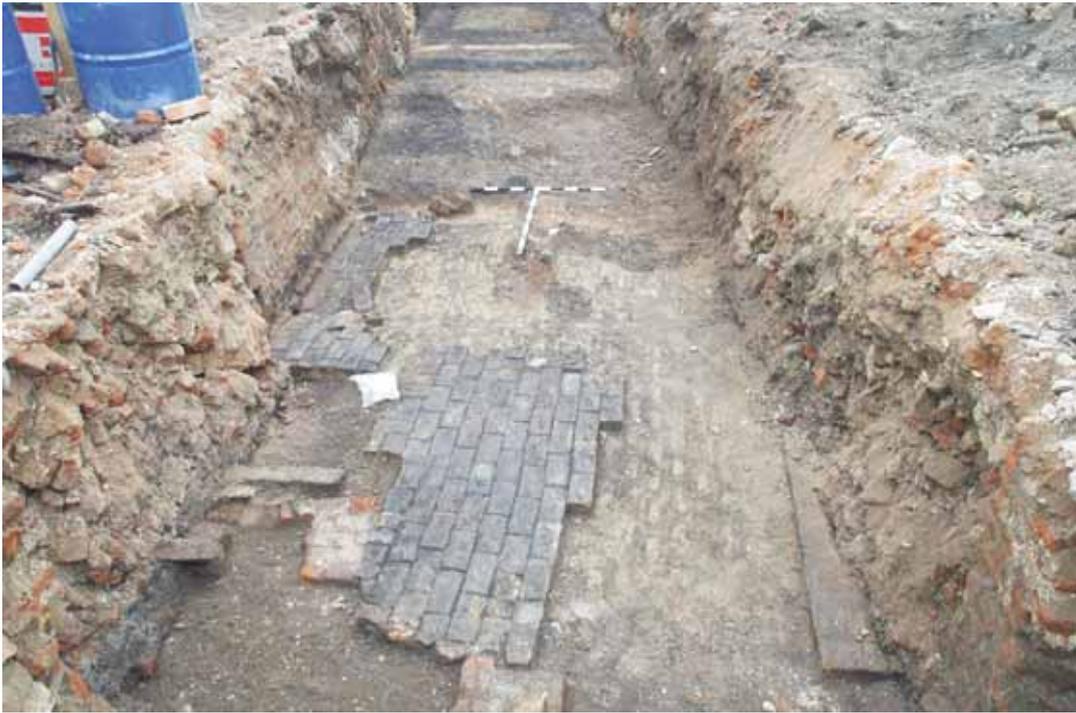
Figure 4: Trench 1 from the northwest showing brick -built C19th cellar floor (1038) (Scale 1m & 1m)

3.5.2 Trench 1 contained the remnants of a cellared property, pre-dating those demolished in March 2004. The cellar (**Figure 4**) which had been infilled with demolition material contained two phases of brick flooring (1038, 1044), the latest of which (1038) had been robbed out. Two possible drains (1026 and 1029), related to the construction and use of the cellar, were also excavated.

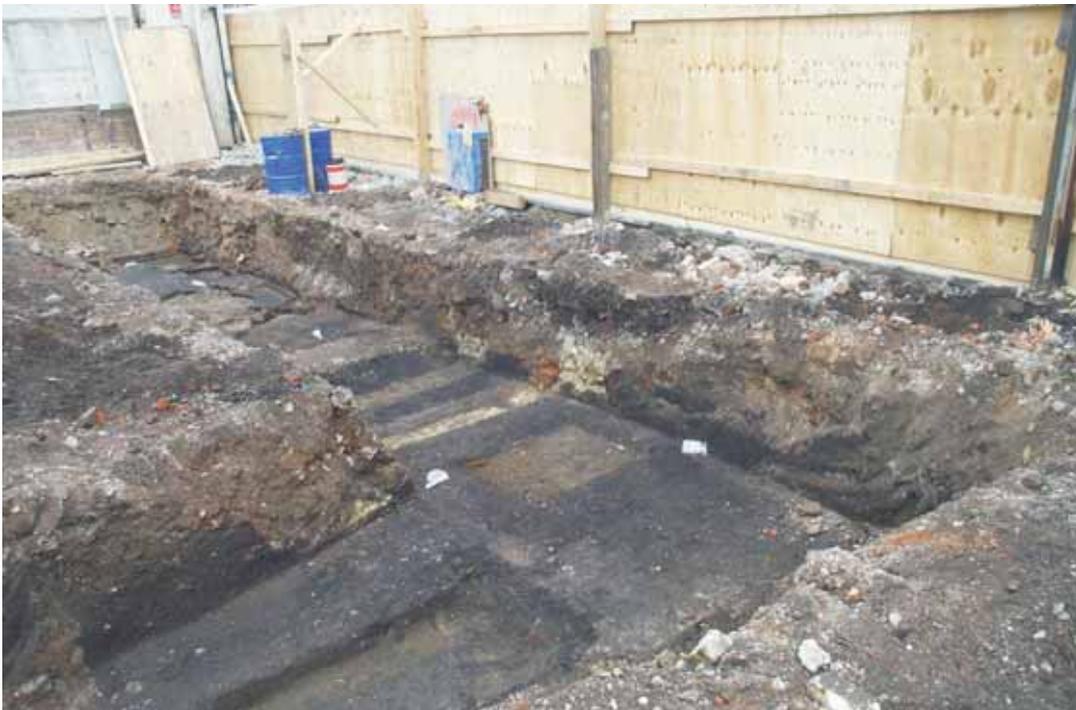
Figure 5: Trench 1 and junction with Trench 2 from the southeast

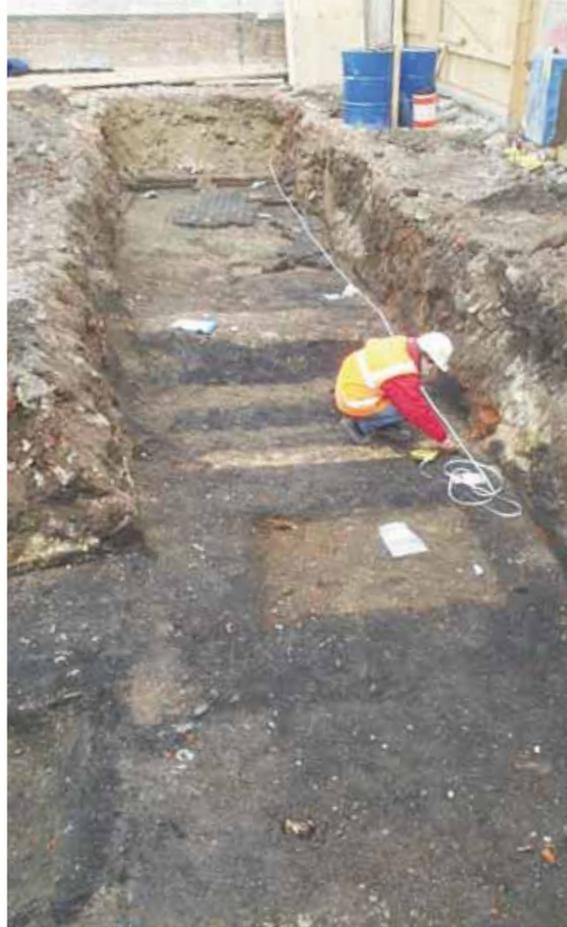
Figure 6: Trench 1 under excavation, from the southeast

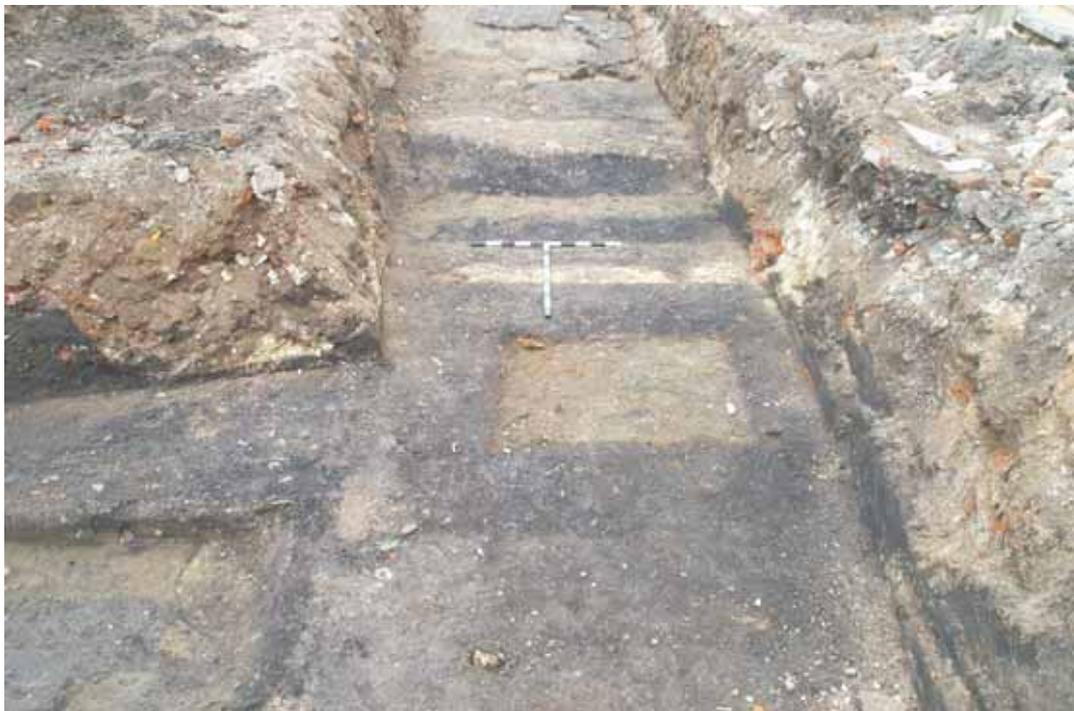
Figure 7: Southeast end of Trench 1 showing Medieval & Post-medieval pitting; and Medieval and Post-medieval garden soils

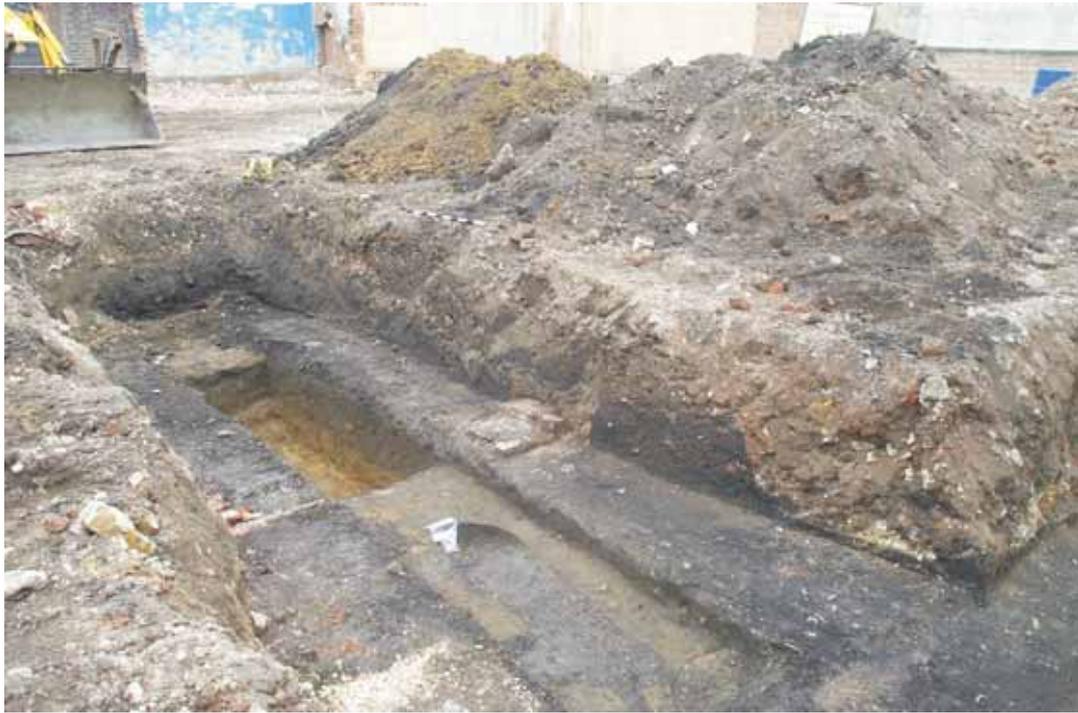
Figure 8: Trench 2 showing sondage, from the northeast (Scale 1m)

- 3.2.1 Three features, probably representing a series of east-west oriented ditches, were recorded dating from the late 1st or early 2nd century AD with amphora and Romano-British ceramic building material from the south end of Trench 2 (**Figure 3 & 8**).

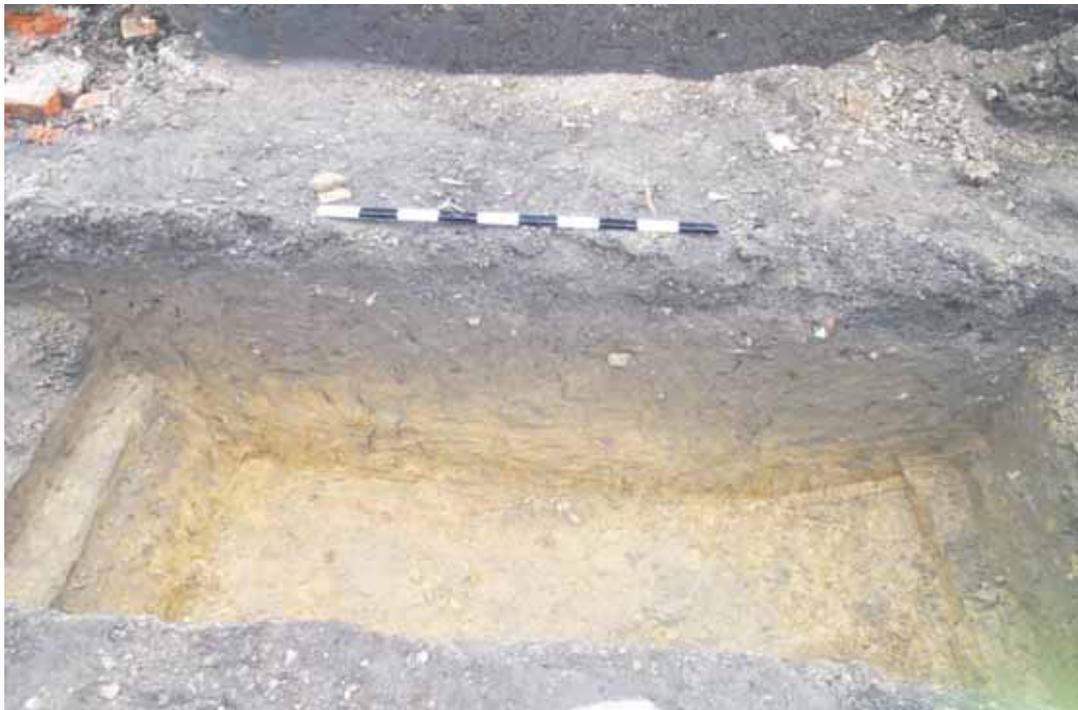
Figure 9: Southeast facing section of sondage in Trench 2 (Scale 1m)
