## Queenborough Castle, Isle of Sheppey, Kent

Archaeological Evaluation and Assessment of Results

**Report reference: 59470.01**

**January 2006**

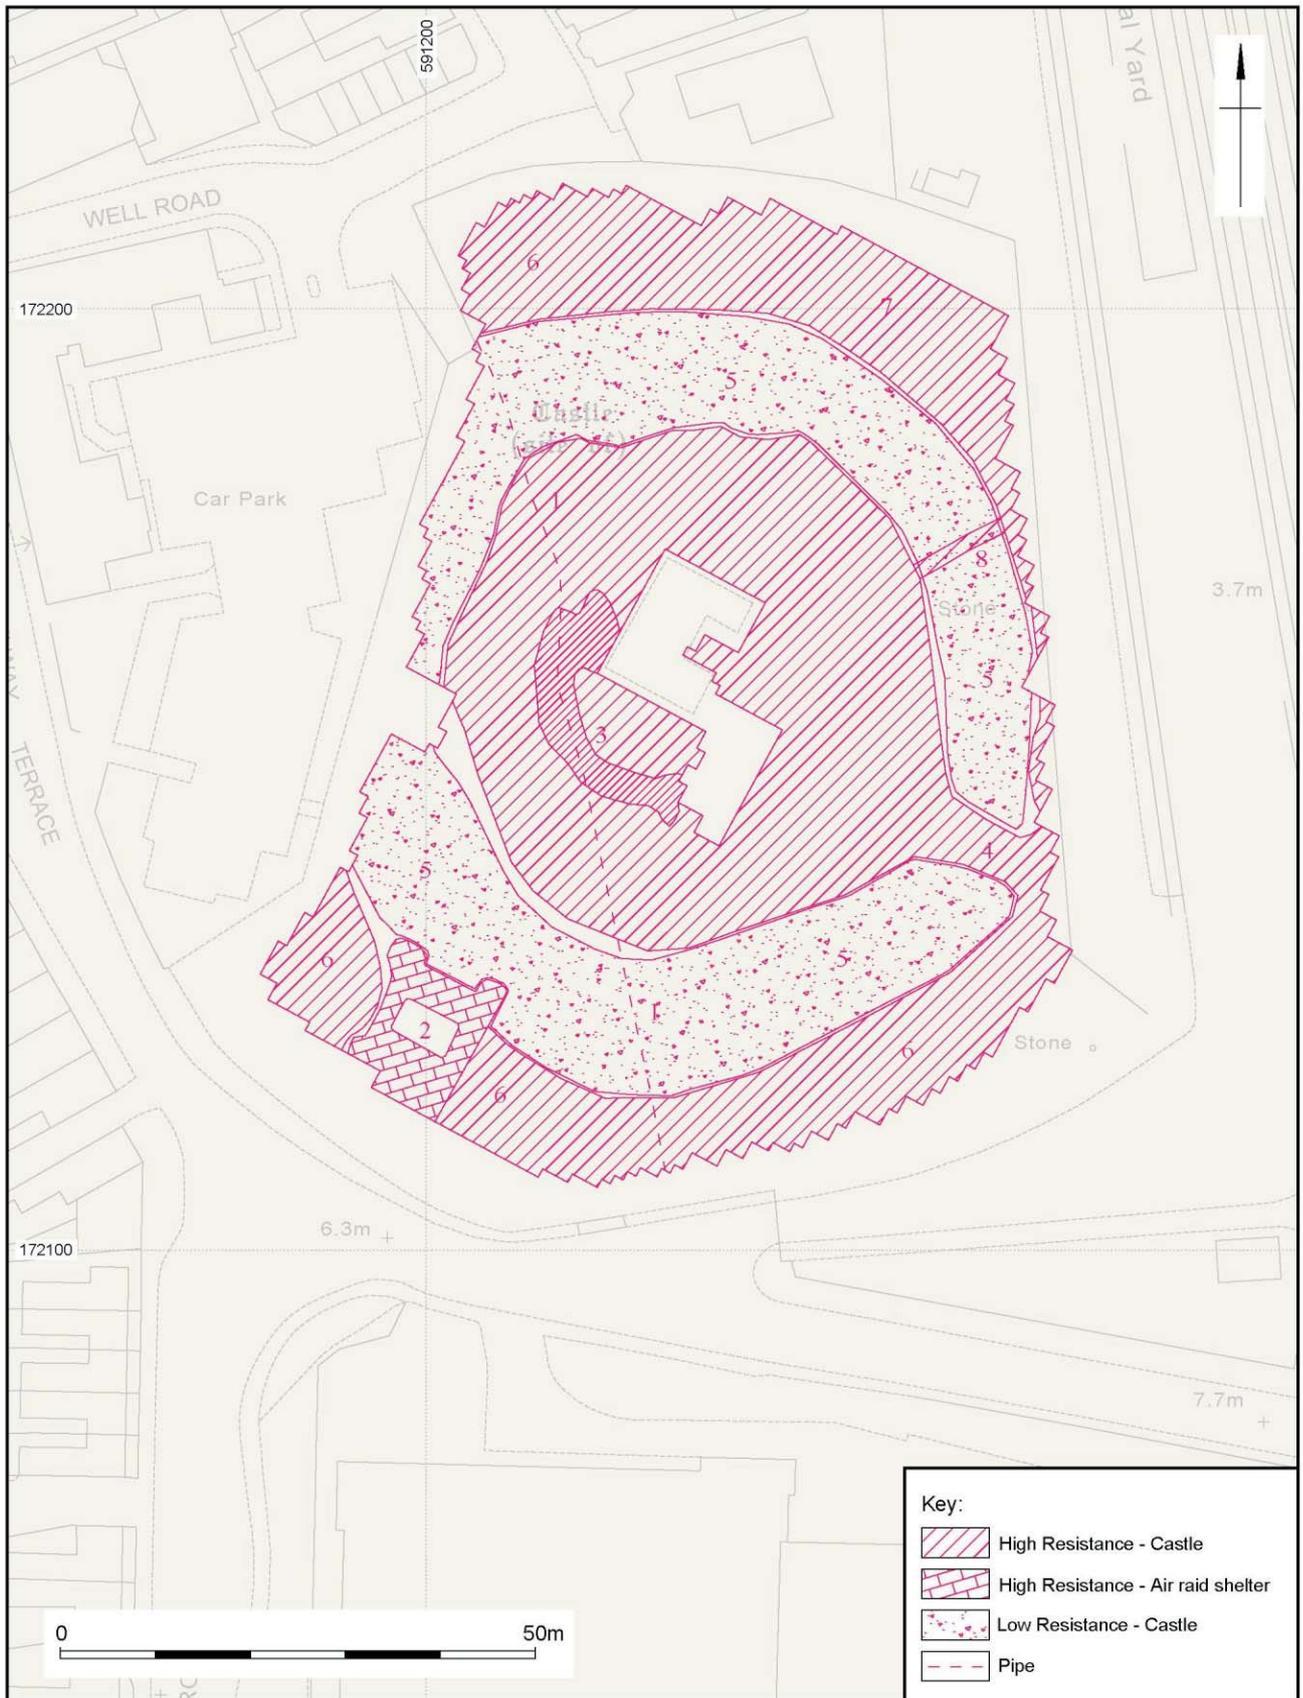
Figure 2

Geophysical Resistance interpretation

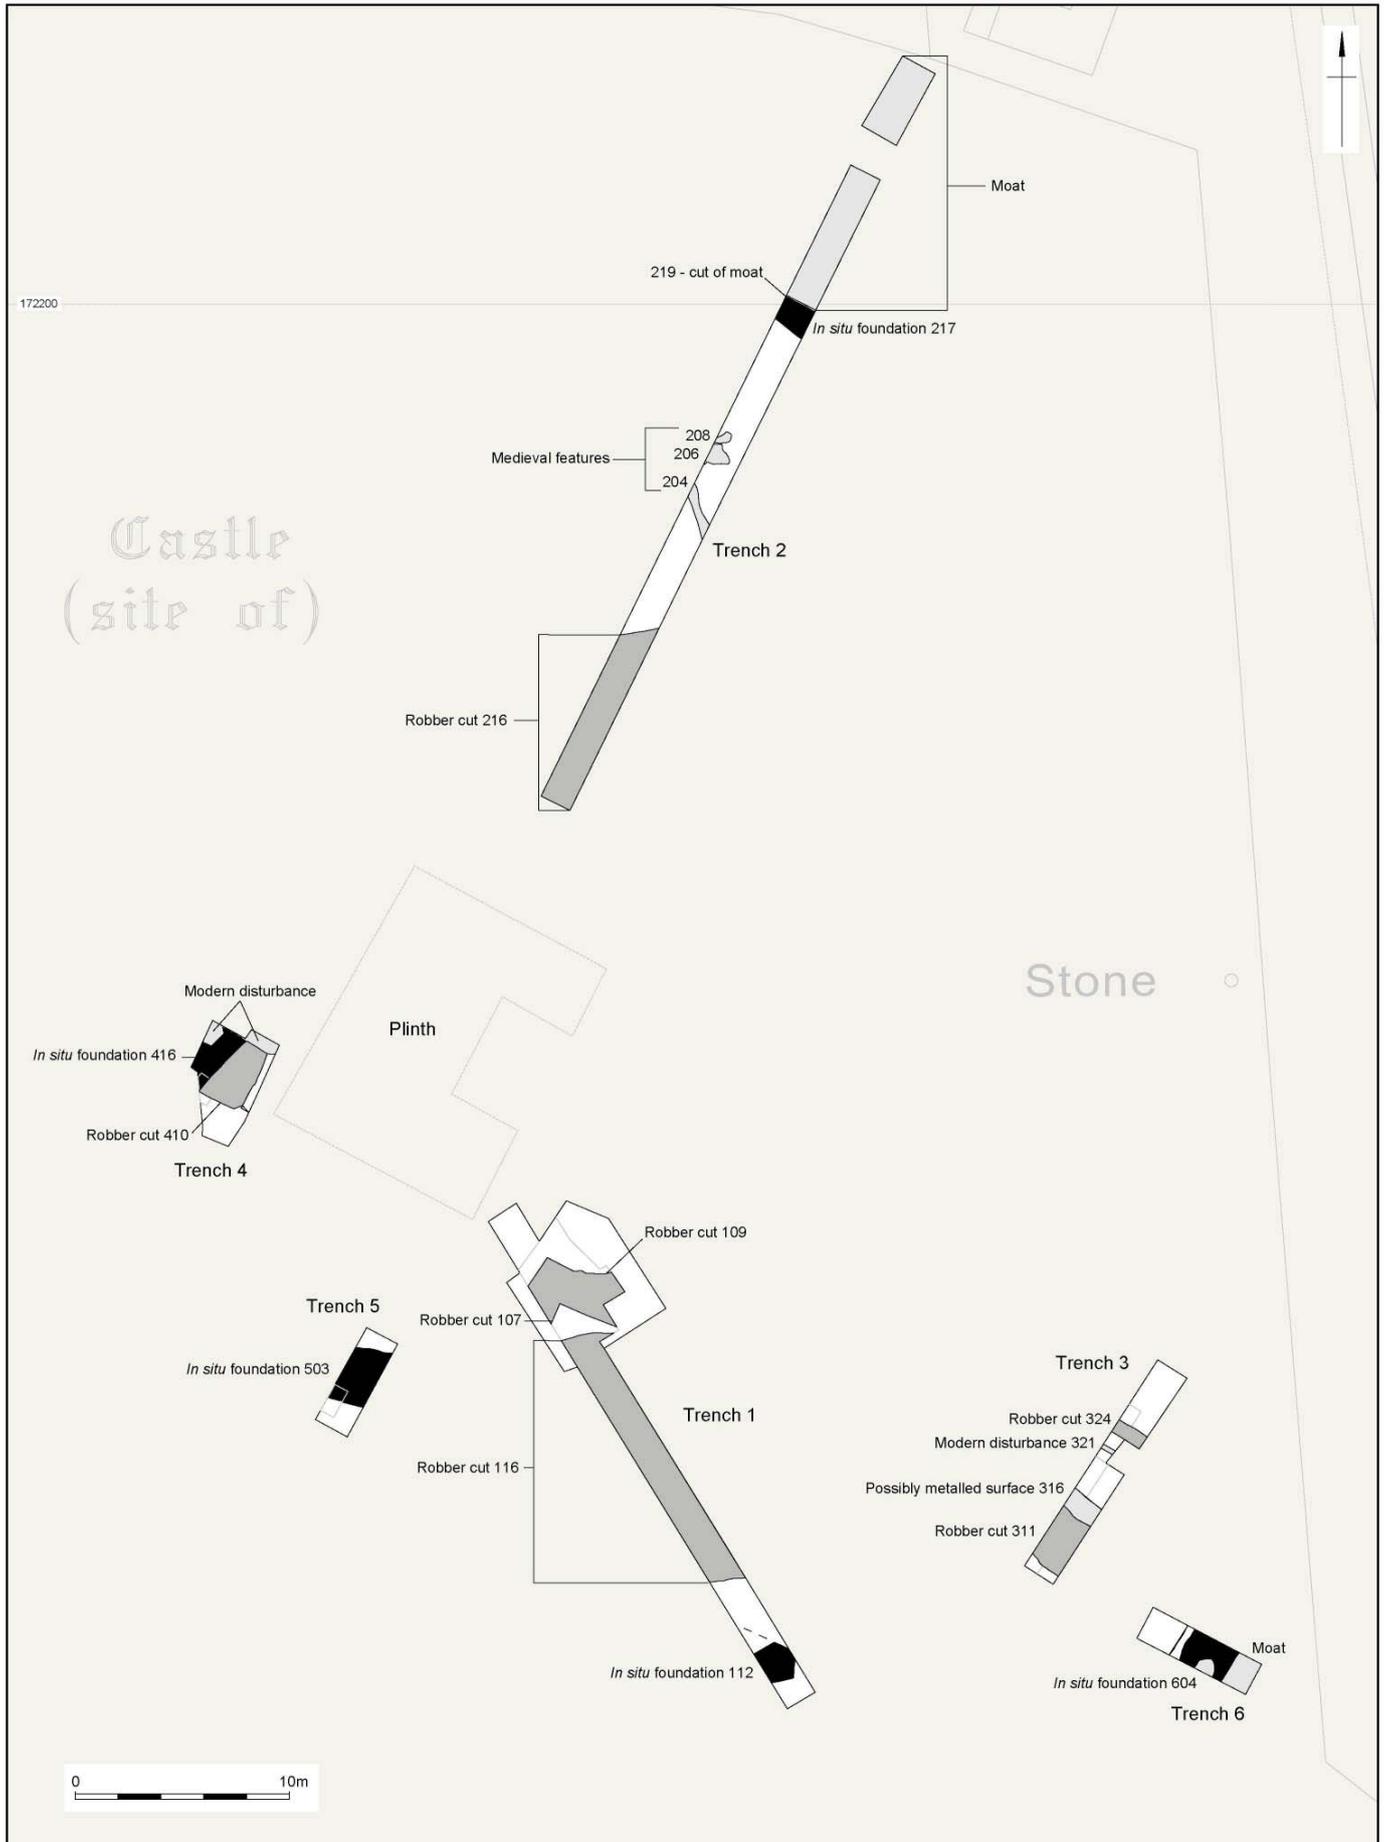
- Key:
- Trench
  - Wall foundation
  - Robber trench
  - Possible castle outline

represented by robber trench 107, was located in the western end of trench 1 (**Figures 3 and 5; Figure 6**, Plate 2); further robber trenches probably representing the inner rotunda wall were recorded in trenches 4 and 5, but were not excavated although a part of the apse-like structure, depicted on the Hatfield plan (**Figure 4**), within the inner court was also located. The robber trench representing the inner wall of the rotunda, and so presumably the original foundation, was 2.10m wide and survived to a depth of over 1.30m; the robber trench was not fully excavated as possible *in situ* foundation deposits were encountered at this depth. Although only a very short length of robber trench was exposed, enough was seen to infer that the central court was approximately 16-17m in diameter. An internal partition wall, or more probably the southern side wall of the passageway into the central court, was also represented by a robber trench in the western end of trench 1 (109). This was also approximately 2m wide and over 1.20m deep.

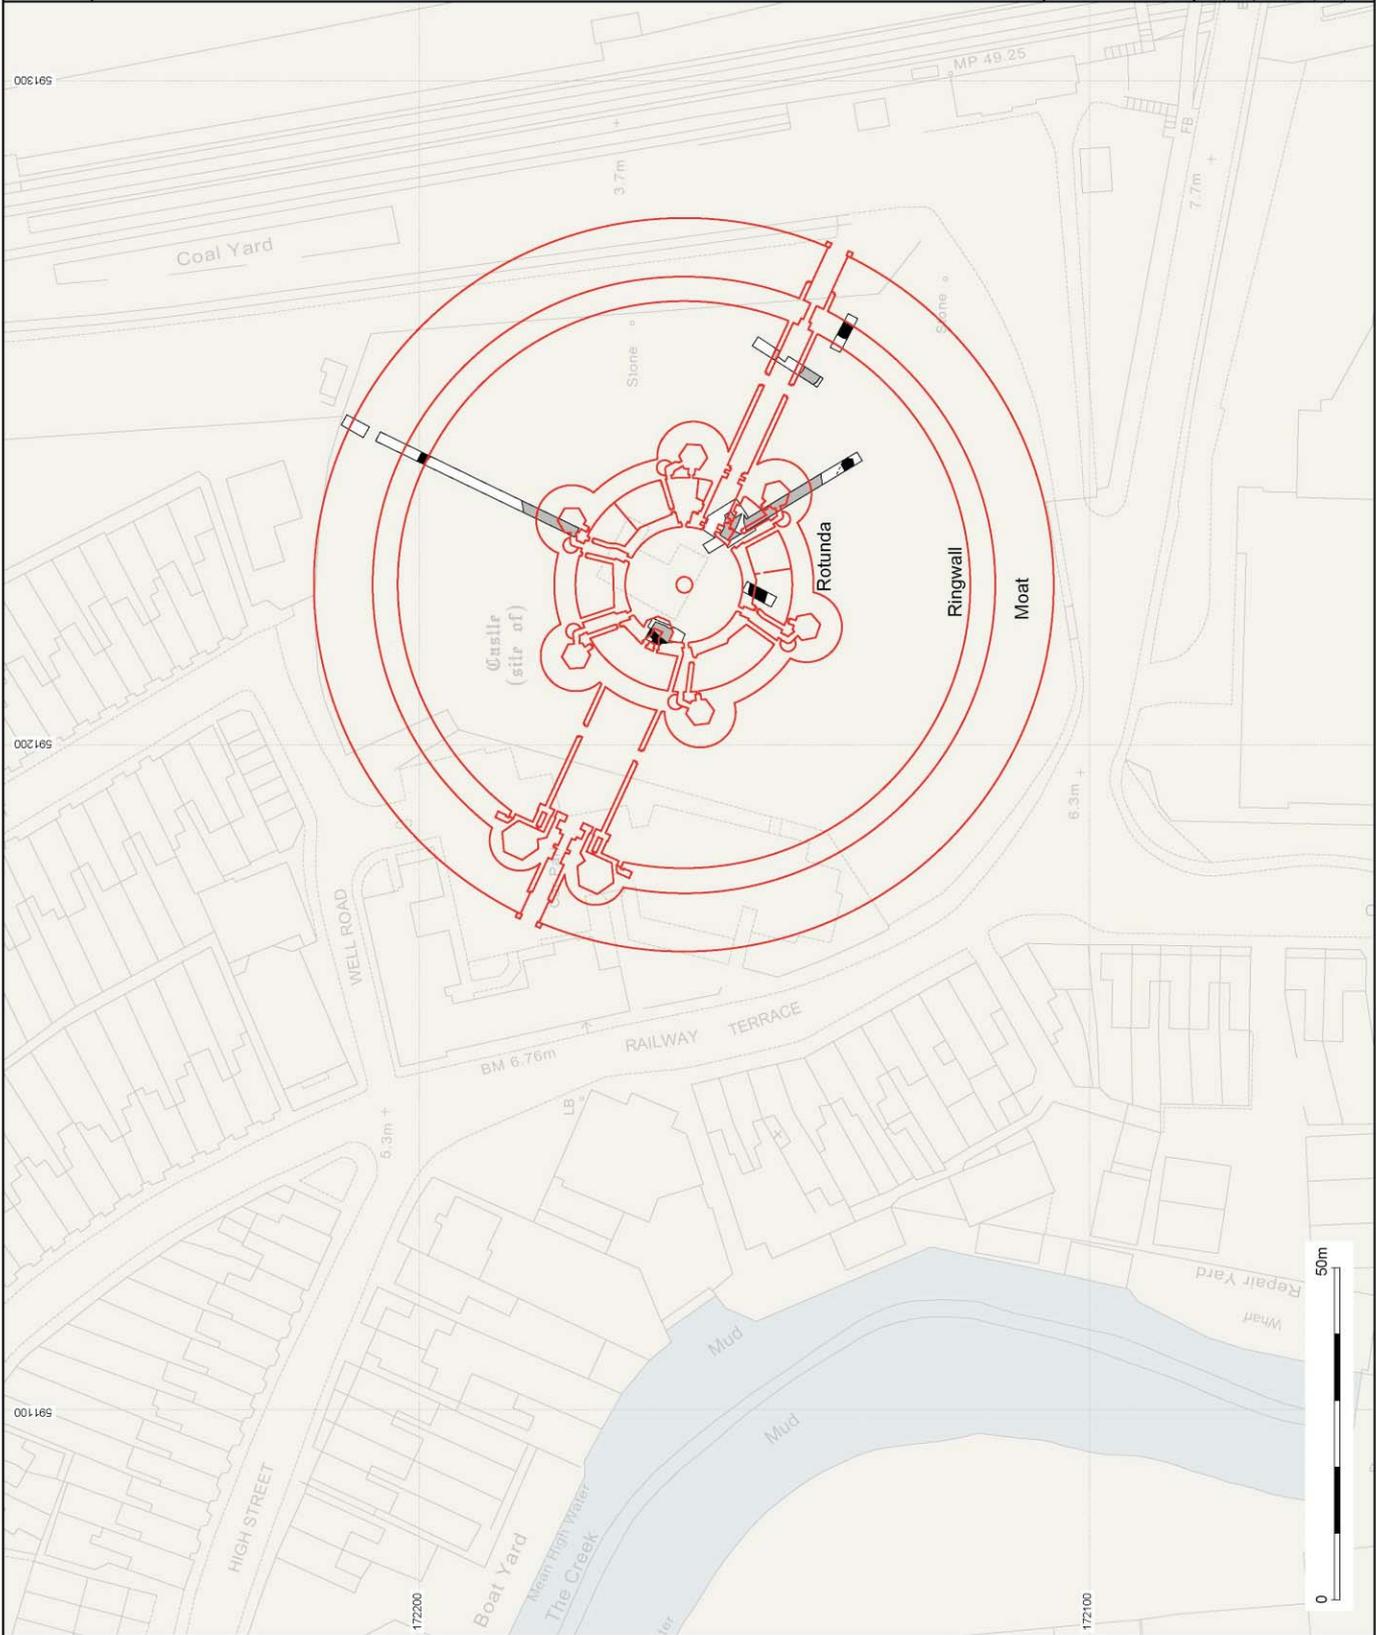
Trenches overlain with Hatfield's plan of Queenborough Castle

- **Preservation:** What is the state of preservation of the archaeological remains?;
- **Size:** Although it has been supposed that the Hatfield MS plan (Section 1.2.8, **Figure 4**) gives an accurate sense of the Castle's morphology and scale, Pratt's investigation (1991) suggests that the moat lies nearer to the centre of the castle than the plans would suggest.

- **Morphology:** The 17<sup>th</sup> Century Hatfield MS plan of the Castle (**Figure 4**) is believed to give an accurate, proportioned representation of the inner and outer curtain walls. However, it does not illustrate any of the buildings within the outer court. Aerial photos suggest underlying structures including the outer ring wall and the central rotunda. The photos also suggest the existence of intra-mural buildings, which do not feature on any of the known plans of the Castle.

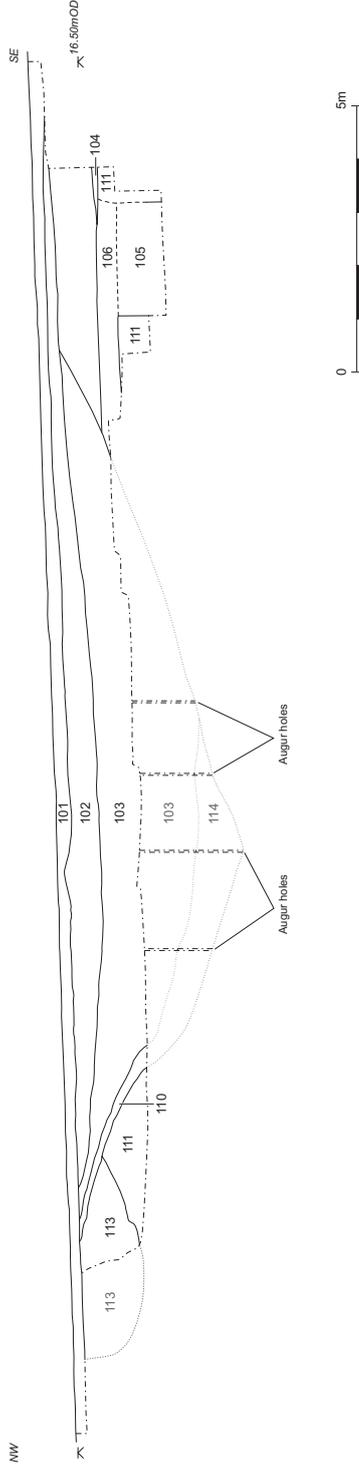
Figure 5

North east facing section of trench 1

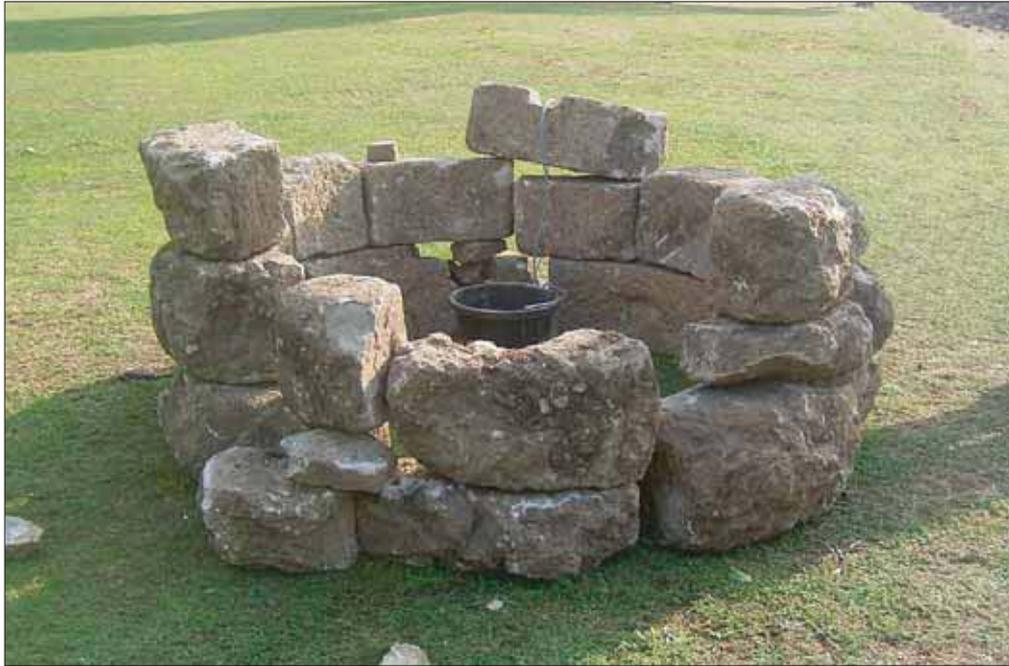
Plate 1: Possible masonry remains of well lining

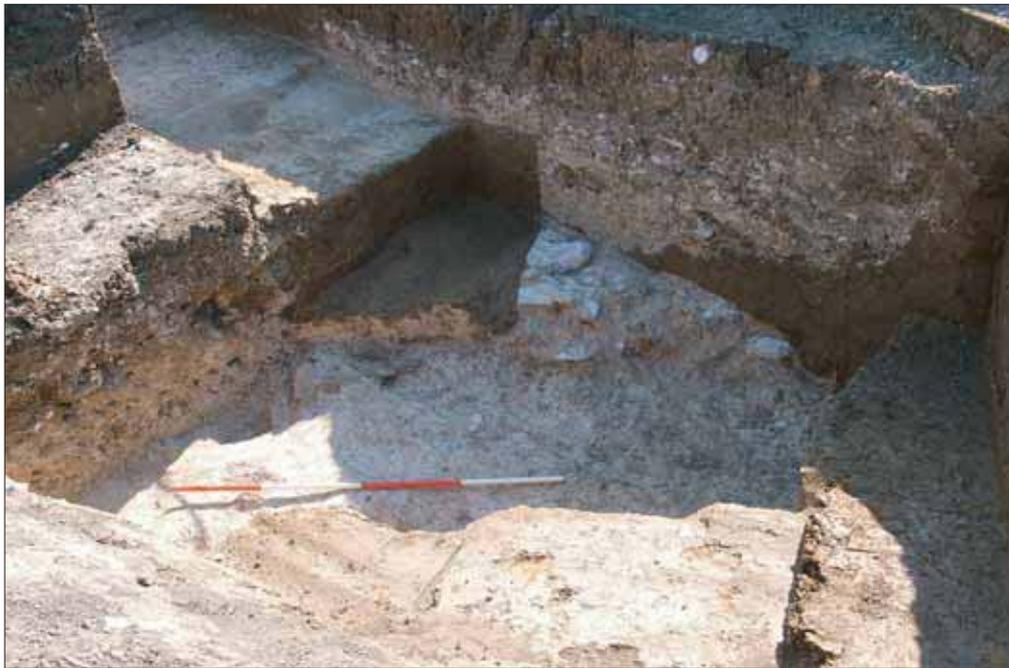
Plate 2: Rubble filled robber cuts in trench 1
