WOODRIDGE HOUSE, SUNNINGDALE, BERKSHIRE ARCHAEOLOGICAL EVALUATION REPORT

Report reference: 61251.2 November 2005

Wessex Archaeology was commissioned by Herring Homes Ltd to undertake an archaeological evaluation on land proposed for redevelopment at Woodridge House, Sunningdale, Berkshire (the Site). The Site is centred on NGR 493800 166450 (**Figure 1**).

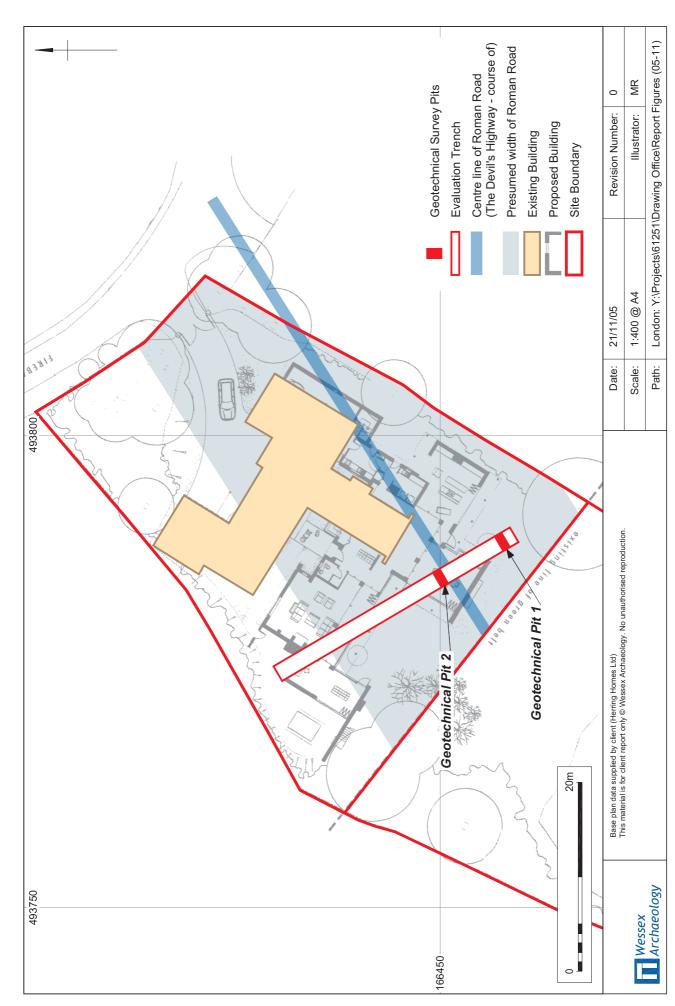
Site Plan showing location of Evaluation Trench & Geotechnical Survey Pits

- 3.2.2 The evaluation comprised the excavation of a single trench measuring 27m by 2m by 1.2m. The trench was located perpendicular to the projected line of the Roman road in order to ensure as far as possible that this feature was located within the Site if present.

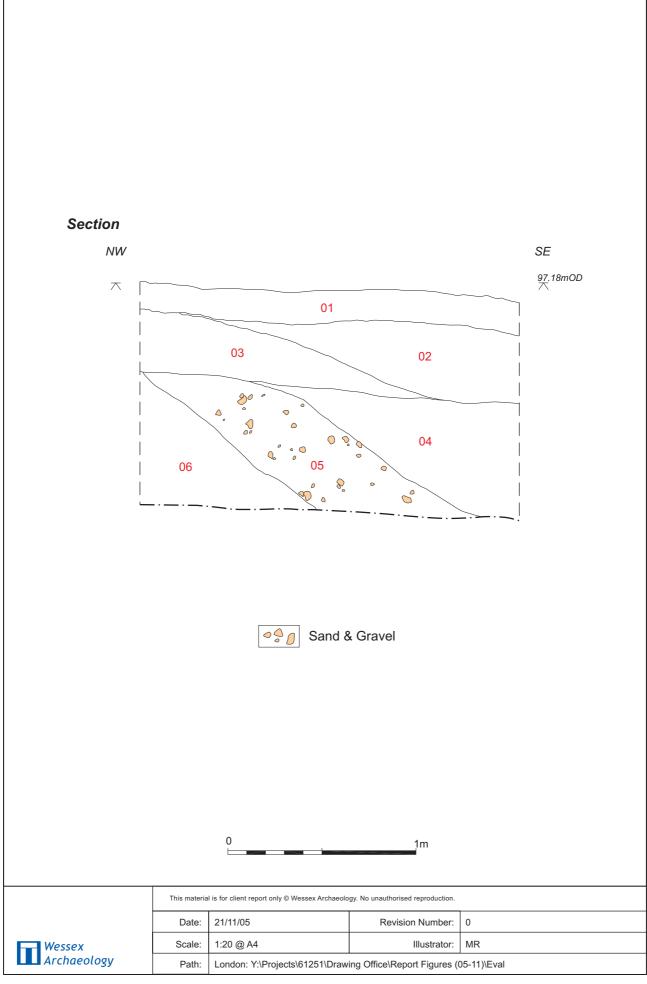
- 3.2.6 A plan and representative section of the trench was recorded by means of drawings at a scale of 1:20 for the plan and 1:10 for sections (**Figure 3**).

- 4.1.1 No significant archaeological deposits or artefacts were recovered from the trench. The mound on which the house stands appears to consist of madeground deposits to a depth in excess of 1.2m. This material had clearly been imported for landscaping purposes, to fill in the hollows left by the construction and demolition of the brickworks.
- 4.1.2 There were no surviving traces of the Roman road.

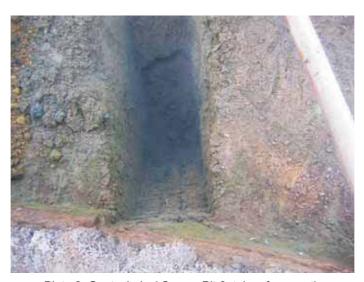
Plate 2: Geotechnical Survey Pit 2, taken from north

4.2.1 Two geotechnical pits were dug in the trench base under the supervision of an archaeologist and a photographic record was made of them. No archaeological remains were present in either pit (see **plate 2**). Both pits were excavated to a depth in excess of 4.5m, but bedrock was not encountered in either pit.
