## **M1 JUNCTION 14 AREA IMPROVEMENTS**

### **Archaeological Watching Brief Report**

**Mouchel Parkman Services Ltd.**

Ref: 64591.03

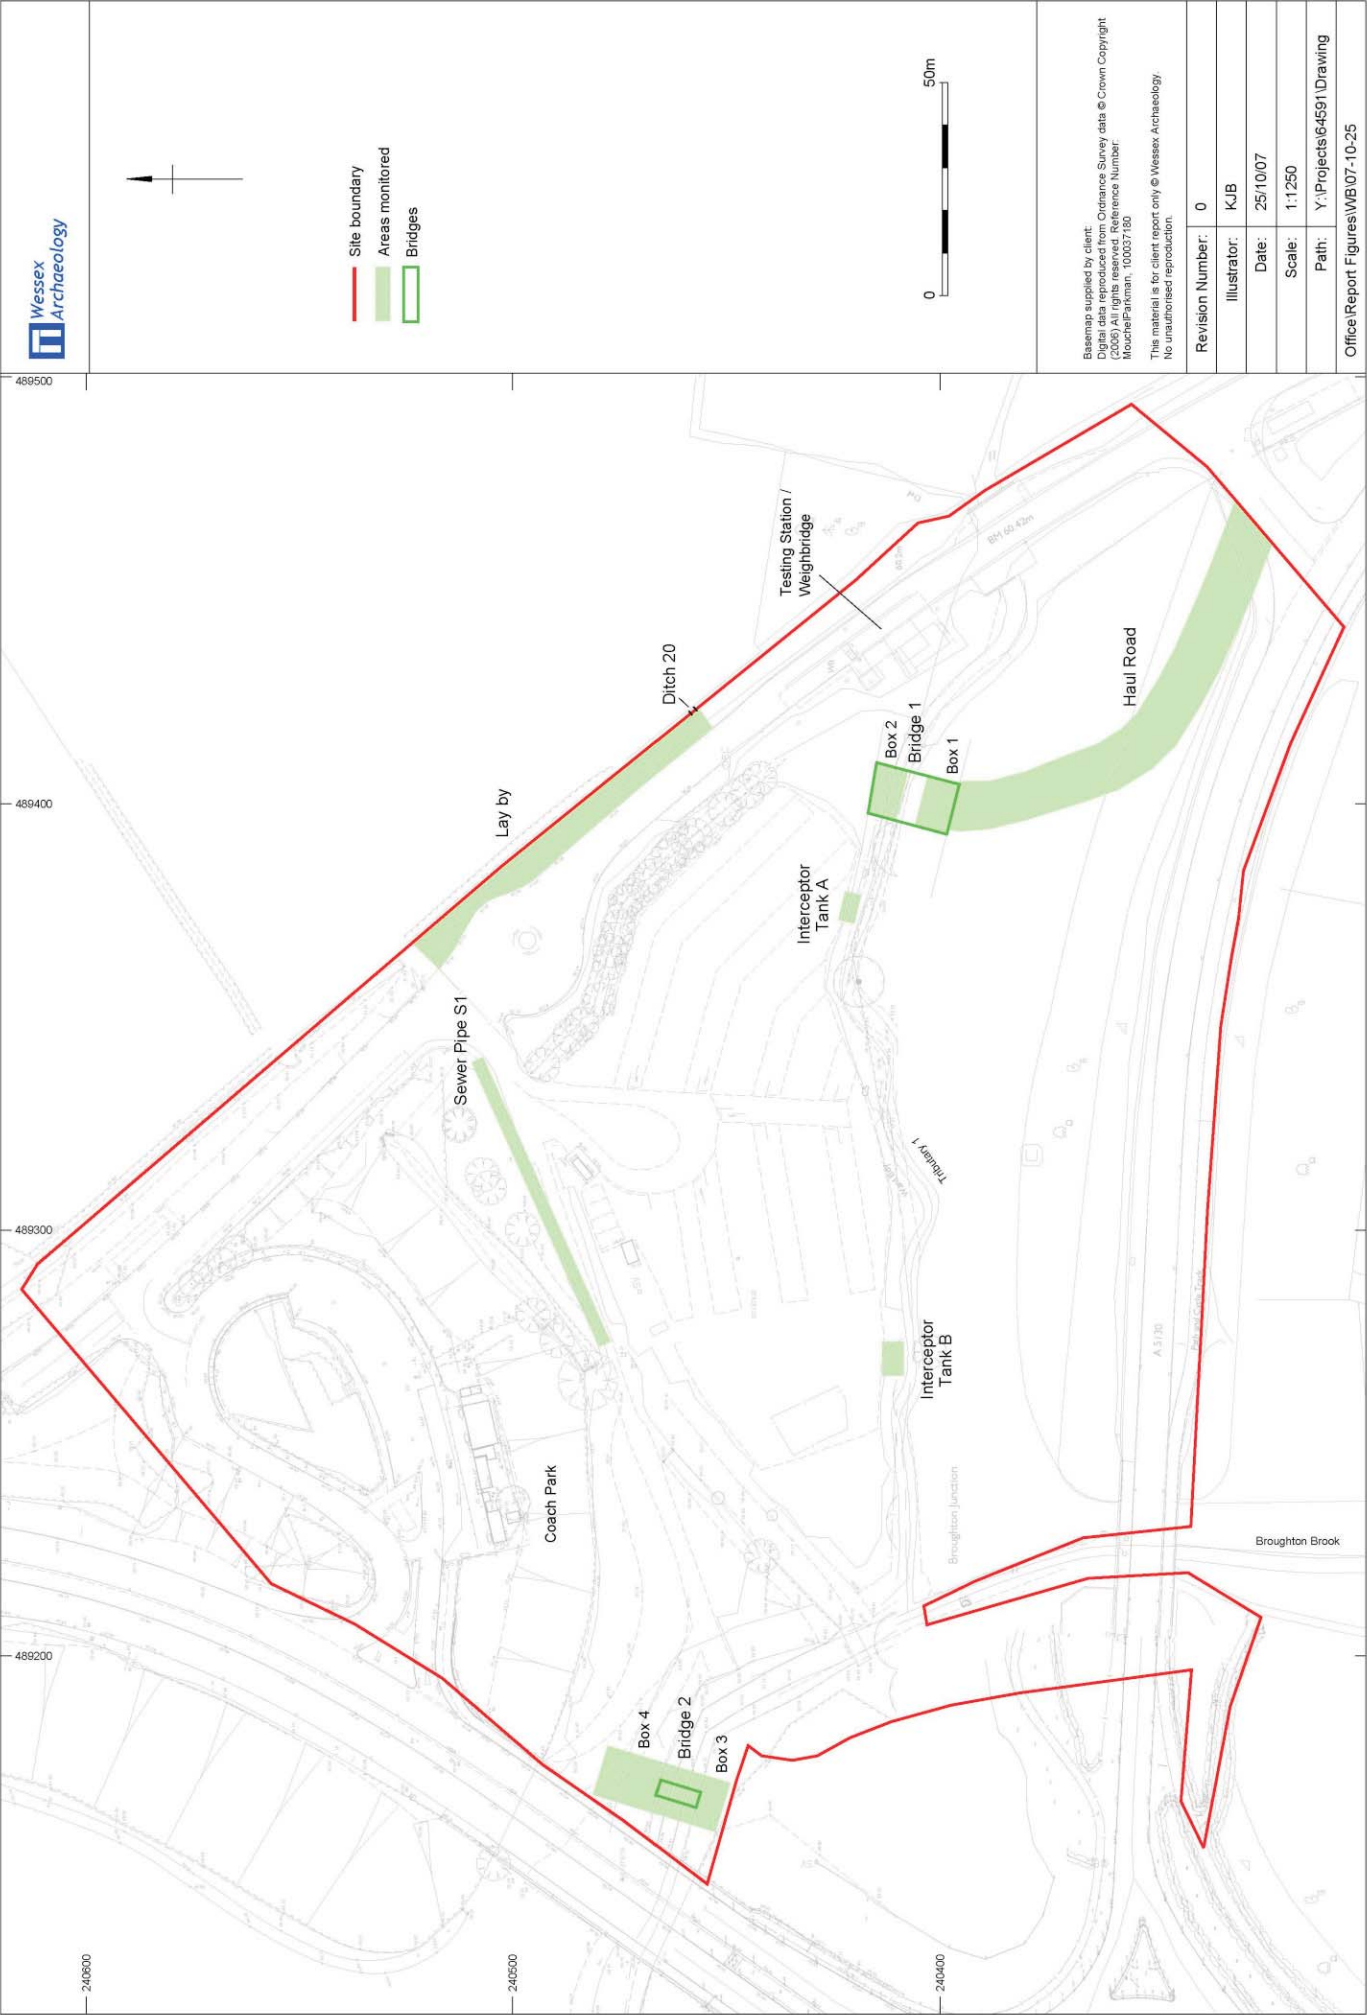
Figure 2

Areas covered by Watching Brief

- 1.4.1 The Site occupies two defined topographical areas (**Figure 2**).
- 1.4.2 The northern portion of the Site is occupied by a raised area (ca. 67.00m above Ordnance Datum aOD). The site of the Coach Park and associated buildings, this partly wooded rise is flanked on its southern side by a steep 6m high slope and an east-west running ditch at its base. This raised area lies at the same height as the adjacent modern road system and appears to be made up of ground imported at the time of the Motorway's construction in the late 1950s.

- 5.2.1 A road bridge (marked as Bridge 1 on **Figure 2**) was constructed spanning Tributary 1 in the south east corner of the Site. Two separate box excavations were conducted, on the north and south banks of Tributary 1 for the bridge piers. These were each approximately 10m x 5m in plan and up to 3.00m deep. For the purposes of this report these excavations have been designated Box 1 and Box 2.

5.3.1 A 105m long haul road was also created leading from the excavation area for Bridge 1 to the A5103 (**Figure 2**).

5.4.1 A pedestrian bridge (marked as Bridge 2 on **Figure 2**) was constructed spanning the Broughton Brook at the western edge of the Site. Two separate box excavations were conducted, on the north and south of the Broughton Brook for the bridge piers. These excavations were approximately 27m x 20m, and up to 1.40m deep. For the purposes of this report these excavations have been designated Box 3 and Box 4.

5.5.1 The east-west running ditch at the base of the coach park mound (marked as sewer pipe S1 on **Figure 2**) was widened and cleaned out to accommodate a concrete pipe for a new covered sewer/drain. This was 73m long 3m wide and up to 2.50m deep.

- 5.6.1 A 12m x 7.50m rectangular 3.00m deep hole was excavated for an Interceptor tank, (marked as Interceptor Tank A on **Figure 2**) some 1.20m from the edge of the southern bank of Tributary 1.

- 5.7.1 A 14m x 8.70m rectangular 3.00m deep hole was excavated for an Interceptor tank, (marked as Interceptor Tank B on **Figure 2**) some 2.20m from the edge of the southern bank of Tributary 1.
- 5.7.2 The following sequence was observed during these excavations **(Plate 6)**.
- 5.7.3 The earliest deposits were light orange coarse clayey sands and gravels of the natural geology **(014)** at a height 55.20m aOD. These were overlain by 2.10 thick alluvial clay deposits **013, 012**. The upper alluvial layer **012** was light brownish grey silty clay and occasional red brick fragments. The lower alluvial deposit **(013)** was a blue grey gleyed

- 5.8.1 The realignment of a lay-by and the VOSA Weighbridge Road required the removal of hedgerow and field boundary/bank along the eastern boundary of the Site (**Plate 8**), as well as the removal of turf and topsoil along the eastern roadside verge to a depth of ca. 0.80m and the redirection of services. This “Area” was 85m long and up to 6m wide (marked as Lay-by on **Figure 2**).

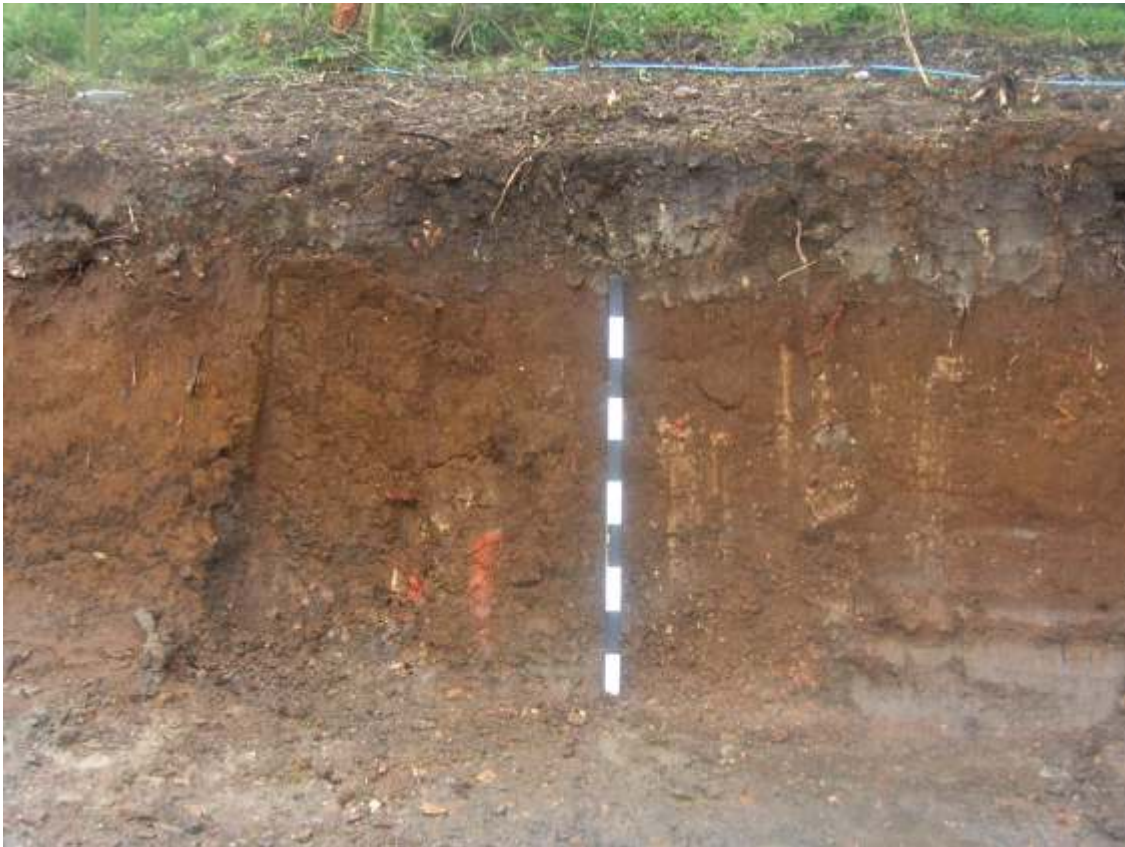
- 5.2.2 Box 1 was excavated on the south side of Tributary 1. The earliest deposits observed were the coarse gravels of the natural geology (**03**) which were encountered at a depth of 0.85-0.95m below ground level. This was overlain by a, 0.55m thick, mixed deposit of re-deposited brown clay and fragments of modern building materials (**02**). This deposit of "made ground" was sealed by a ca. 0.30m thick layer of grey-brown sandy silt (**01**) which represented the topsoil in this part of the Site (see **Plate 1**). No archaeological remains were observed and it appears likely that any remains in this area have been destroyed by previous truncation.

Plate 1. Box 1 from north, 1m scale

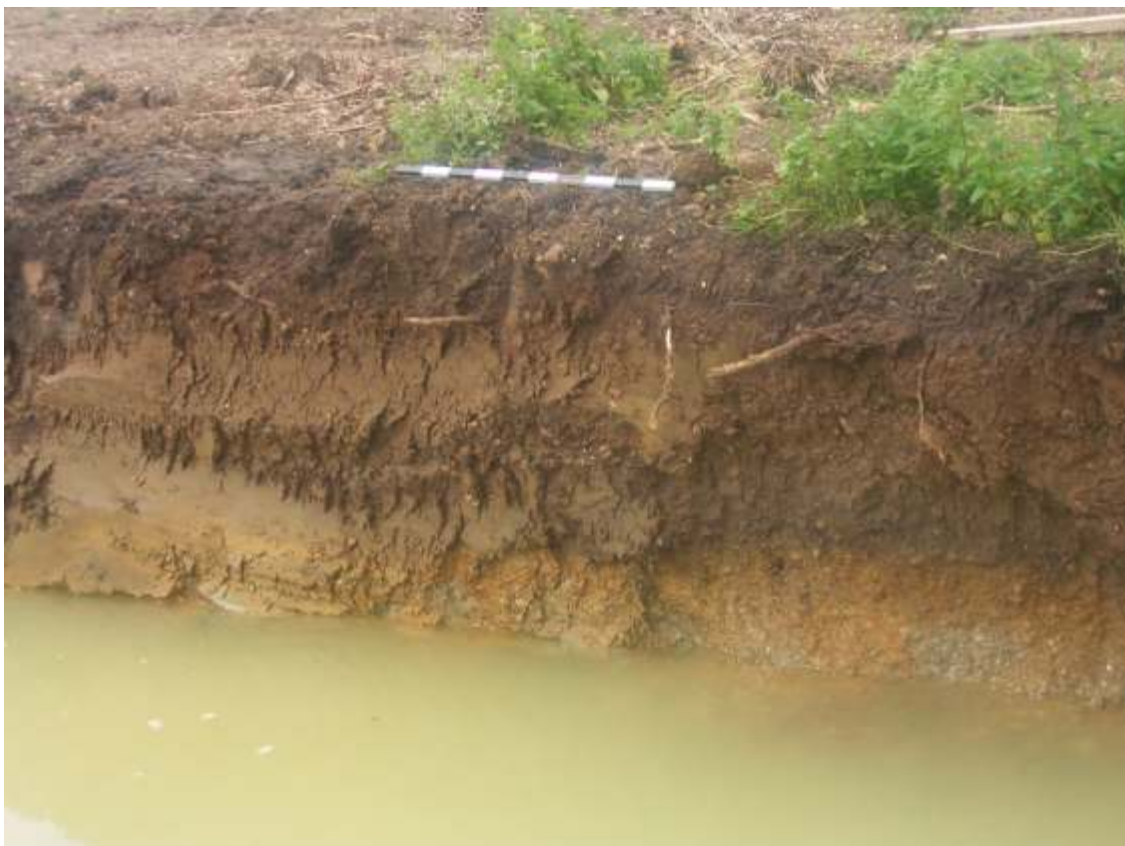
5.2.3 Box 2 was excavated on the north side of Tributary 1. The soil sequence in this excavation differed from Box 1. Deposits of naturally bedded gravel and clay (**04**), which sloped gently downward toward the water channel, were overlain by 0.30m thick grey-brown topsoil similar to that seen in **Box 1** (see **Plate 2**).

5.2.4 In Box 2 an undisturbed *in situ* soil sequence appears to have been left intact with no evidence of the truncation or disturbance seen in Box 1. However, no archaeological remains or deposits were observed in this part of the Site.

Plate 2. Box 2 from south, 1m scale

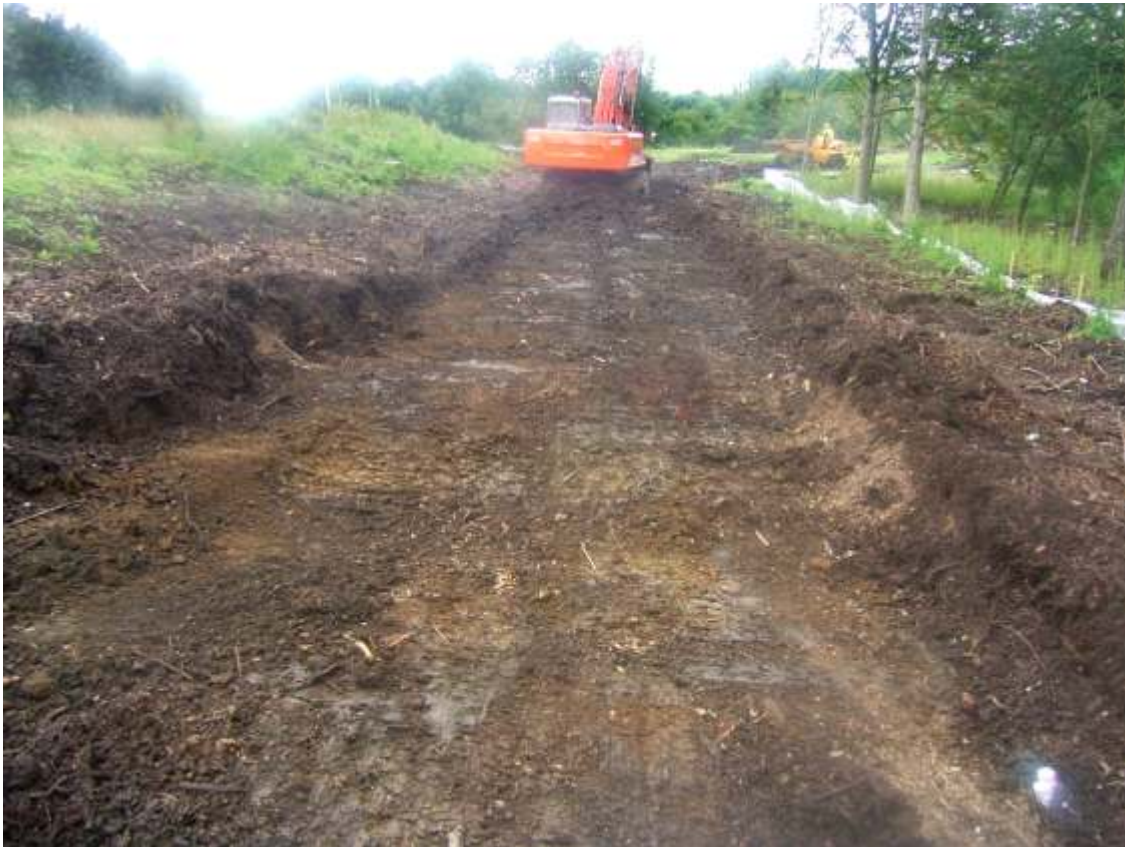
5.3.2 Construction of the haul-road for Bridge 1 involved minimal topsoil removal (up to 0.3m), after which a sheet of Terram was laid over the exposed ground. This was then covered with hardcore and gravel to form the road. No archaeological features were observed (see **Plates 3 and 4**).

Plate 3. Haul road

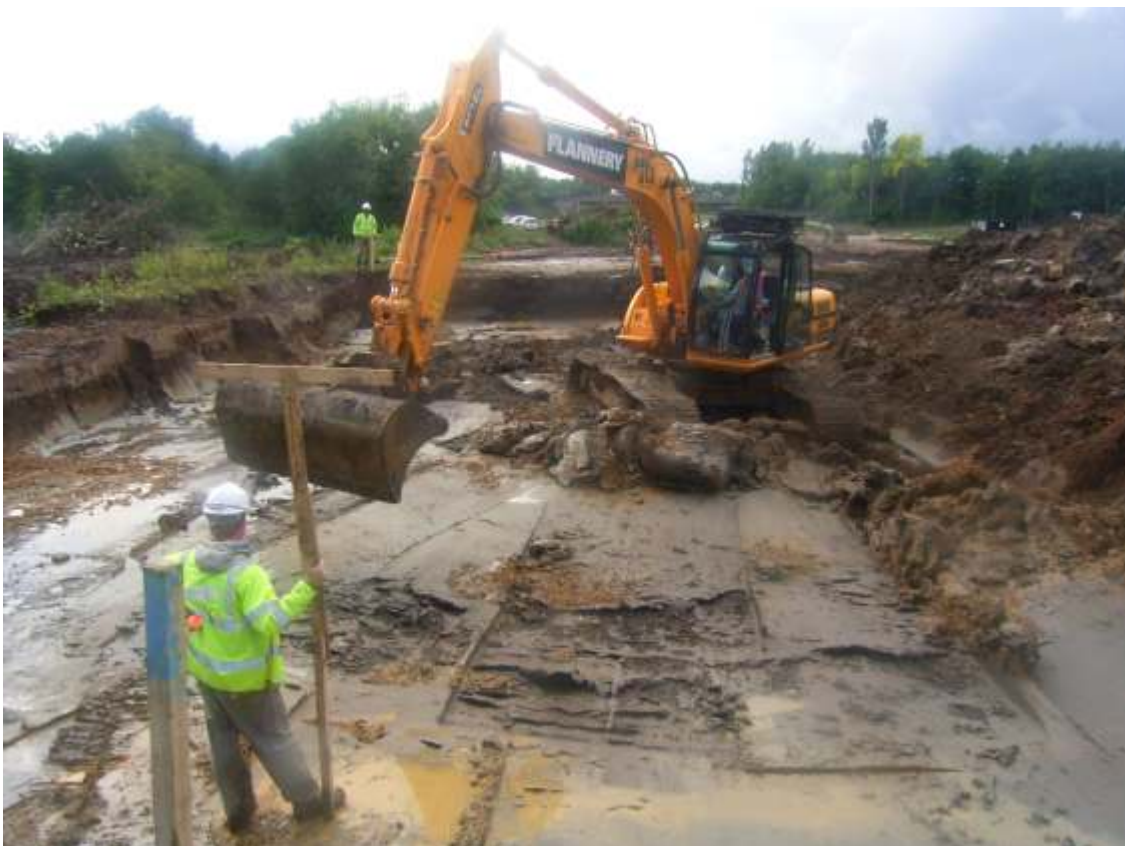
Plate 4. Working shot

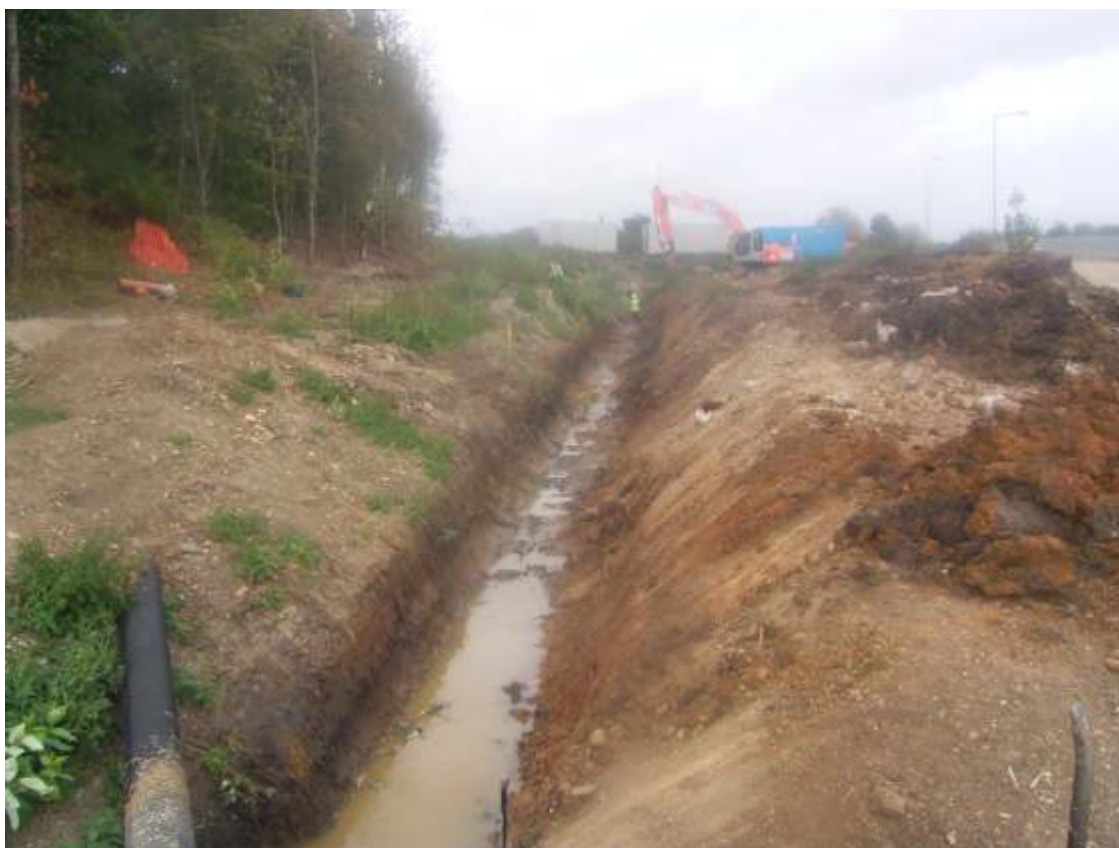
5.5.2 The earliest deposits observed in this part of the Site, were the mid grey orange brown mottled coarse sandy clay gravels of the natural geology (**019**) which were encountered at a depth of 2.20m below ground level (57.88m aOD). This was overlain by 0.20m thick, light yellowish brown

fine sandy silty clean alluvial clay which contained no dateable material **(018)**. This was in turn sealed by a 0.40m thick mid grey brown clay silt with very occasional small sub-rounded pebbles. Above the B-Horizon, 0.40m thick, light yellowish grey brown clay silt with no inclusions represented the former, buried, topsoil on this part of the Site. This was itself sealed by a 1.20m thick loose modern deposit of “made ground” **(015)** comprised of a mid grey brown fine clayey clay silt containing frequent sub-angular pebbles, and fragments of unfroged red brick and concrete and tarmac **(Plate 5)**.

- 5.5.3 The section of the sewer trench appeared to show an *in situ* soil sequence overlaying alluvial deposits. These were buried beneath a thick layer of modern “made ground” which was almost certainly derived from the material brought in to make the “Coach Park Mound” in the 1960’s. No evidence of the truncation or disturbance seen elsewhere on Site was observed in this trench. The buried topsoil was seen to contain exclusively modern or post-medieval material. No archaeological remains were observed during the work on the sewer pipe trench.

Plate 5. Sewer pipe trench from west

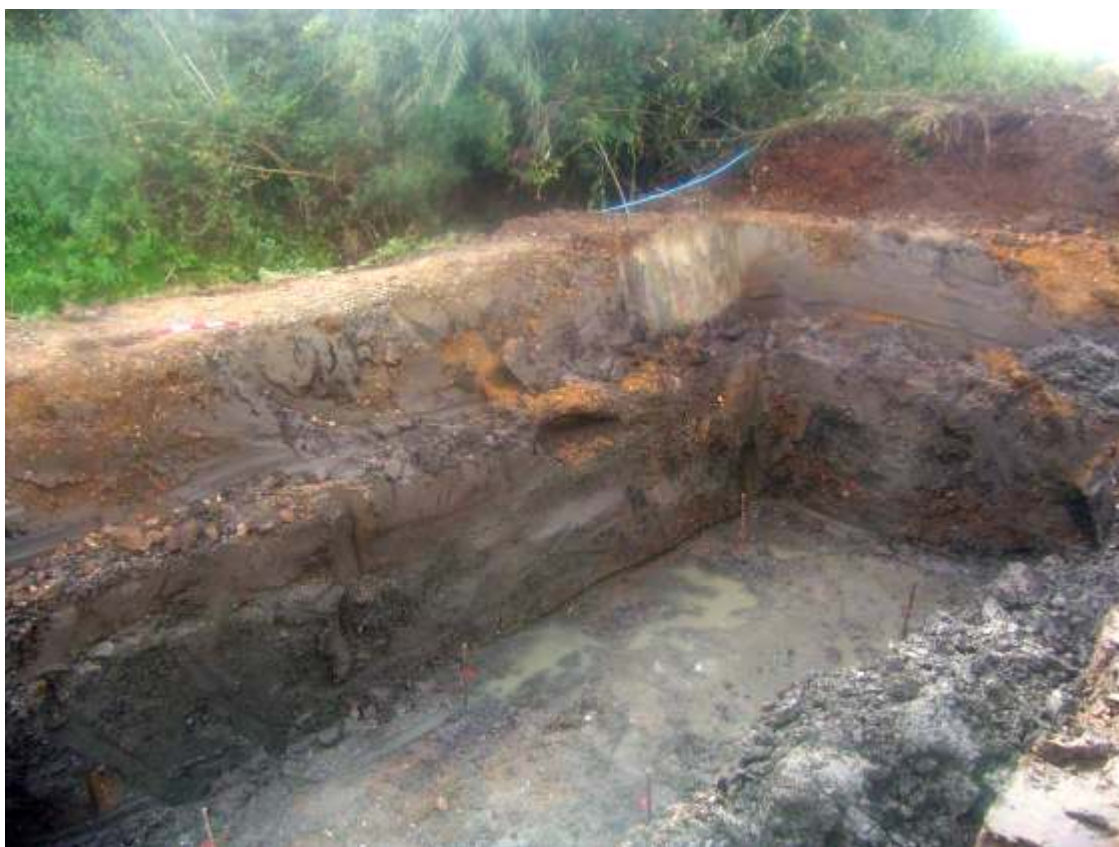
deposit which contained occasional small fragments of wood, twigs and branches and small shell fragments but no dateable material.

- 5.7.4 The alluvial deposits were in turn overlain by a 0.30m thick grey brown mottled clay silt (**011**) which formed the B-Horizon on this part of the Site, and by a thin (0.10m thick) dark grey brown, topsoil (**010**).
- 5.7.5 The sections of Interceptor Tank B appeared to show an *in situ* soil sequence overlaying alluvial deposits with no evidence of the truncation or disturbance seen elsewhere on Site. The buried topsoil was seen to contain exclusively modern or post-medieval material. No archaeological remains were observed during the work on this part of the Site.

Plate 6. Interceptor Tank B from north

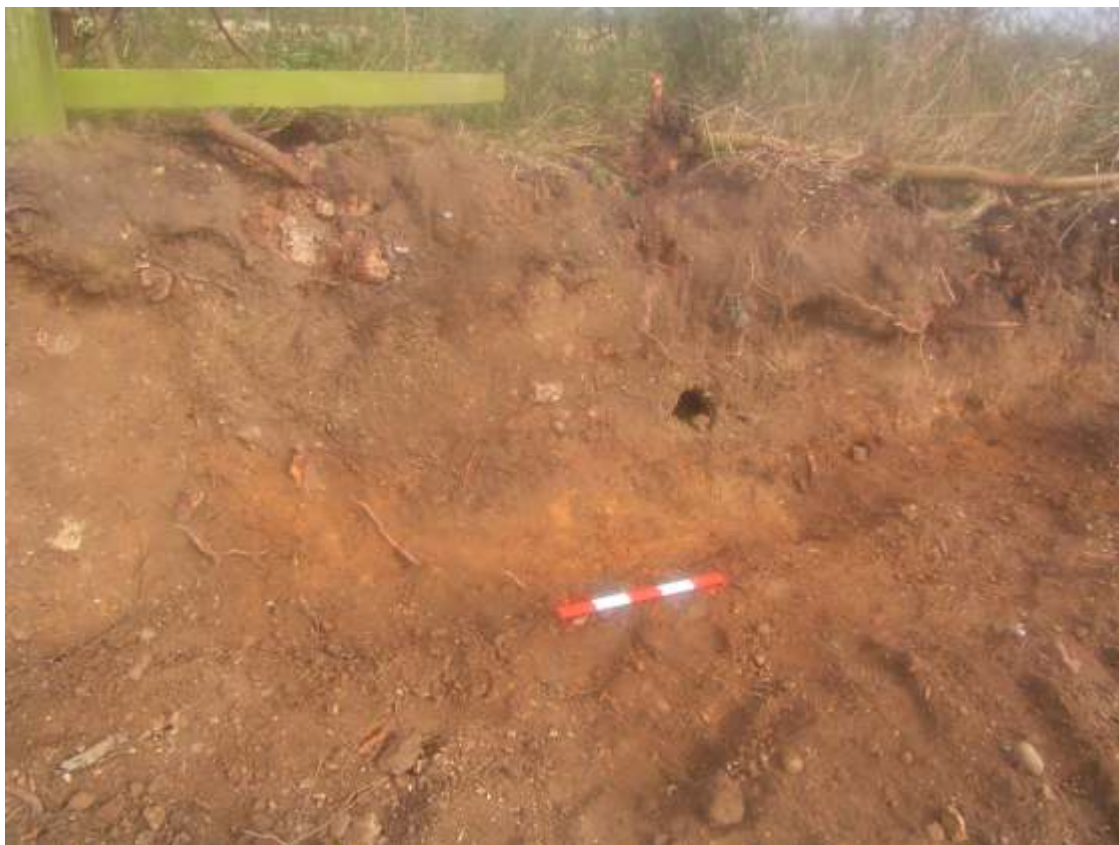
- 5.8.3 At the southern end of the Lay-by a 1.50m wide east-west running ditch (**20**) (**Plate 7**) was observed in the eastern section of the former hedgerow this undated feature was truncated to the south by a modern rabbit warren and to the north by the modern hedgerow bank. The base of Ditch **20** was some 0.20m above the level of the modern road which cuts it to the west and no trace of this feature was seen beneath the former road side verge.

Plate 7. Ditch 20 from west

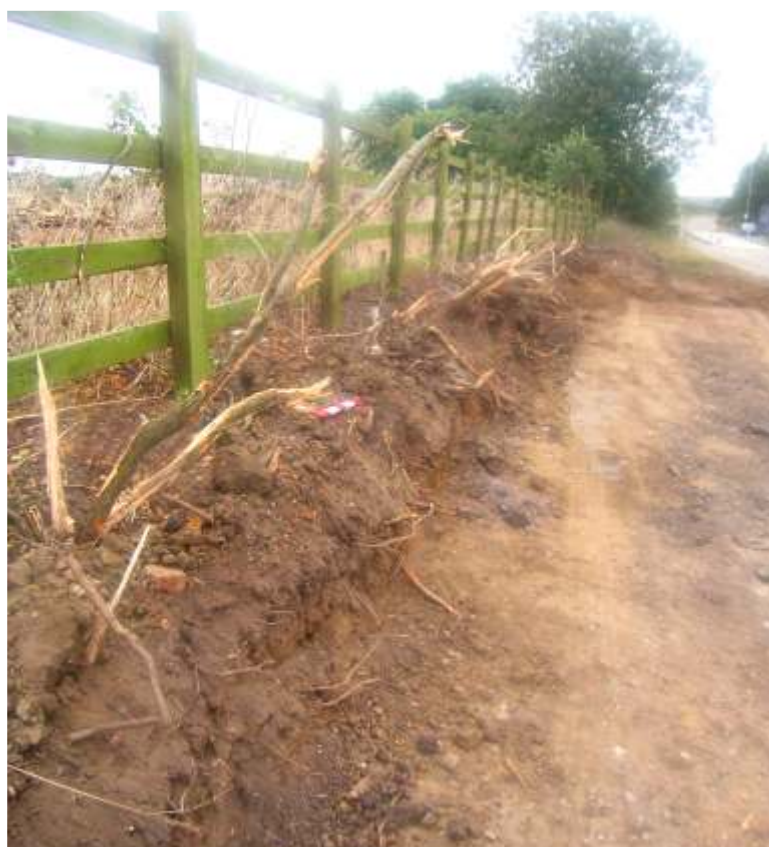
- 5.8.2 Yellow coarse gravels of the natural geology were observed along the whole length of the Lay-by realignment. These lay some 0.20m below the present ground surface (60.70m aOD). These were overlain by a 0.10m layer of crushed “hardcore” made-up of builder’s rubble. Right up against the eastern edge of the Site the truncated remains of the backfilled former roadside ditch was observed. This was filled with a light grey blue clay deposit (**05**) and was covered by a series of layers which made-up the modern hedgerow bank. This was up to 1.20m high and appeared to date from the construction of the road, with most of the layers within the bank containing fragments of tarmac and other modern building material.

Plate 8. Lay by from north
