Former Grill Bar (The Mile House)
London Road, St Albans, Hertfordshire

Archaeological Evaluation Report

Report reference: 65130.03

May 2007

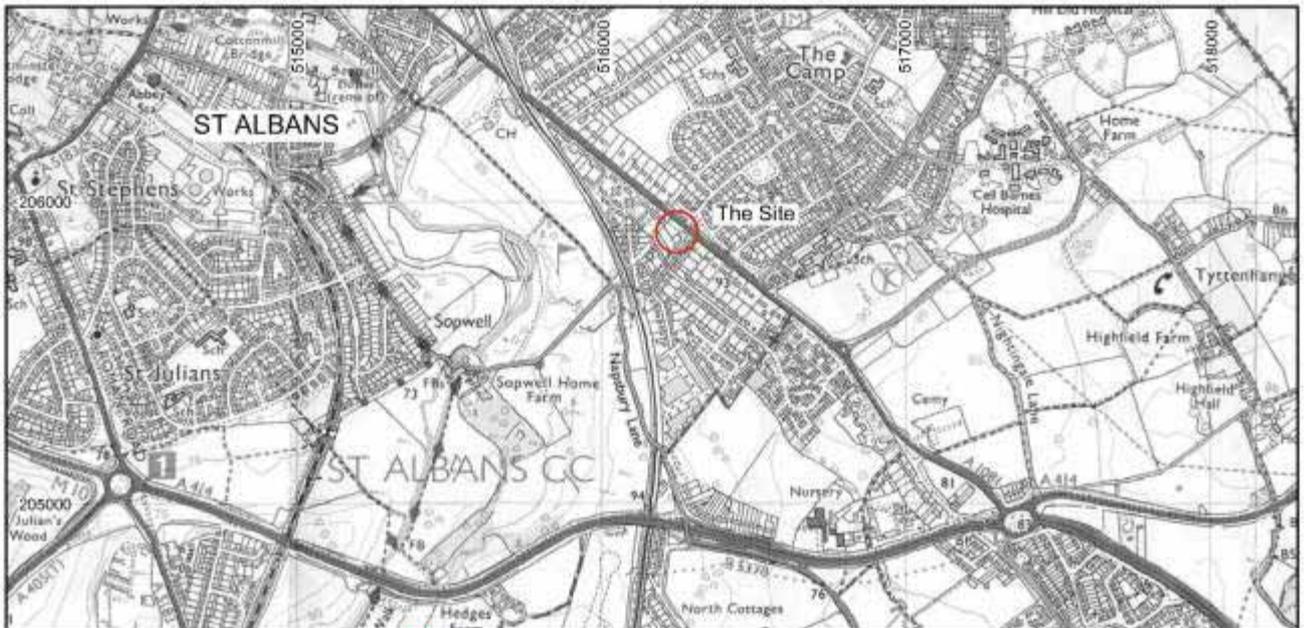
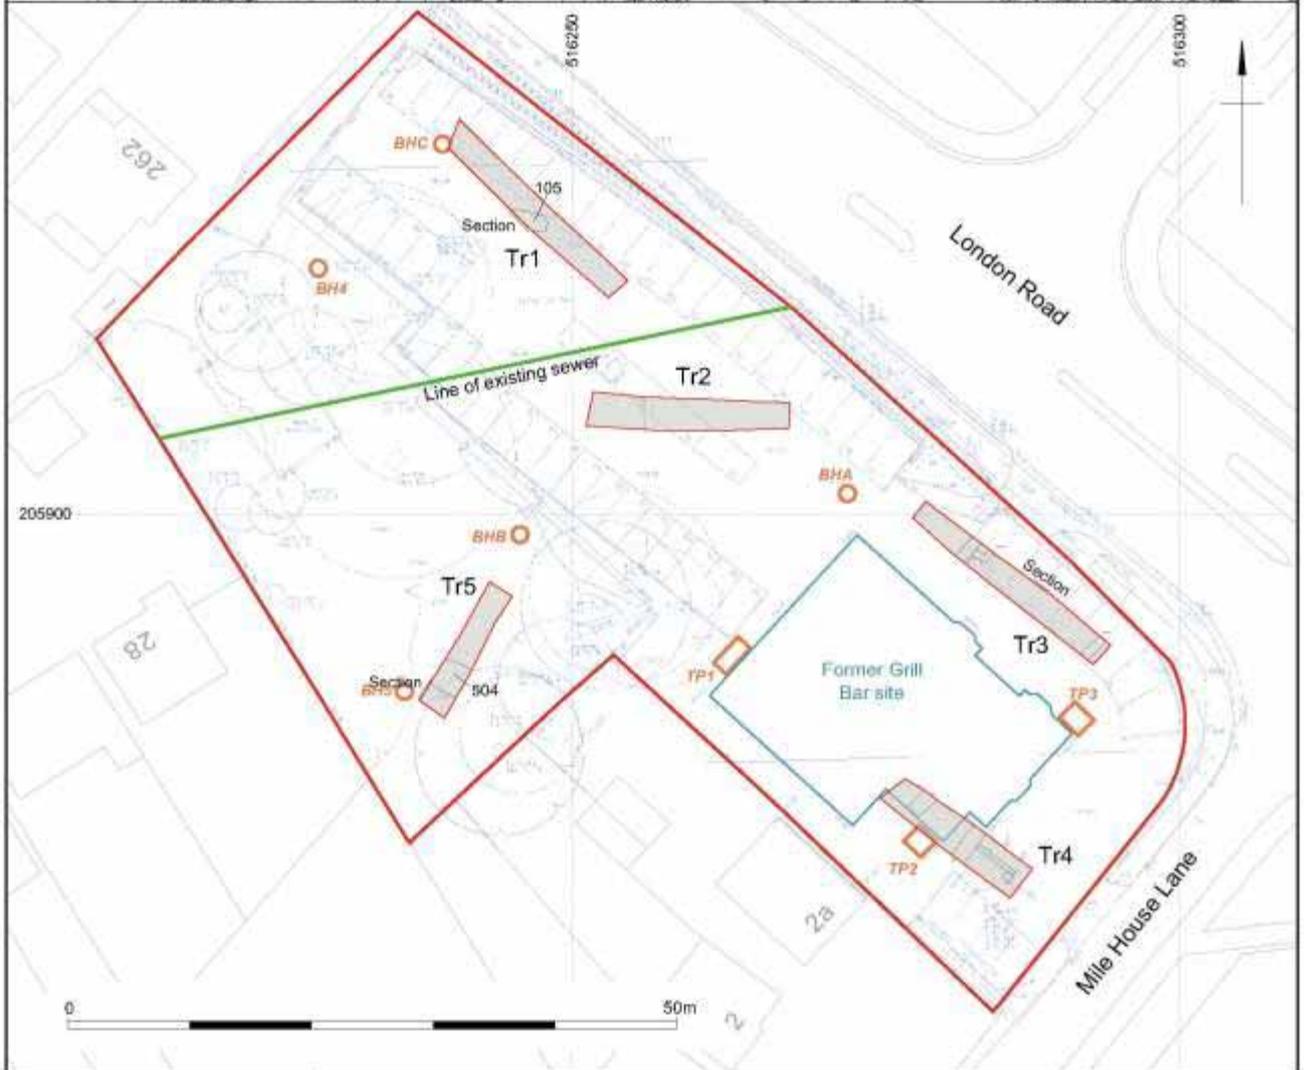
Figure 1

Site and trench location

- 2.3.1 In August 2003 ground investigations comprising three deep boreholes and six trial pits (TP) (**Figure 1**) were undertaken by KF Geotechnical within the Site (**Appendix 3** - TP6 is not shown on the location plan, but the report text states it was located at the northwest corner of the Site). The investigations identified in two boreholes (BHA and BHC) within the area of the car park, 0.50m (in the north) to 1.30m (in the south) of modern made ground directly below the tarmac/concrete surface. The made ground was observed to overlie the natural brickearth. Trial pits (TP1 – TP3) carried out next to the then still standing public house only identified modern material contained within the foundation cut for the building. Further exploratory work (BHB, BH4, BH5 and TP6) was undertaken in the northwest corner of the Site covered in trees and revealed directly below the turfline/surface the natural geology (**Appendix 3**).

4.1.3 The evaluation comprised the excavation of five trial trenches, comprising 3 No 20m x 1.8m trenches (Trenches 1-3) and 2 No 10m x 1.8m trenches (Trenches 4-5) (**Figure 1**).

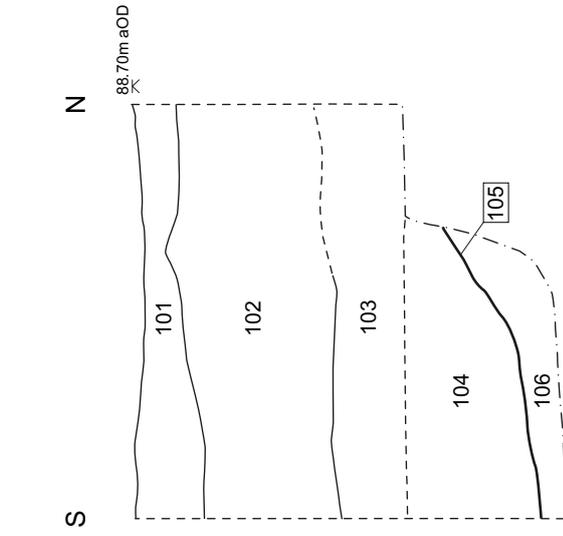
Trench 1: North west facing section

- 5.2.1 In Trenches 1 and 3 which were aligned north-west – south-east and parallel to the London Road edge of the Site, natural geology was encountered at a depth of between 1.10m and 1.20m. No evidence for a ditch that may have been associated with the Tudor Boundary was identified. Given the close proximity of these trenches to London Road and therefore the 16th century boundary bank, these two trenches were thought to be the most likely candidates for providing evidence for the associated boundary ditch. A modern treethrow (**105**) was noted in Trench 1 (**Figures 1, 2 and Plate 2**) and a number of modern services were identified in Trench 3 (**Figure 1 and Plate 4**).

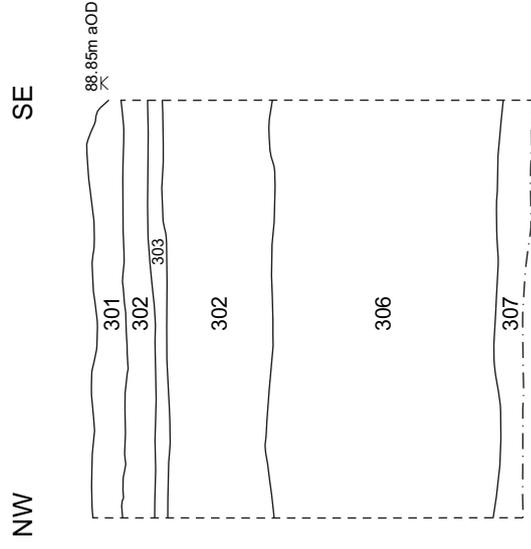
Trench 3: South west facing section

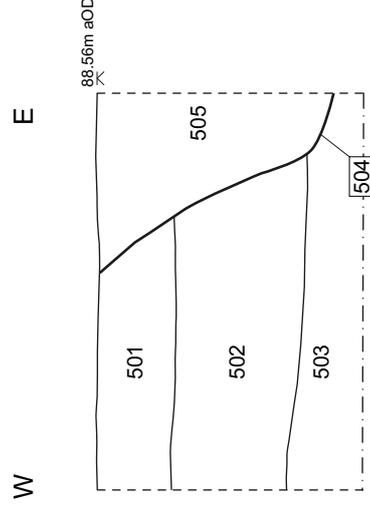
Trench 5: South east facing section

- 5.2.4 Trench 5 (**Figures 1, 2 and Plate 6**) was opened within the former garden of the Grill Bar which had been laid to grass. After removal of modern topsoil and made ground, natural geology was encountered at a depth of 0.6m in the southern part of the trench and 0.45m in the northern part of the trench.

This confirms the results of the geological borehole survey in this area, which had encountered a shallow depositional sequence (**Appendix 3**). A large modern rubbish pit (**504**) (**Figures 1 and 2**) at least 2.5m in diameter, truncated the natural geology in the southern part of the trench. No archaeological features or finds were retrieved.

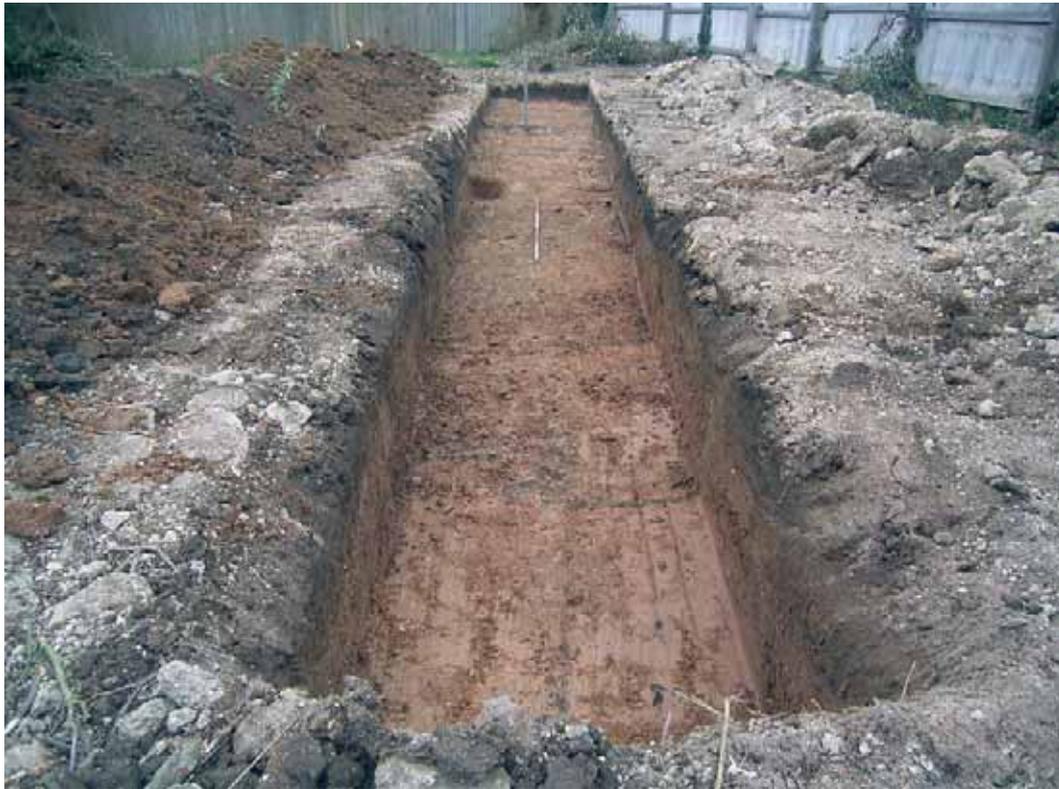
Plate 1: Trench 1 from the south east

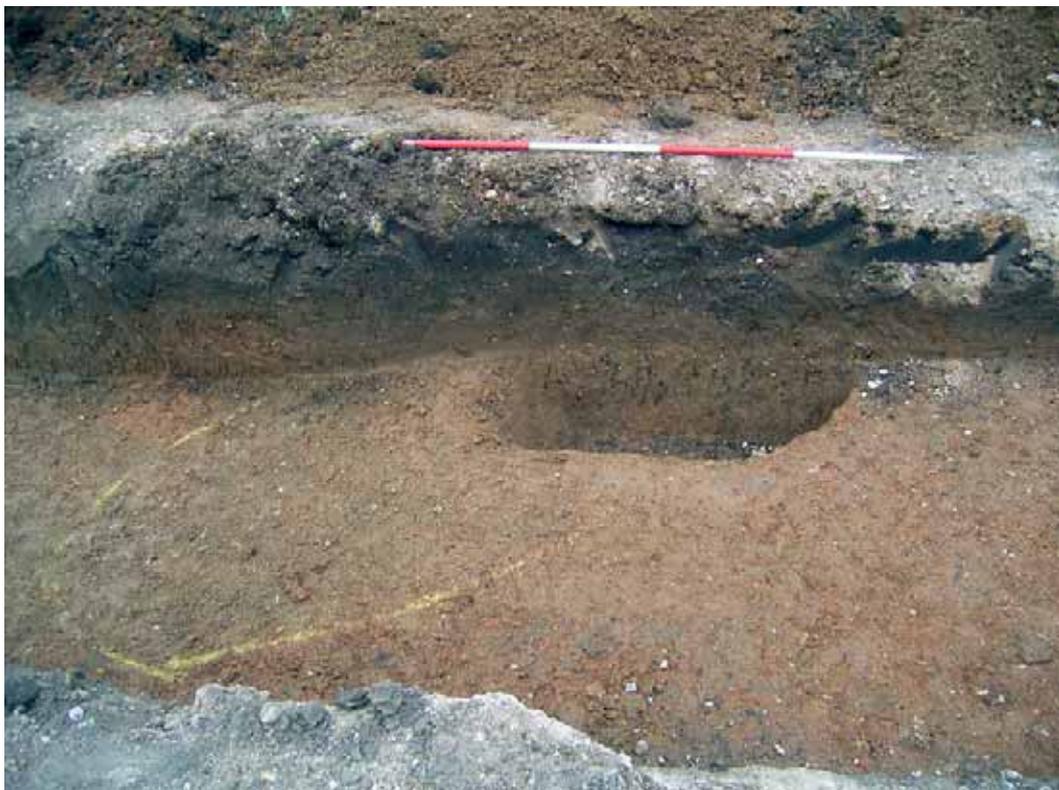
Plate 2: Trench 1 - tree throw (105) from the north east

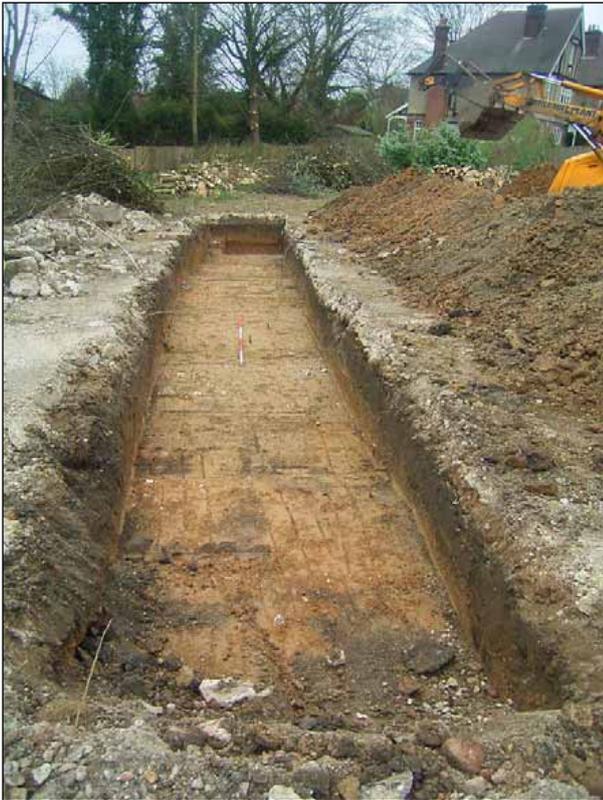
Plate 3: Trench 2 from the east

- 5.2.2 In Trench 2 (**Figure 1 and Plate 3**), the majority of deposits related to modern made ground horizons, and natural geology was encountered at a depth of 1m below the present ground surface. At the eastern end of the trench, a number of modern services were encountered and the opening of the trench was curtailed 2m short of its proposed full extent of 20m. No archaeological features or finds were encountered.

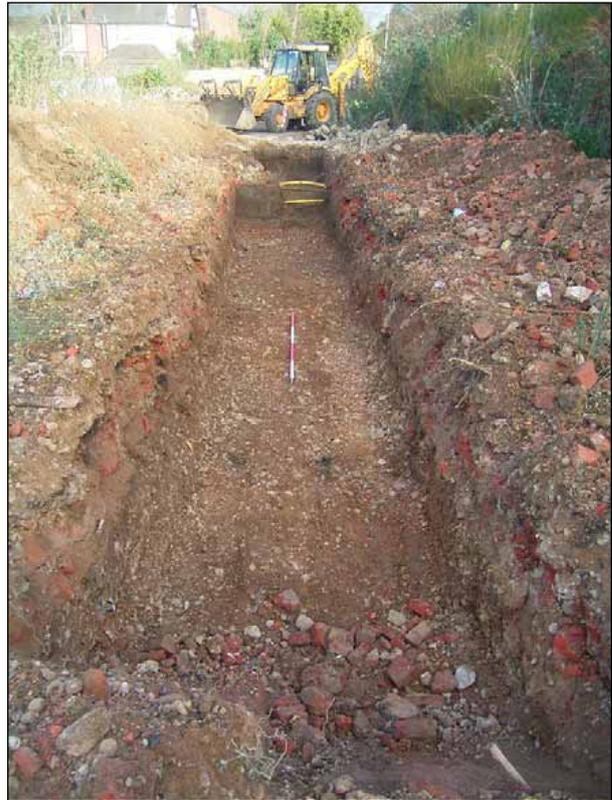
Plate 4: Trench 3 from the south-east

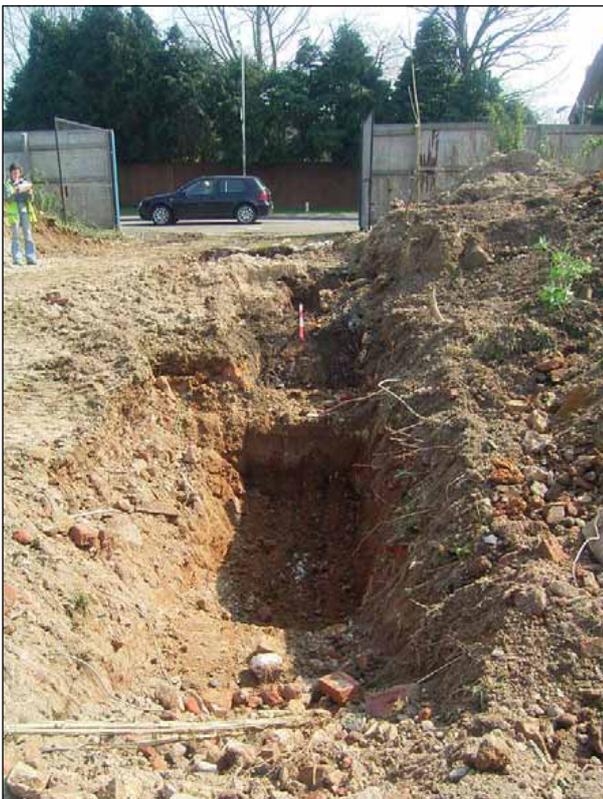
Plate 5: Trench 4 from the north-west

- 5.2.3 Trench 4 (**Figure 1 and Plate 5**) had been subject to major modern disturbance, as a result of its direct location over the former Grill Bar. A series of services were encountered in the south-eastern part of this trench, including a man hole cover and two water pipes. Modern wall footings associated with the foundations of the Grill Bar were present in the central and western parts of the Trench, truncating all earlier deposits in this area. Natural geology was noted at 1.25m below the modern ground surface demonstrating that any previously surviving archaeological horizons would have been completely truncated by the former building. No archaeological features or finds were identified.

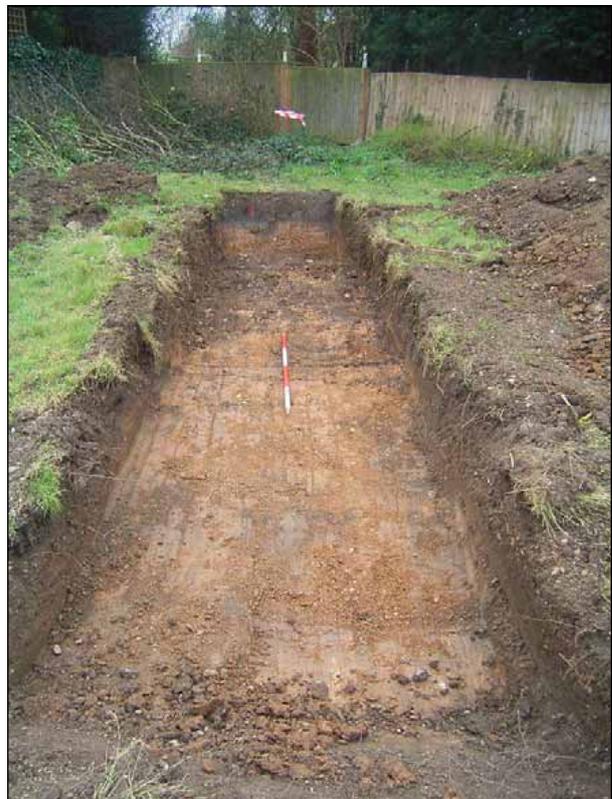
Plate 6: Trench 5 from the north-east
