Harold's House, Portskewett, Monmouthshire, South Wales

Archaeological Evaluation and Assessment of Results

Ref: 65301.01
June 2007

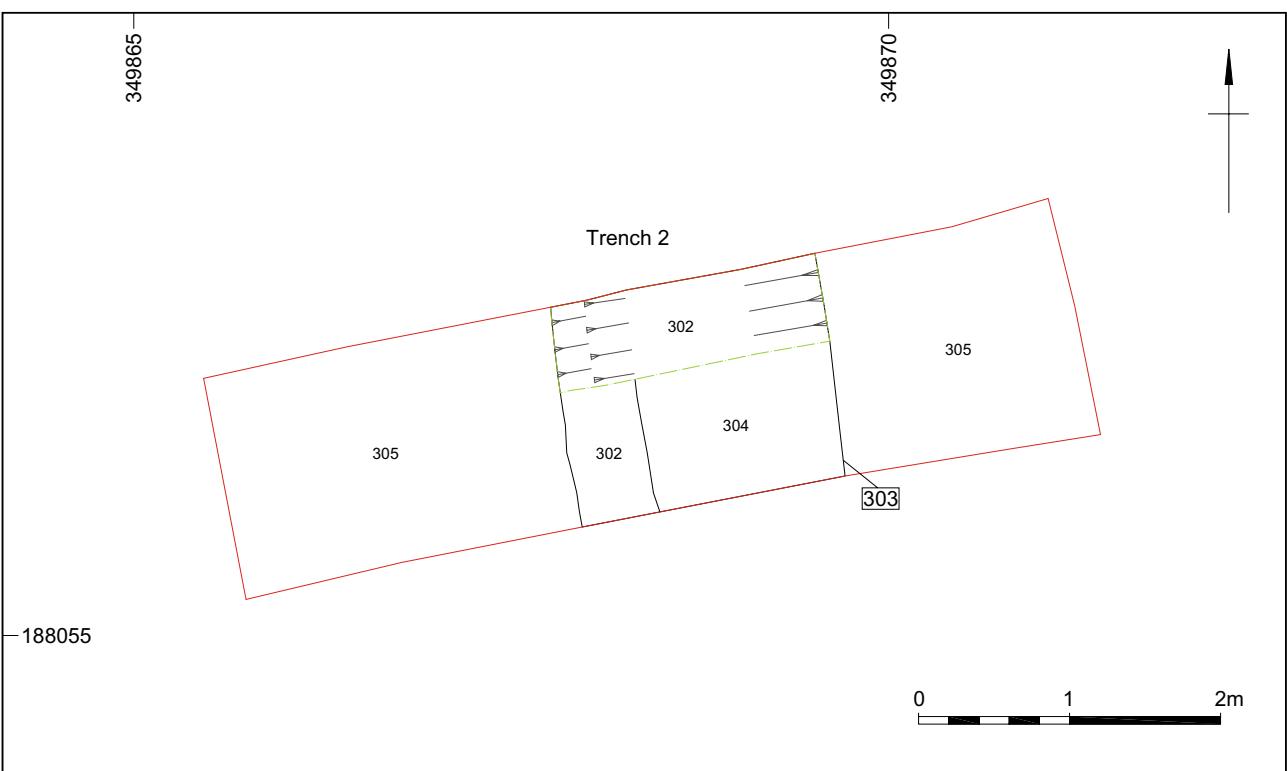
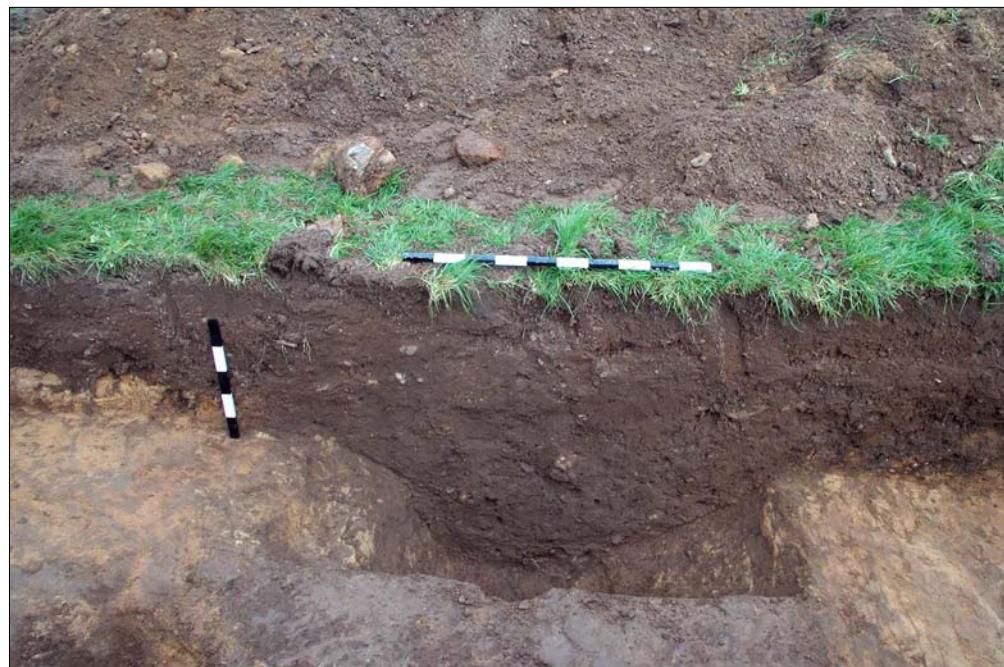
Ditch (303) from the south

- 4.5.29 Trench 3 targeted geophysical anomaly (E), which was interpreted as a possible wall. After the removal of the topsoil and subsoil it became clear that the anomaly was in fact caused by an outcrop of natural sandstone (307). However, a large north-south aligned ditch was found, cutting (306).
- 4.5.30 Ditch (303) had two fills, lower (302) and upper (304). Both these secondary fills were the result of multiple depositions of similar material, the surrounding ground surface (topsoil and subsoil) giving rise to a homogenous fill. No dateable material was recovered from Trench 3.

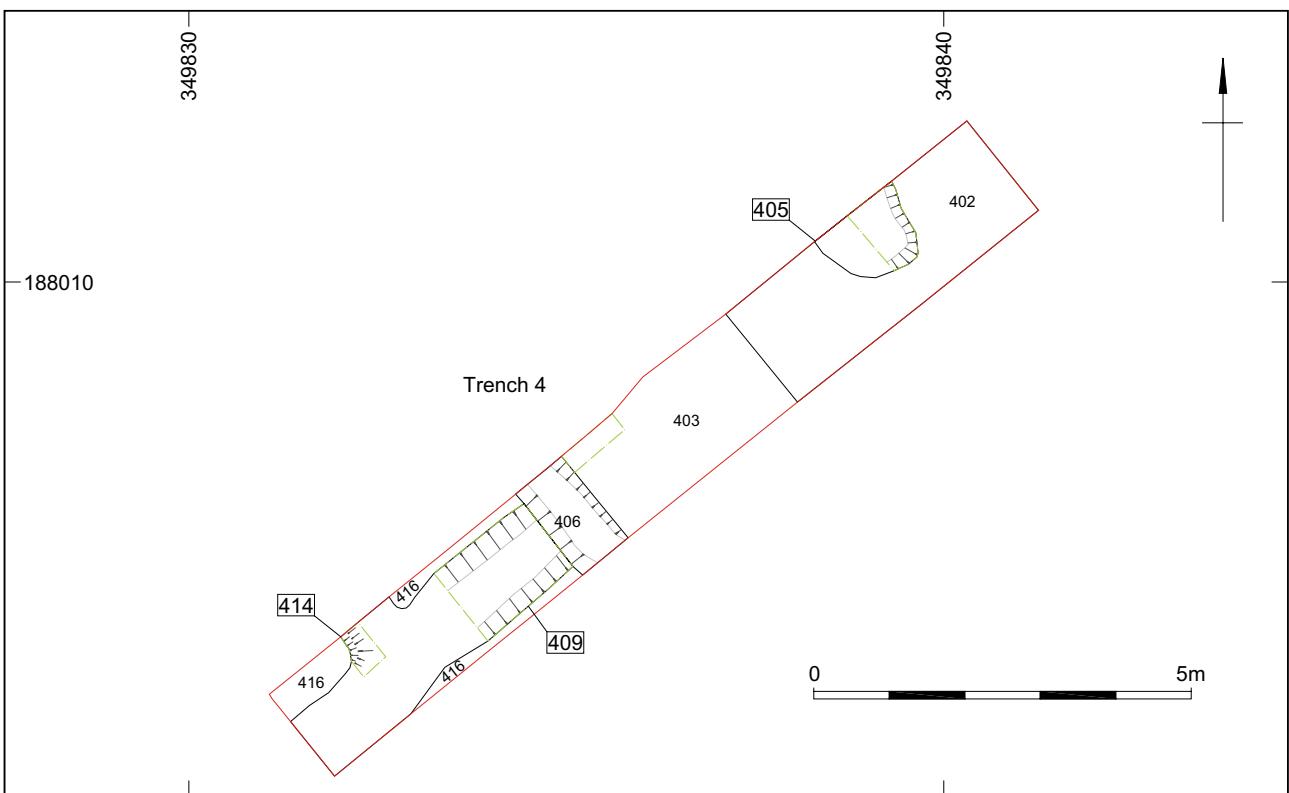
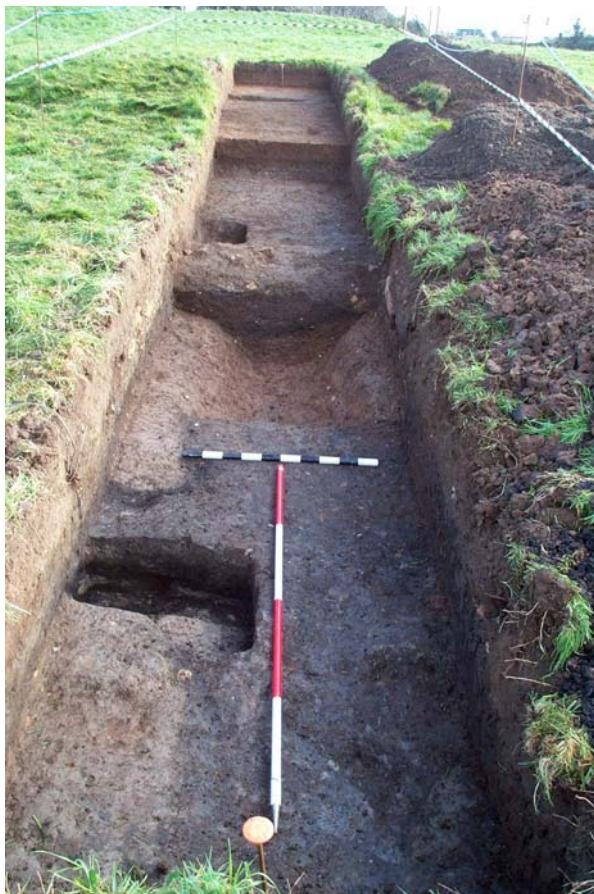
Trench 4 from the south west

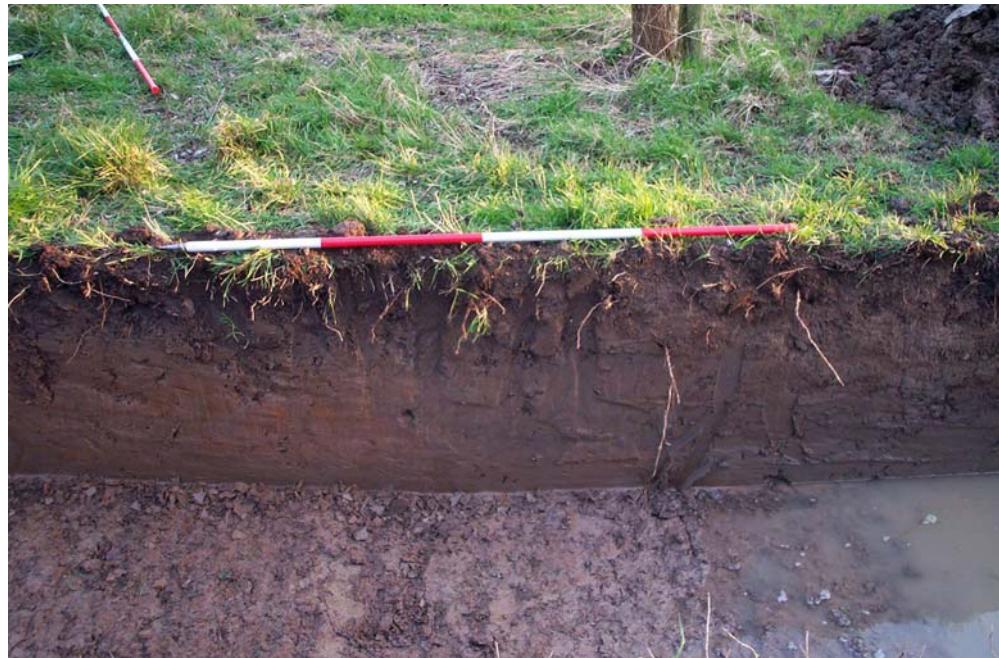
Figure 6

North facing section showing edge of palaeochannel

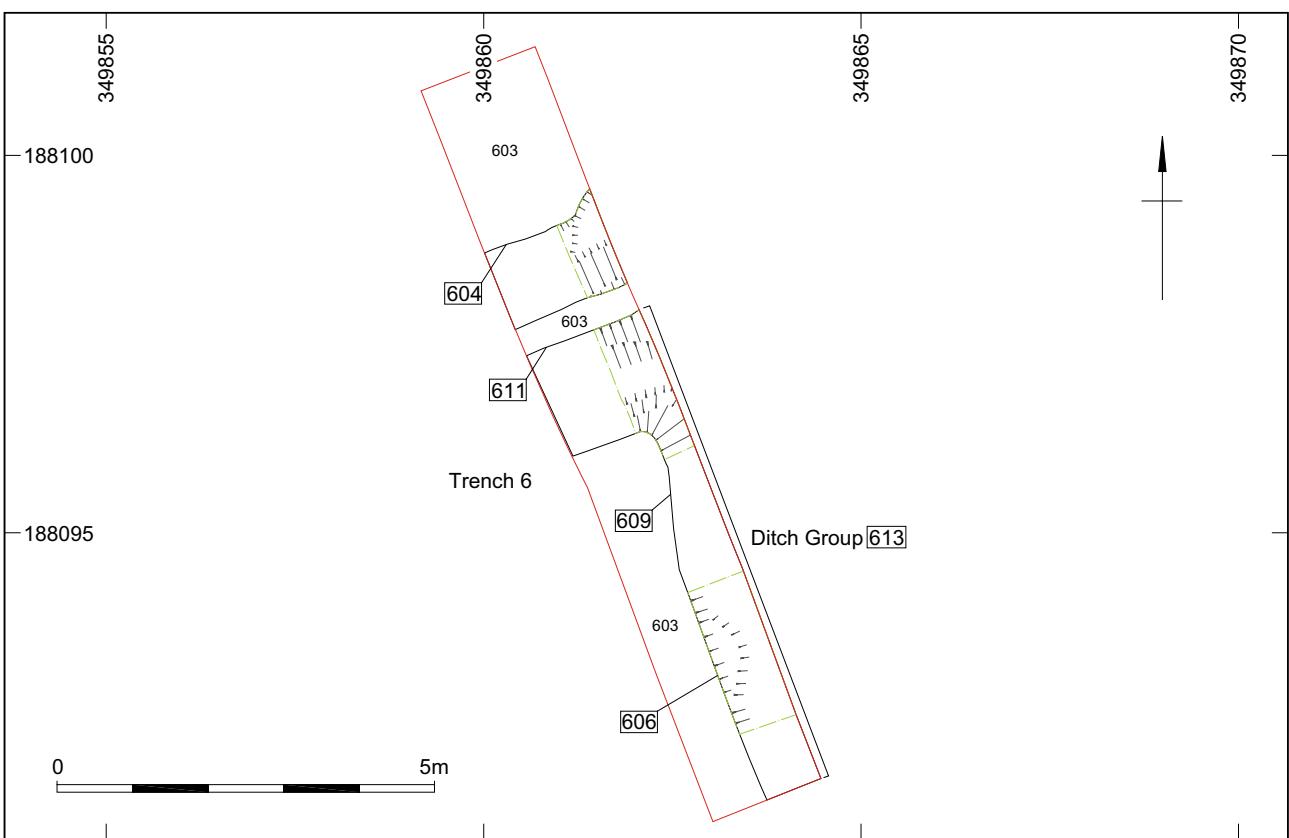
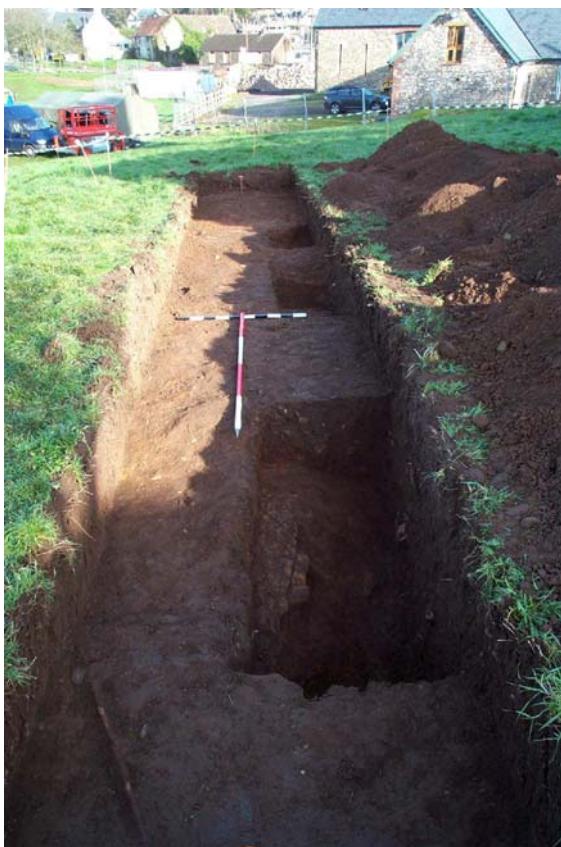
Trench 6 from the south
