## 'The Castles', West Shipley Farm Hamsterley, Co. Durham

Archaeological Evaluation and Assessment of Results

Ref: 65303.01  
May 2008

Prepared on behalf of  
**Videotext Communications Ltd.**  
49 Goldhawk Road  
LONDON  
W12 8PQ

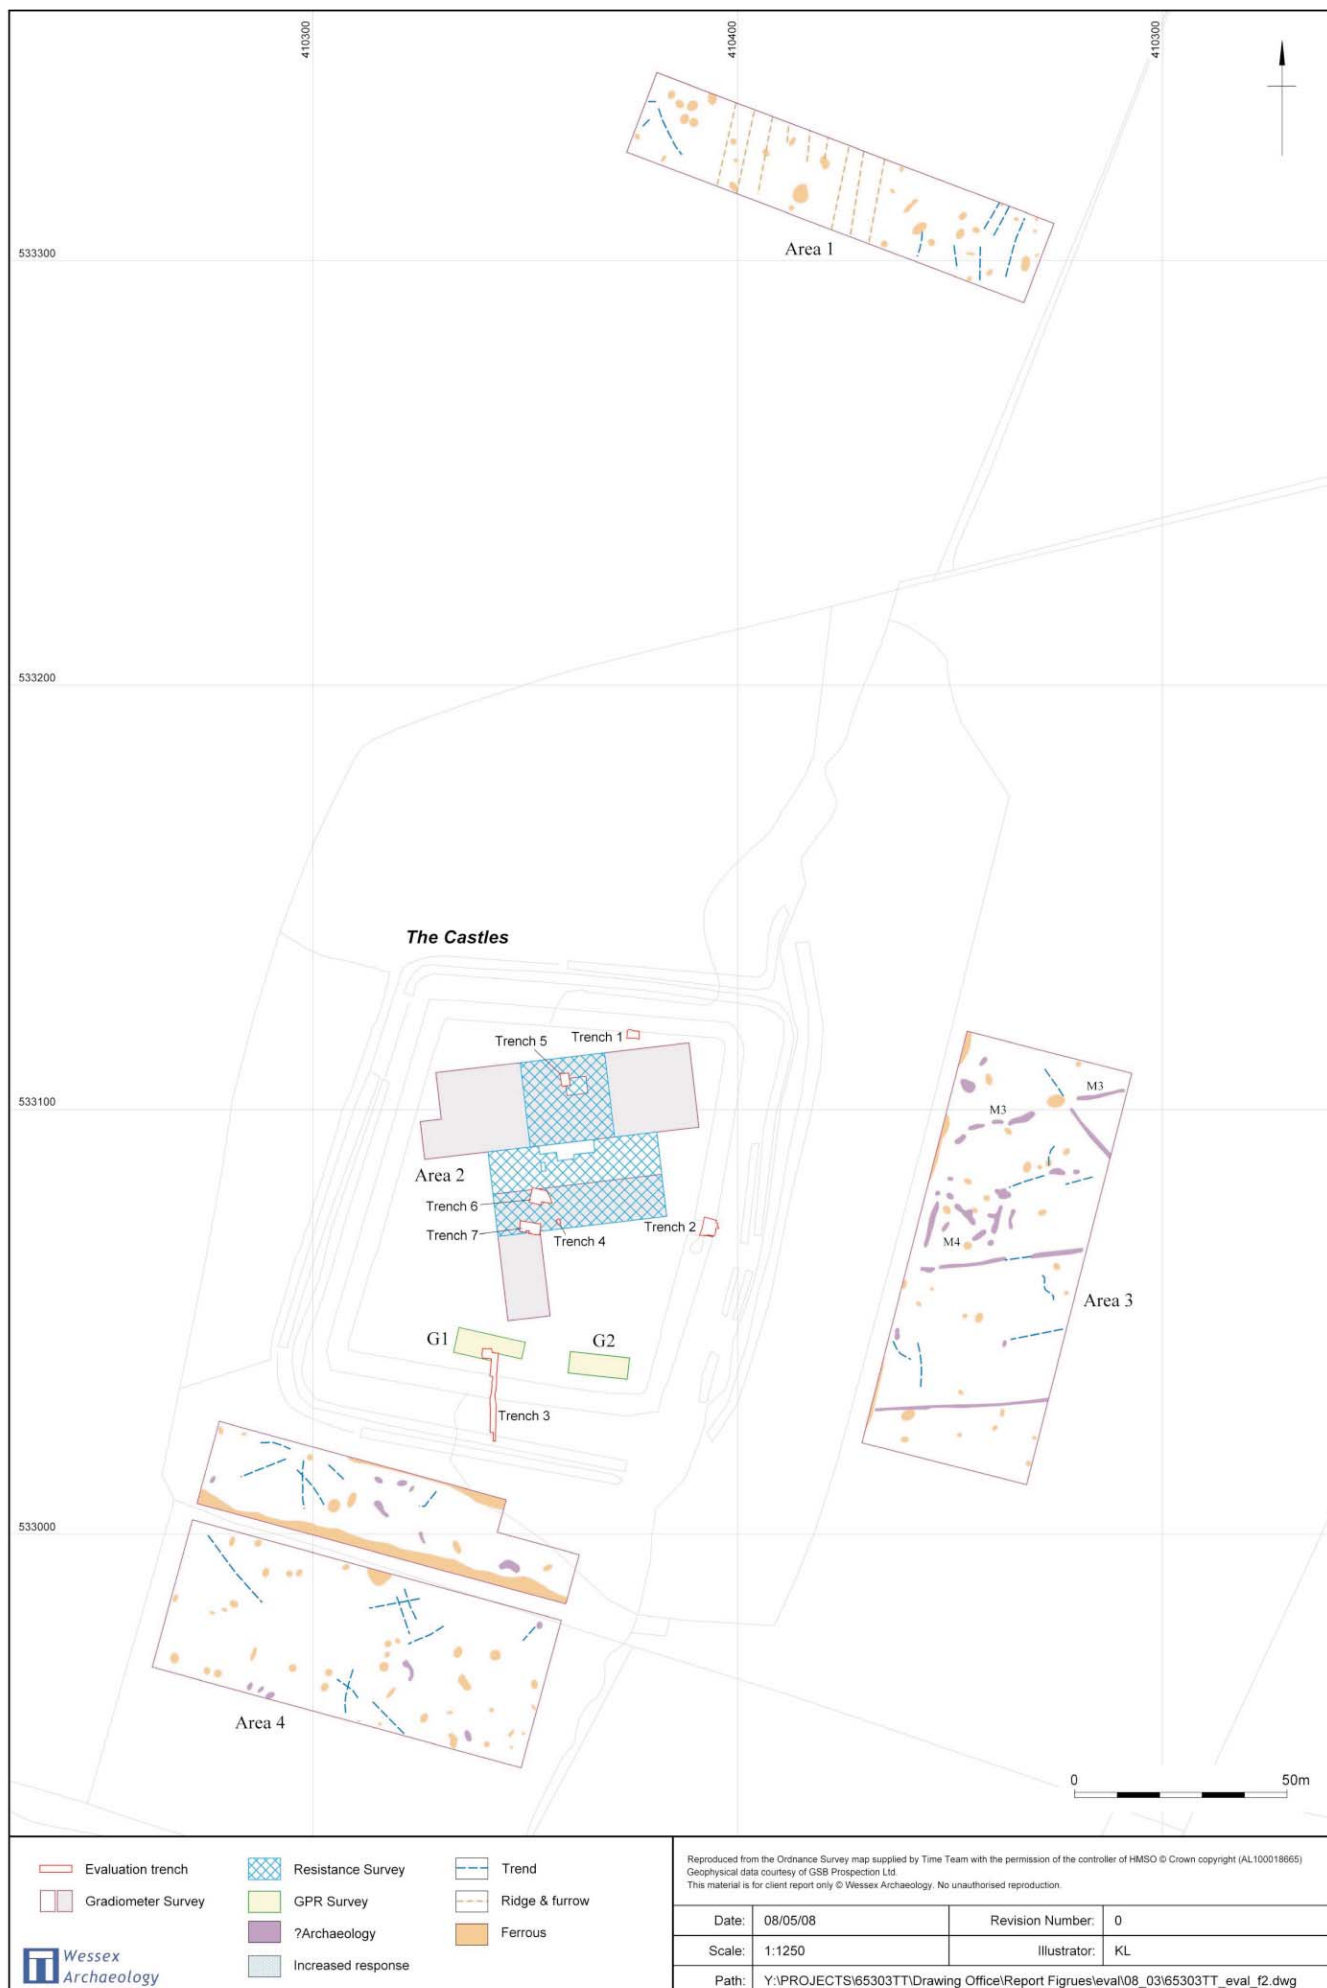
Figure 2

Trench locations (1-7) and areas of geophysical survey (Areas 1-4) with summary of results from Areas 1, 3 and 4

- 1.3.1 'The Castles' comprises a large, rhomboidal dry-stone monument, describing an area *c.* 81.26m (west)/85.46m (east) by 65.83m (north)/79.54m (south). There is a single entrance roughly mid-way along the east side and a ditch appears to surround the monument on all sides (Figure 2).

- 2.3.2 The geophysical survey was undertaken in four areas; within the area of the fort (Area 2), and to the north (Area 1), east (Area 3) and south (Area 4) of the monument (Figure 2). All four areas were subject to a magnetometer survey using Bartington Grad 601-2 and Geoscan FM 256 gradiometers; readings were logged at 0.25m intervals along 1.0m traverses (GSB Prospecting 2007). Parts of Area 2 were also subject to resistance survey using a Geoscan RM15 meter, readings at 1.0m intervals over 1.0m traverses, and Ground Penetrating Radar (GPR) survey using Sensors and Software SmartCart Noggin<sup>plus</sup> over 0.05m intervals across 0.5m traverses. The survey grid was set-out by Dr. Henry Chapman and tied into the OS grid system using a Trimble R8 Real Time Kinematic GPS system.

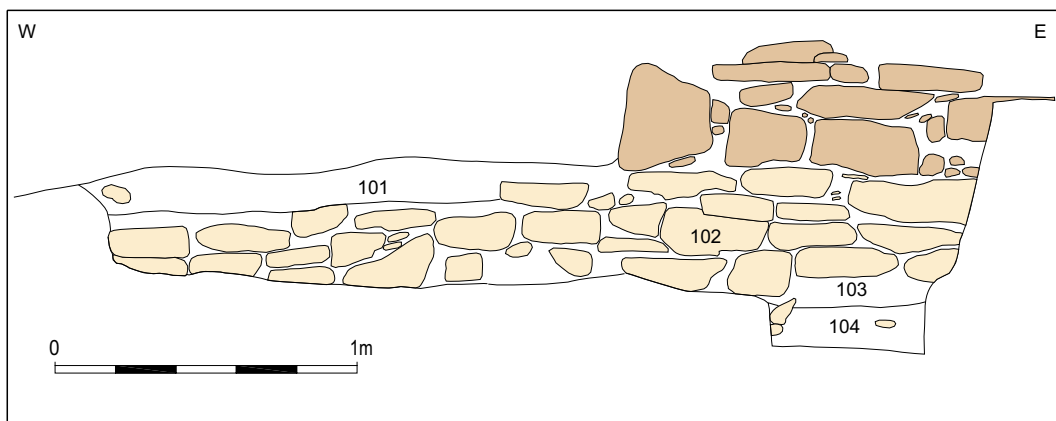
**Figure 4:** Trench 1: South-facing section showing inner-face of north wall 102 (original and re-build).

South-facing section showing inner-face of north wall 102 (original and re-build)

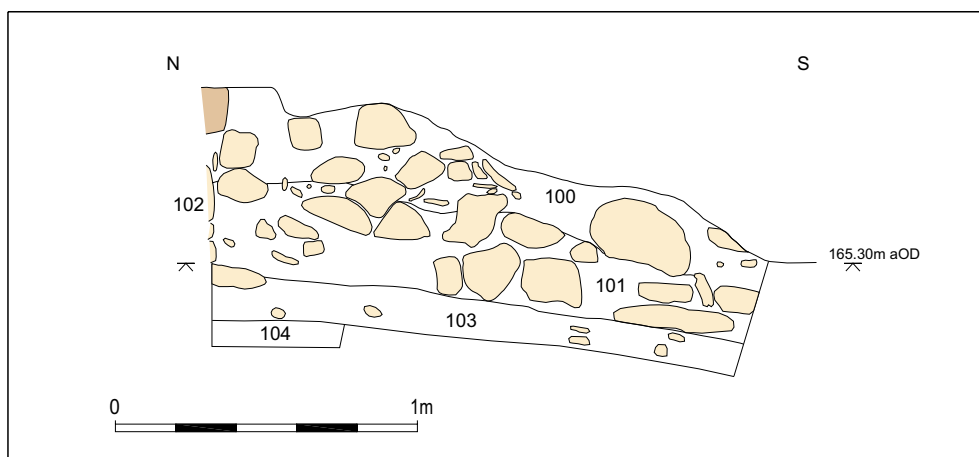
West facing section showing inner-face of north wall (102) and tumble therefrom (original - 101; from re-build - 100)

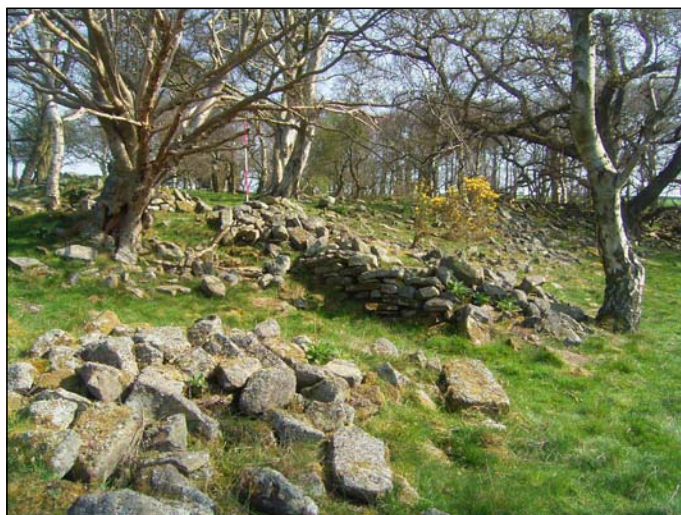
View from SW interior of structure looking north and showing part of inner face, core and tumble from the north wall

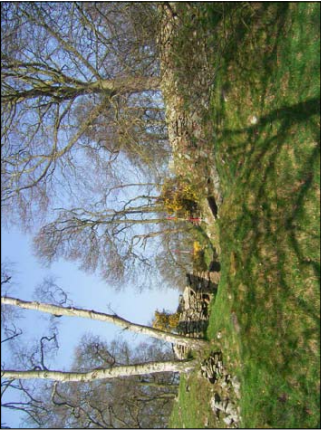
View from E. exterior to monument looking towards the gateway from stream (pre-excavation)

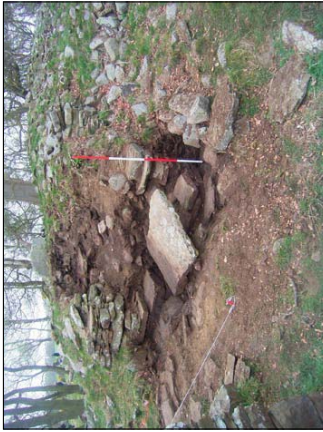
View from the SE exterior to the monument showing the N. wall of the entrance post-excavation (note robbed-out core)

- 3.4.7 The collapsed (and probably partially robbed) wall core on the north side of the entrance was investigated for evidence suggestive of the presence of a cellular structure to match that on the south side, but none was found (Figure 5). It was observed, however, that the southern wall is stepped-in by *c.* 0.50m from a point *c.* 1.35m west of the outer wall (213); a feature not matched in the wall on the north side of the entrance. This may suggest a more substantial collapse and remodelling of the walling on the south side.

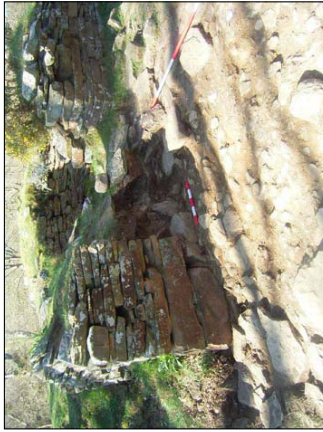
View from the NE exterior showing the S. wall of the entrance, flagged and cobbled surfaces and the 'guard cell' post-excavation

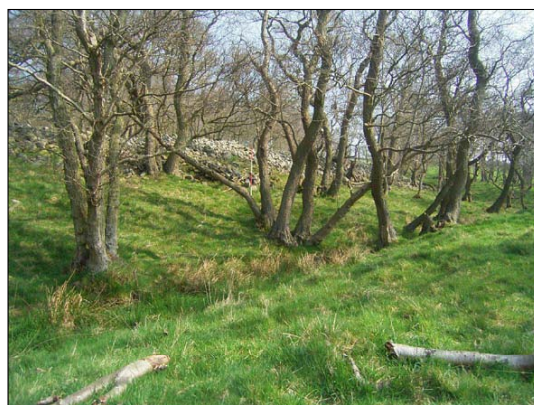
View from SW of monument showing southern line of ditch and slope up to the south wall

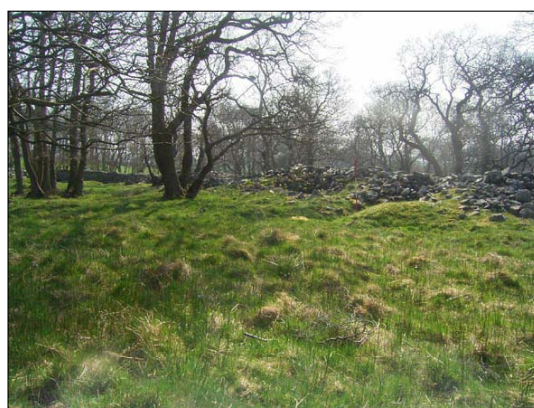
View of south wall from interior of monument showing position of Antiquarian trench prior to excavation (from WNW)

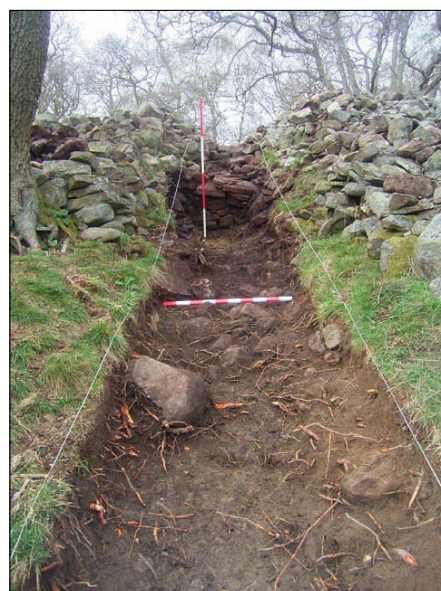
Post-excavation view of outer-face of south wall looking north from level of ditch

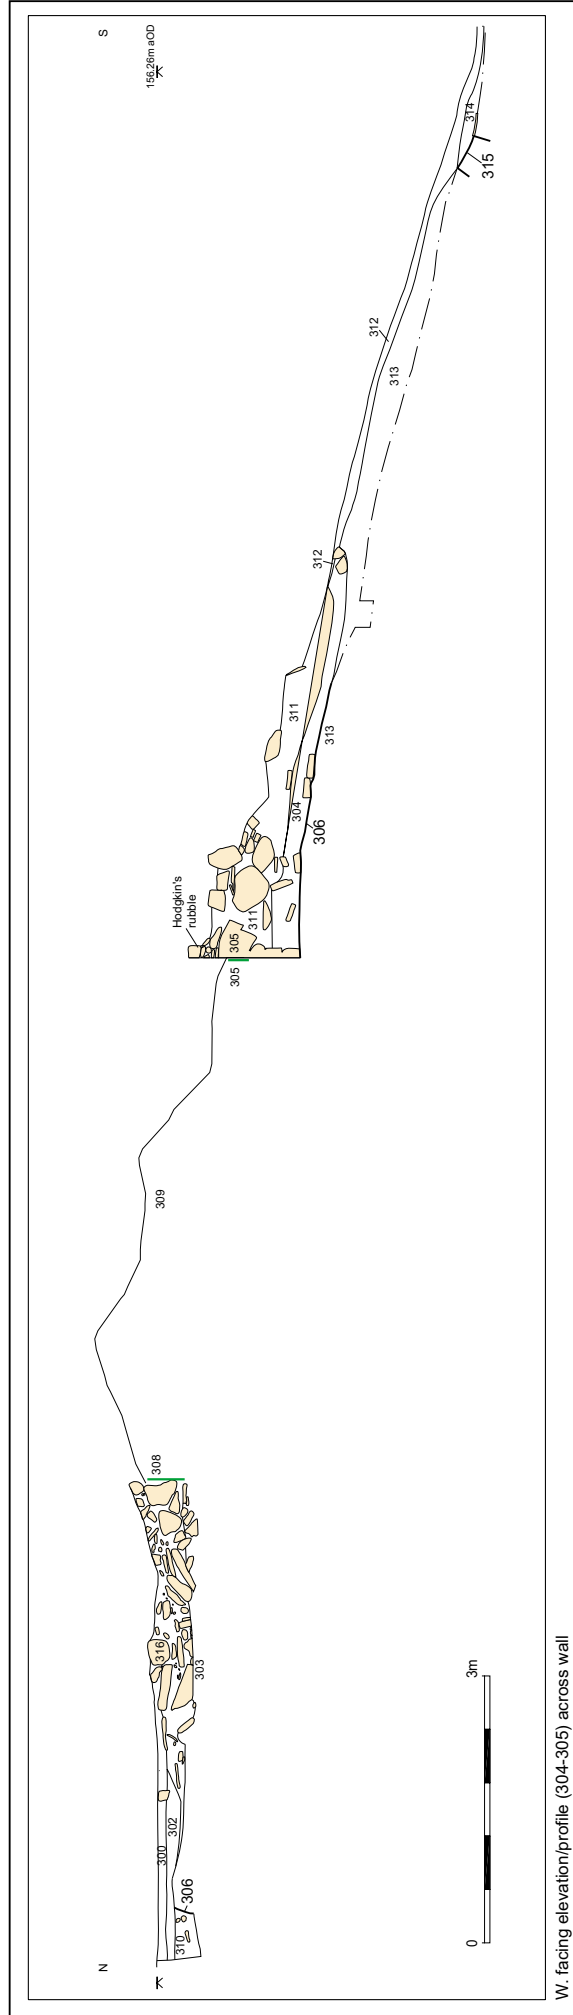
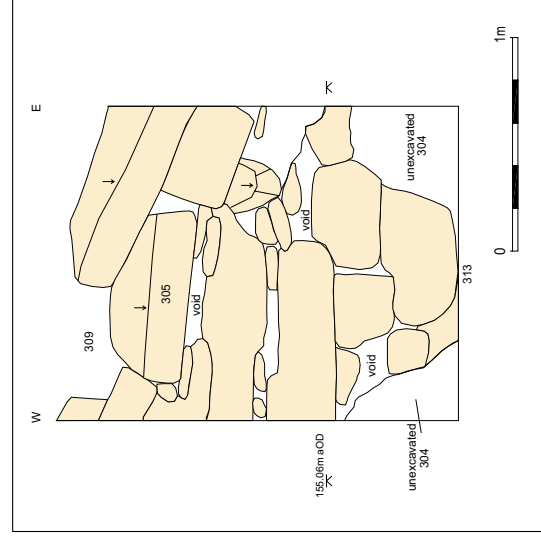
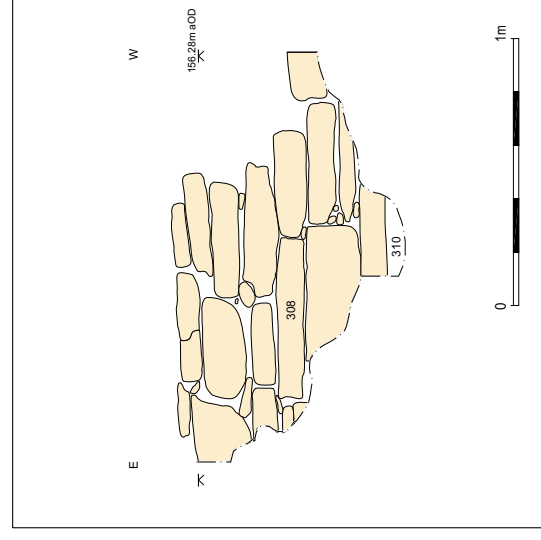
**Figure 7:** West facing elevation/profile across wall. North facing section of *in situ* inner face of wall (308). South facing elevation of outer-face of wall (309).

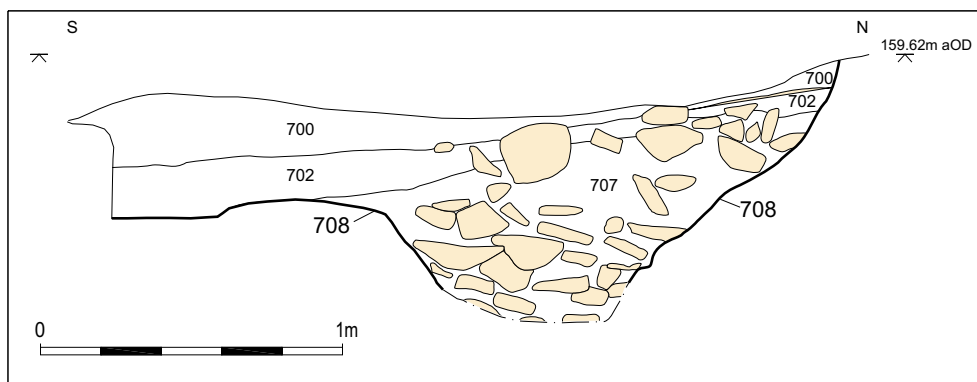
E. facing section showing cut 708 with rubble fill

<b>Trench 7 ( cont.)</b>		
<b>context</b>	<b>description</b>	<b>depth (bgl)</b>
704	Cut of Antiquarian trench: T-shaped in plan, moderate concave sides & obtuse concave base. Fills (705) & (706). Max. depth 0.28m	0-0.28m
705	Lower fill of [704]: very dark grey slightly silty clay (waterlogged at base), with occasional yellow sand mottles. Rare subangular stones (0.02-0.22m). Max. 0.06m deep.	0.22-0.28m
706	Upper fill of [704]: mid greyish brown silty loam (similar to subsoil), with occasional small-medium (0.08-0.30m) subangular stone.	0-0.22m
707	Fill of [708], possibly revetting for terrace to N: moderately sorted dense rubble, subangular & subrounded stone (0.04-0.50m), predominantly small-medium stone. Mid greenish grey sandy clay soil matrix. Min. 0.65m depth (nfe)	0.02-0.70m
708	E-W linear cut (uneven), 1.75m wide; ?foundation trench for revetting for terrace to N. doubling as drainage trench?: acute concave N slopes & shallow-moderate S. slopes, base unseen (nfe).	0.02-0.70m

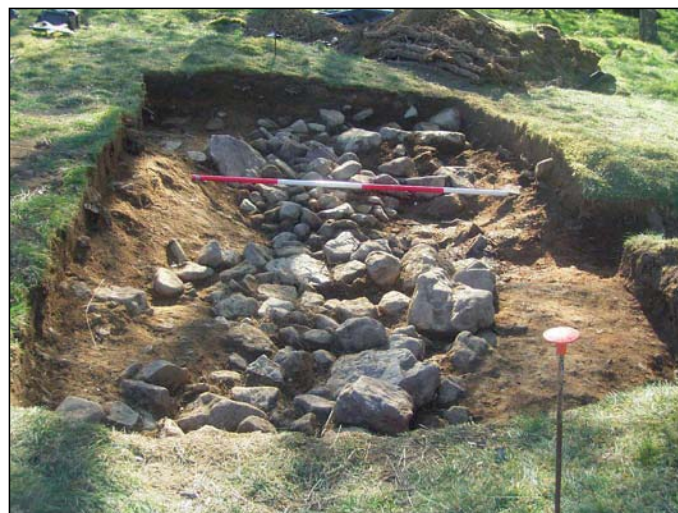
View of features from west
