Land at the Esso Sports Field, North Road, Purfleet, Essex

Archaeological Watching Brief Report

Report reference: 65901.01

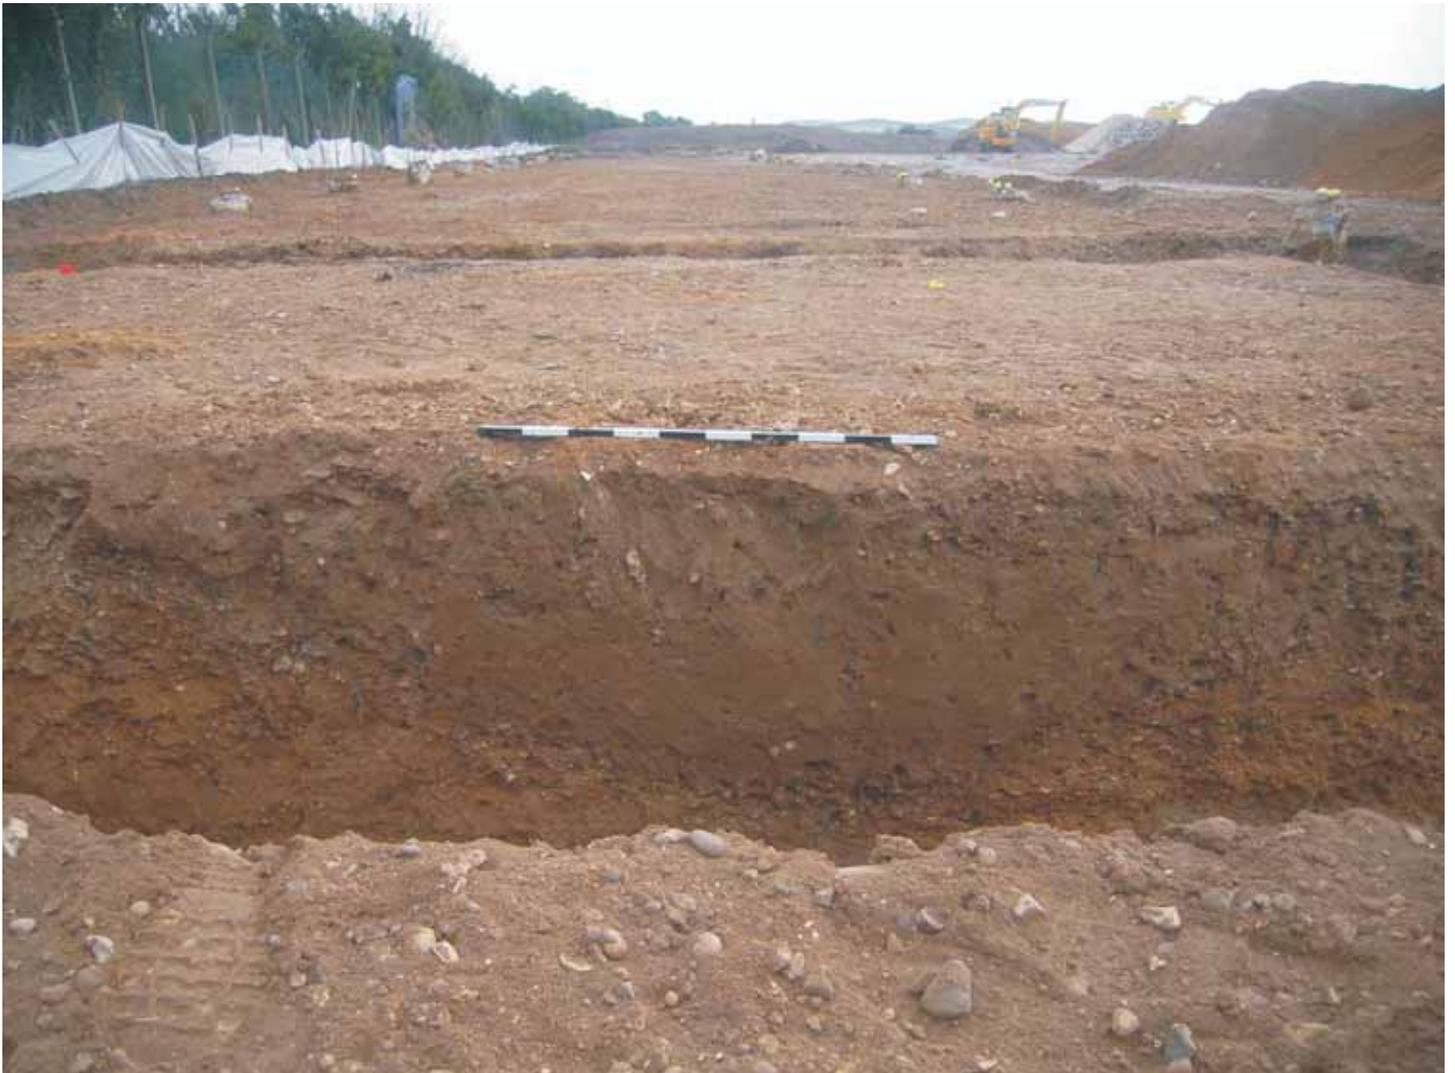
FRONT COVER:

3.5.6 The west-east part of the larger boundary ditch **3414** identified in the evaluation was also seen in section in each of the north-south foundation trenches (see photograph on front cover). Its profile and characteristics were as seen in the evaluation and it displayed a strong degree of uniformity along its length. No further dating evidence was obtained. The ditch was shown to continue beyond the western extent of the Site. The smaller boundary ditch was not seen in these sections lending credence to the idea that this is an earlier feature that has been destroyed by the excavation of **3414**.

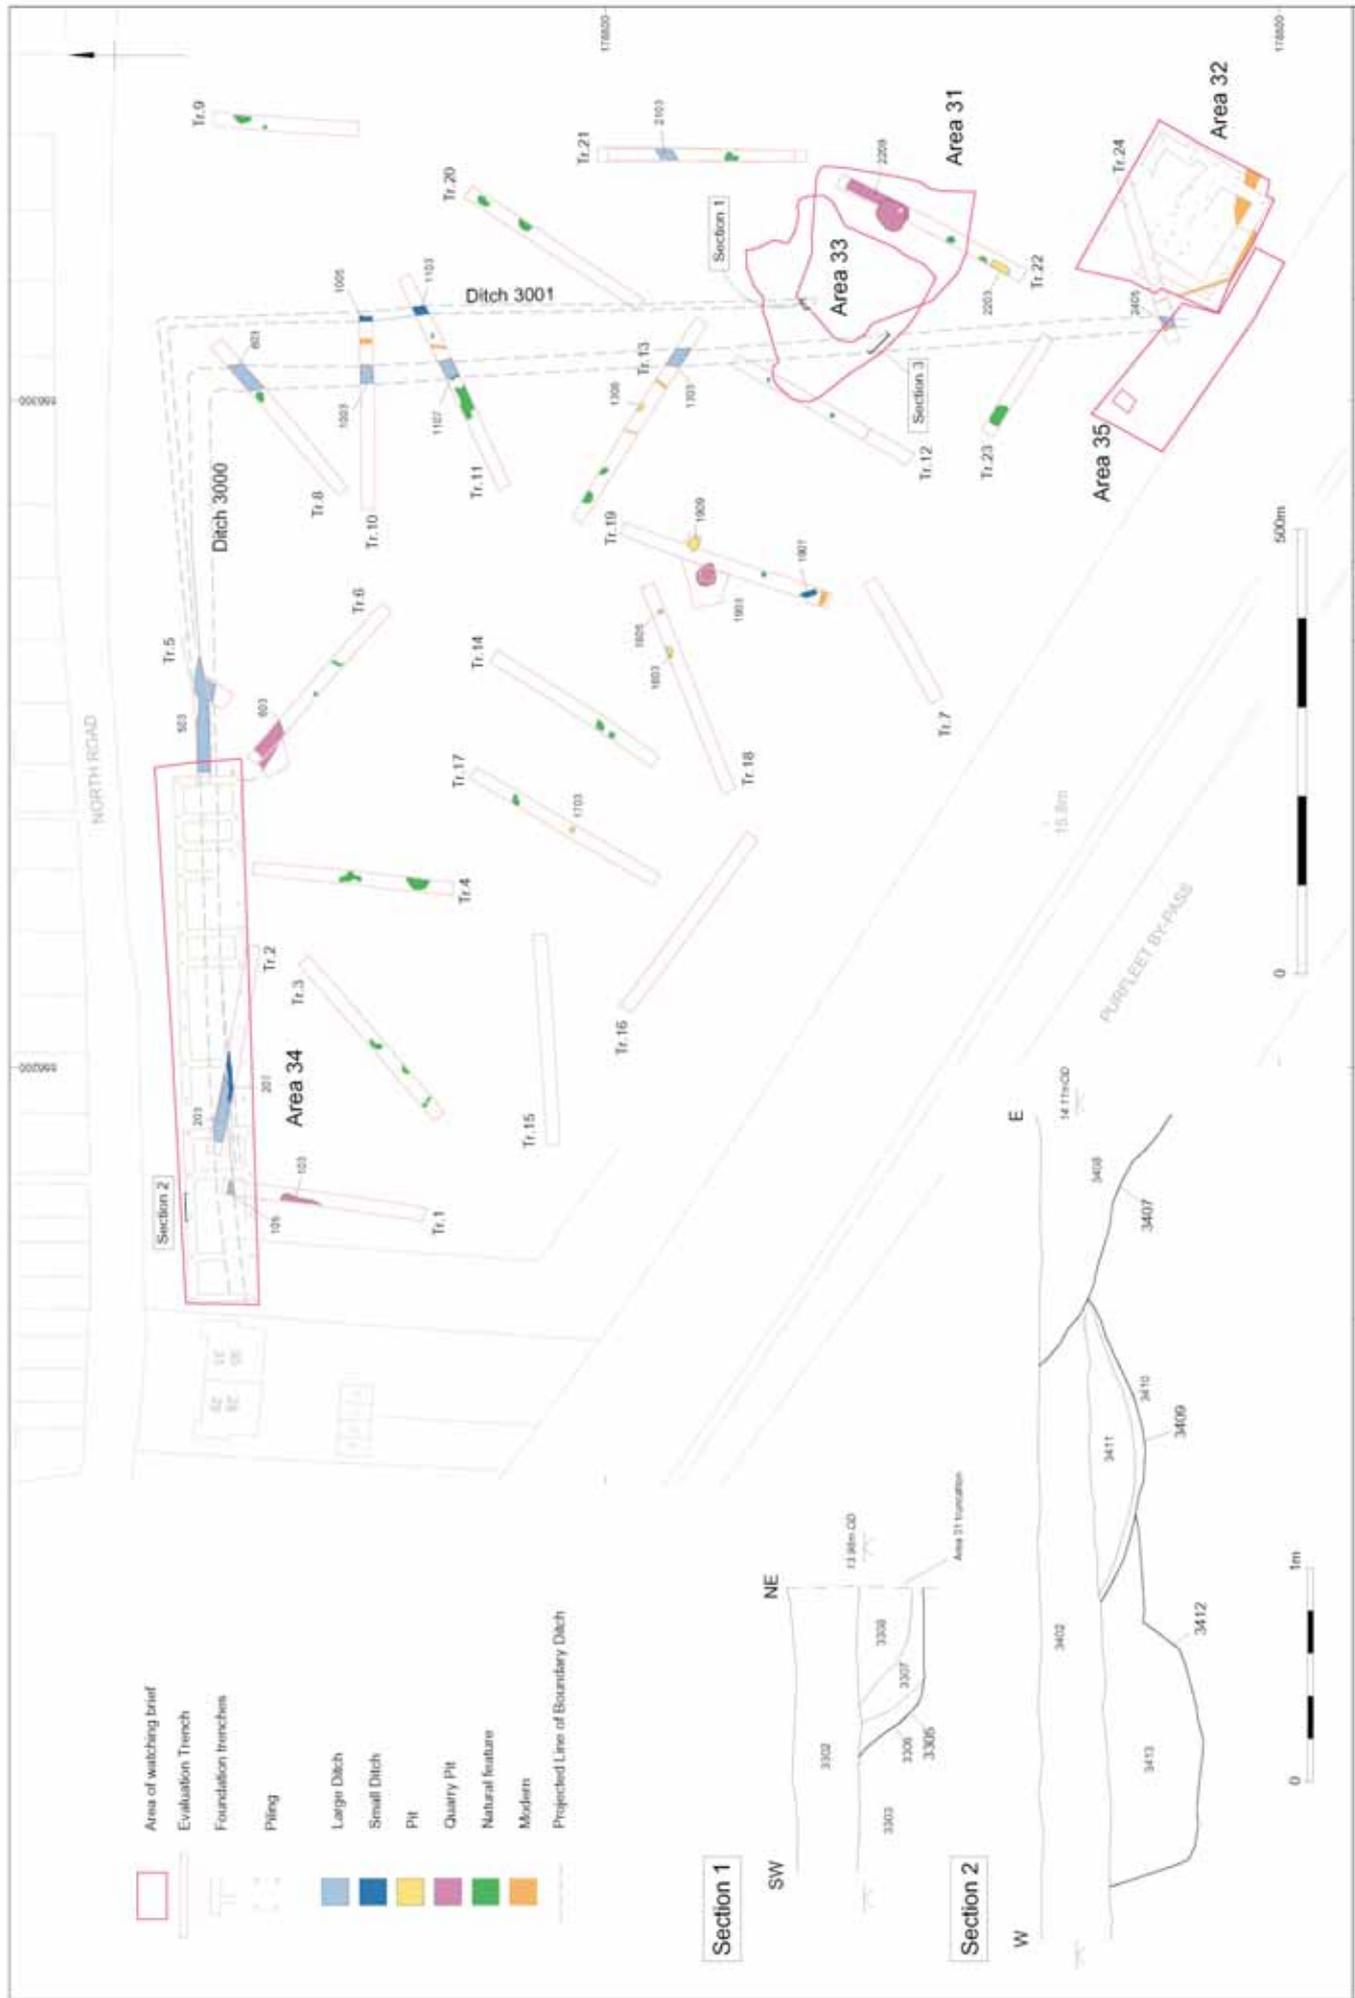
Results of the evaluation and watching brief/observation Figure 2

- 1.3.2 The evaluation primarily identified two boundary ditches running west-east and then turning south (**Figure 2**). The smaller ditch (group number **3001**) lay slightly to the north-east of the larger ditch (group number **3000**). A number of quarry pits were also identified as well as some smaller pits.

- 3.1.2 The location of the areas of watching brief in relation to the proposed development is indicated on **Figure 1**. The detailed results of the watching brief are shown in relation to the 2007 evaluation results on **Figure 2**.

3.4.2 Feature (**3305**) was observed in section, though truncated by the excavation of Area 31, it is believed to be the smaller boundary ditch identified in the evaluation (**Section 1, Figure 2**). This extends the previously known course of the ditch a further 50m to the south.

3.4.3 The larger boundary ditch (**3309**) was also observed in the south-western part of the area (**Section 3, Figure 2; Plate 2, Figure 3**). It was observed twice as the area was expanded several times. The profile and characteristics were similar to those recorded in the evaluation but no further dating evidence was observed or recovered.

3.5.5 Three intercutting features (**3407**), (**3409**) and (**3412**) were seen in the south-facing section of the northern-most foundation trench (**Figure 2**). While (**3407**) was undoubtedly modern and could be seen cutting the subsoil, (**3409**) and (**3412**) were undated. However the dark bands of topsoil-like deposit within (**3412**) would appear to suggest that both of these are also likely to have been modern.

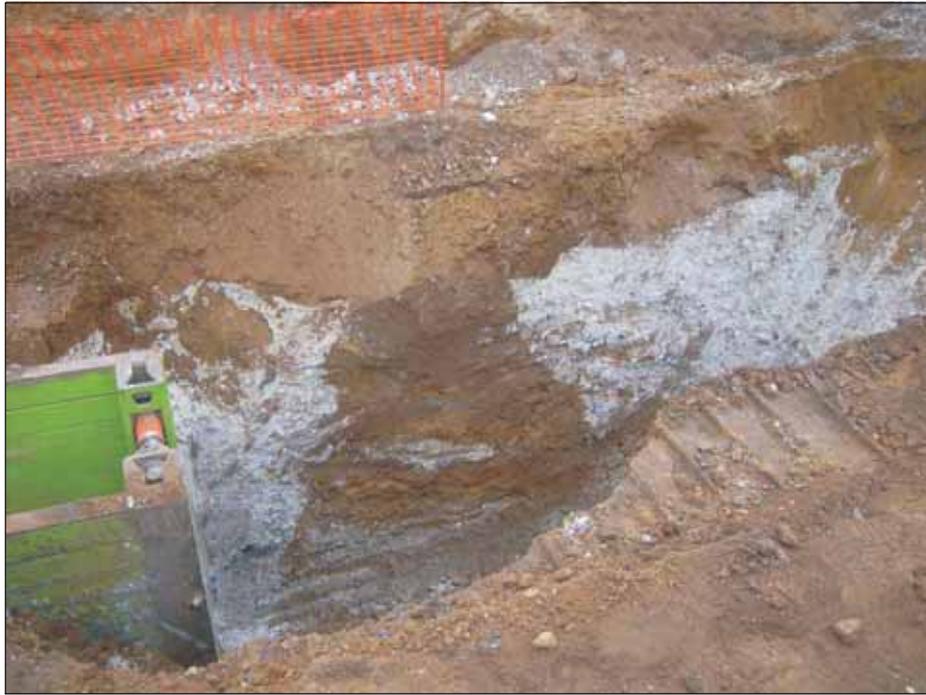
- 3.2.2 While most of the excavation was undertaken using a toothed bucket an area was reduced down to the top of the natural sand (**3103**) using a toothless ditching bucket. This exposed what was initially thought to be a sub-circular 'quarry pit' (**3105**). The same feature was identified in the 2007 evaluation as (**2209**). A sondage was excavated down to a depth of 0.6m into the south-eastern edge of this feature in order to understand and characterise it. The feature appeared to continue down to a depth of over 4m and the sides started to widen out, rather than tapering in (**Plate 1, Figure 3**). Further excavation identified sand and gravel banding within the lowest exposed portion of the feature. What had originally been interpreted as fills of a quarry pit in 2007, have now been identified as the upper fills of a swallow hole.

Plate 1: Swallow hole beneath quarry pit 3105 viewed from the west

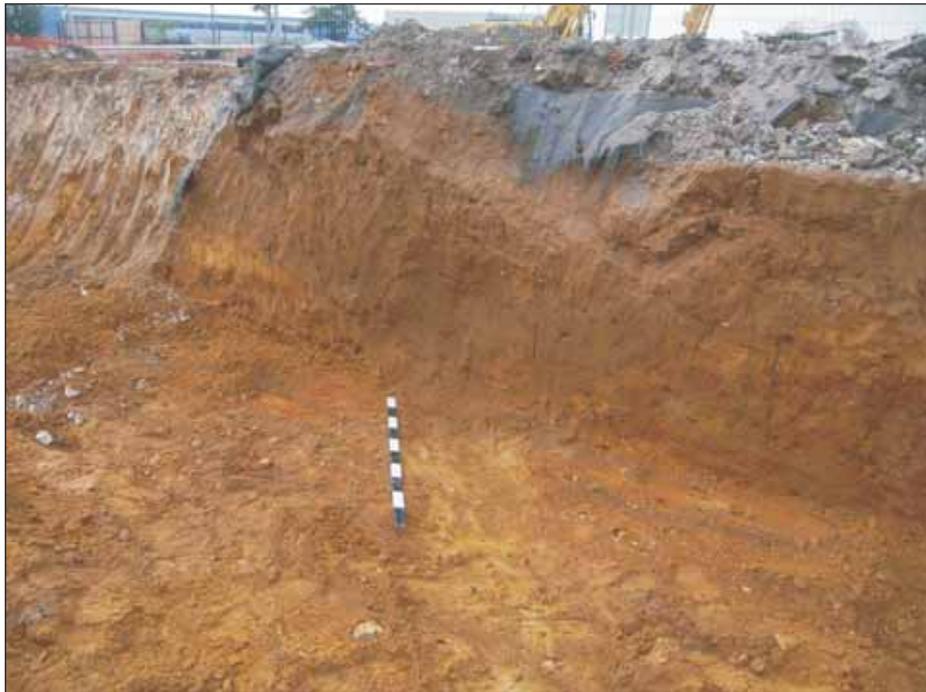
Plate 2: Section 3, boundary ditch 3309. (Scale positioned along the ditch alignment)
