## Great Maytham Hall Rolvenden, Kent

Landscape and Building Study

Prepared for  
**Sunley Group**  
20 Berkeley Square  
London  
W1J 5LH

Report reference: 67240.01

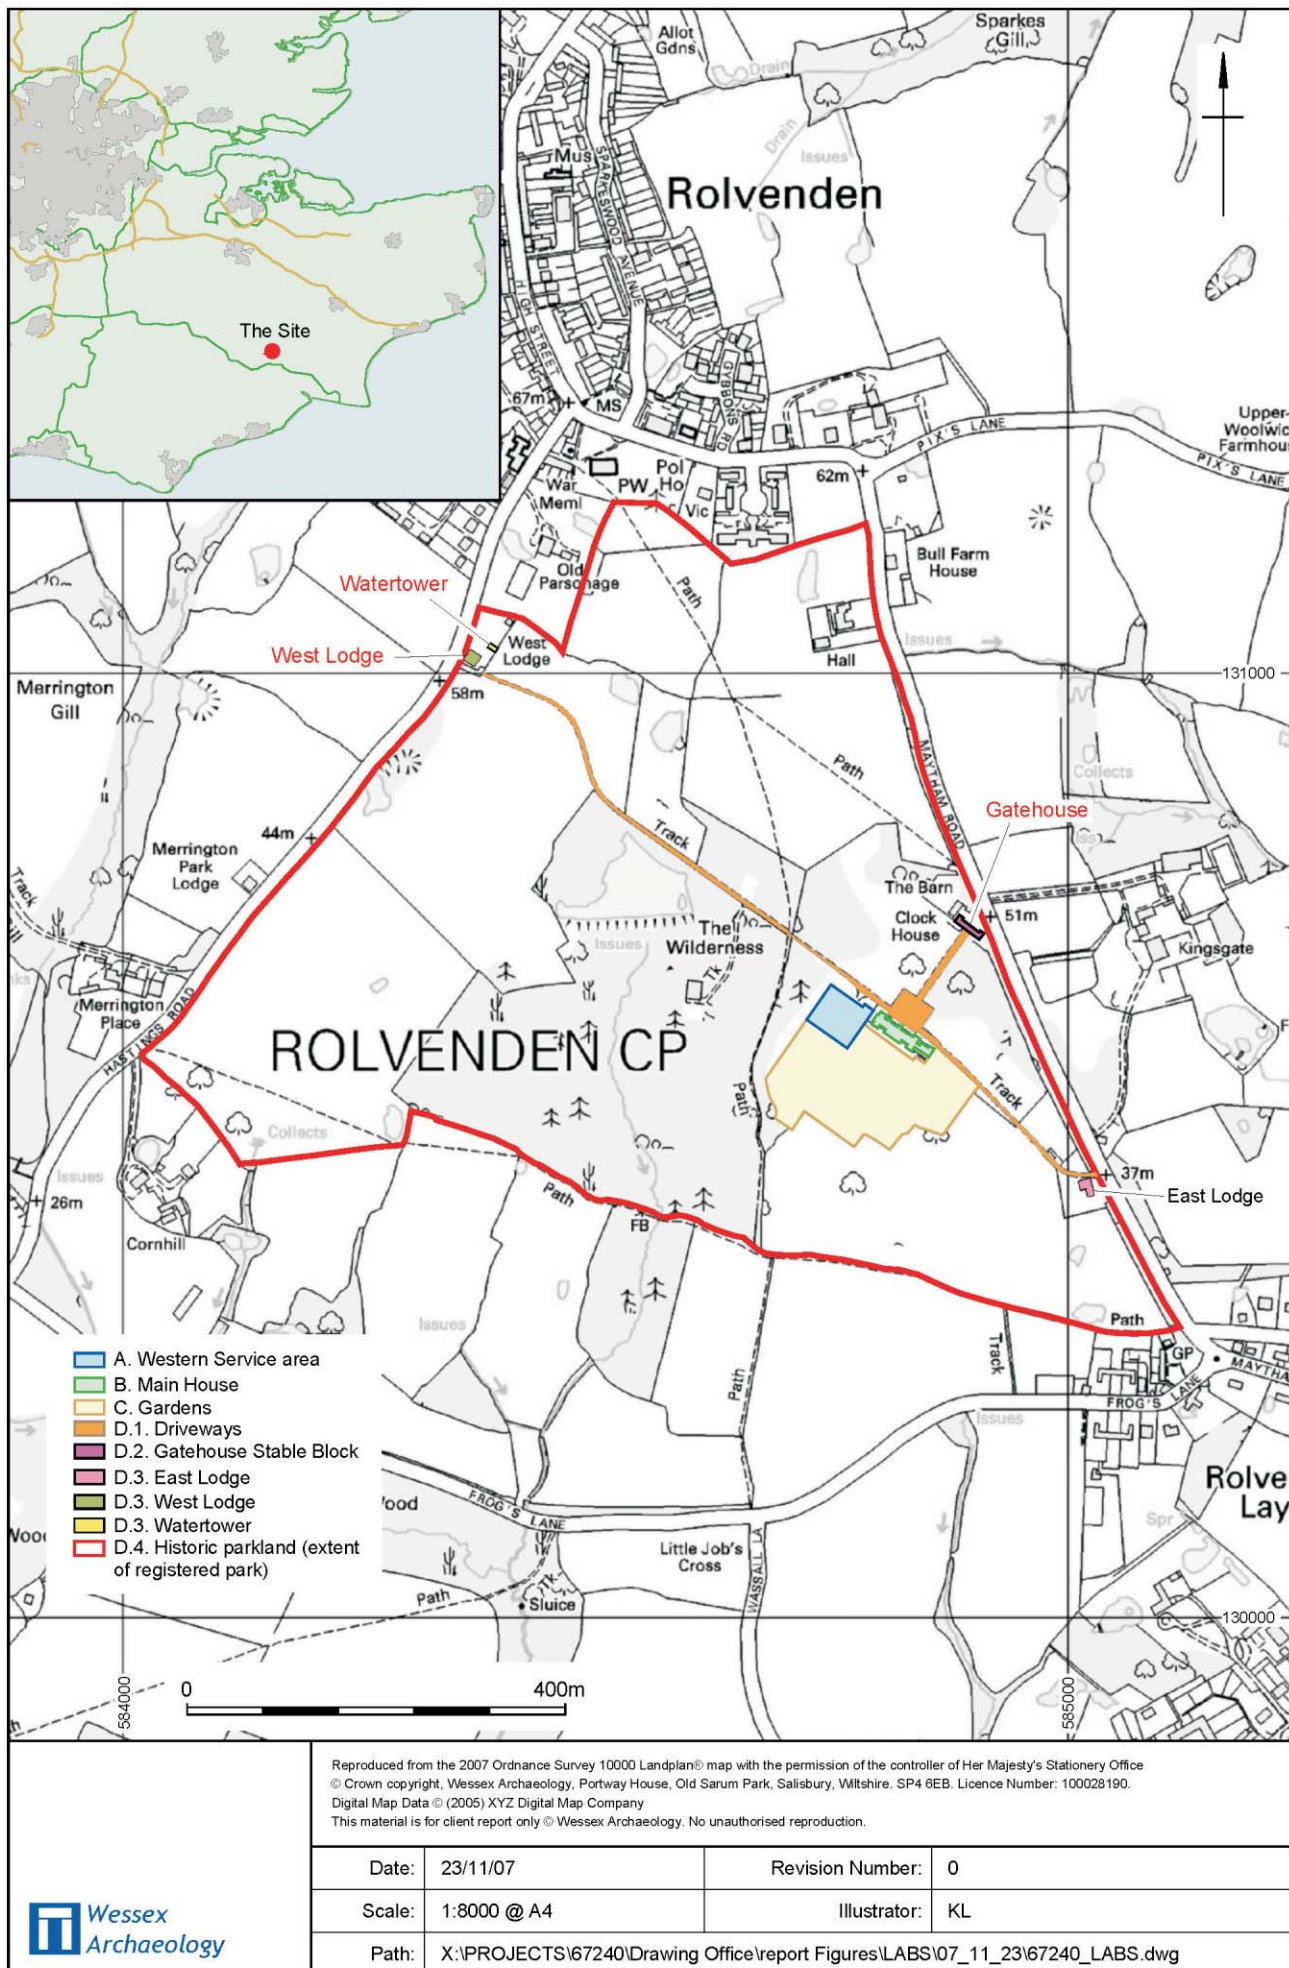
Figure 1

Site location and plan showing major components of the former estate

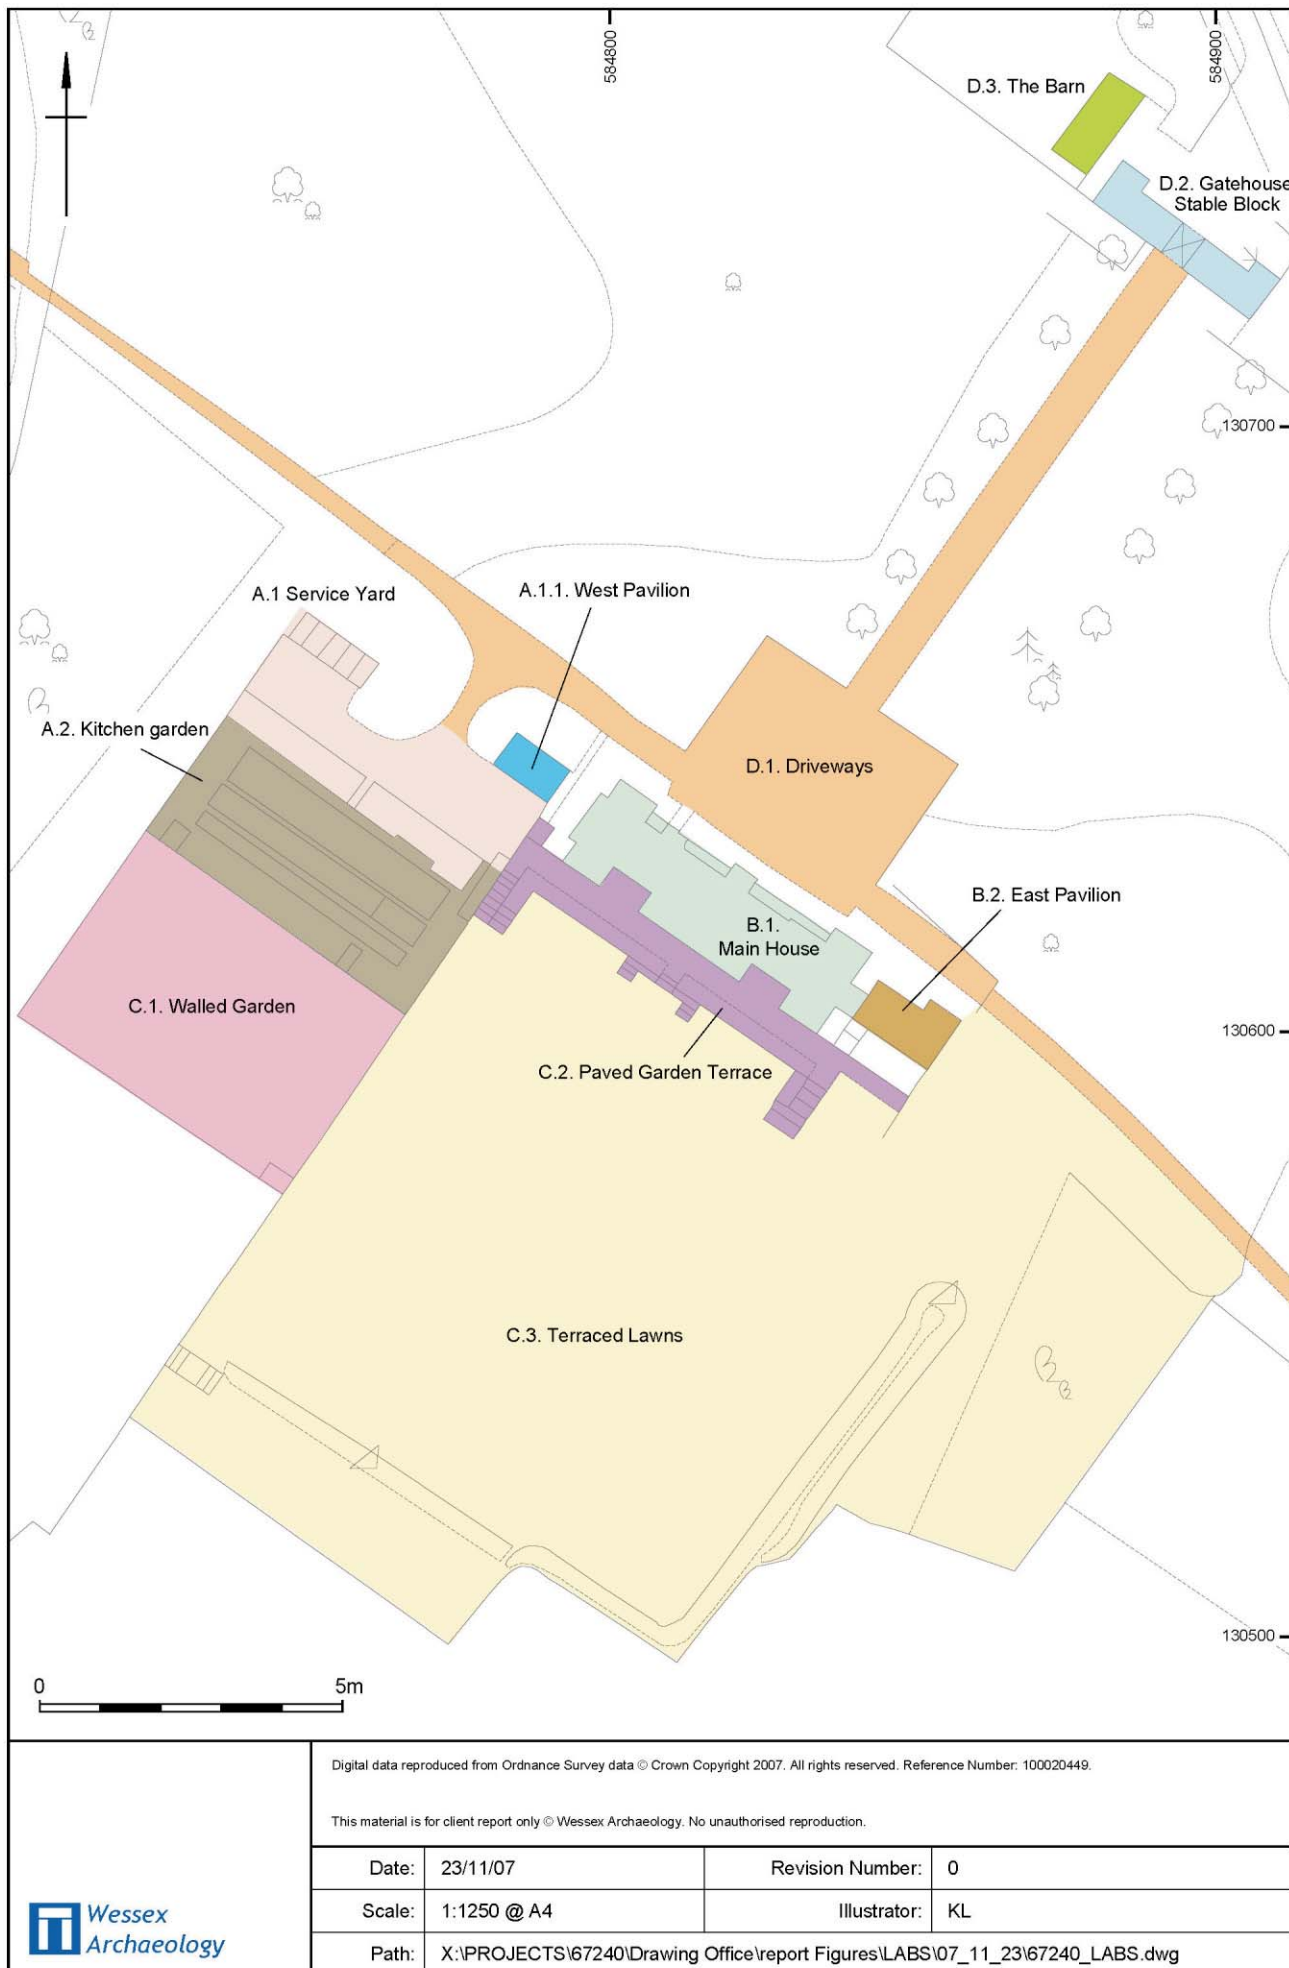
Figure 8

Current plan of the existing property identifying individual components

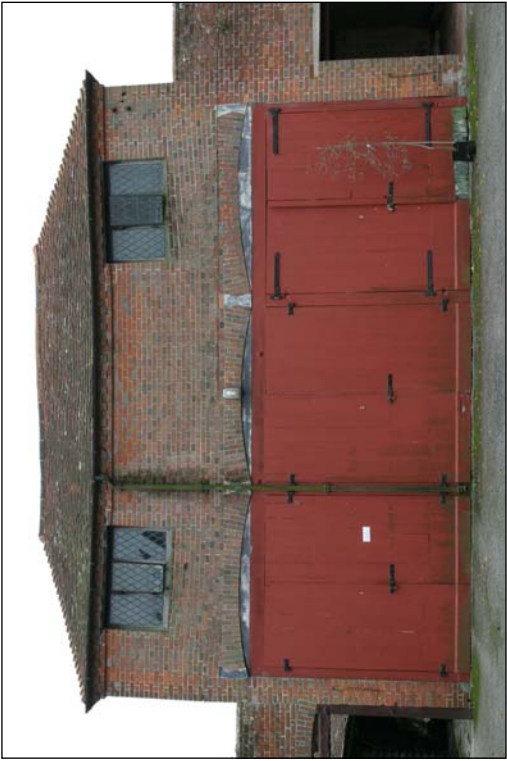
- 3.4.4 The front (north-east facing) elevation has three large pairs of double doors at ground level, indicating accommodation for three vehicles, and two tripartite windows under the eaves (A.1.2.p1). Further tripartite windows are found at ground (A.1.2.p4) and first floor levels in south-east elevation, and at first floor level only in the north-west elevation. The south-west elevation is blind (A.1.3.p2).

Plate A.1.2.p1: Front (north-east facing) elevation of East Coach House.

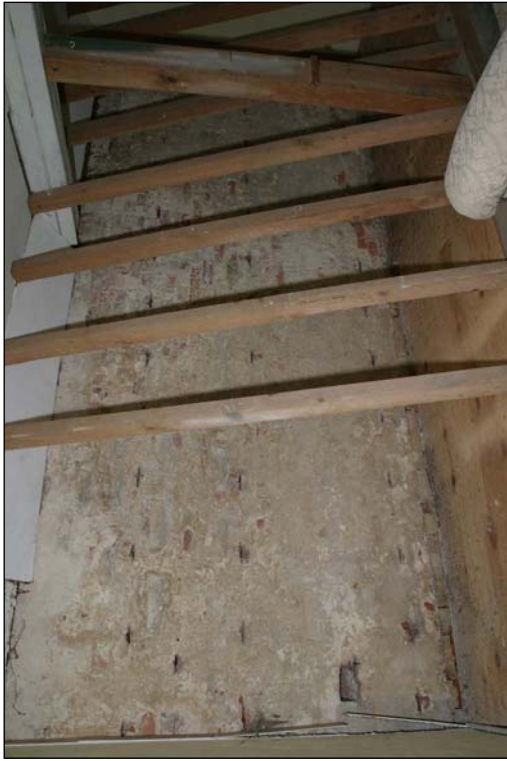
- 3.4.10 However, the integrity of the building is currently threatened by the parlous condition of parts of its structure. The first floor brickwork of the north-east elevation is sagging badly, and a number of remedial measures have been taken to provide additional and temporary support to the structure. Steelwork has been introduced to the ground floor to provide additional support to the beams supporting the first floor (A.1.2.p3). At first floor level, downstand beams supporting the ceiling joists have been propped, and sections of ceiling have also been propped with raking struts (A.1.2.p7).

Plate A.1.2.p7: Internal propping in east room at first floor.

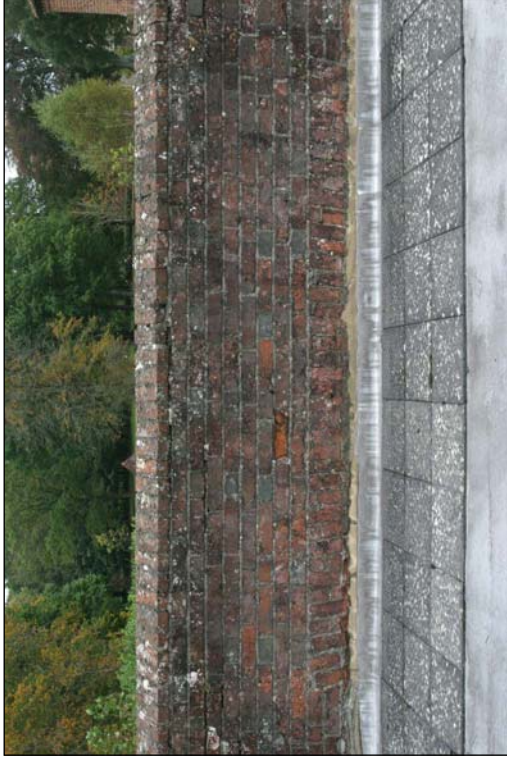
Plate A.1.3.p3: Flat brick arch of former opening in parapet above garages, looking north-east.

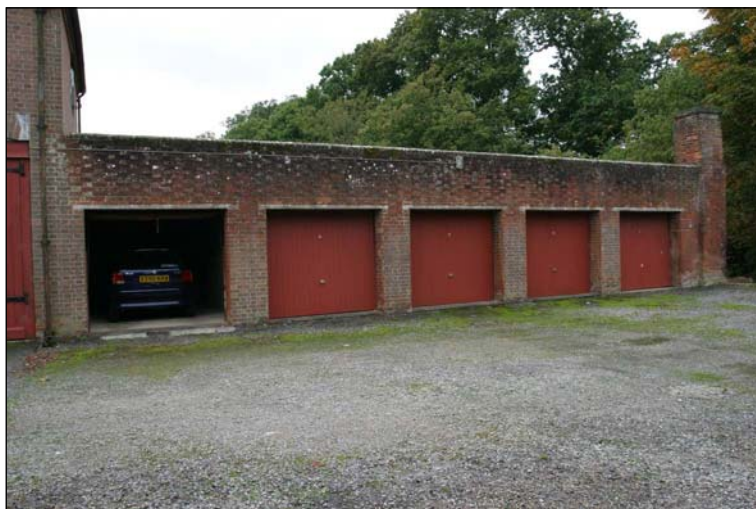
- 3.7.4 As noted, the two long walls of this garage range are not contemporary. The front wall is of smooth, deep red brick (A.1.5.p1), while the rear, south-west wall, and west end walls are of common Flettons, rendered above plinth level. The garage openings have been created by cutting through the wall with an angle grinder, and the insertion of thin concrete lintels. Rather curiously, the cut faces of brickwork have then been rendered with a dark red, coarse sandy mortar, upon which faux mortar joints have been applied (A.1.5.p3). It is assumed that this took place during the 1960's when the building was converted to apartments, in order to provide garage parking for the residents.
- 3.7.5 At the north-western end of the front wall of the garages, there is a chimney which appears to be of contemporary construction (see A.1.8 below).

Plate A.1.5.p1: Front elevation of south garages, looking west.

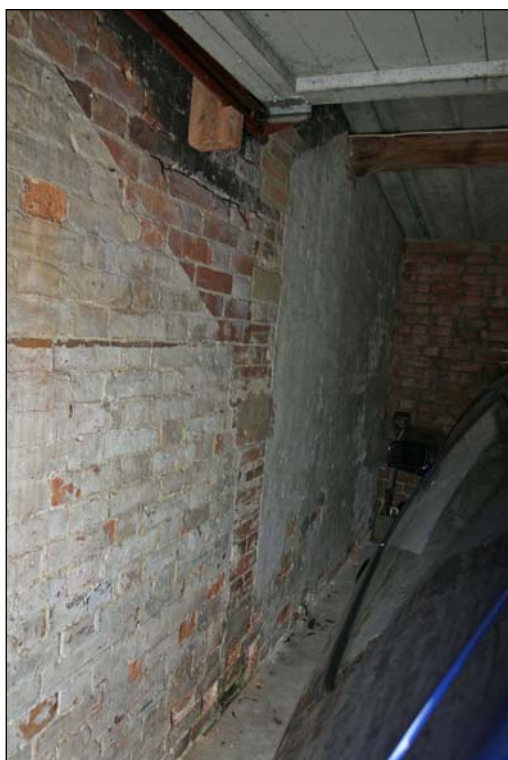
- 3.7.1 This range of garages obviously post-dates the construction of the west coach house [A.1.5], and replaces the earlier lean-to structures whose painted ghosts survive on its north-west flank wall (A.1.5.p2). However, the front and rear walls of the garage range are not contemporary, and the creation of the garage openings along the north-east side, suggest that this was, at one time, a continuous boundary wall.

- 3.7.3 Paint finishes applied to the north-west side wall of the West Coach house, indicate that some form of lean-to structures abutted the inner (south-west facing) face of the boundary wall, which were later replaced by the row of garages which survive today.

Plate A.1.5.p2: Paint 'shadows' of former lean-to buildings.

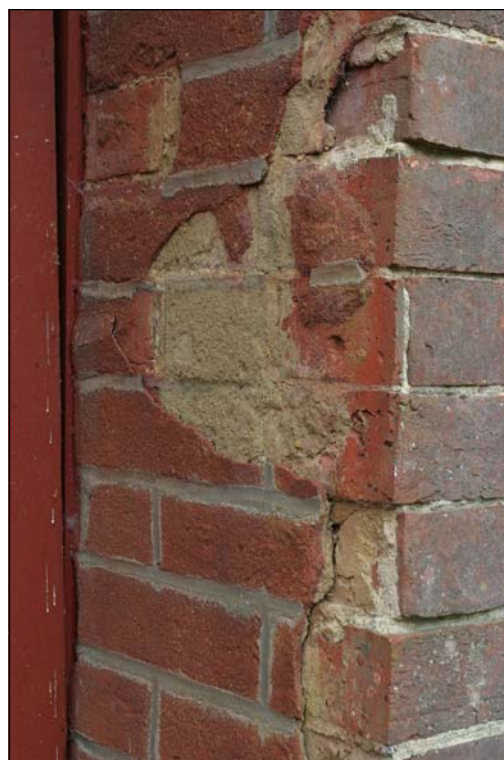
Plate A.1.5.p3: Detail of repair following creation of garage openings.

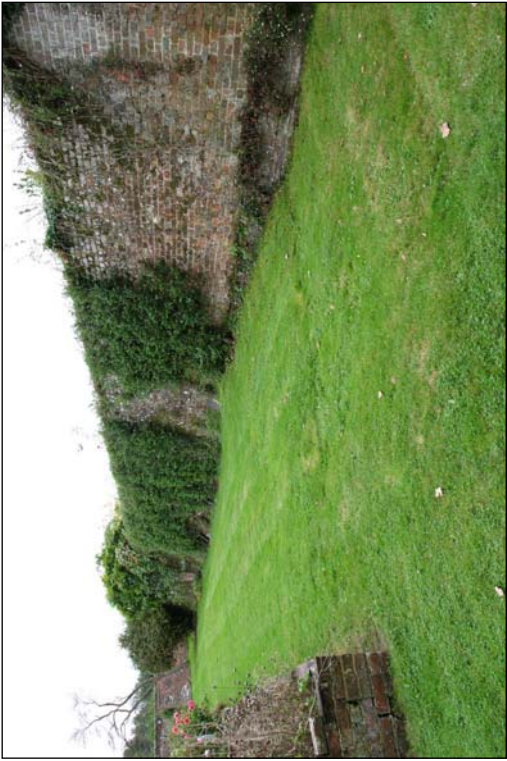
Plate A.2.1.p2: View along south-western wall of Kitchen Garden showing footprint of former structure in the foreground. Looking south-east.

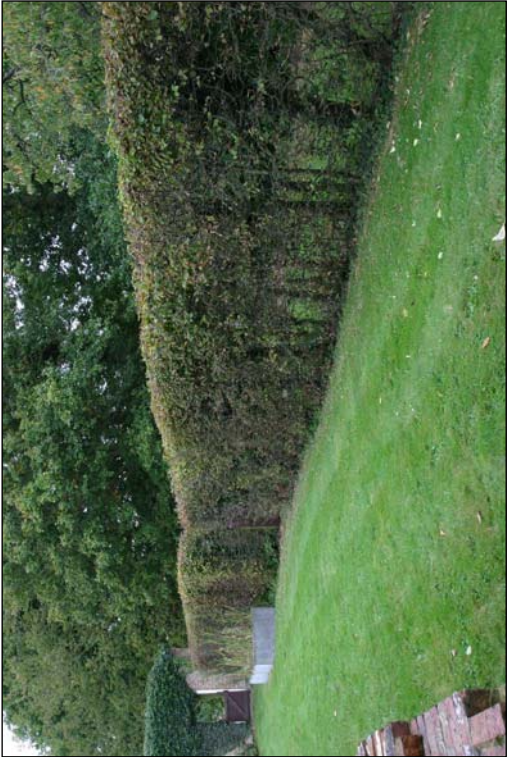
Plate A.2.1.p3: View along hedge which defines the north-western boundary of the Kitchen Garden. Looking south-west.

- 3.12.2 The hornbeam hedge which forms the western boundary of the area (A.2.1.p3) reflects the historic extent of this area, though this has been planted since the demolition of the furnace house (see [A.2] above). No physical evidence for a pre-dating wall along this alignment was noted at the time of the site inspection. The 1842 Tithe Map (Fig. 3) shows the western extent of this area to be beyond the western side of the walled garden (that is, west of its present location), although this line may represent the edge of the adjacent woodland rather than an artificial boundary. By the time of the 1872 OS edition (Fig. 4) the existing western boundary is in place with small structures (possibly pig sties) built up against the south-western section of the boundary. In 1898 (Fig. 5), this boundary is shown extending northwards to form the western boundary of the service yard, this alignment within the kitchen garden is retained to the present day.

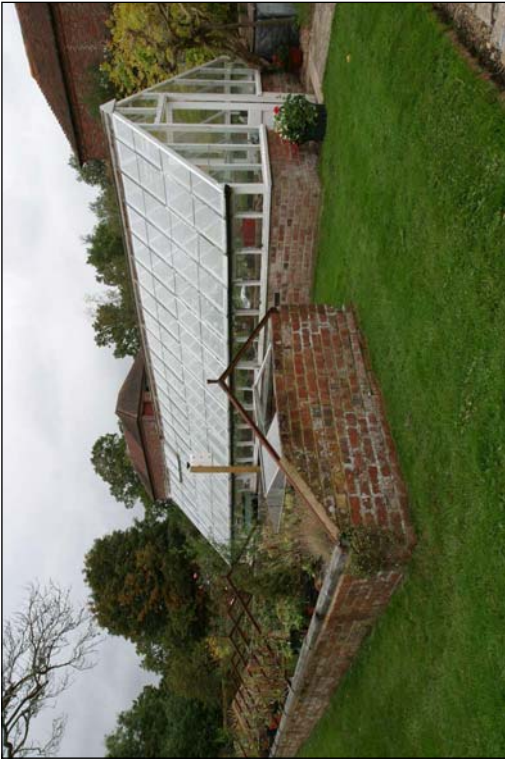
- 3.13.17 The surviving green house at Maytham, and the remains of the extensive cold frame running parallel to it on the south-west side appear to have been part of Lutyens comprehensive development of the estate, and are therefore of some historic significance.

Plate A.2.2.p1: View of extant glasshouses with Kitchen Garden. Looking north.

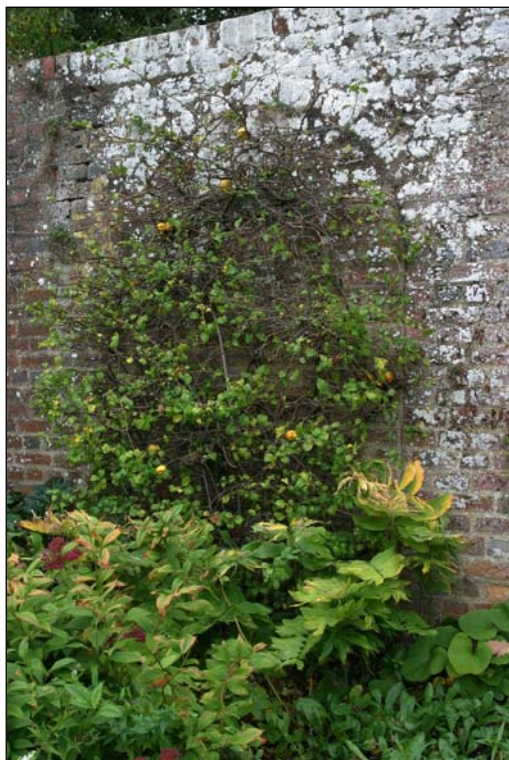
Plate C.1.1.p2: View of blocked up opening in north-west wall of Walled Garden. Looking north-west from interior of garden.

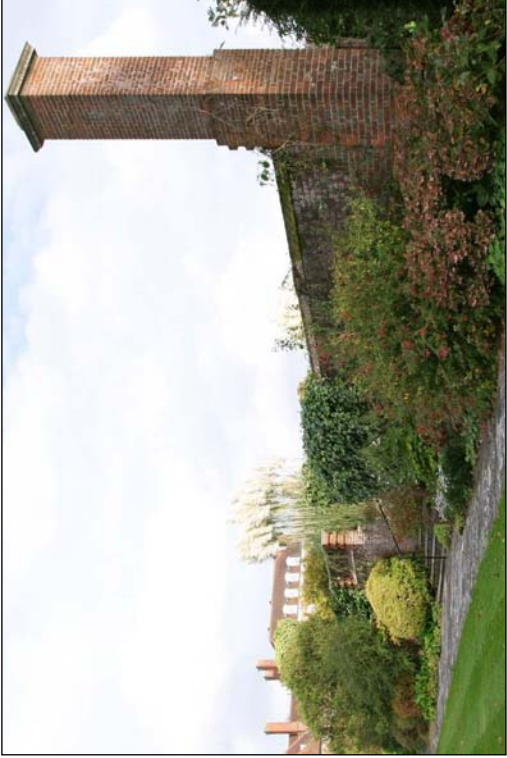
Plate C.4.p2: Detail of south-eastern wall of Lower Garden showing Lutyens design. Looking north-east.
