41 Manor Road, Fishponds, Bristol

Archaeological Watching Brief Report

Ref: 68270.03

February 2008

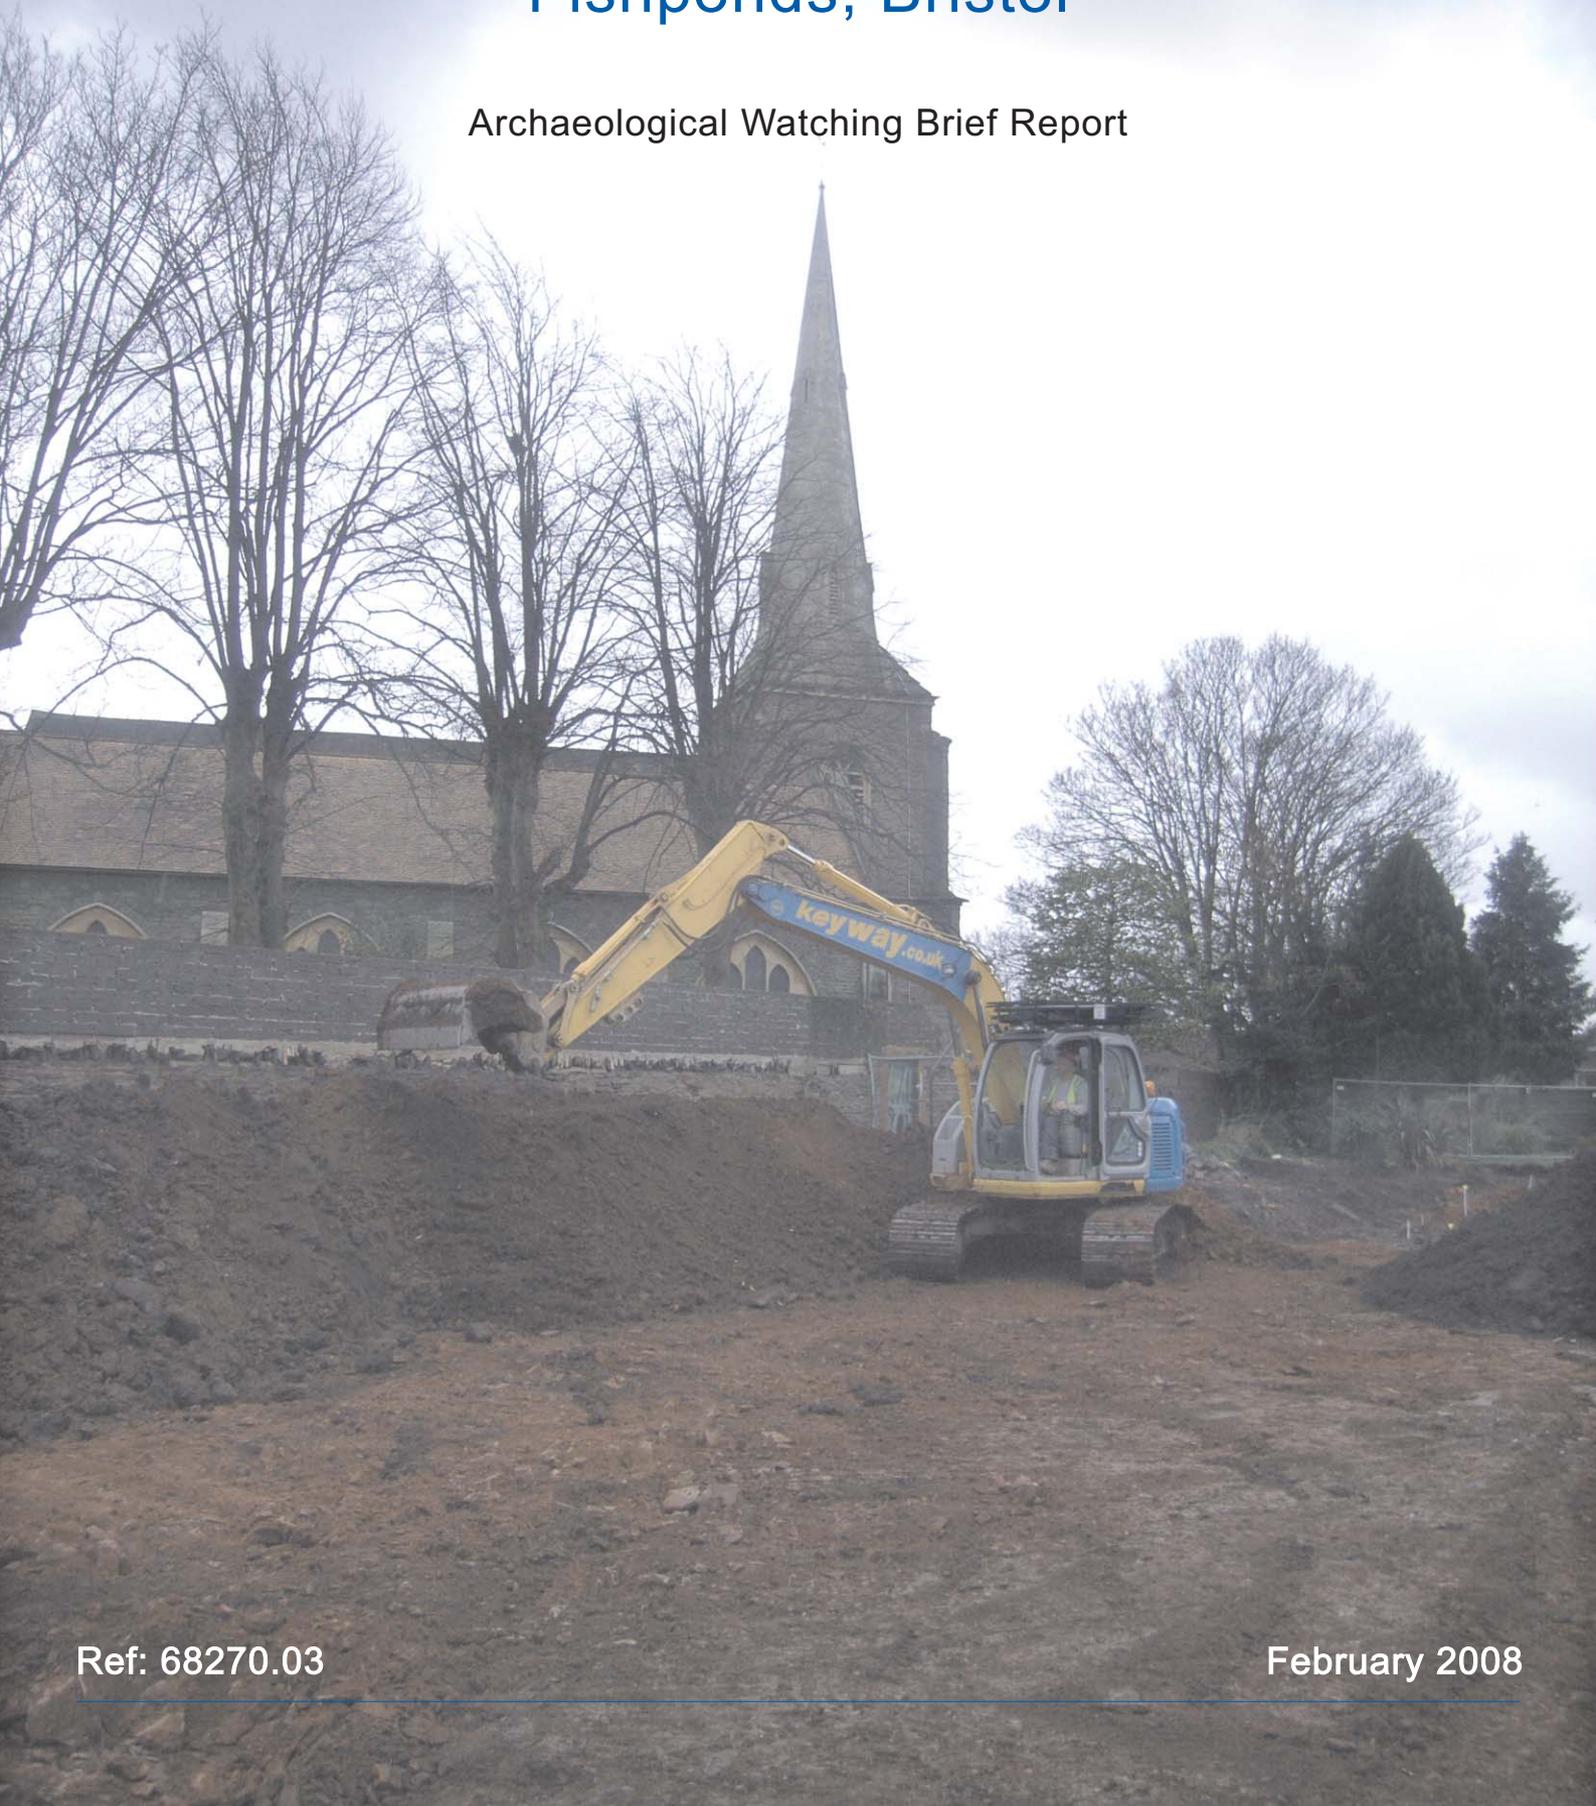
Front cover – Machine stripping in the North-east corner of the site with St. Mary’s Church in the background. View from the north.

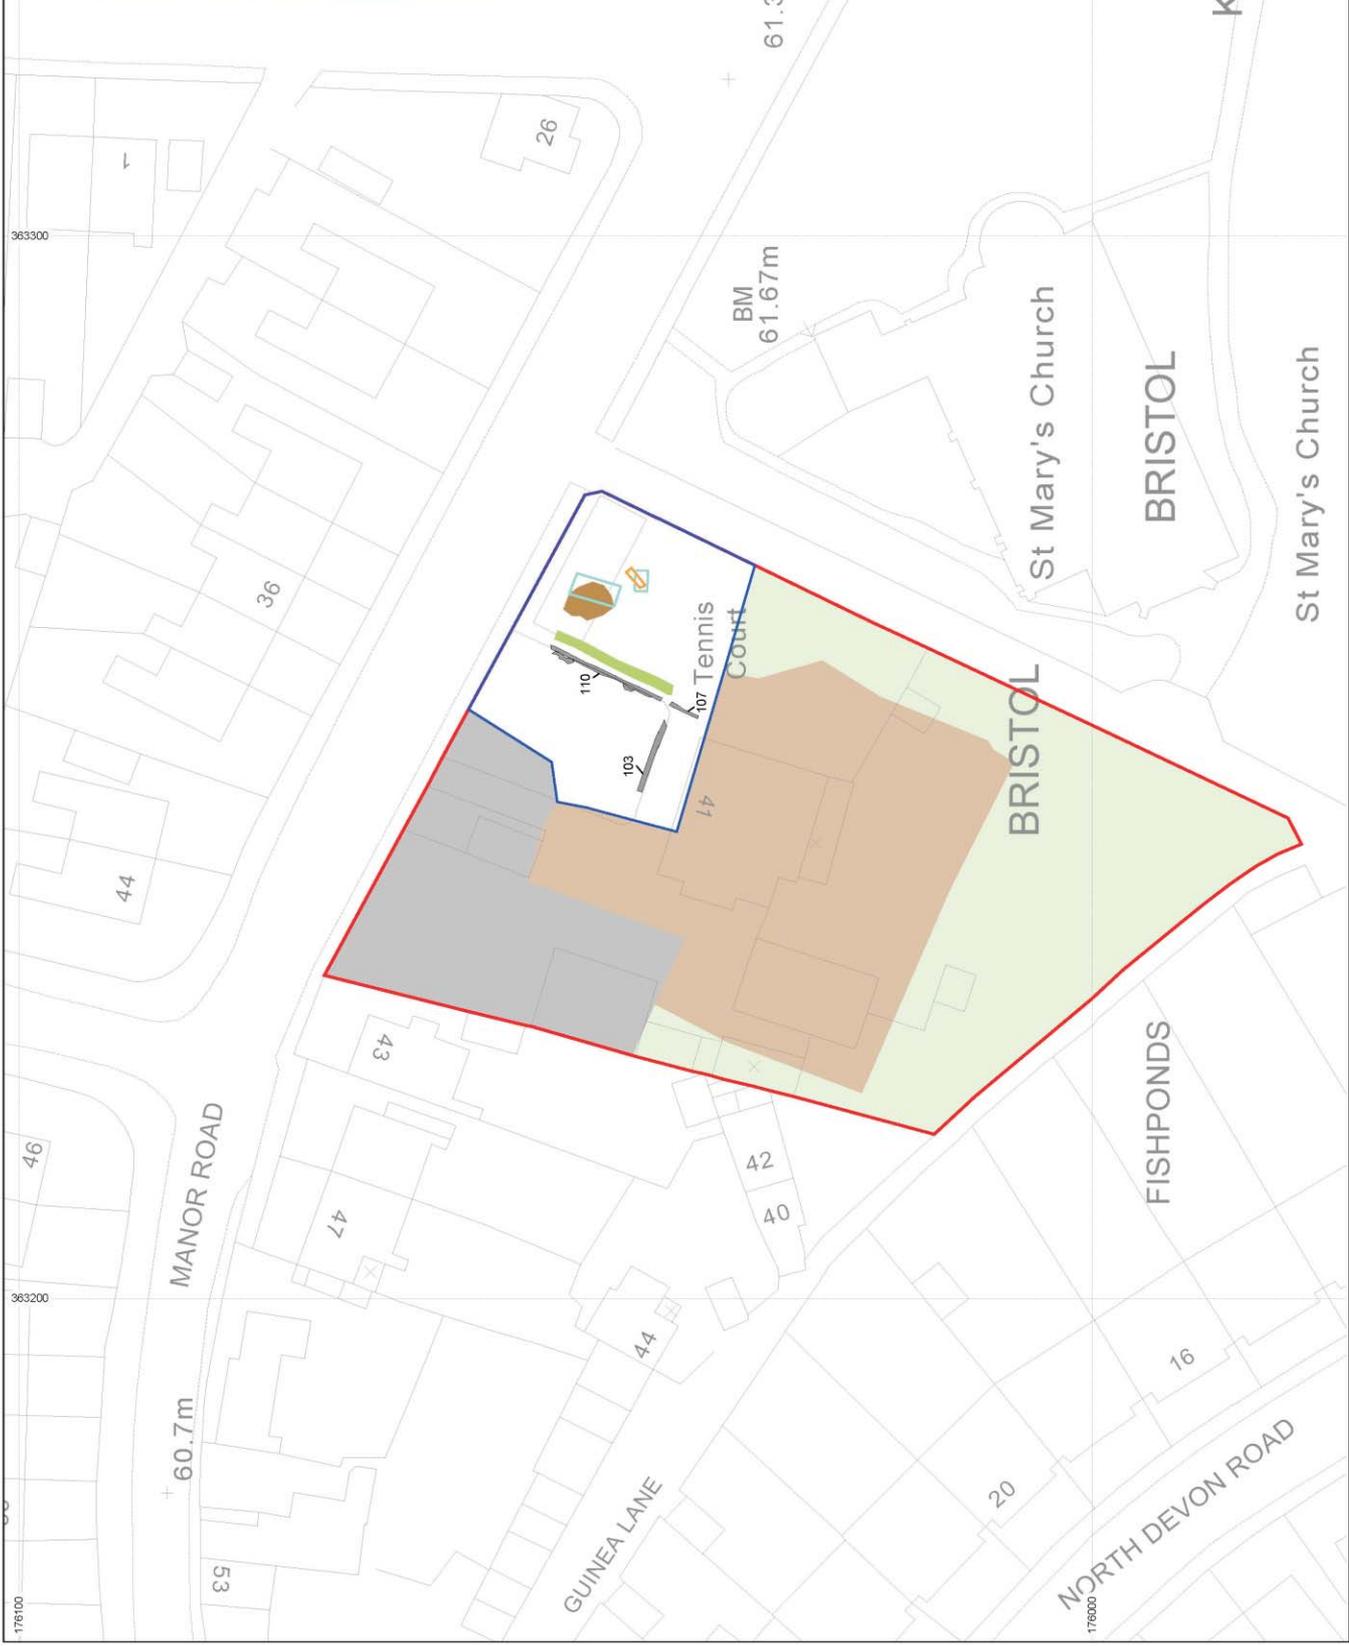
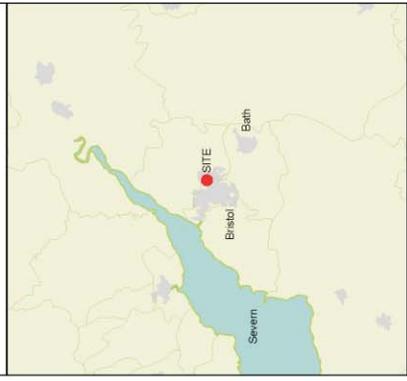
Figure 1 – Site, area and feature location plans.

Site location and plan

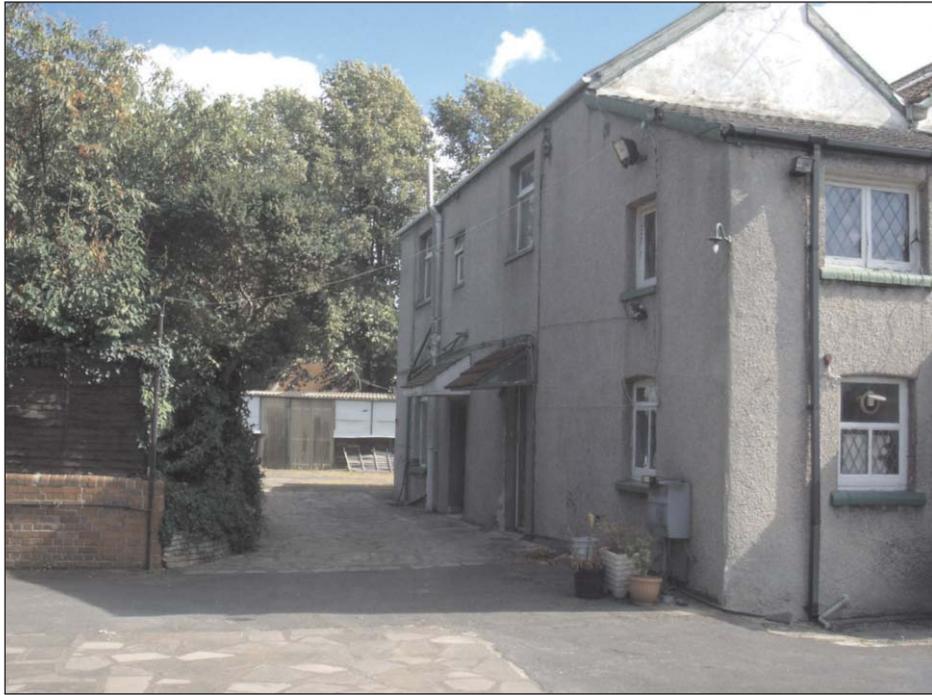
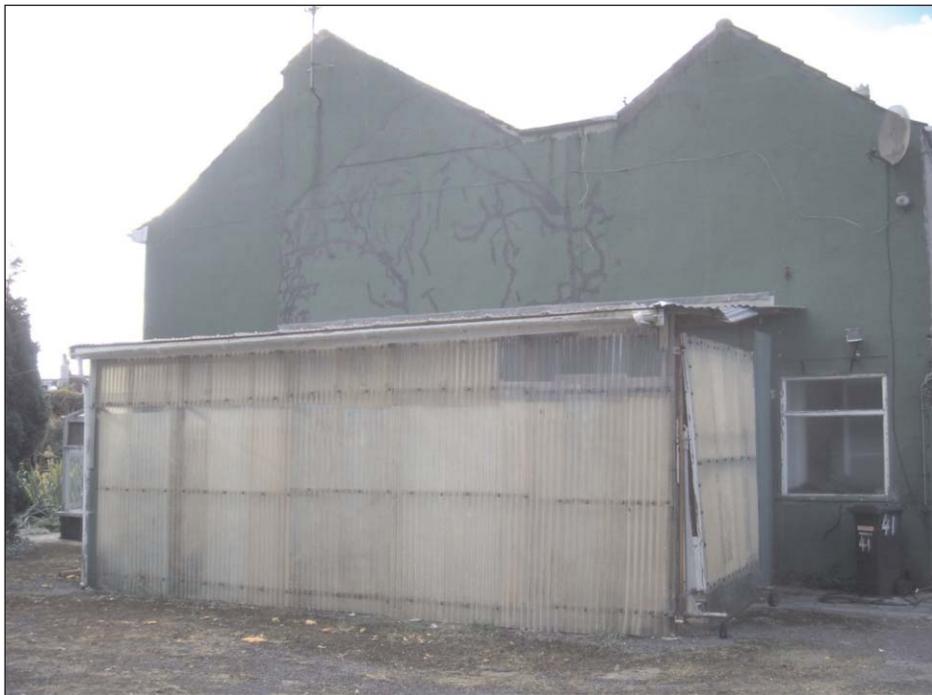
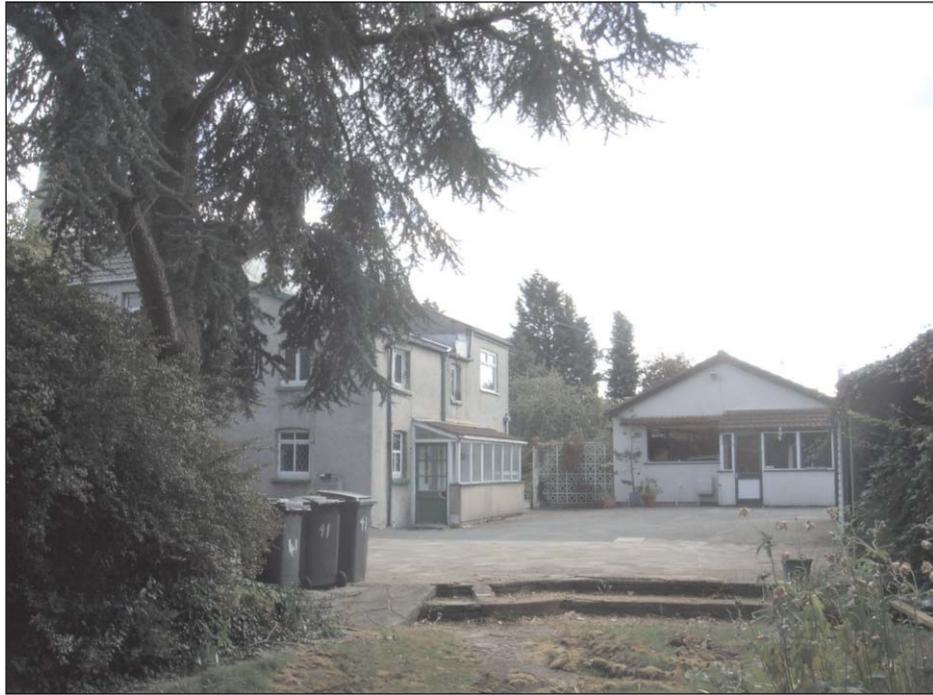
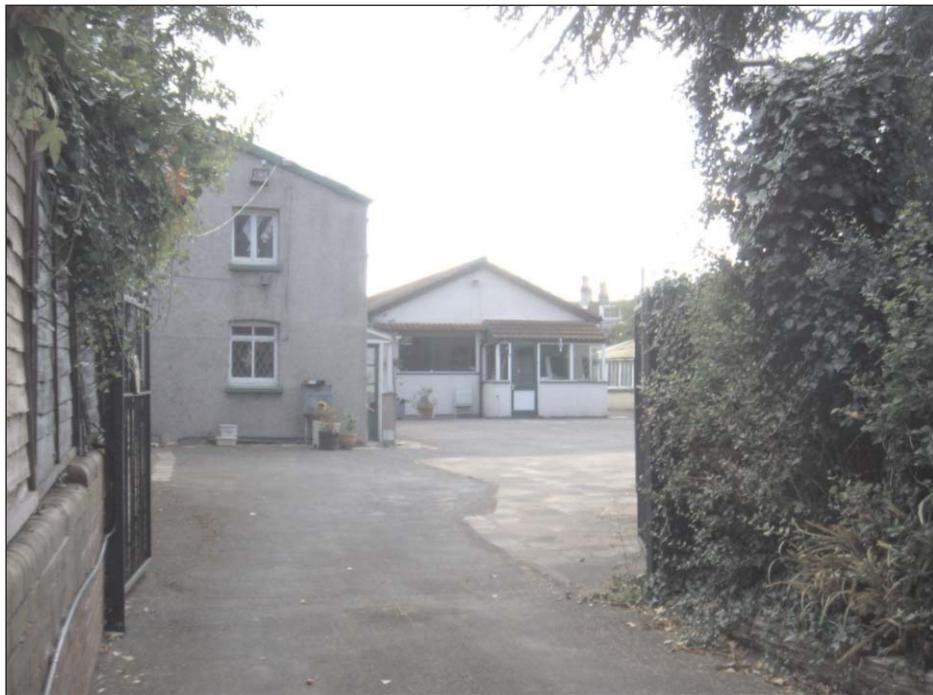
Plates 1 to 4 - General Photographic shots of the 18th/19th century house prior to its demolition. Photographed and images supplied by Churchill Retirement Living Ltd

- 6.1.11 Photographs of the house prior to its demolition, taken by Churchill Retirement Living Ltd., show that the building had been rendered, obscuring the original brickwork and making it impossible to know if the original house walls were constructed from the same materials. The building as seen in the photographs, had clearly undergone a series of extensions and adaptations before falling out of use over a decade ago (**Plates 1 - 4**).

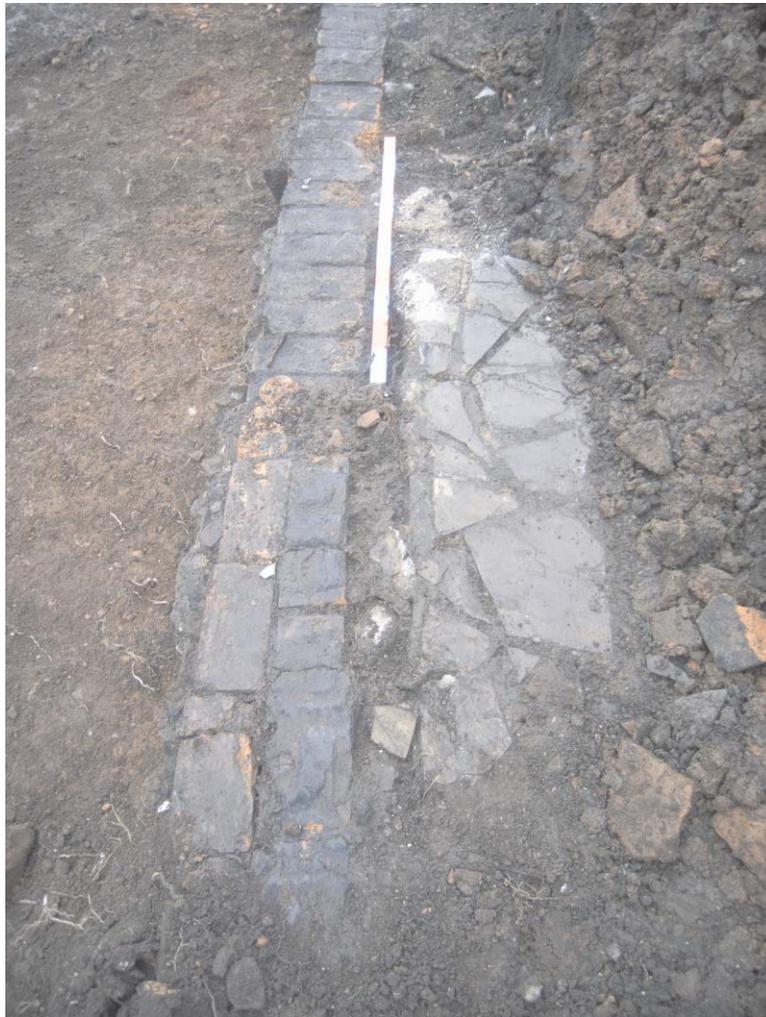
Back cover – Remains of north-south orientated wall foundation and paving slabs identified during the watching brief and interpreted as being part of the 18th/19th century garden design.

- 6.1.12 A second wall made from the same unfrogged bricks as **107** was found in the north-east of the site and, being close in proximity, identical in orientation and similar in construction, it is likely that this once joined wall **107 (back cover)**. Wall **110/111** was situated c. 1m to the north of **107**.

- 6.1.13 To the west of **110/111** sandstone paving slabs were identified and to the east the remains of a hedgeline which runs parallel to these foundations was excavated. It is thought that **110/111** originally extended from the north-eastern corner of the late eighteenth/early nineteenth century house and existed as a garden feature with hedge planting behind it and slabs leading to the property entrance and Manor Road in front of it.

- 6.1.14 This wall was demolished at some time during the use of the late eighteenth/early nineteenth century house as it is not present in photos of the property and it is
