Salisbury Cathedral Wiltshire

Archaeological Evaluation and Assessment of Results

Report reference: 68741.01

February 2009

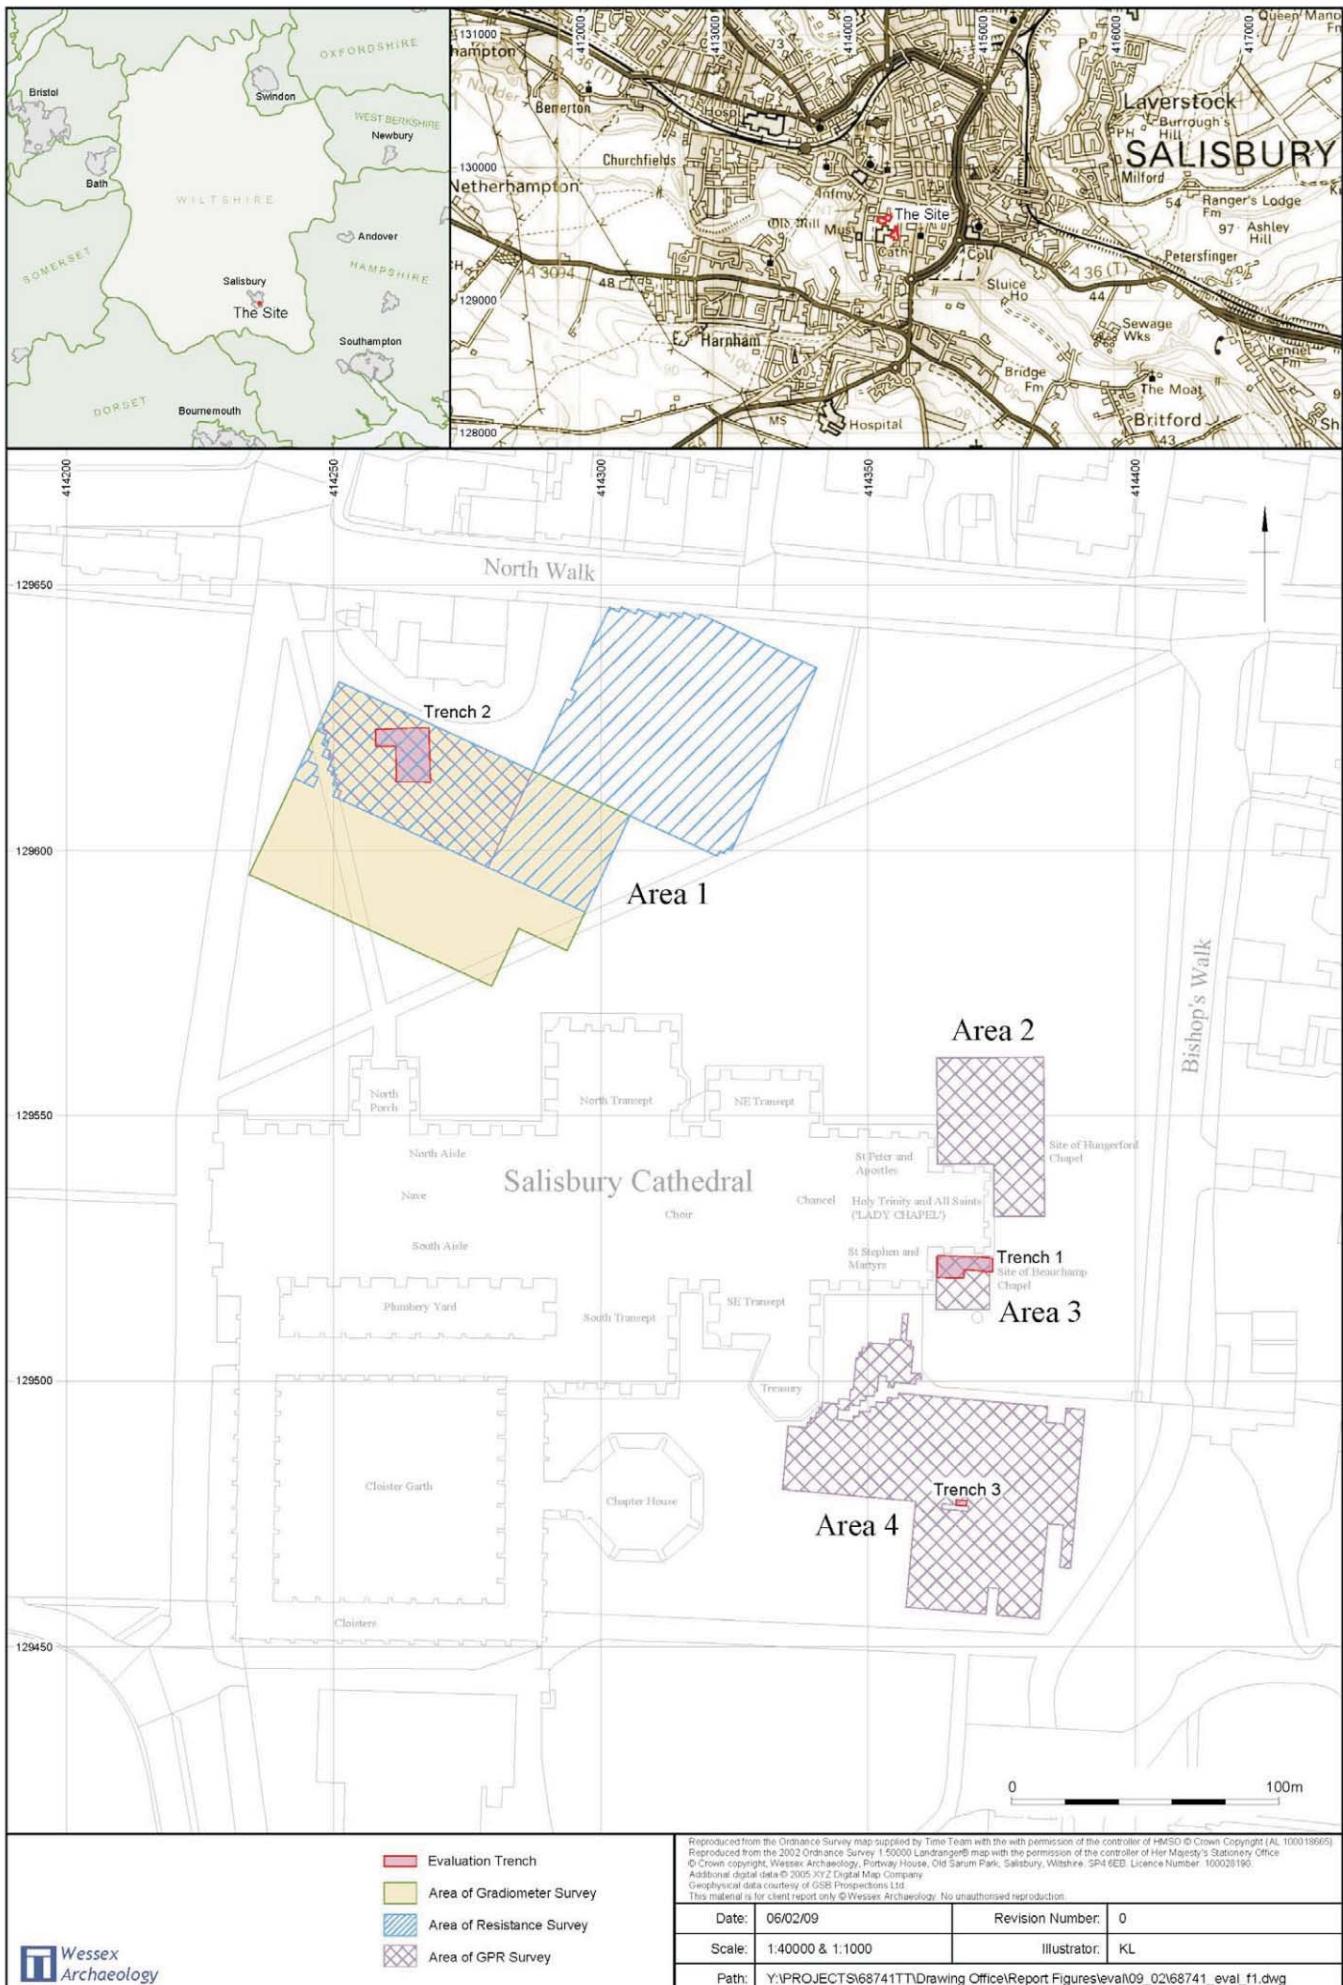
Figure 1

Site, trench location and geophysical survey area

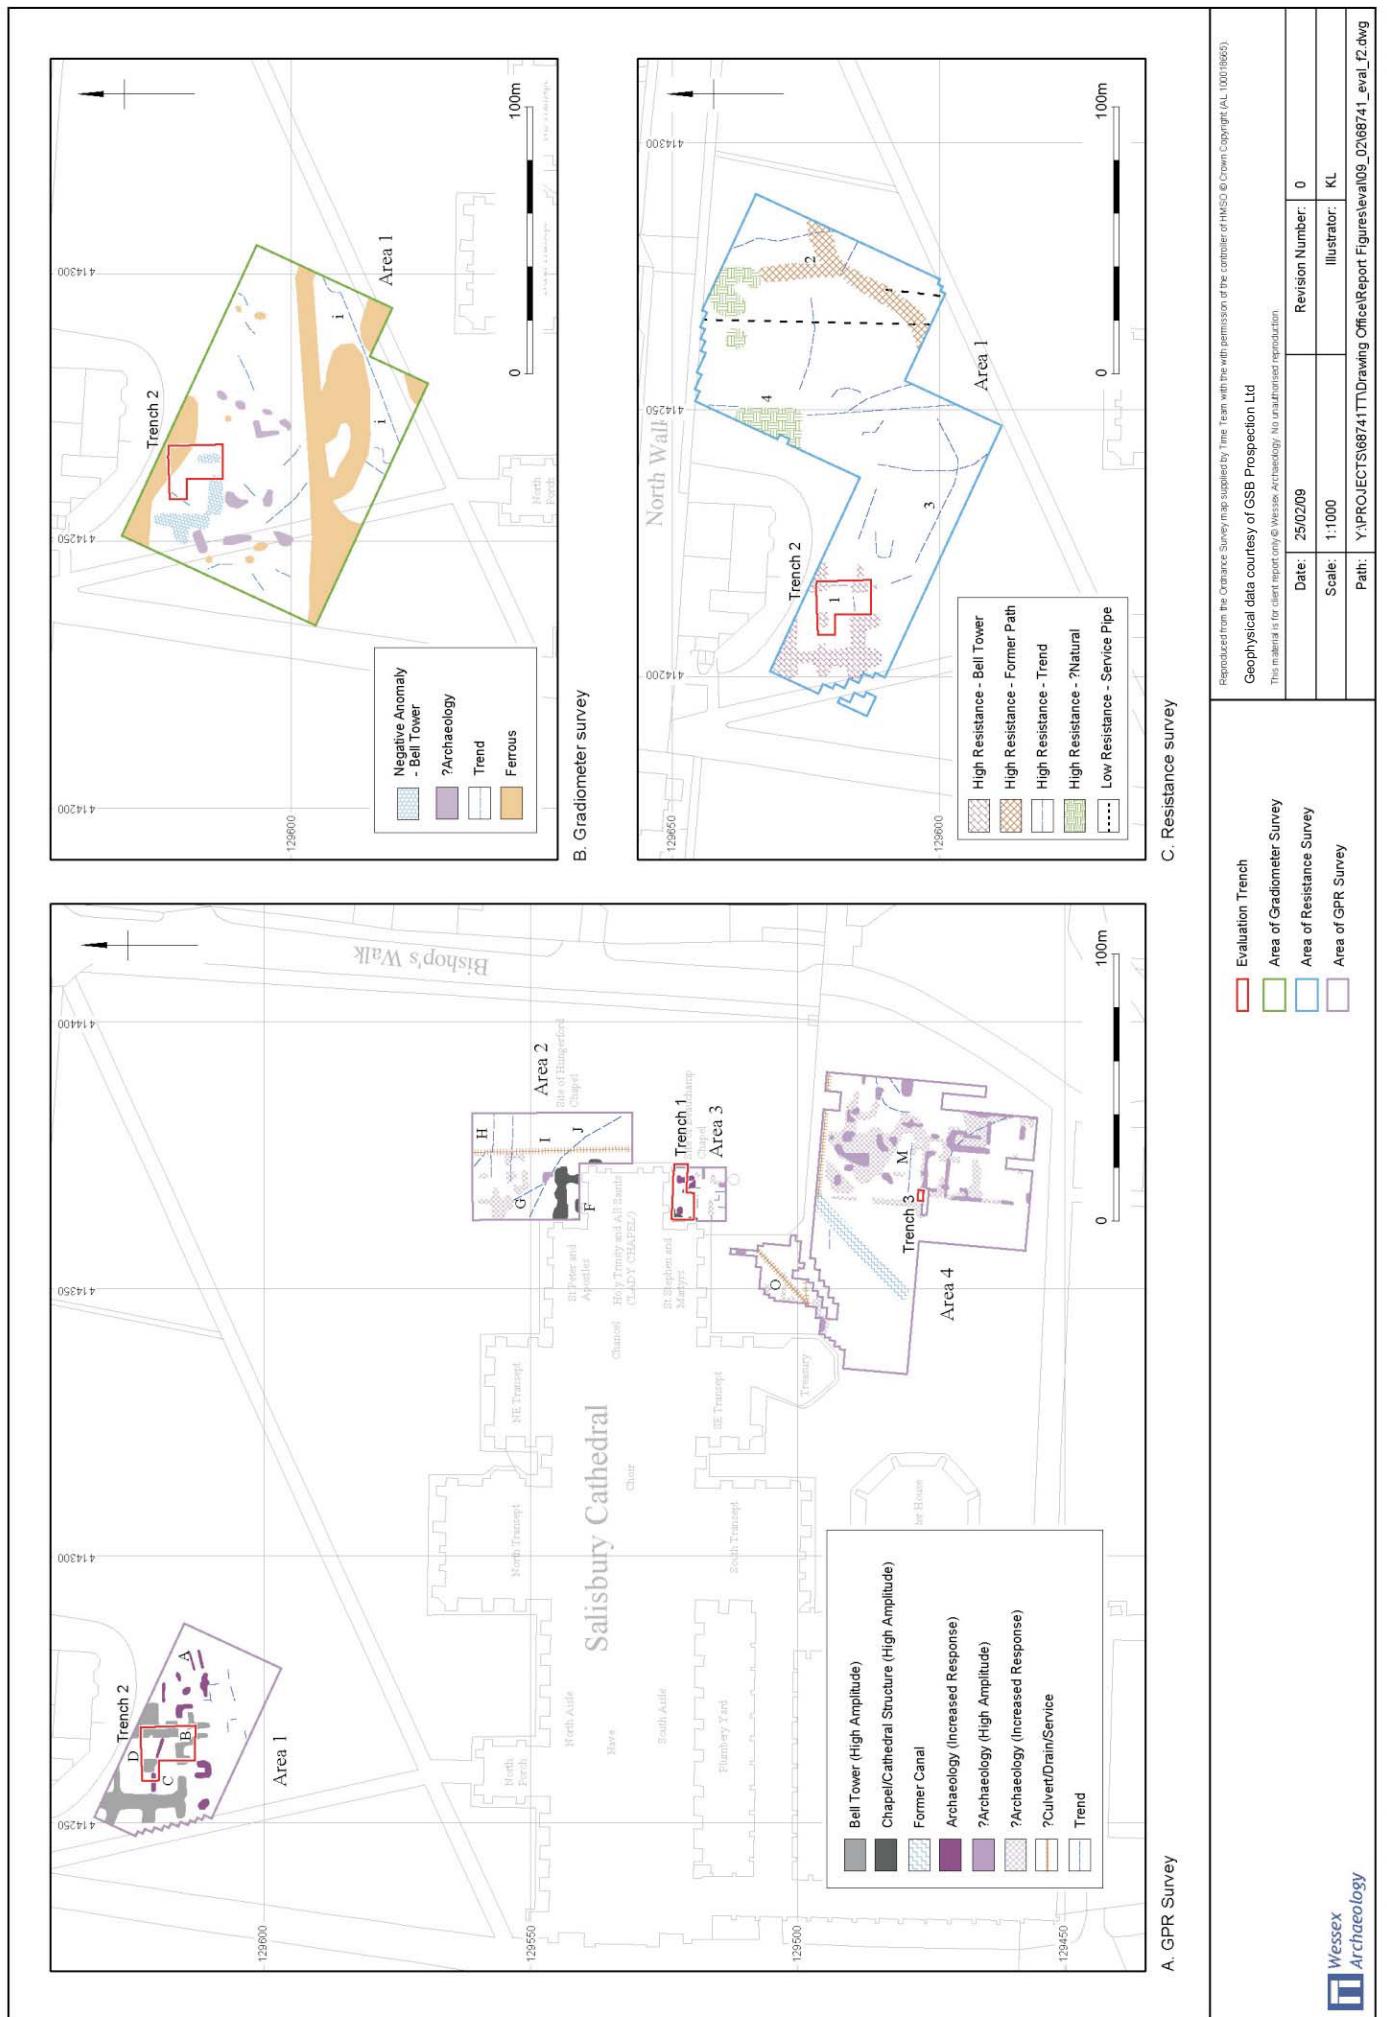
Figure 2

Interpretation of geophysical survey data

- 4.2.4 A reasonable level of detail has been recorded over the Bell Tower and it can be seen that the shallowest (or most robbed-out) foundations are to be found on the south-east corner, whilst the deepest are those in the south-west. The south-east buttress also has a well defined 'quiet zone' (B) at its core; the definition of this 'space' is very sharp and coincides with the remains of an internal stairwell. A wall-line (C) has also been identified which runs through the central pier (D) although, from the GPR data alone, it is not clear whether this is contemporary with the tower; in fact excavation revealed this to be part of an earlier structure.

- 4.2.15 The magnetic survey confirmed the results of the GPR survey for the foundations of the Bell Tower and data correspond to some of the GPR anomalies. Potential further archaeological anomalies have been identified but as the magnetic background levels are quite noisy, the dataset is difficult to interpret. They could, however, be associated with the buildings surrounding the Bell Tower.
- 4.2.16 A former path as marked on a plan of the church and churchyard from 1786 was identified and a band of ferrous response crossing the data is a service pipe, whilst similar responses in the north and south relate to a metal fence and Heras fencing, respectively.

- 4.2.17 Foundations of the Bell Tower and central pillar were clearly visible within the data as high resistance readings (1). The buttresses are well defined, and as with the GPR data, the south-east corner walls appear to be ‘robbed out’.

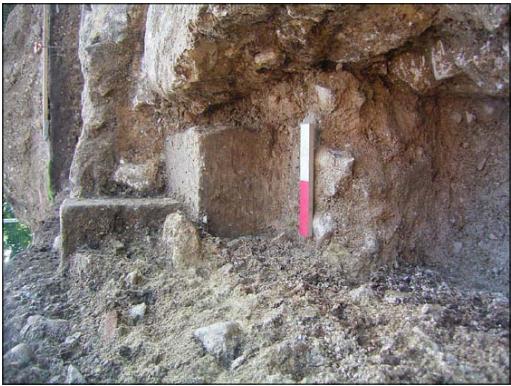
Plate 4: West-facing elevation buttress 116 in 148

- 4.3.5 Chalk raft (126) was cut through by (143) and (148). The foundation trenches for buttresses (115) and (116) respectively, on the southern wall of the Trinity Chapel. Foundation trench (148) also apparently cut grave (151). The buttresses were constructed in dressed Chilmark/Tisbury stone on flint and compact lime mortar foundations, with the void between the edge of the foundation trench and the buttresses themselves backfilled with loose chalk rubble derived from (126). Foundation trench (148) was backfilled by a series of deposits (149), (154), (155) and (156) against buttress (116) (**Figure 3, section & Plate 4**).

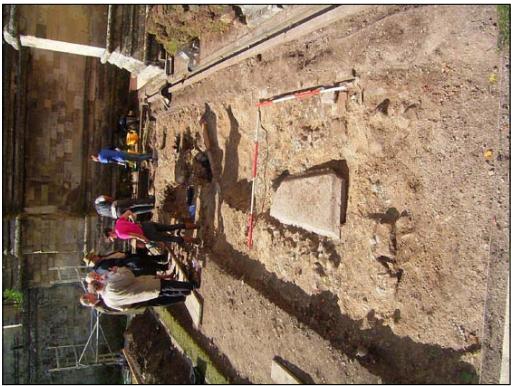
Plate 3: Trench 1 from the east

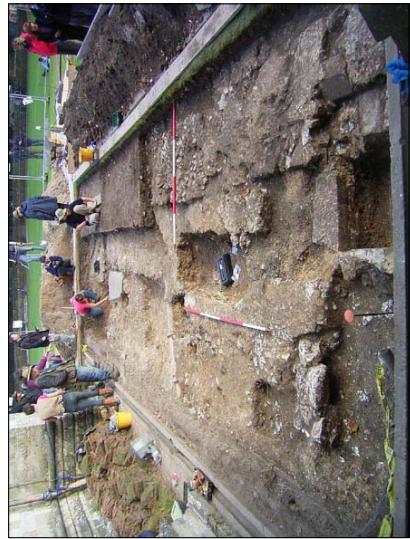
Plate 2: Trench 1 from the west

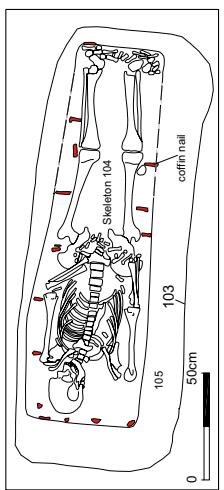
A photograph of two human skeletons lying side-by-side in a stone-lined grave. The skeletons are oriented with their heads towards the bottom left. A red and white vertical scale bar stands to the right of the upper skeleton. Two horizontal pink and white scale bars are placed at the bottom of the grave. The surrounding earth is dark brown and textured.

- 5.10.4 None of the *in situ* bone was lifted and the remains of only one of the burials – (104), grave (103) - were fully exposed. Only a small proportion of each of the other three burials was uncovered (**Table 3**) severely limiting osteological comment. The *in situ* remains were examined on site by the writer and assessed for basic demographic data with a note on condition and any readily observable pathological lesions. The disarticulated material was subject to a rapid scan to assess minimum numbers of individuals (MNI), some detail of age/sex and readily observable pathology before being reburied in the upper fill of grave (103).

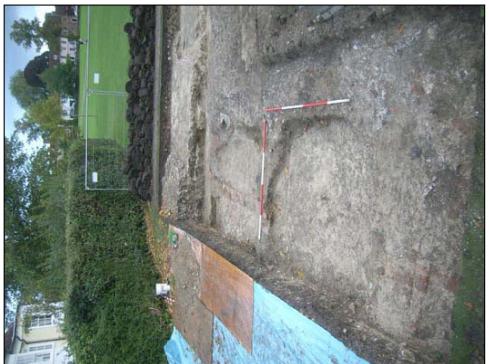
Plate 7: Trench 2 from the west showing remains of central pier base 234 and 233

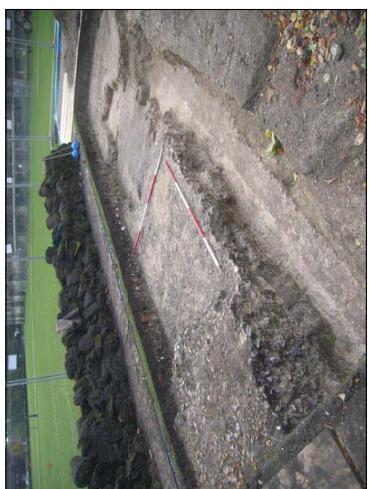
Plate 5: Wall 206 from north showing broken keying-in stones 251 and base mortar spread 261

- 4.3.26 Wall (206) was built upon a large, compact mortar foundation deposit (209/246). Lying directly on the foundation deposit were a series of large Chilmark/Tisbury stone blocks (251) and (243) which projected out from the core of the wall to be keyed into the internal ashlar facing stones (now robbed) of the main Bell Tower wall; the proximal ends of the stones formed part of the facing stonework (**Figure 4, Plate 5**). These stones had been broken during the robbing of the facing stones.

- 4.3.29 Evidence of the robbing of the internal ashlar facing stones of wall (206) was provided by the remains of deposit (261), which lay directly upon (209). This line of mortar adhered to the base of the first course of stones; its width (0.32m) gives the thickness of the ashlar facing stones. Contemporary with wall (206) and the entrance structure was (233/234), the central pier foundation for the Bell Tower, a square-sectioned column with plain chamfered corners, creating an 8-sided structure (**Figure 4, Plate 6**).

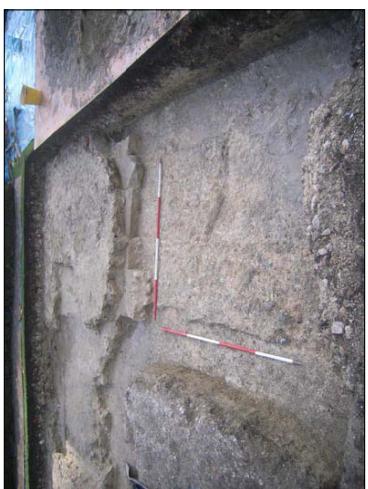
Plate 6: Trench 2 from the west showing the entrance and spiral staircase foundation 24:1

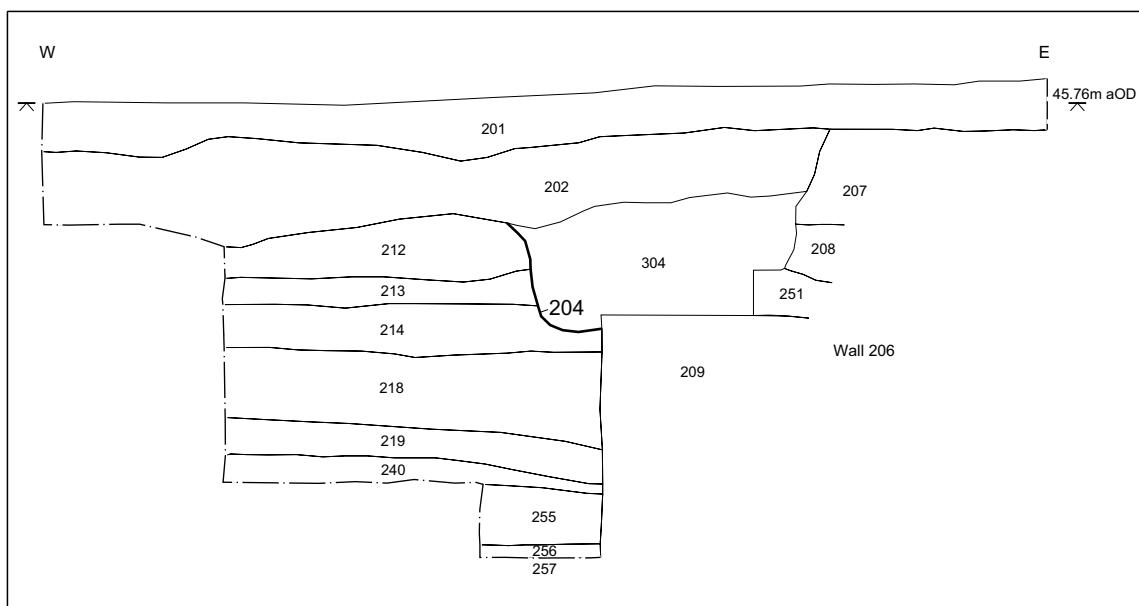
Trench 2 section

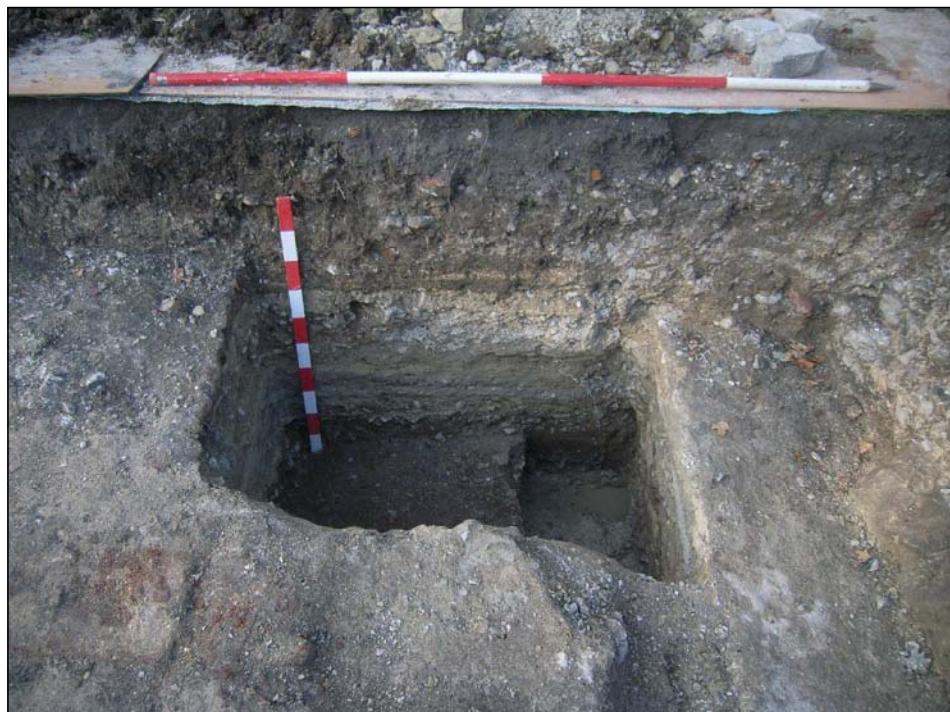
Plate 8: South-facing section showing bell tower make-up layers, wall 206 and robber cut 204

- 4.3.25 Wall (231) and the trample layer were sealed by a series of levelling deposits associated with the construction of the Bell Tower, which was completed by 1266. The preparation of the site began with the covering of the trample layer and the sealing of the earlier wall by levelling layers (219/252), (218/228) and (214), a mix of stone chippings (Chilmark/Tisbury and Purbeck marble) and waste mortar and gravel from the Cathedral construction (**Figure 5, section**). This created a level working platform which was then cut through by (258), the foundation trench for the main eastern wall (206) of the Bell Tower. Layer (218/228) contained a single sherd of medieval (13th century) Laverstock-type fineware and a single sherd of post-medieval German stoneware. The post-medieval pottery does not fit with the proposed sequence and is possibly intrusive, derived from one of the later levelling layers associated with the use of the Tower as an inn (see below).

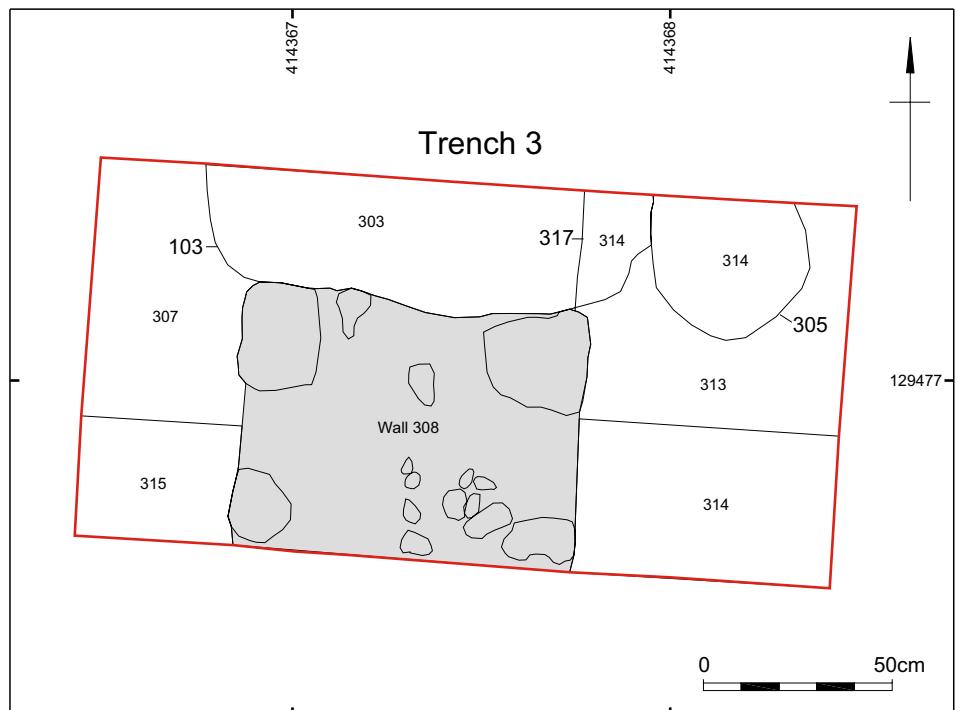
Trench 3 plan

- 4.3.34 The natural basal geology (314/315) was sealed by (307/313), possibly natural geology reworked by trample activity. Cutting through the trample deposit was (317), the foundation trench for a north-south wall (308) (**Figure 6, Plate 9**). The wall corresponds to the geophysical results, and lines up with a scar on the east-west wall to the north which separates the grounds of the school from the cemetery area to the north.

- 4.3.35 To the east of wall (308), a series of floor make-up layers or bedding layers for floor surfaces, (306), (309)-(312), indicate the interior of the structure. On the western side of (308) only natural deposits (305) and (307) were observed.

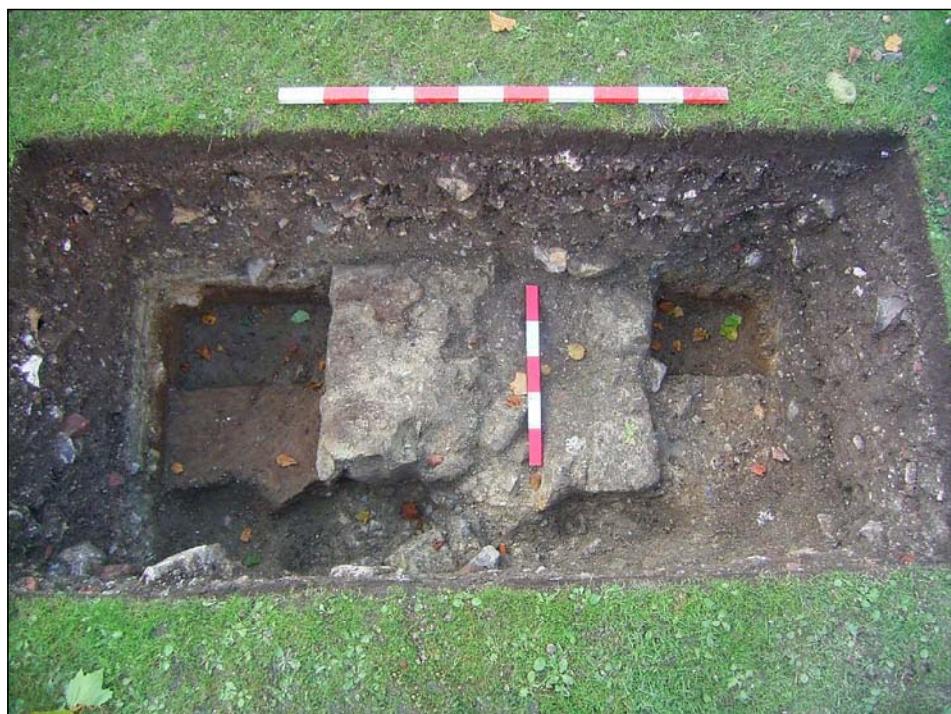
Plate 9: Trench 3 from the north
