## Blythburgh Priory Blythburgh, Suffolk

Archaeological Evaluation and Assessment of Results

Report reference: 68742.01

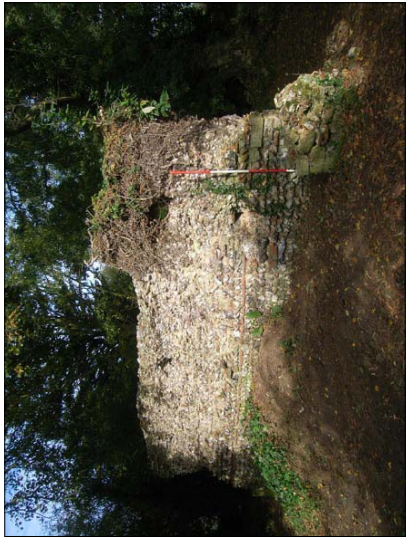
Plate 1

Plate 1: Upstanding wall 102/202

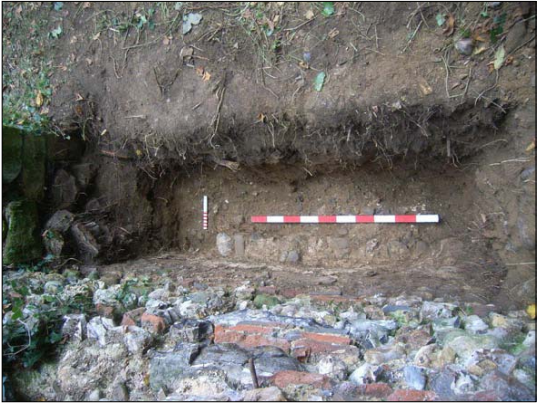
Plate 2: Trench 1, view from west

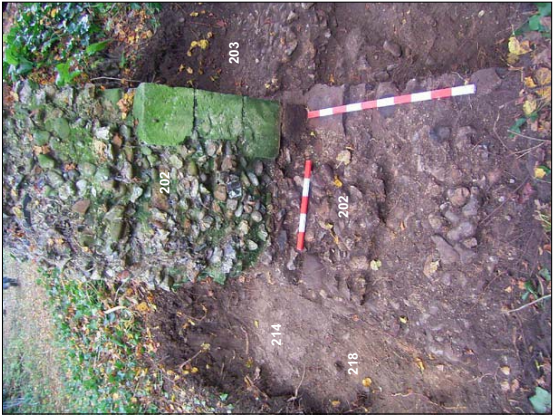
Plate 3: Trench 2, view from west

- 4.3.8 Layer (210) was cut by the foundation trench (209) for wall (202). Trench (209) also contained foundation material (217). Butting wall (202) and sealing foundation material (217) was (212), a deliberate dumping layer. Layer (212) was subsequently overlain by cobbled/metalled surface (203) **Figure 3, Plate 3**).

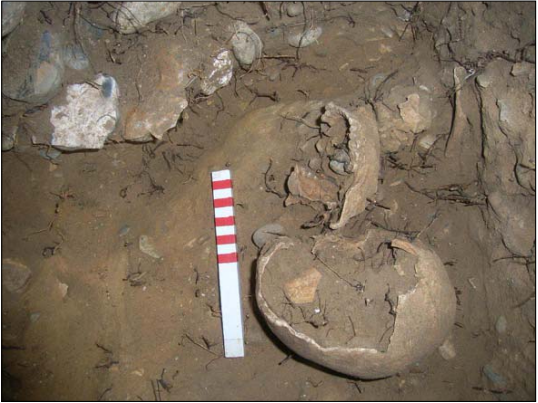
Plate 4: Trench 2, detail of skeleton 207

- 4.3.7 On the external (southern) side was a highly disturbed grave (206) containing skeleton (207) (**Figure 3, Plate 4**); the grave appeared to cut the natural geology (216). The remains were those of an adult (>40 years), possibly female (see **Table 3**). A sample taken from the clavicle of skeleton (207) was submitted for radiocarbon dating and yielded a middle Saxon date of AD 670-780, thus pre-dating the acquisition of Blythburgh church by the Priory of St. Osyth in c.1120. The grave was sealed by layer (210), a possible levelling/make-up layer, possibly equivalent to (215), observed within the interior of the church and deposited to create a level building platform of the construction of the church. Layer (210) contained disarticulated human remains, from an adult male and a young infant.

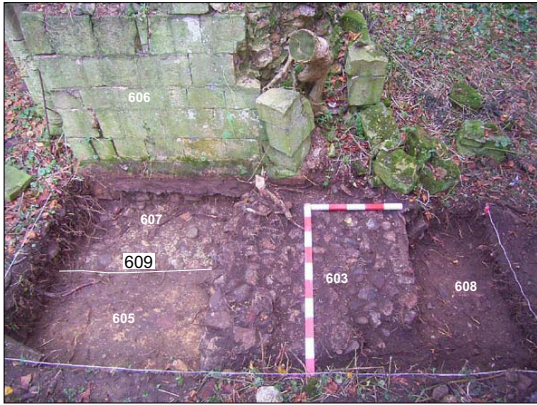
Plate 8: Trench 6, view from north

- 4.3.22 Column (606) was constructed upon stepped footing (607) within foundation trench (609), and was clearly butted by the remains of a later north-south aligned wall (603) (**Figure 5, Plate 8**). Wall (603) did not butt (606) centrally but was slightly off-set to the east; it had been robbed down to ground level and was butted on the western side by levelling/bedding layer (605) and by rubble layer (608) and on the eastern side by rubble layer (604). The robbing of wall (603) destroyed part of the column (606).

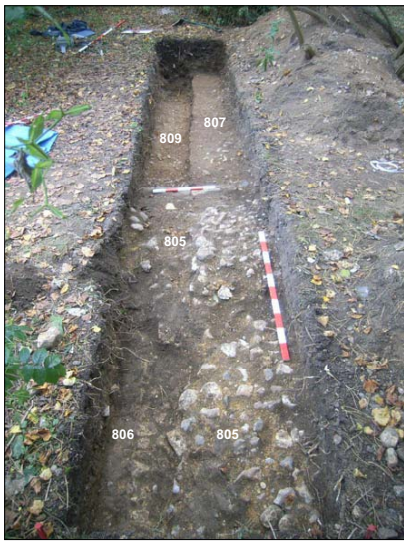
Plate 9: Trench 8, view from east

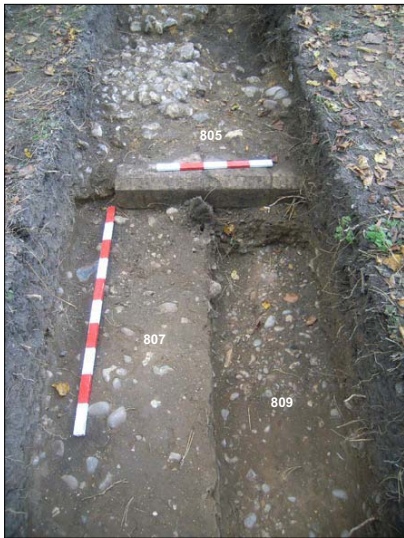
Plate 10: Trench 8, view from west

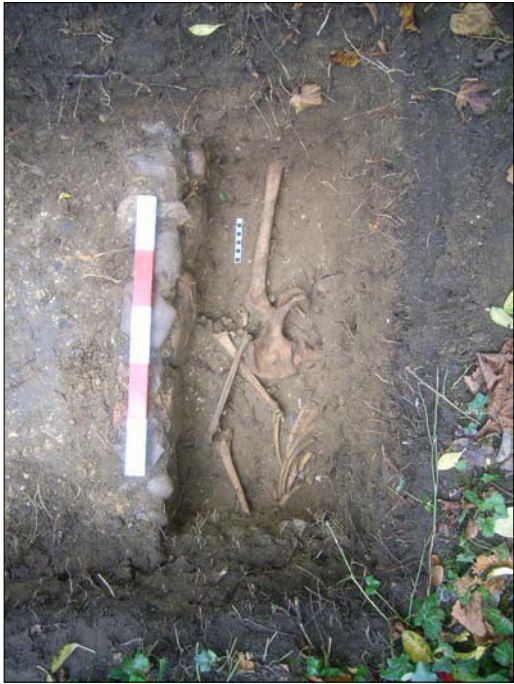
Plate 12: Skeleton 704 against wall 708

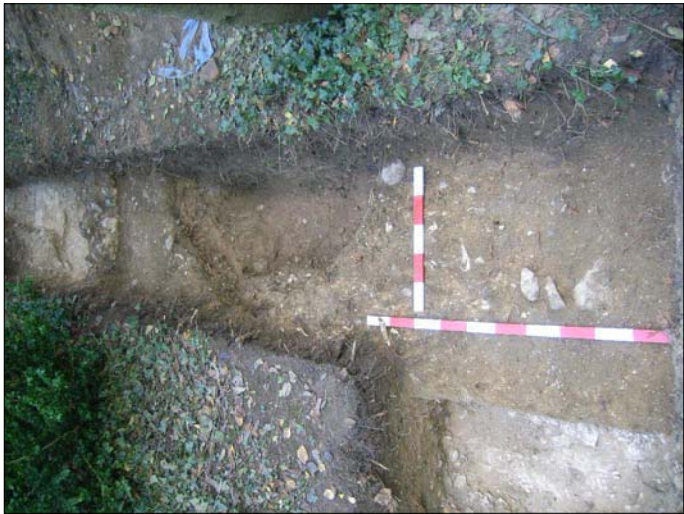
Plate 11: Trench 7, view from east

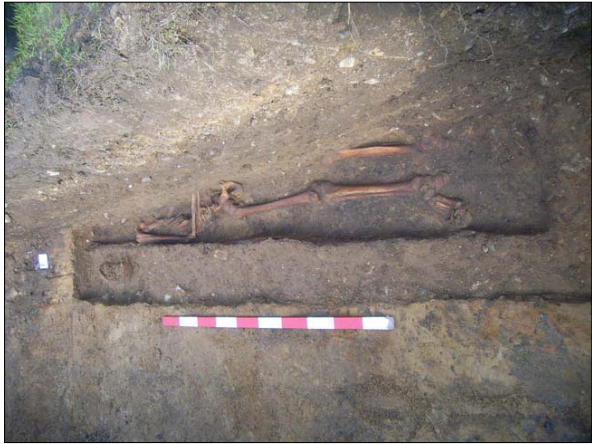
Plate 17: Skeleton 1606 in Grave 1604

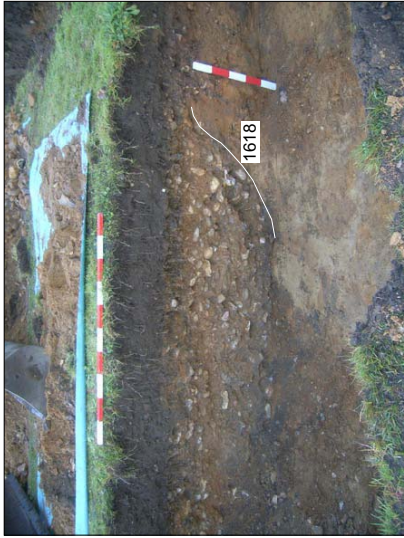
Plate 18: South-facing section of ditch 1618

- 4.3.51 An east-west ditch (1618) (**Figure 8, Plate 18**) cut the natural geology. Its function is unclear – it may have been a large enclosure ditch, or alternatively it may have been the foundation trench for the eastern wall of the Church, contemporaneous with the crossing tower pillars (606), (1009), (1018) and (1404). The latter interpretation was considered to be less likely given the difference in construction techniques between (1618) and the other second phase structures.

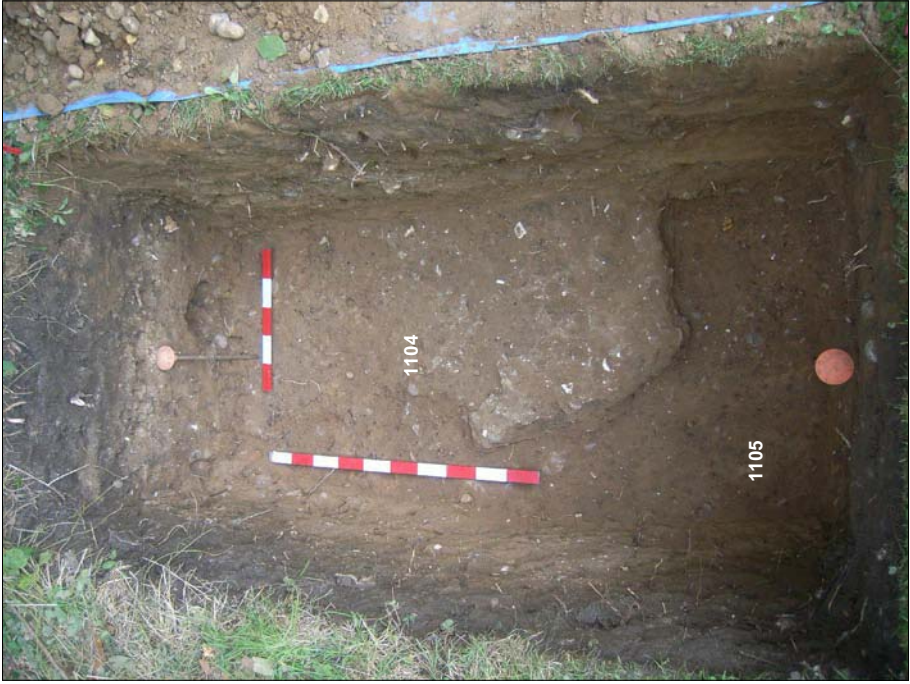
Plate 19: Trench 11, view from west

4.3.42 Trench 11 was targeted upon geophysical anomalies thought to represent the south-west corner of the cloister of the Priory (see **Figure 2**). An irregular spread of rammed clay (1104) was observed at 0.85m below the current ground surface and overlying the natural (1105). It was interpreted as a possible floor surface or bedding layer but it was unlike any of the exposed floor or bedding layers associated with the Priory.
