## Newbury Racecourse Car Parking Area, Newbury, West Berkshire

### Archaeological Evaluation Report

Reference: 70091.03

**October 2008**

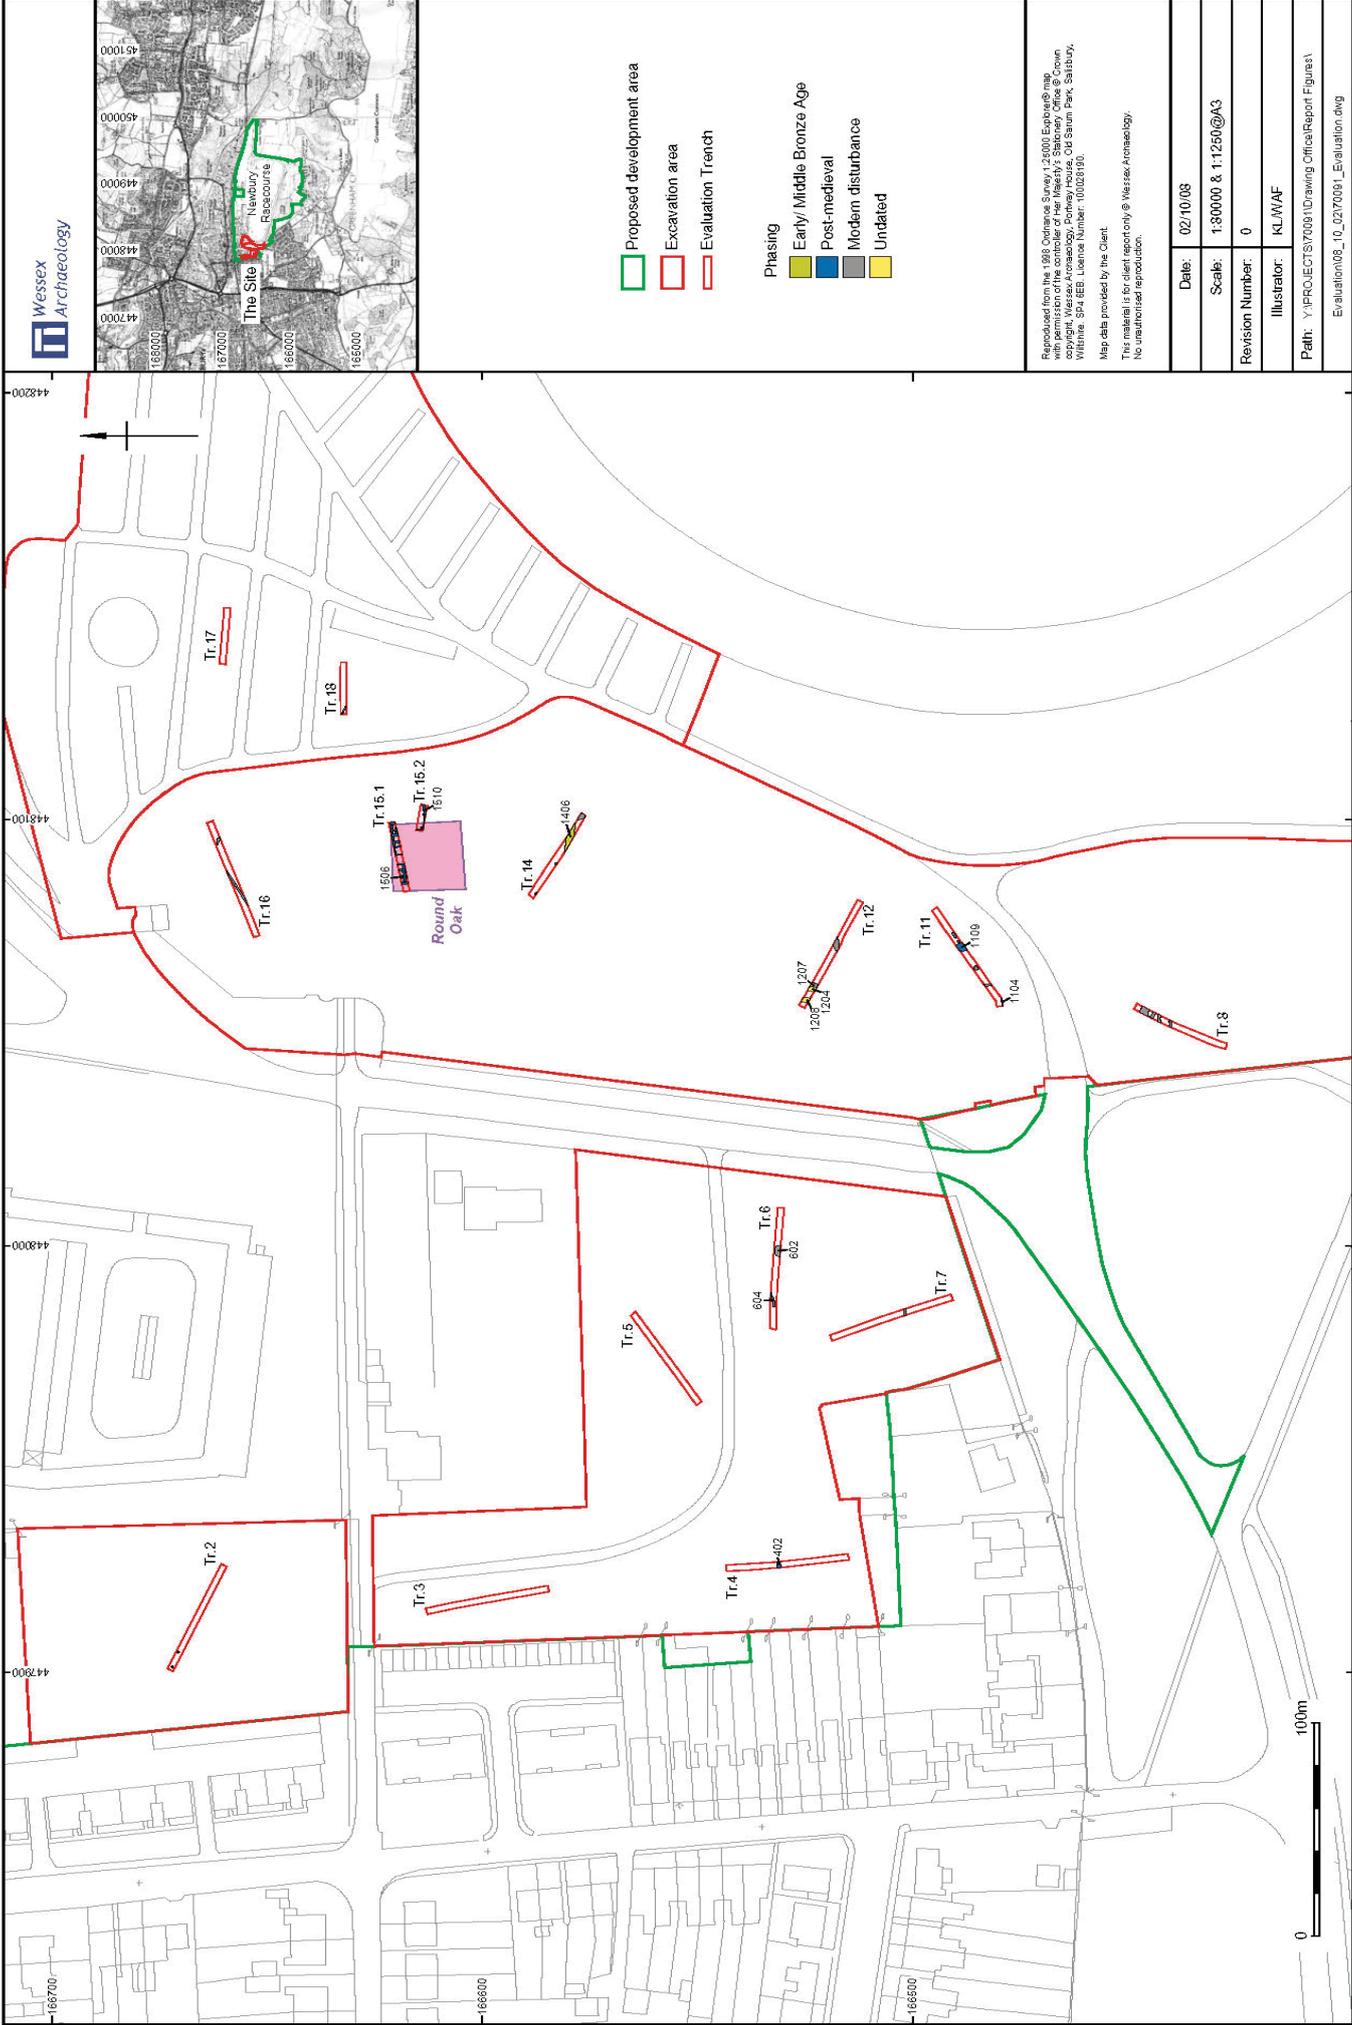
Figure 1  
Site location and Trench layout plan

- 4.3.1 The Site can be broken up into two areas. Trenches Two to Seven on land west of the Racecourse and Trenches Eight to 18 lying on land to the immediate west of the Racecourse (**Figure 1**).

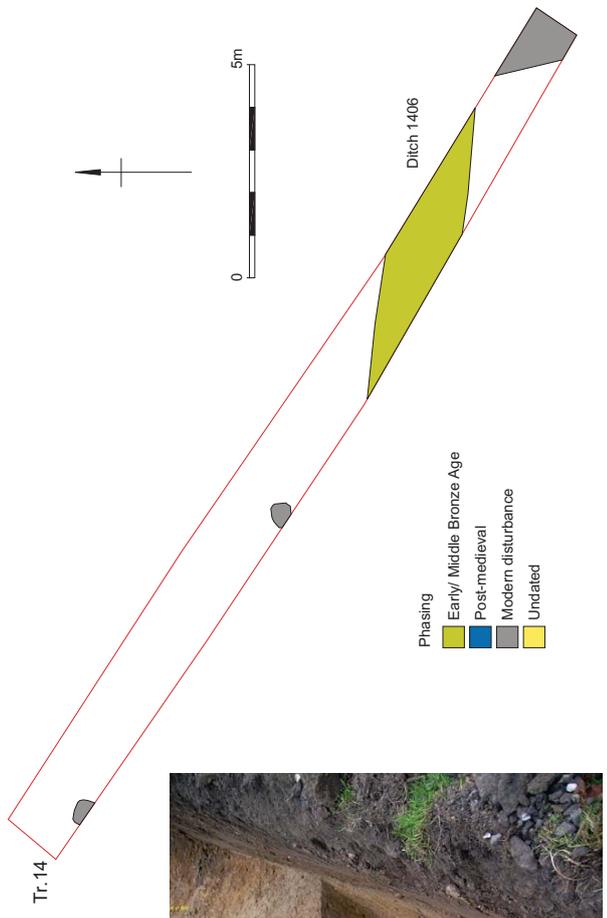
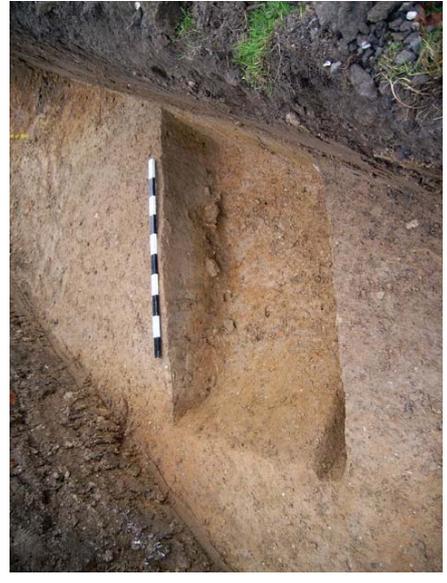
Plate 1: West facing section of Ditch 1406

- 4.3.10 The north-western end of Trench 14 revealed two similar circular features. These modern postholes were observed to cut through the current topsoil and are possibly associated with works related to the racecourse. At the south-eastern end of the trench was a pale grey east-west aligned linear feature **[1406]** (**Figure 2, Plate 1**). The oblique angle of the trial trench to the ditch meant that a complete 90° slot could not be achieved. Excavation of the feature identified it as a field boundary containing pottery of a Middle to Late Bronze Age date (**Figure 2, Plate 2**). At the south-east end of the trench was a patch of post-medieval/modern disturbance. Insufficient area was exposed within the trench to determine the character of the disturbance.

- 5.2.1 Prehistoric pottery was recovered from contexts **(1407)** and **(1408)** in linear feature **(1406)**. Ten body sherds of abraded Middle to Late Bronze Age pottery came from context **(1408)**, possibly from a single vessel. None had diagnostic form, but the flint temper was fairly fine and the vessel walls quite thin, suggesting a later date from within this range. The single sherd from context **(1407)** was thicker walled and the flint temper was coarser and less well-sorted and so was possibly earlier in date. A further two very small fragments of possible prehistoric pottery were found in context **(600)** and two more in context **(807)**. Both contexts are in areas of disturbed ground so no dating inference can be made from these sherds.

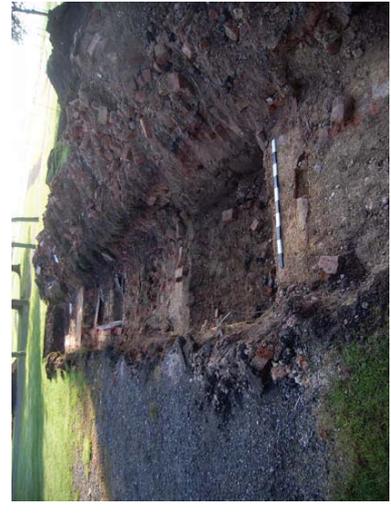
Plate 3: Trench 15.1 looking east-north-east

- 4.3.11 Trenches 15.1 and 15.2 were targeted over the known location of Round Oak house. Trench 15.1 revealed fragments of the surviving floor plan of the house including several intact cellars (**Figure 2, Plate 3**). The trench revealed eleven walls on a north-south alignment connecting to two east-west aligned walls. Health and Safety constraints, due to open voids within the cellar backfill, resulted in the cellars not being excavated and all recording of the trench being conducted from the trench side (**Figure 2, Plate 4**). The foundation construction cut **[1506]** was observed to be cut from the top of the original subsoil and through into underlying natural geology. Following construction, the land surrounding the house was subsequently landscaped by adding material to increase the ground surface of the gardens to approximately 78.78m aOD. This garden deposit was sealed by a layer of rubble associated with the demolition of Round Oak which was overlain by the present day ground surface/turf line.

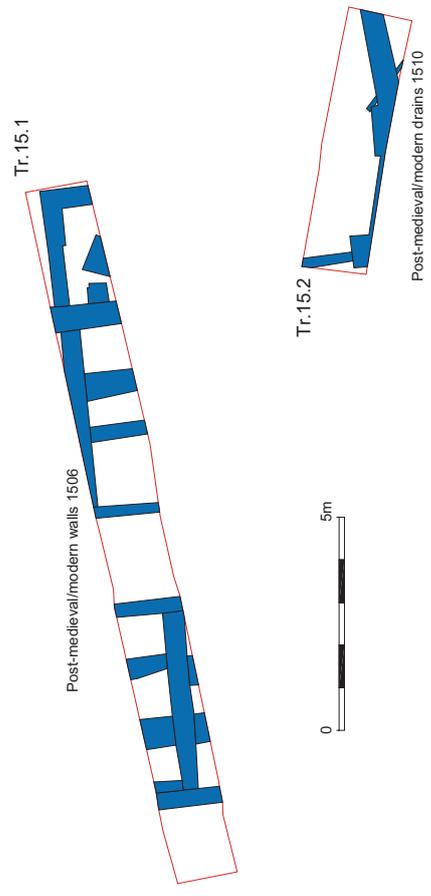
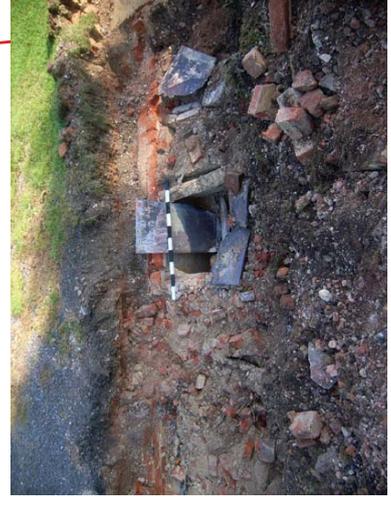
Plate 4: Shot of open cellar looking north

rubble bonded concrete (0.45m-0.78m deep) foundations with the same mortar matrix.	
		Trench contained the surviving cellars of Round Oak, some of which were opened during machining revealing voids. Unstable area. Trench was shortened to account for tree canopy exclusions.

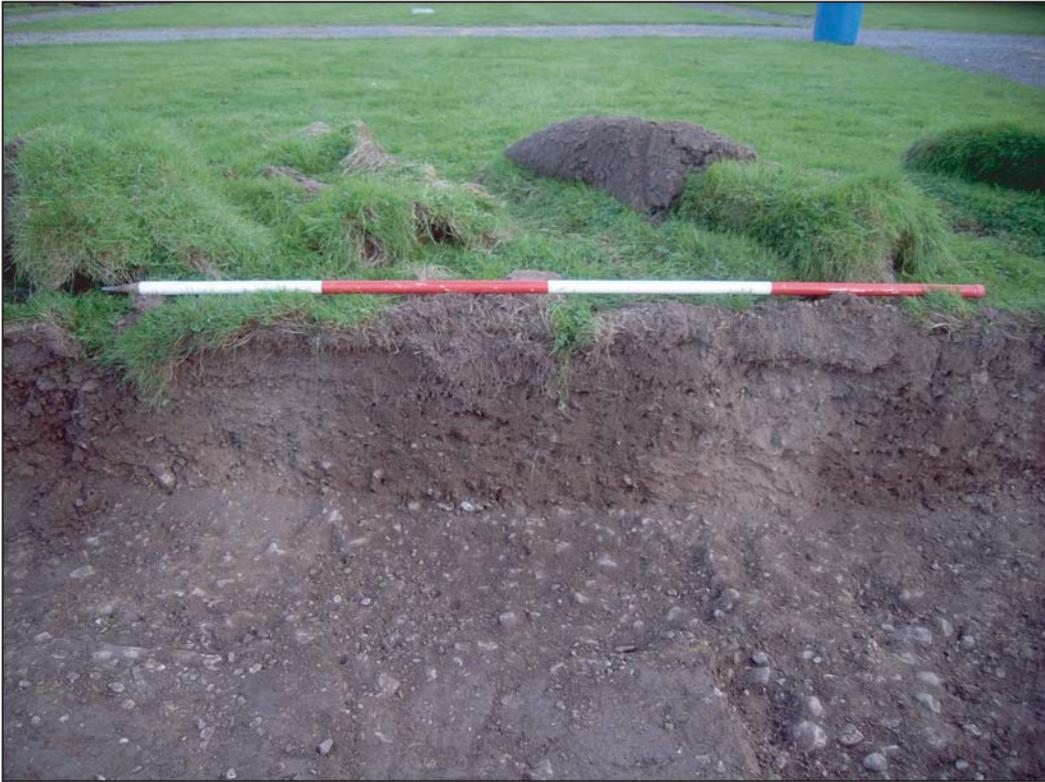
Plate 5: South facing section of modern intrusion 604 in Trench 6

- 4.3.4 Trench Six contained two irregularly shaped features, **[602]** and **[604]**, which were only apparent in the south facing section of the trench and are believed to be modern in date as they were observed to cut through the current ground surface (**Figure 3; Plate 5**). Two other possible features were identified, following investigation, as natural hollows within the gravel.

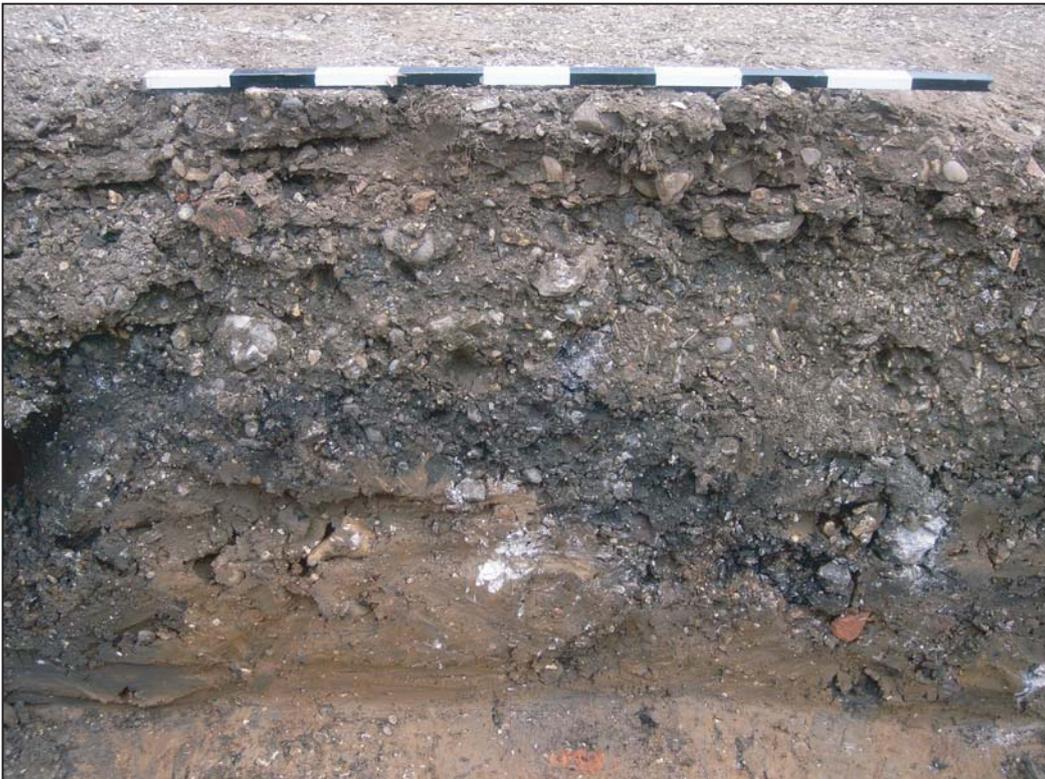
Plate 6: South-east facing section of disturbed ground in Trench 8

- 4.3.7 Trench Eight was located in an area of heavily disturbed land and showed made ground to a depth of 0.74m (77.65 aOD) (**Figure 3; Plate 6**). Aerial photography (**Front Cover**) shows the presence of a series of small worker cottages in this area but no evidence of the structures was revealed during the evaluation, however, three modern linear features (all containing post-medieval/modern Ceramic Building Material (CBM)), including a service trench, are possibly associated with the structures. Patches of discoloured natural, probably as a result of leaching of contaminated material from the made ground above, were observed in the base of the trench.
