## Land to the Rear of 182 High Street, Tonbridge, Kent

### Draft Archaeological Evaluation Report

Report reference: 70370.01

NGR: TQ 589 468

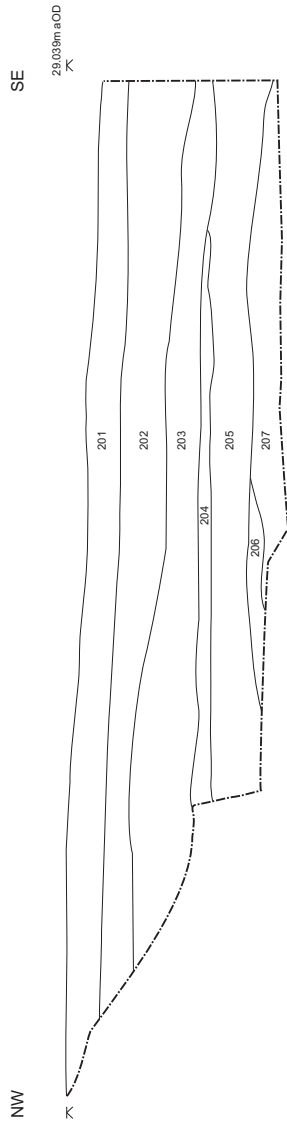
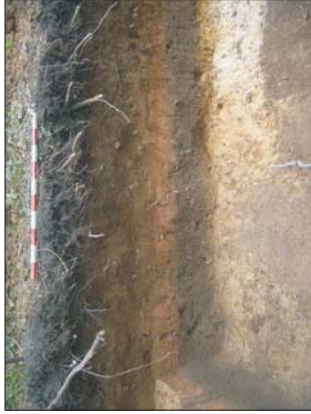
Plate 1: West facing section of Trench 2

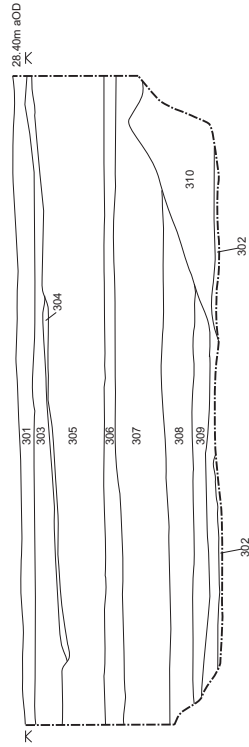
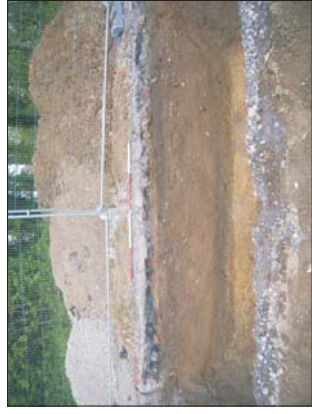
Plate 2: South-east facing section of Trench 3

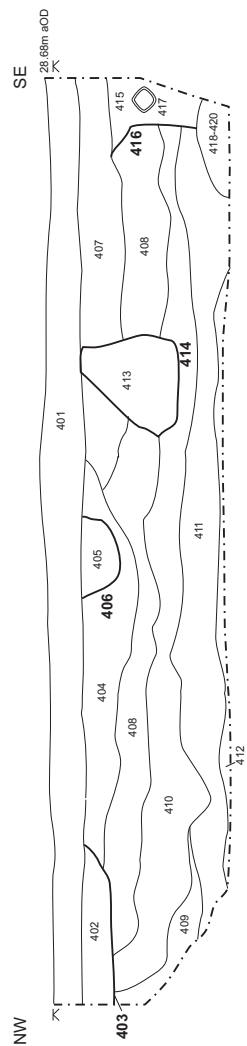
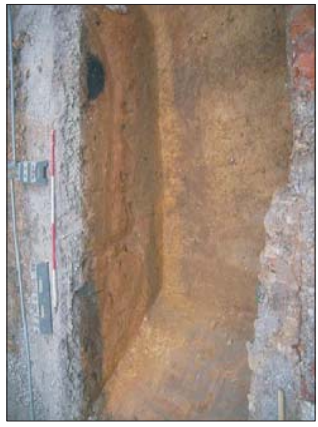
Plate 3: South facing section of Trench 4

- 5.3.13 A shallow narrow linear [403] measuring 0.22m in depth was revealed in Trench 4 (Figure 3), the full extent was not visible within the trench; it was filled by a dark brownish black loamy sand with moderate flecks of charcoal and small fragments of brick containing one piece of modern ceramic (402). A small shallow pit [406] measuring 0.29m in depth was recorded to the south of linear [403], this had a u-shaped, rounded profile and was filled by a black burnt gravely silt (405). The remains of a wall [414]/(413) were revealed to the south of pit [406]. The full extent of the wall was not visible within Trench 4. It had an irregular rectangular profile measuring 0.71m in depth, extending to 0.98m bgl demonstrating more substantial evidence of modern ground disturbance (Figure 3). It was filled by a red brick wall structure in a chalky matrix (413). A drain [416]; filled by a mid greyish brown silty clay (417), overlain by a mixed greyish brown silty clay around the pipe (415) was recorded to the eastern end of Trench 4. It had an irregular profile measuring 0.48m in depth observed between 0.63m and 1.11m bgl further indicating significant ground disturbance (Figure 3).

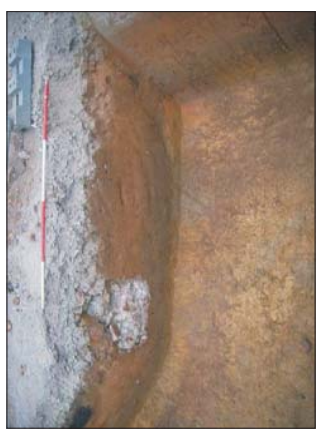
Plate 4: South facing section of Trench 4

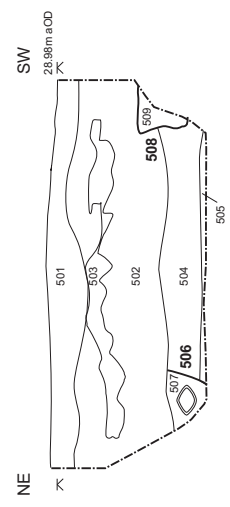
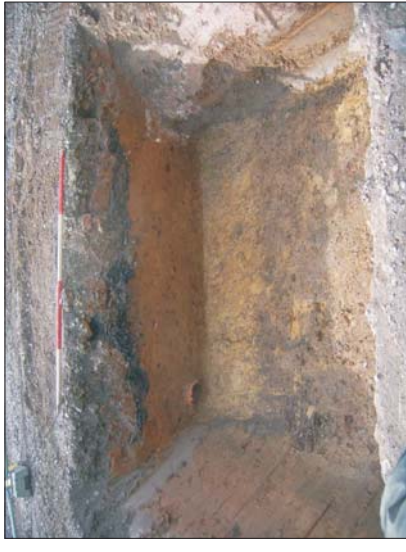
Plate 5: North-west facing section of Trench 5

- 5.3.7 Trench 5 (Figure 3) revealed two layers possibly relating to Medieval activity on the site. Layer (502) was a light pinkish red clay with occasional stone inclusions and flecks of charcoal (502). A layer of burnt building material, possibly roofing material (503) was recorded within the upper level of (502) and it is difficult to identify if (502) represents an in-situ bank deposit or the natural collapse/erosion of the bank which had been truncated by modern activity or was re-deposited material from the bank as a result of modern disturbance on the Site. It was underlain by layer (504) which was similar to layers (205), (308) and (411), possibly signifying activity pre-dating the constructing the bank.
