LIDL Norway Road Hilsea, Portsmouth

Archaeological Watching Brief Report

Report reference: 70600.03

December 2008

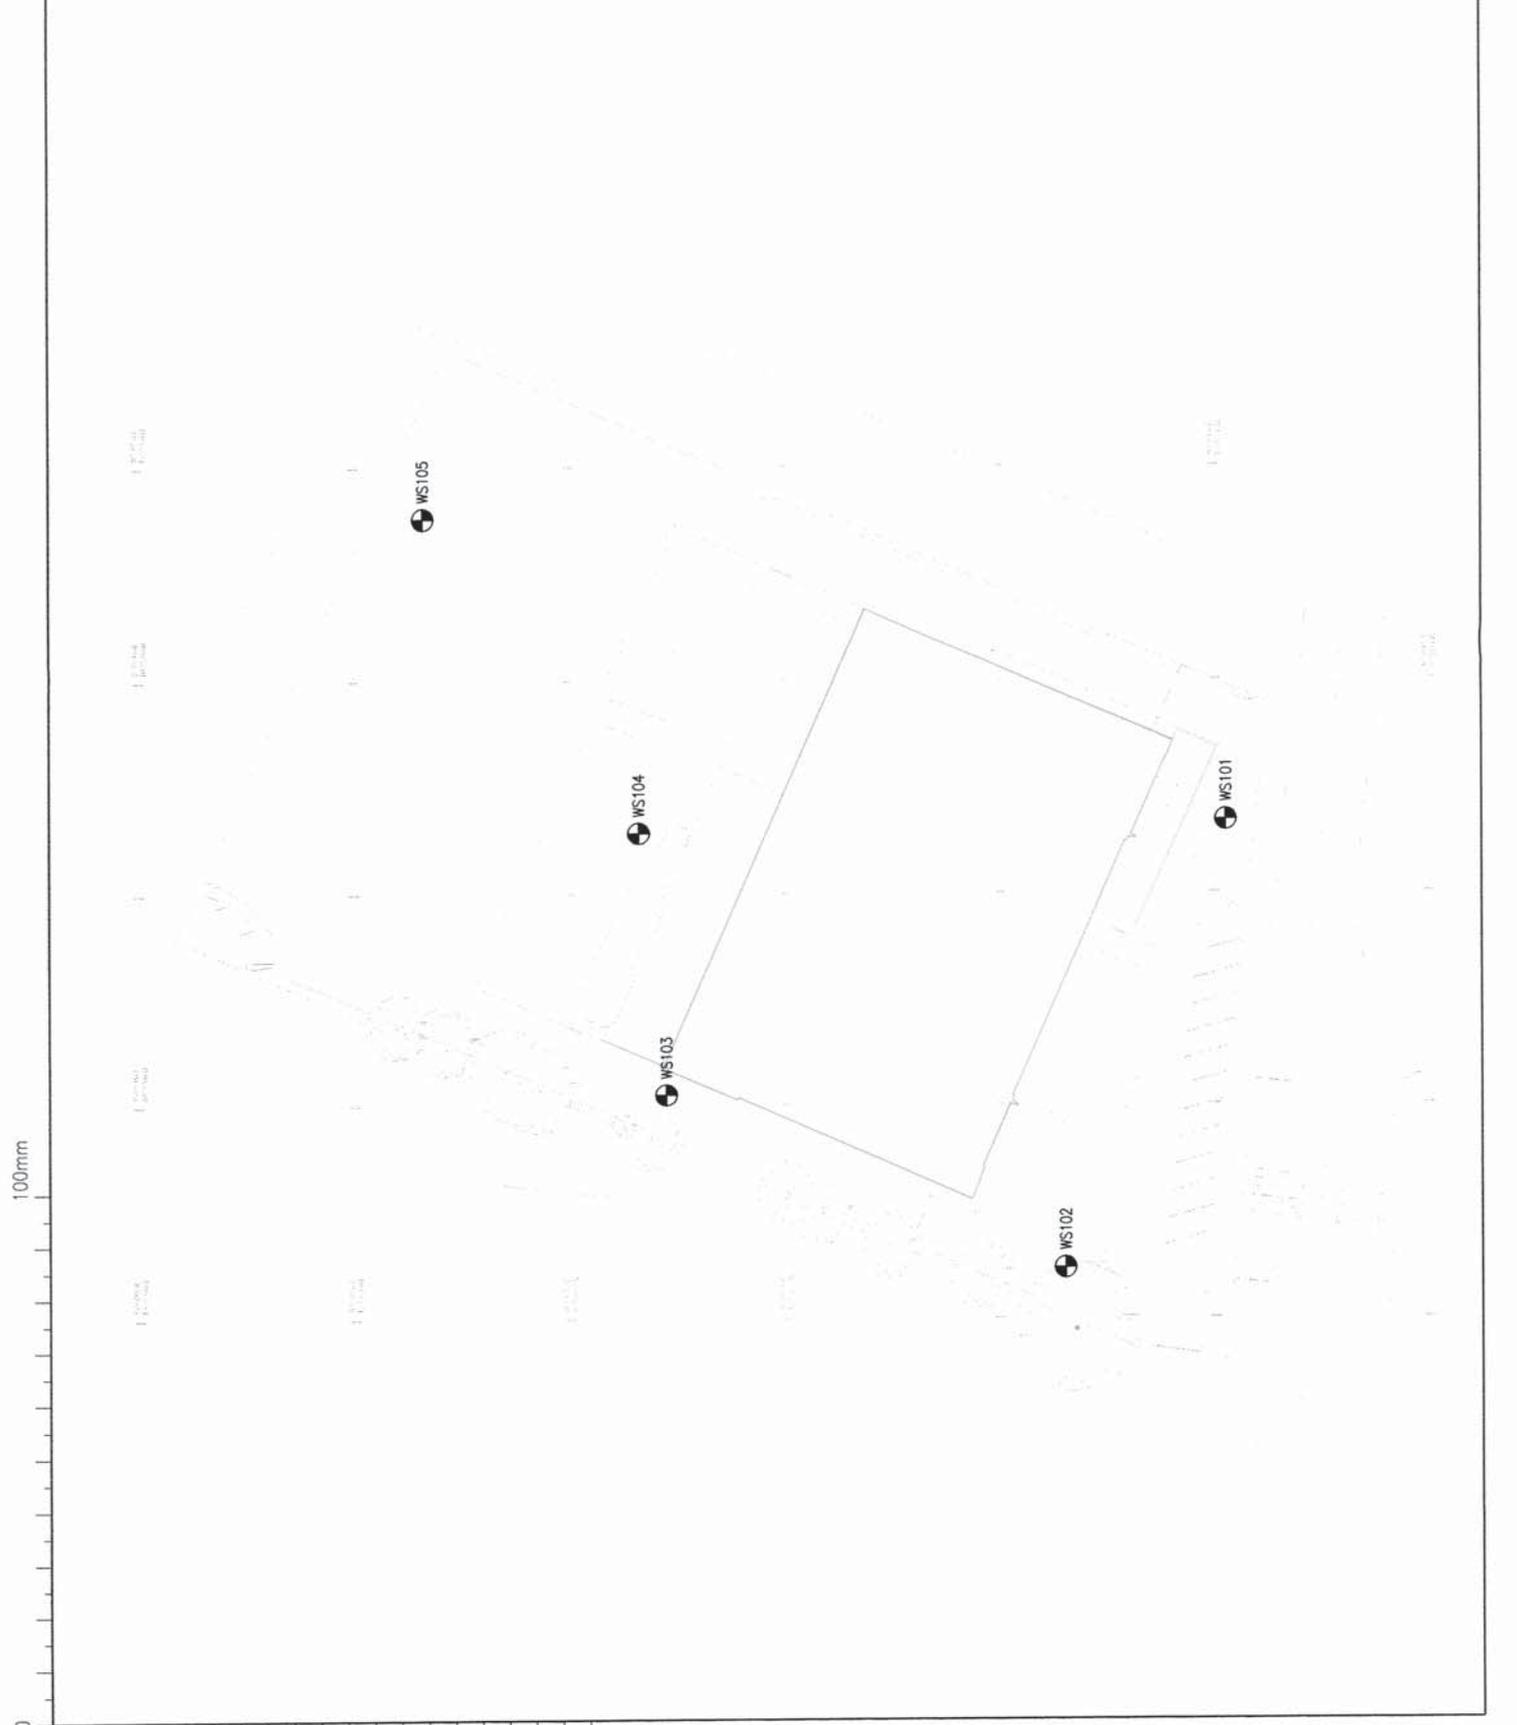
CLIENT		Lidl UK GmbH	
PROJECT TITLE		Norway Road, Hilssea, Portsmouth	
DRAWING DETAIL		Exploratory Hole Location Plan	
DRAWN	CC	DATE	Sep 2007
PROJECT ENGINEER	AS	CHECKED	AS
APPROVED	AS	SCALE	1:500 @ A3
DRAWING NUMBER	16070169/002		
REVISION	-

- 2.2.2 The investigation comprised of five window sample holes (WS101 to WS105 – **Appendix 2**), which were advanced using a tracked rig to depths ranging from 3.00 to 5.00m.

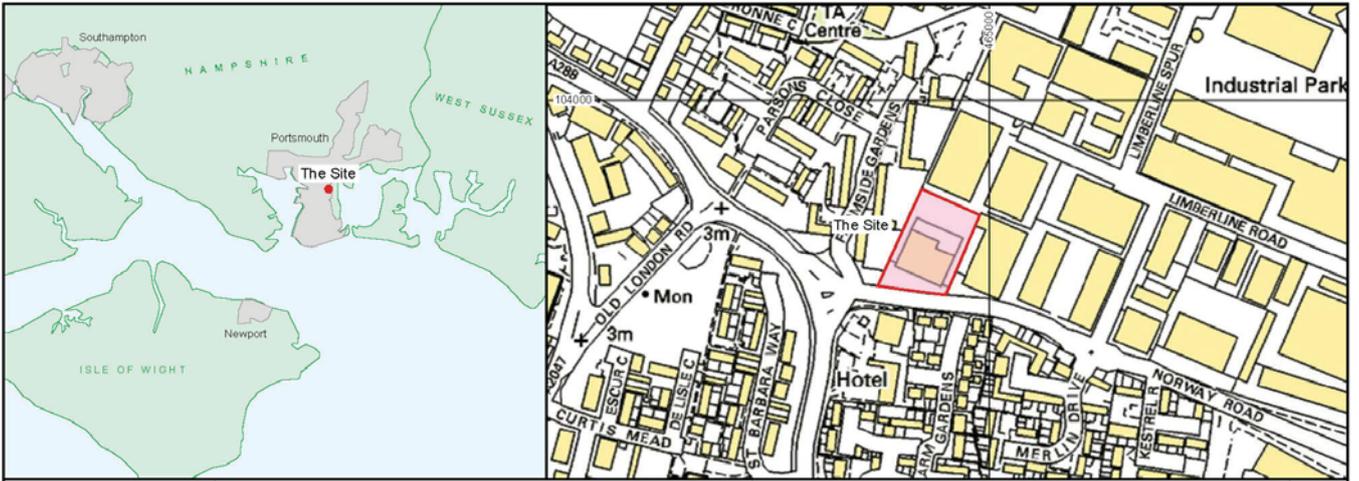
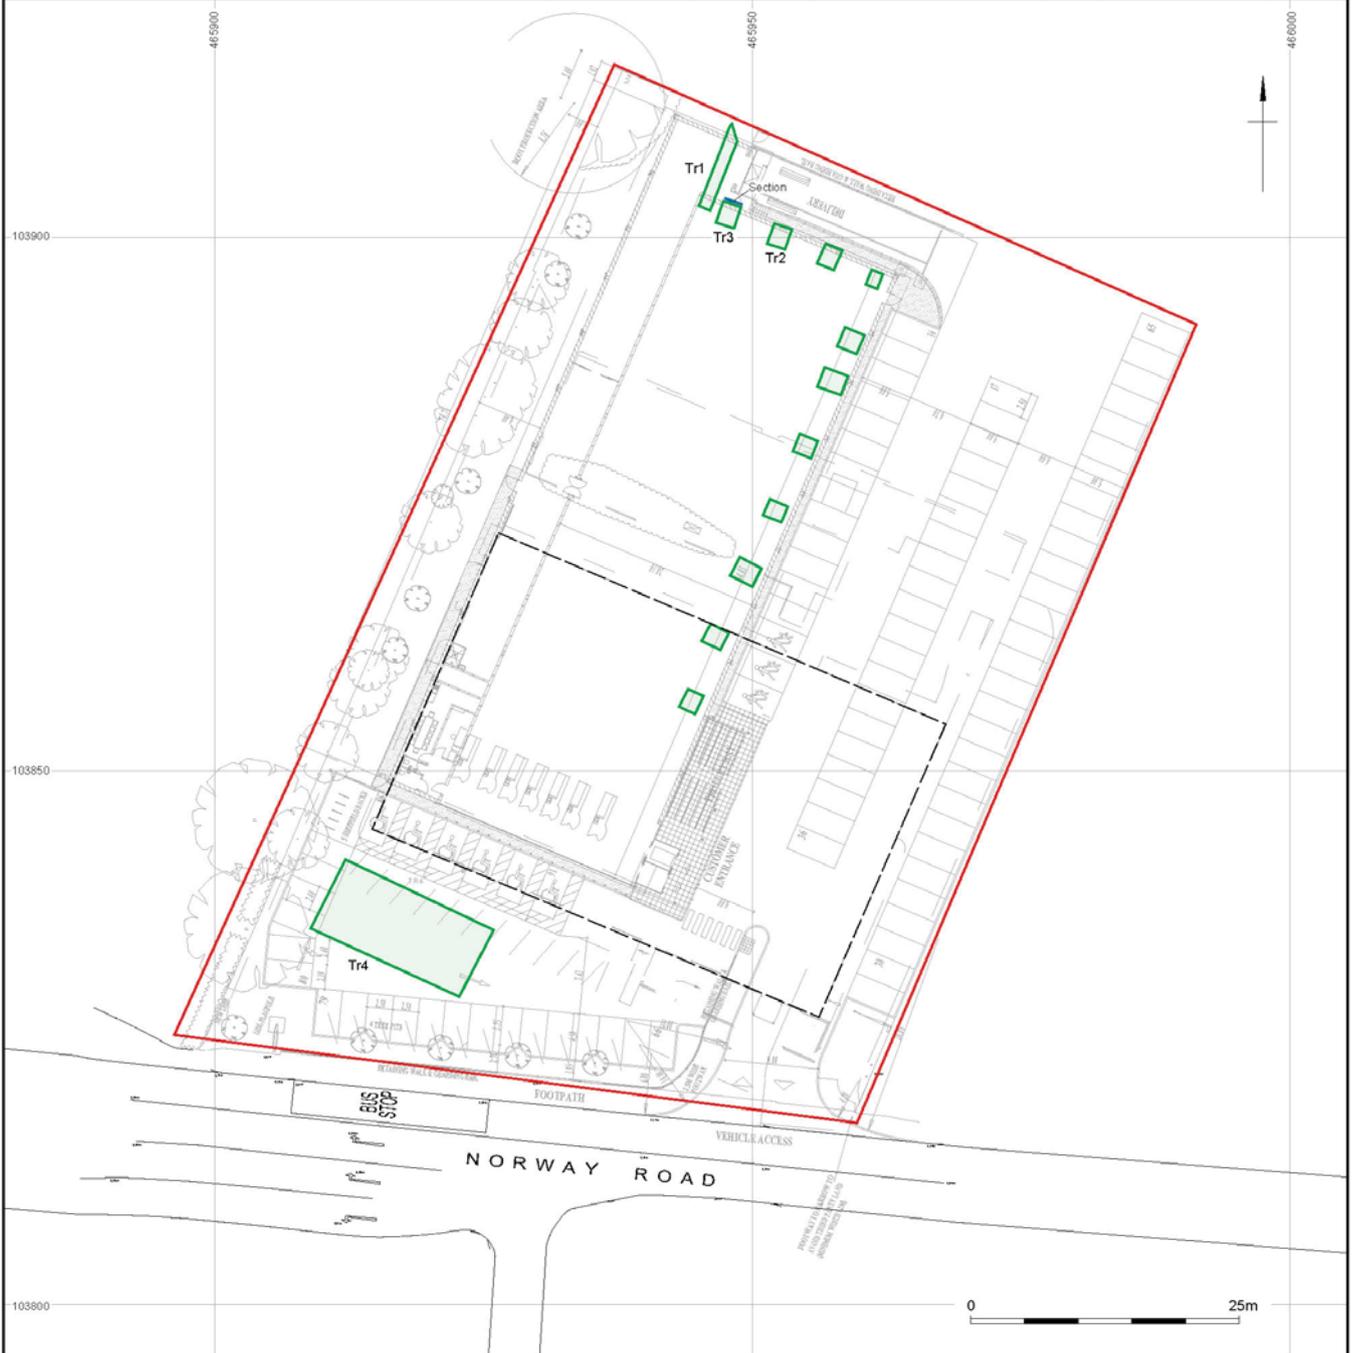
Figure 1

Site and trench location plan

4.2.1 The groundworks comprised the excavation of twenty nine foundation trenches, forming the footprint of the new LIDL store along with associated services. The foundation trenches were c.2m² by c.0.30m deep. Trenches 2 and 3 were excavated to a depth of 1.60m. A north-south orientated service trench (Trench 1), measuring 8m by 0.80m wide was excavated to a depth of 1.20m deep. A large 15.80m by 1m by 2.10m deep trench (Trench 4) for the installation of a water storage area was also excavated. (**Figures 1 and 2**)

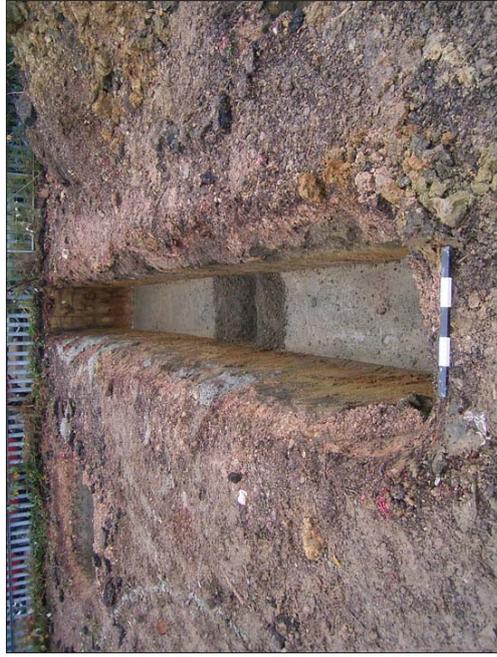
Plate 1: Trench 1, view from the west

Trench 1		Digital Photos 024-028, 048, 049
Dimensions (length x width x depth) 8.20m x 0.78m x 1.21m		1.78m aOD
Context	Description	Depth
100	Modern backfill: mid whitish red silty clay mixed with sub-angular flint <0.10m and gravels. It was placed by the constructors prior to digging for better drainage and levelling of the site.	0m - 0.19m
101	Modern backfill: dark brownish grey silty clay loam. Very compact with abundant charcoal inclusions <0.10m. Moderate sub-angular flint <0.10m. Evidence for manganese and modern ceramic built material. Clear boundary. Possibly formed during the construction and demolition of the pre-existing warehouses.	0.19m - 0.44m
102	Natural sandy clay: light yellowish brown sandy clay. Mid greyish brown mottling. Fairly loose, clear boundary. Sparse sub-angular flint <0.05m.	0.44m - 0.89m
103	Natural brick earth: mid yellowish red very compact and thick clay loam. No inclusions.	0.89m - 1.21m

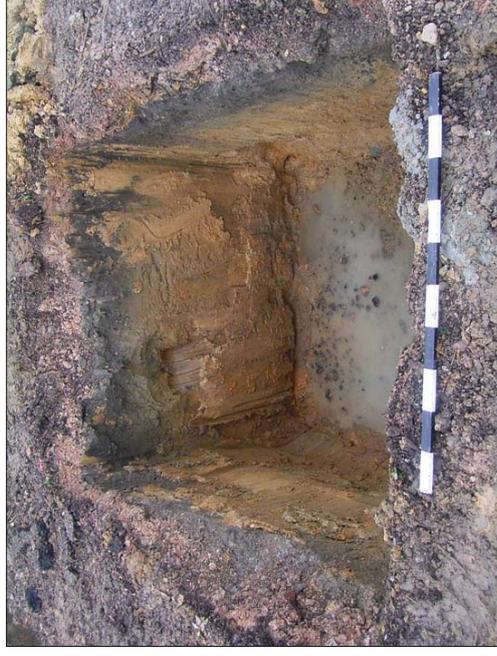
Plate 3: Trench 2, view from the south

Trench 2		Digital Photos 030, 031, 032, 033, 050
Dimensions (length x width x depth) 2.30m x 2.05m x 1.60m		1.96m aOD
Context	Description	Depth
200	Modern backfill: mid whitish red silty clay mixed with sub-angular flint <0.10m and gravels. It was placed by the constructors prior to digging for better drainage and levelling of the site.	0m - 0.20m
201	Modern backfill: dark brownish grey silty clay loam. Very compact with abundant charcoal inclusions <0.10m. Moderate sub-angular flint <0.10m. Evidence for manganese and modern ceramic built material. Clear boundary. Possibly formed during the construction and demolition of the pre-existing warehouses.	0.20m - 0.42m
202	Natural sandy clay: light yellowish brown sandy clay. Mid greyish brown mottling. Fairly loose, clear boundary. Sparse sub-angular flint <0.05m.	0.42m - 0.70m
203	Natural brick earth: mid yellowish red very compact and thick clay loam. No inclusions.	0.70m - 1.60m

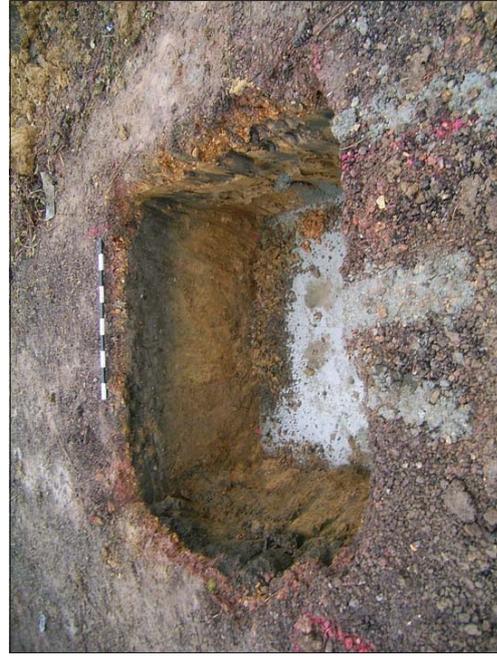
Plate 4: Trench 3, view from the south

Trench 3		Digital Photos 034, 035, 036
Dimensions (length x width x depth) 2.35m x 2.10m x 1.20m		1.38m aOD
Context	Description	Depth
300	Modern backfill: mid whitish red silty clay mixed with sub-angular flint <0.10m and gravels. It was placed by the constructors prior to digging for better drainage and levelling of the site.	0m - 0.20m
301	Modern backfill: dark brownish grey silty clay loam. Very compact with abundant charcoal inclusions <0.10m. Moderate sub-angular flint <0.10m. Evidence for manganese and modern ceramic built material. Clear boundary. Possibly formed during the construction and demolition of the pre-existing warehouses.	0.20m - 0.42m
302	Natural sandy clay: light yellowish brown sandy clay. Mid greyish brown mottling. Fairly loose, clear boundary. Sparse sub-angular flint <0.05m	0.42m - 0.70m
303	Natural brick earth: mid yellowish red very compact and thick clay loam. No inclusions.	0.70m - 1.60m

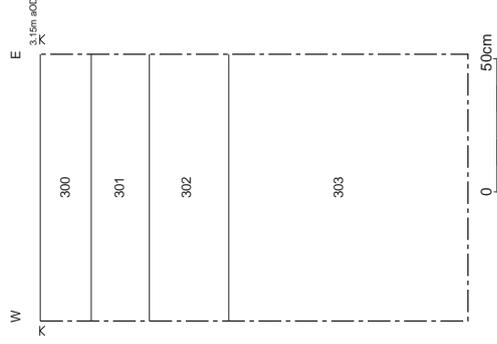
Trench 3 section

5.1.3 A layer of modern redeposited gravel was recorded to a depth of 0.19m. This overlay a layer of modern backfill c. 0.44m deep consisting of a dark brown silty clay with modern building rubble and charcoal inclusions. Beneath the modern backfill, natural geology comprising of a light yellowish brown sandy clay layer was revealed to a depth of 0.89m, below which a change in the natural was observed comprised of a thick layer of mid yellowish brown silty clay with no inclusions (**Figure 2**).

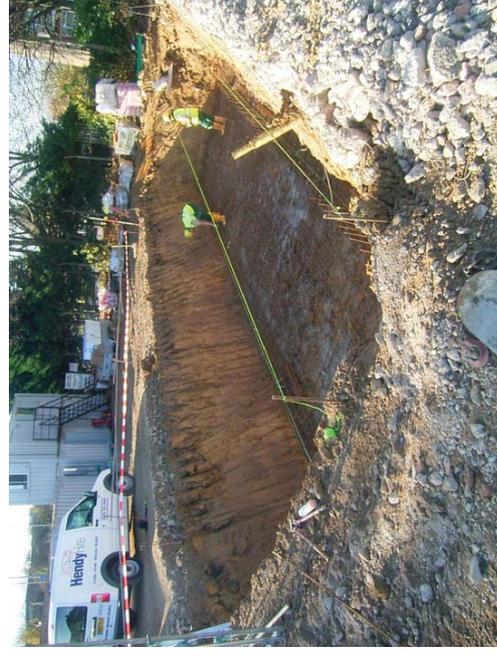
Plate 5: Trench 4, view from the north-east

Trench 4 (Water Storage Area)		Digital Photos 061-065
Dimensions (length x width x depth) 15.8m x 7m x 2.10m		2.68m aOD
Context	Description	Depth
400	Natural sandy clay: light yellowish brown firm sandy clay. Mid greyish brown mottling. Fairly loose, clear boundary. Sparse sub-angular flint <0.05m.	0m - 2.10m
