## Dynamic Bus Facility Chatham Medway, Kent

Archaeological Watching Brief Report  
on Geotechnical Trial Pits

**Report reference: 71182.01**

**March 2010**

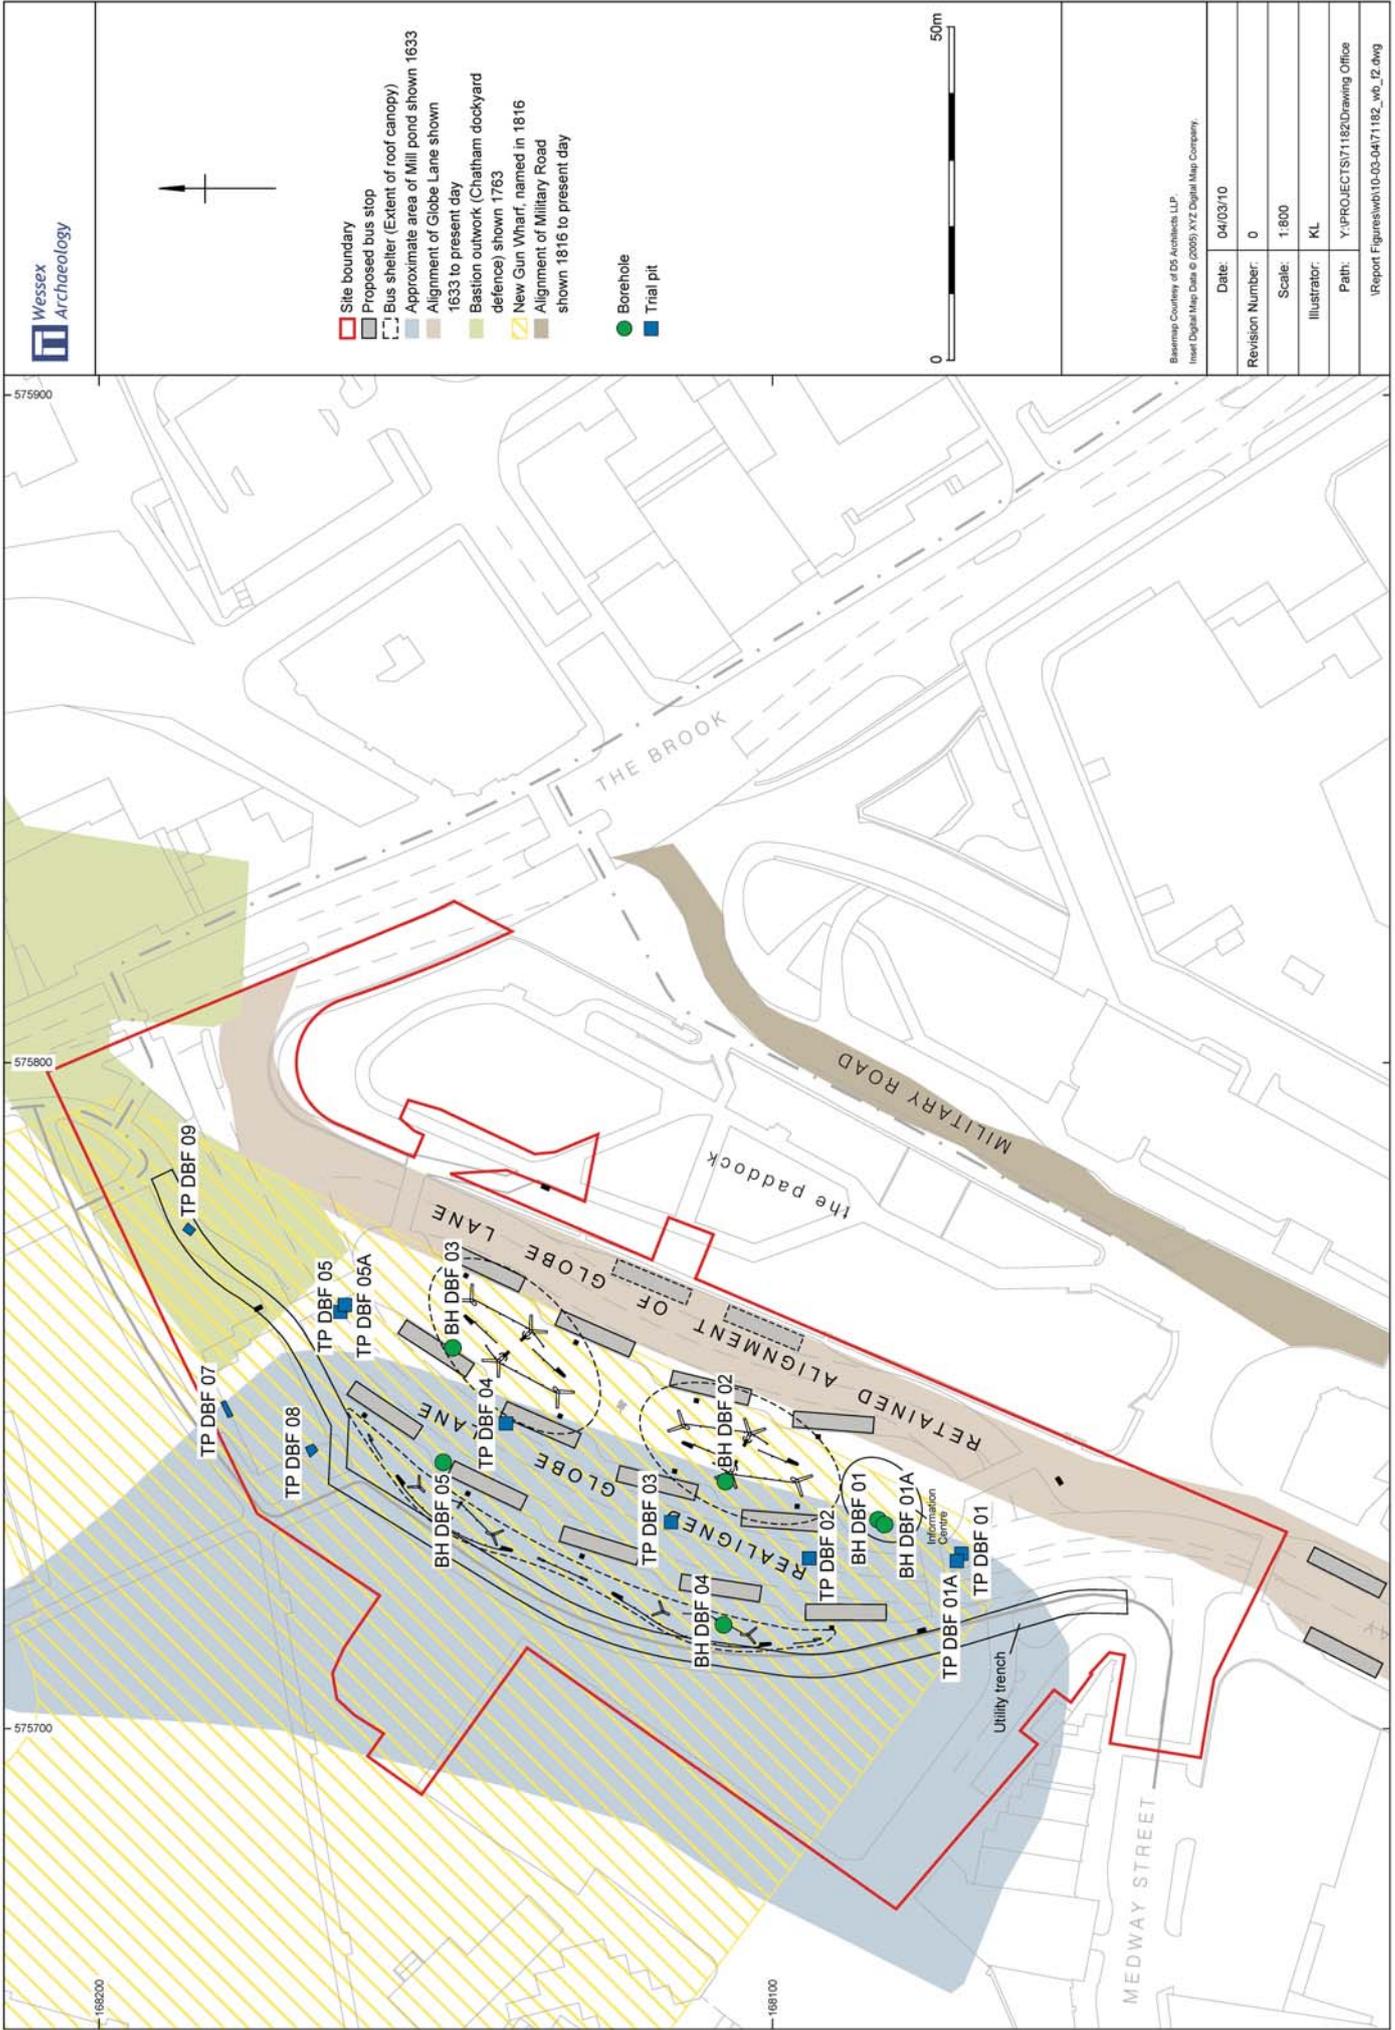
Plan showing the potential location of key archaeological features on Site identified through map regression overlaid with the current development scheme: relation to the boreholes and trial pits

- Site boundary
- Proposed bus stop
- Bus shelter (Extent of roof canopy)
- Approximate area of Mill pond shown 1633
- Alignment of Globe Lane shown 1633 to present day
- Bastion outwork (Chatham dockyard defence) shown 1763
- New Gun Wharf, named in 1816
- Alignment of Military Road shown 1816 to present day
- Borehole
- Trial pit

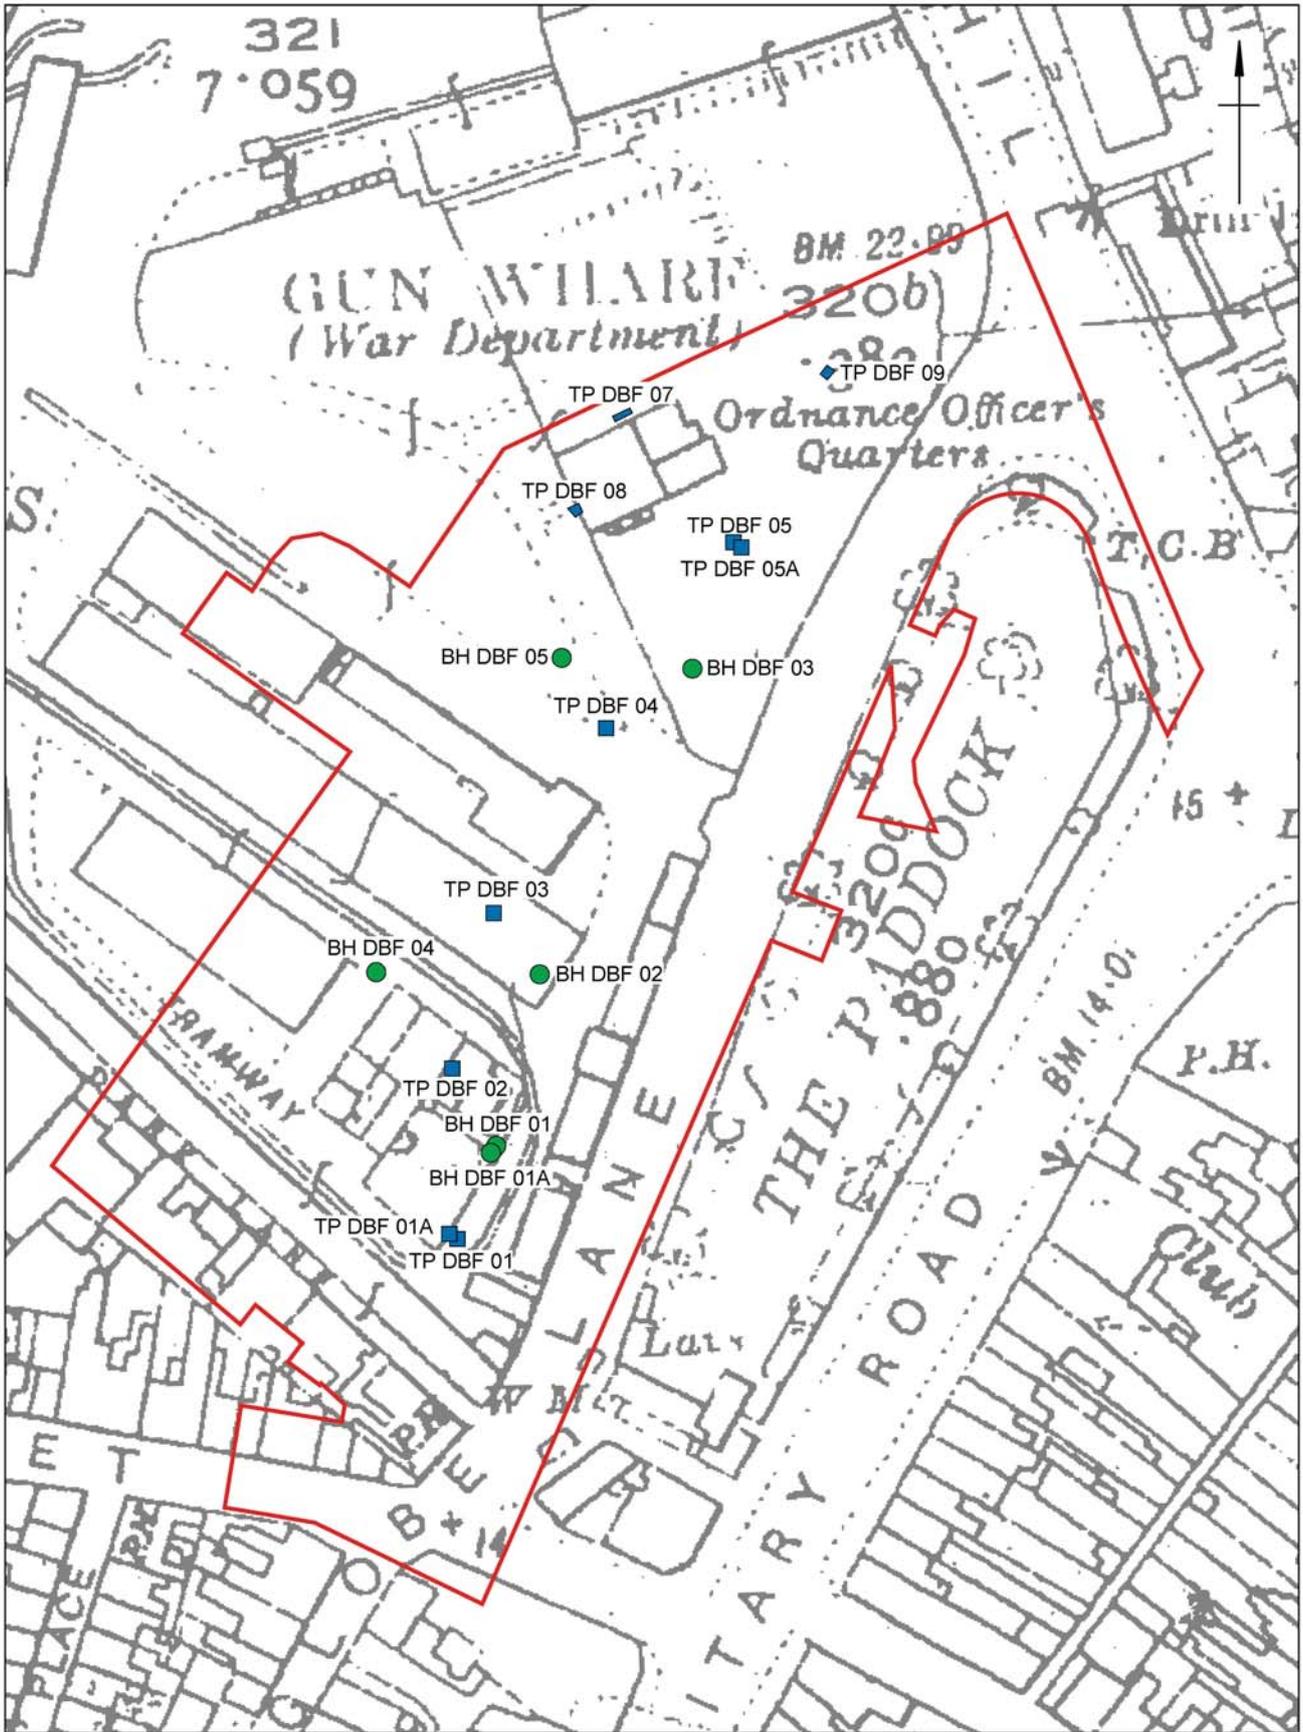
Figure 4

Ordnance Survey Map, 1932, with boreholes and trial pits overlaid

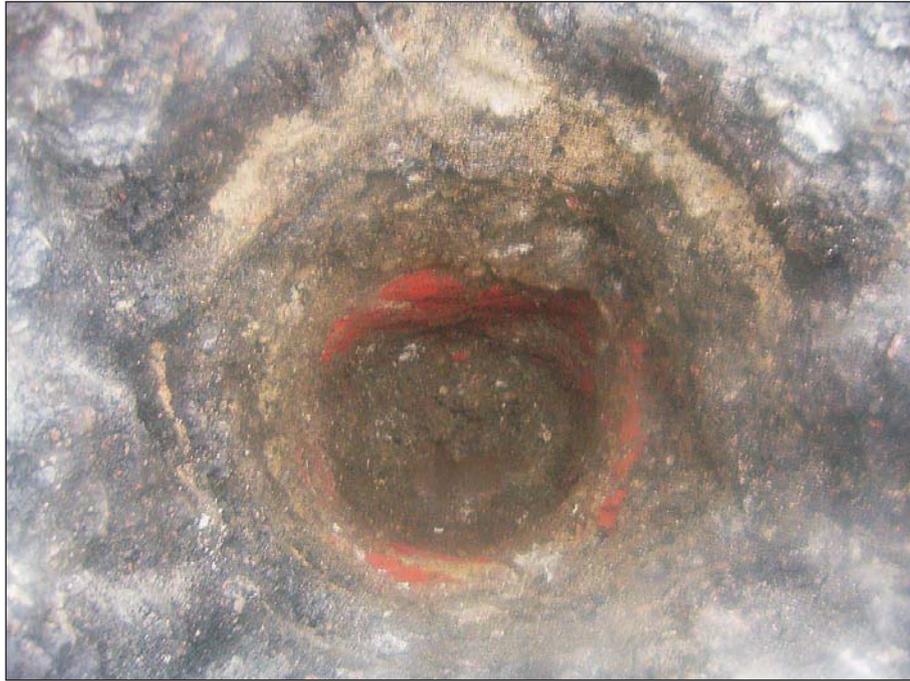
- 6.1.1 Archaeological features were only identified within two of the trial pits, and in none of the bore holes.
- 6.1.2 In **TP DBF 01a**, a feature (**103a**) of uncertain function, comprised of laid red brick courses was observed between two layers of made ground (**102a** and **104a**), 0.48m below ground level (**Plate 1**). This brick coursing layer was only about three courses (or 0.32m) thick. The feature is presumably either post-medieval or modern in date. Within the restrictions of the trial pit it was not possible to determine for certain its function (if any). It may have been simply discarded and used as make-up to help raise ground levels as with much of the other made ground on the Site. This seems the most likely explanation since it was sealed between two other dump layers.

Plate 1: Laid brick (103a) within TP DBF 01a: facing south-east

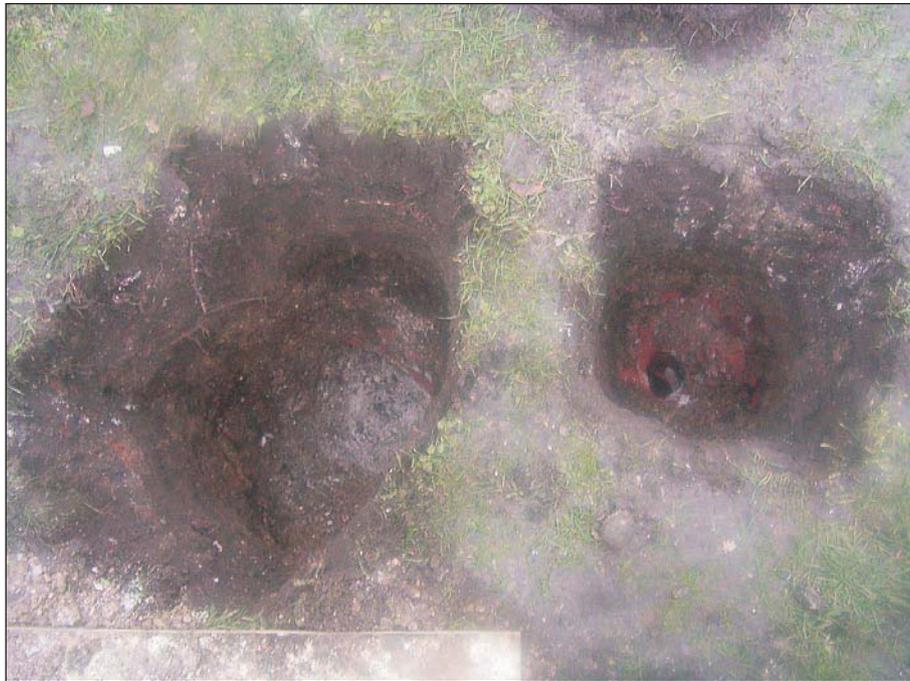
Plate 2: Brick culvert (503/503a) within TP DBF 05 and TP DBF 05a: facing south-west
