West Berkshire Integrated Waste Management Facility, Padworth, Berkshire

Archaeological Evaluation Report

Report reference: 71270

April 2009

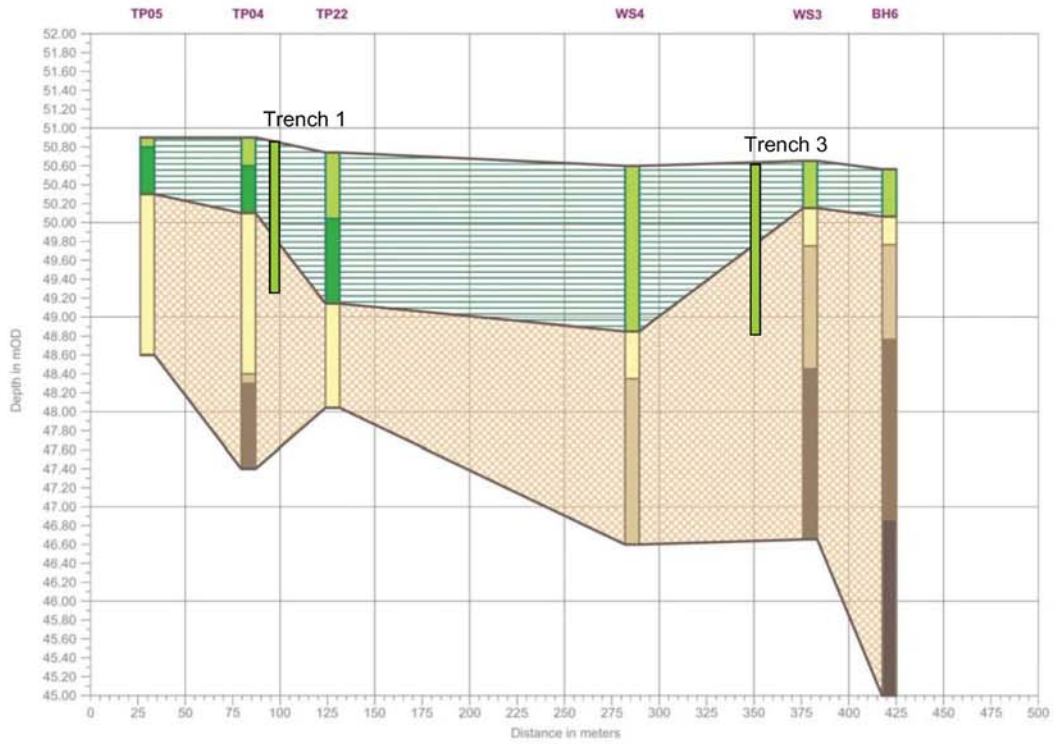
Transects A & B and locations of Evaluation Trenches

- 6.1.3 These conclusions are largely in accord with results compiled from bore hole and geotechnical test pit logs (Norwest Holst 2004; Capita Symonds 2007; Scott Wilson 2008, Fig 5). These records indicated that the depth of made ground, as reconstructed in transects aligned north-west to south-east across the former quarry, consistently measured between 1.5 -2m through the central part of the extracted area. This area largely coincides with where the evaluation trenches were located.

- 6.1.4 The deepest parts of the former quarry are between 3 and 4m below the modern surface height of the River Kennet floodplain.
- 6.1.5 The transects (as produced by Scott Wilson from data supplied by Norwest Holst and Capita Symonds, 2004) reproduced and updated here with the latest evaluation results, also indicate that the depth of made ground thins to approximately 0.5m near the edges of the former quarry (see **Sections A and B, Figure 2**). In these areas a greater depth of gravel remains is suggested; however as our own results indicate, what has previously been interpreted as undisturbed gravel may actually be redeposited and in addition it is probable that even where this may not be the case, surface stripping of topsoil and subsoil, in advance of quarrying, will also have damaged or removed most if not all traces of archaeological deposits from these peripheral areas.

Section A

Section B
