Anton Laundry, Shepherds Spring Lane Andover, Hampshire

Archaeological Evaluation Report

Report reference: 72300.02

October 2009

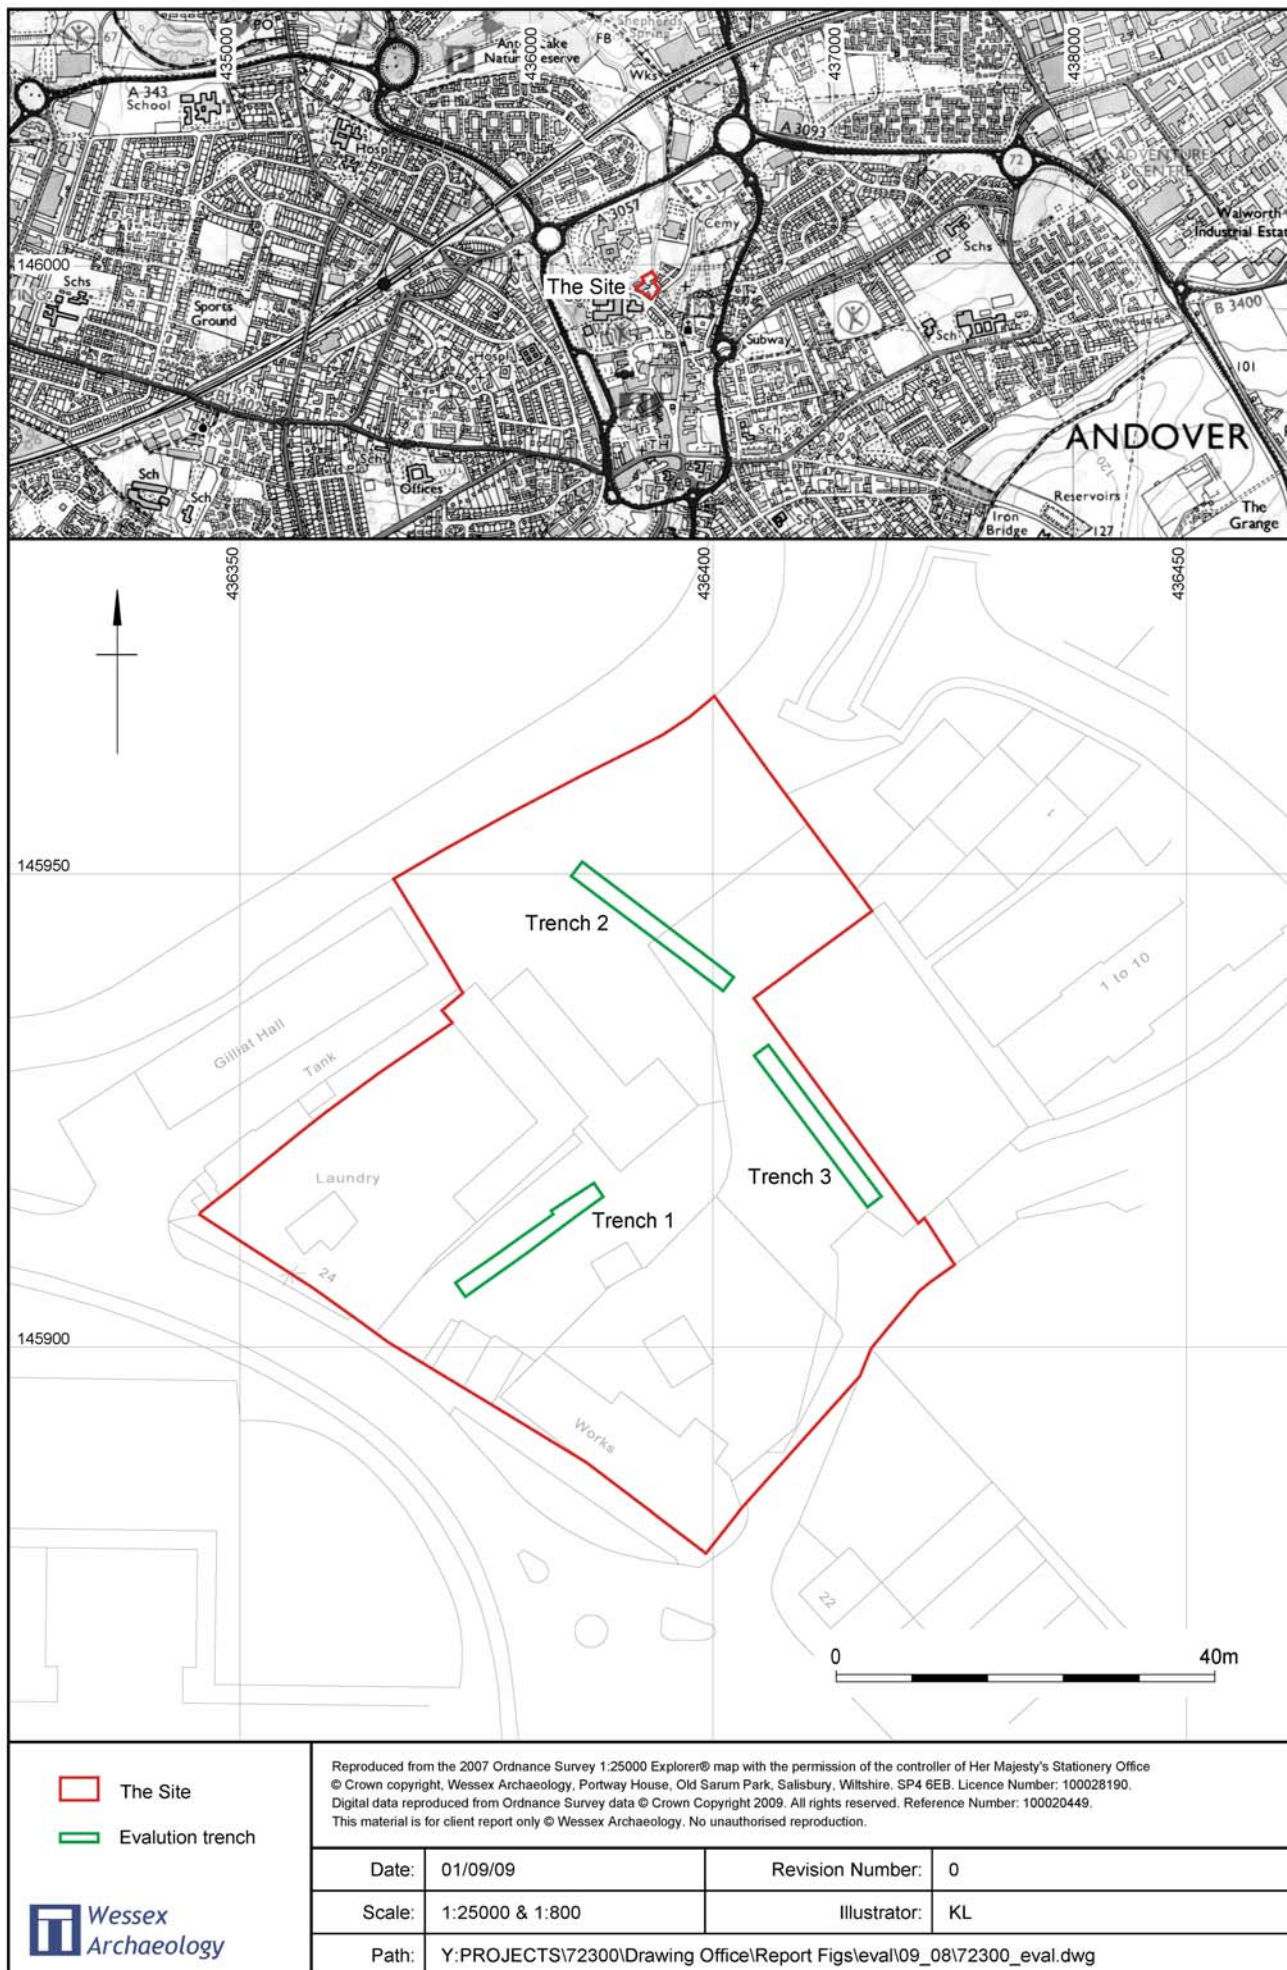
Figure 1

Site and trench location

1.2.1 The Site occupies a 0.27 ha area of land at the junction between Shepherds Spring Lane and Marlborough Street in Andover, Hampshire (NGR 436385 145923) (**Figure 1**) (hereafter the Site). At the time of the evaluation it comprised yard/car park space amongst upstanding 18th – 20th century buildings that were formerly the premises of the Anton Laundry.

- 2.1.1 Three trenches (**Figure 1**) were excavated using a JCB with a toothless bucket under constant supervision by an archaeologist. In line with Health and Safety requirements the trenches did not exceed 1.2m in depth unless investigative sondages were required, in which case records were made from the edge of the trench and the sondages were rapidly backfilled in consultation with the Client and LPA Advisor.
