## Tamworth Castle, The Holloway Tamworth, Staffordshire

Archaeological Assessment of Loggia Porch  
and Courtyard Evaluation

Report reference: 72370.01

**November 2009**

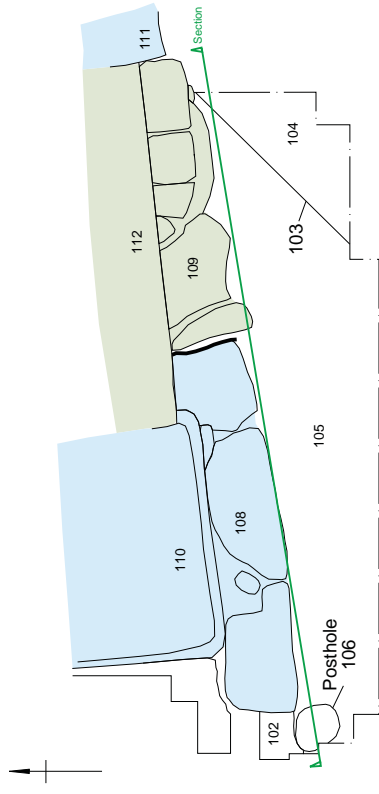
Trench 1: plan

- 3.2.8 The foundation area beneath the blocked opening is constructed in a clearly different style to that recorded below pier 110 (**Figure 3**). This foundation (context 109) is of rubble limestone construction with looser binding matrix. The upper east part has been repaired at some point using cementitious mortar and there are three ceramic roof tiles stuck to the face of the wall at the west end (**Plate 10**).

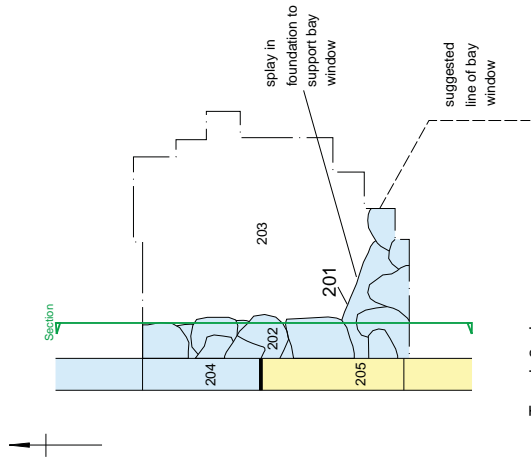
Trench 2: plan

- 3.3.2 After the removal of the courtyard bricks the underlying primary Motte material was identified (Context 203). The foundation for the east wall of the shop/café was clearly identified cutting into the Motte material (context 202). This consisted of rubble limestone bedded in a coarse lime mortar. Crucially an angled change in direction was recorded at the south end of the trench (**Plate 11**). This change in direction would be consistent with a foundation necessary to support the splayed angle of a bay window.

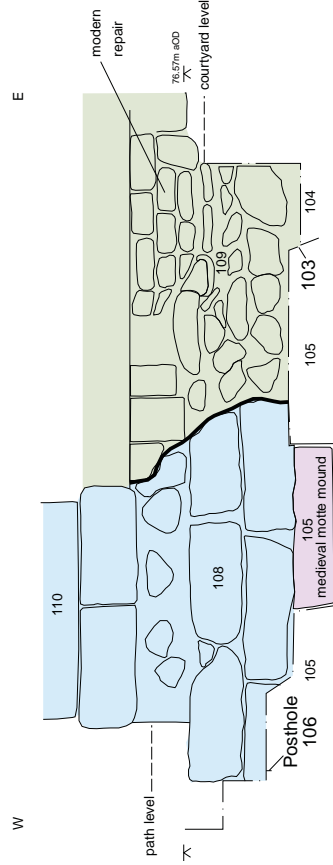
Trench 1: south facing section

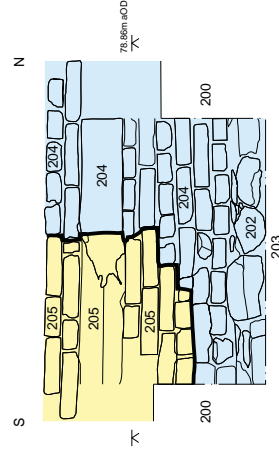
Trench 2: east facing section

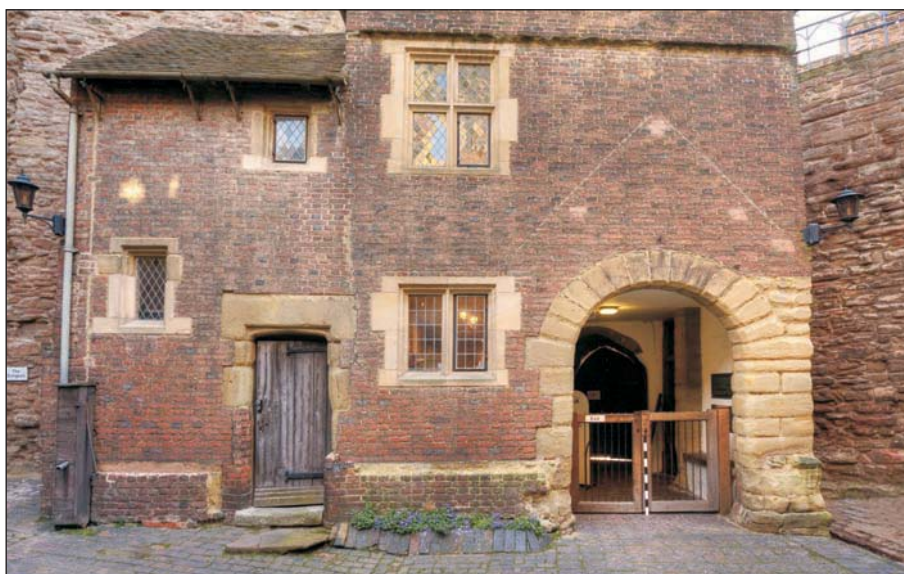
Plate 1: West facing porch elevation

- 3.1.3 The porch has been constructed from brick laid in English bond and there are limestone dressings around the window and door openings (**Plate 1**). The north end of the west facing elevation is built off a low plinth, the chamfered top of which is matched by the top of the plinths of the two arcade piers. The main rusticated arch is supported on dressed limestone springers with similar dressed and rusticated voussoirs. The outside faces of most of the voussoirs have stone masons marks on them. These consist of a mixture of the letters G and B. Similar marks are to be found on the voussoirs in the arch over the south entrance to the hall.

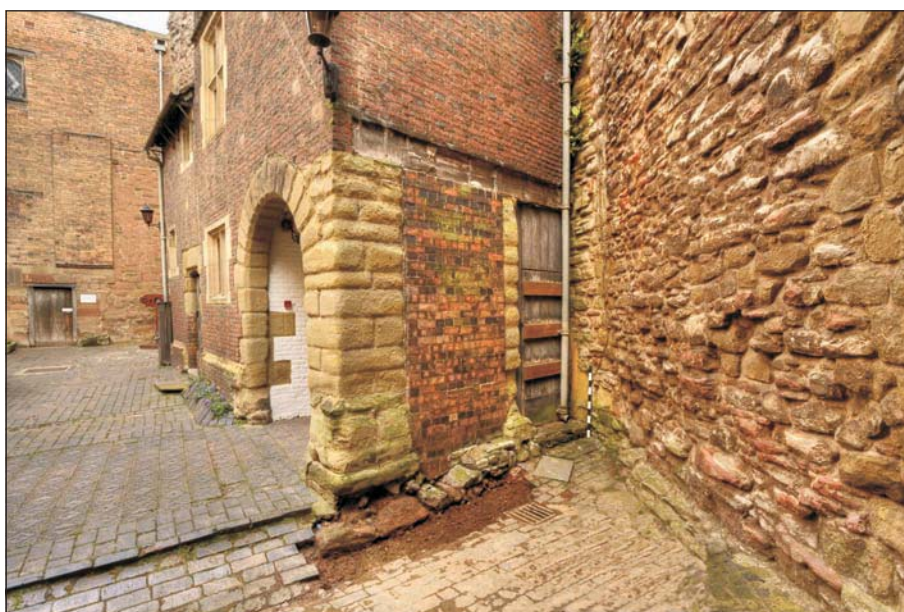
Plate 2: South side of loggia showing infilled arcade openings

- 3.1.4 The south side of the porch has two piers; one large stone pier (context 110) stands at the south-west corner of the porch and one smaller stone pier (context 111) is located to the east. The two piers originally formed an arcade of two openings which have both been infilled (**Plate 2**). The piers are constructed from ten courses of limestone blocks with very fine bed joints of lime mortar. These ten courses stand on dressed stone plinths of four courses above courtyard level.

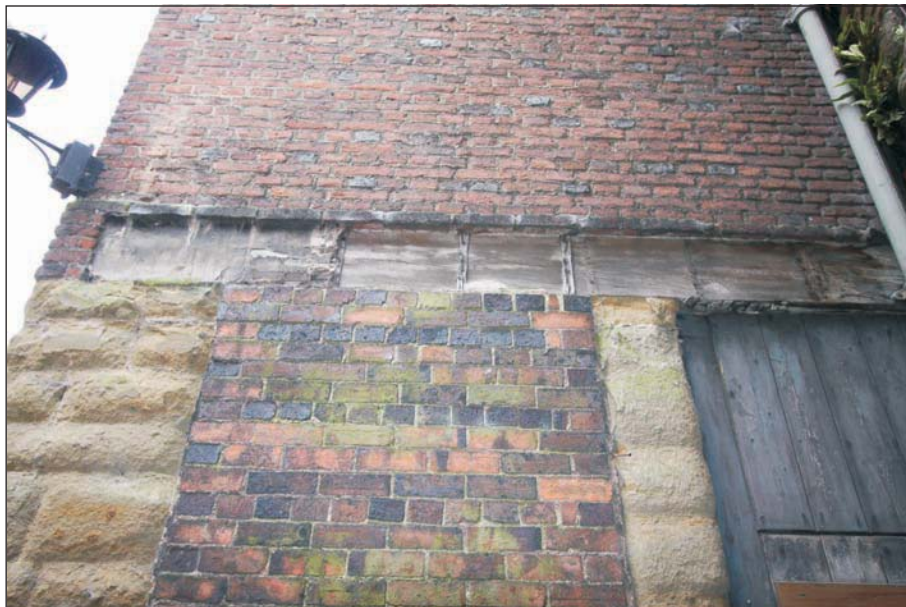
Plate 3: Horizontal beam spanning between piers

- 3.1.5 The two piers support a large horizontal timber beam 0.35m deep, its west end is supported on the south-west pier and its east end is set into the stone wall of the Castle for an unknown distance (**Plate 3**). The beam has some residual lath and plaster covering the south face of the beam and there is also a section of lath and plaster on the soffit of the beam (**Plate 4**). This section of lath and plaster protrudes slightly from the eastern-most arch soffit suggesting that it once extended south of the porch. It is possible that the east arch of the loggia porch was partly covered by a canopy but there is no further supporting evidence. No evidence of fixings or roof line was seen in the opposing curtain wall of the Castle but as large areas of this wall have been re-pointed this evidence may have been covered.

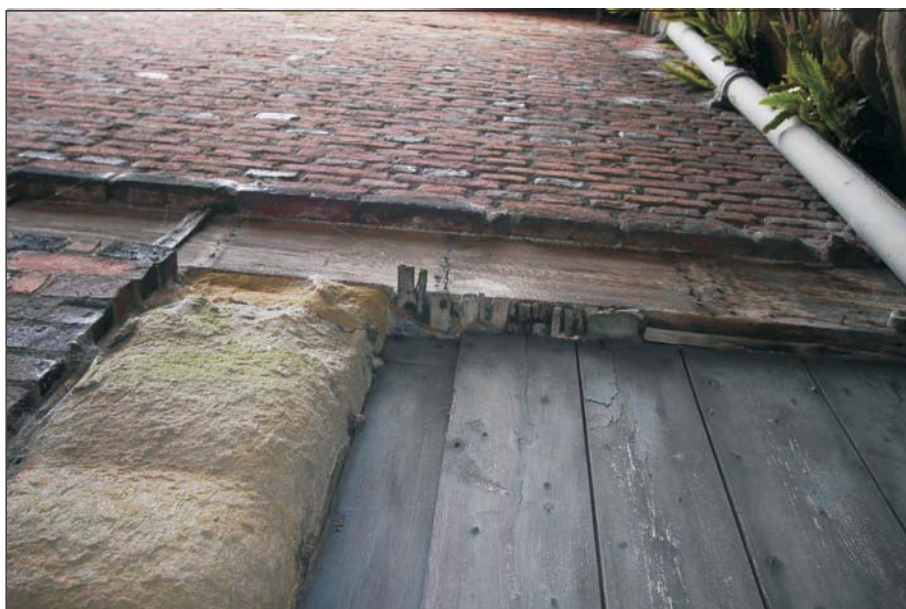
Plate 4: Detail of remnant lath and plaster on soffit of beam

- 5.1.3 Study of the south side of the porch has suggested that the lath and plaster, recorded on the soffit of the wooden lintel beam, at one time extended further to the south. No evidence could be found on the opposite stone curtain wall to indicate if it was once covered by a canopy. The large wooden beam appears to be part of the original build of the Warders Lodge. If any future work has to remove the plaster ceiling of the porch then important evidence might be exposed to shed more light on its relationship with the timber first floor of the lodge. It is difficult to determine if the lath and plaster are contemporary with the original build of the Lodge but its general appearance and style suggest a later, perhaps, 19<sup>th</sup> century date.

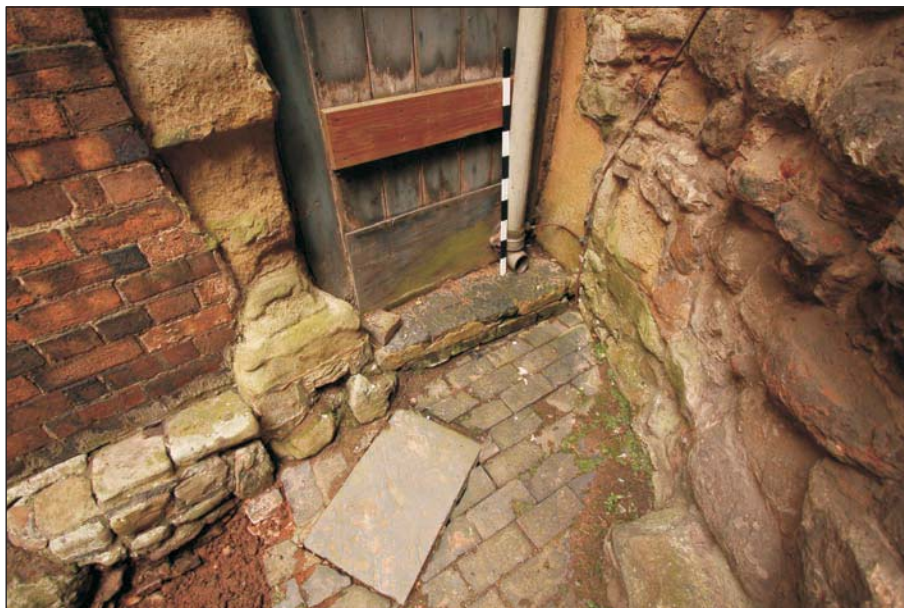
Plate 5: East blocked opening showing patterned tile step

- 3.1.8 The base of the east blocked opening has a step formed from the same patterned blue ceramic tiles (**Plate 5**). The opening has subsequently been blocked with wooden framing and panelling designed to look like an antique door (**Plate 6**).

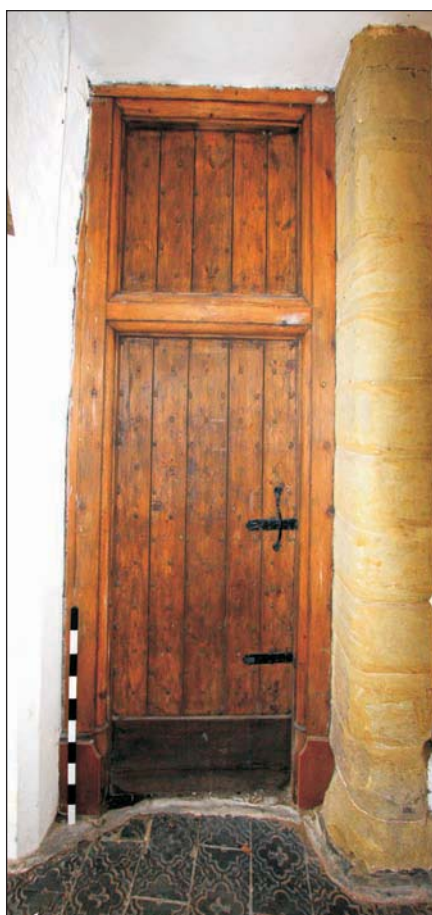
Plate 6: North side of false door in eastern blocked opening

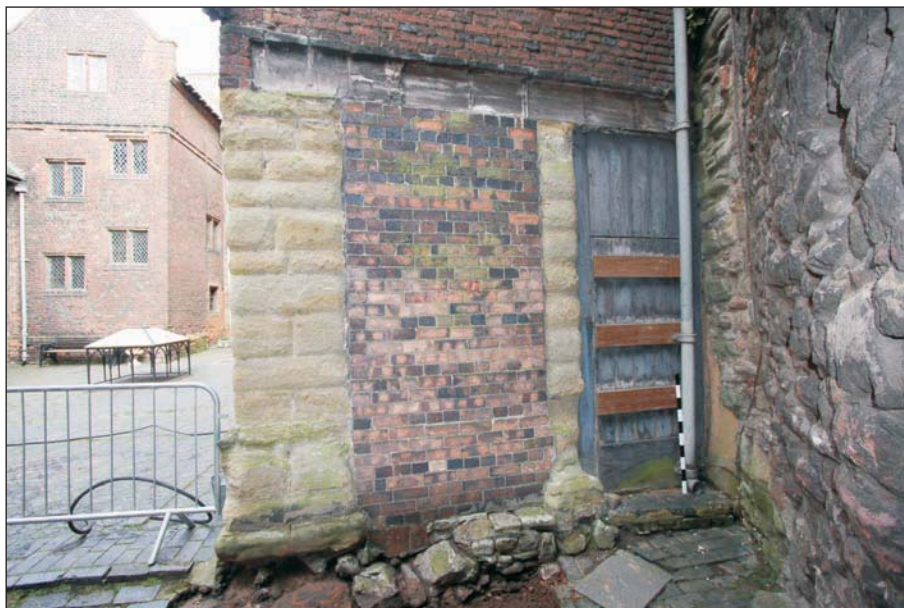
Plate 7: South side of west opening blocked with 19th century bricks

- 3.1.9 The west opening has been blocked with 19<sup>th</sup> century mottled coloured bricks (context 112) laid in English bond and bedded in coarse lime mortar (**Plate 7**). This forms a 9" (22cm) thick wall, the south side of which has not been painted. The north side has a low bench seat finished with a single course of overhanging bricks laid flat and the wall elevations painted white. Two bronze memorial plaques have been fixed to this side of the wall. The upper plaque was placed there in 1897 to commemorate the purchase of the Castle by Tamworth Corporation. The lower plaque commemorates the centenary of the public opening of the Castle.

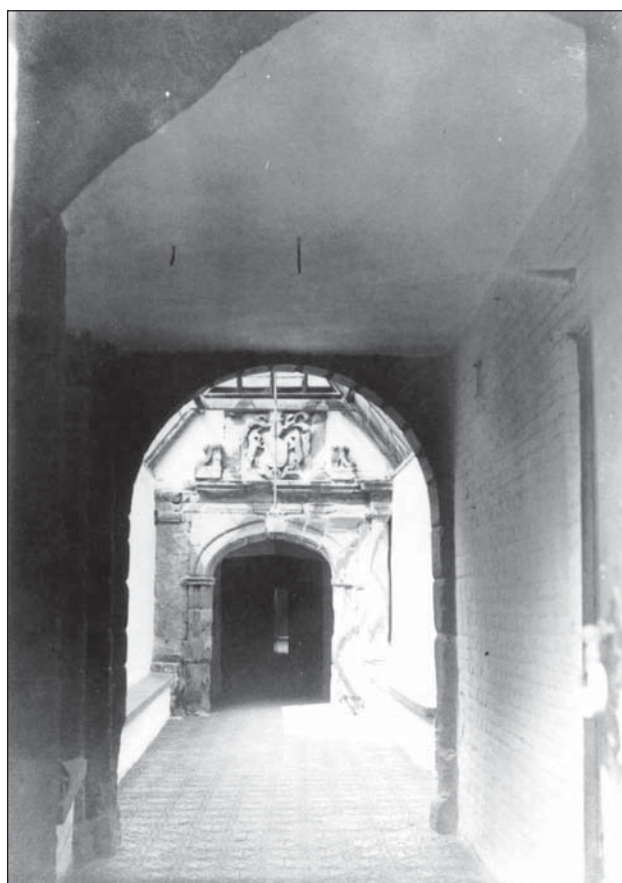
Plate 8: Late 19th century photograph of porch entrance viewed from east and showing 19th century covered way with glazed roof

- 3.1.11 An Ordnance Survey map of 1883 shows a block plan of the Castle Keep and surrounding area (**Figure 2**). This map shows a glazed covered way spanning between the loggia porch and the main building. A photograph dating to the late 19<sup>th</sup> century shows the covered way still extant (**Plate 8**).

- 3.1.12 The photograph of the covered way appears to show the structure had tall solid masonry walls along the north and south sides with a pitched and glazed roof. At low level along the north and south walls is a masonry bench seat similar to that recorded on the north side of the blocked west opening of the loggia porch.

- 3.1.13 The photograph has been taken when the sun was high as shadows are cast from south to north. The only light passing through the covered way is through the glazed roof. The walls are therefore thought to have been solid with no windows. The photograph also shows what appears to be an opening at the west end of the north wall. This would have given access to the north part of the courtyard. Access to the south courtyard was via the east opening in the loggia porch. The pattern tiled step noted above has the same tiles as the covered way.

- 3.1.14 The roof of the covered way was pitched and had a wooden frame with glazed panels. At its east end the roof timbers were set into the west wall of the storeyed porch. Evidence of a ridge board, purlins and wall plates can be seen where these features have been removed and the spaces in the wall infilled with bricks (**Plate 1**). The west end of the roof was a different design with a hip formed at first floor window sill level. This was created so that the height of the covered way roof did not extend over the window.

- 3.1.15 The photograph also shows what looks like a connecting rod for a ventilated panel running between the apex of the roof down to the centre of the main door arch.

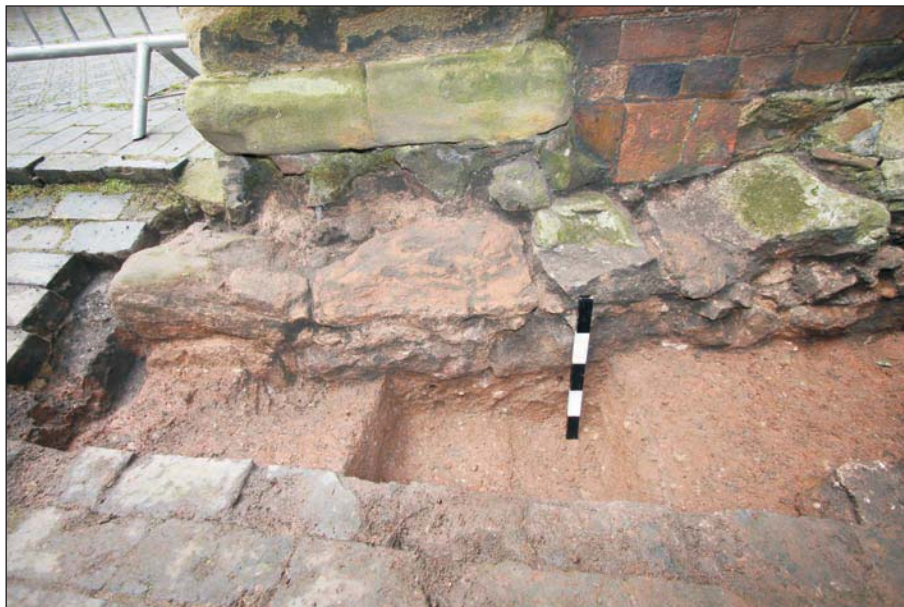
Plate 9: South facing section of Trench 1 showing foundation base cut into Motte mound

- 3.2.4 The south-west pier of the loggia porch was assigned context number 110 for the purposes of identification during excavation. The bottom of the foundations for the pier was encountered at a depth of 76.17m Aod (Above ordnance datum). This consisted of two courses of roughly squared

limestone blocks (context 108) laid in a coarse lime mortar (**Plate 9**). These formed a pad 1.4m wide and it is assumed that this foundation 'pad' was 1.4m square forming discrete foundations under each of the piers rather than strip foundations.

- 3.2.5 This foundation layer had clearly been cut into the underlying Motte material 105. The cut for the pier foundation (context 113) was tight against the faces of the stones so a wider foundation trench was not dug.

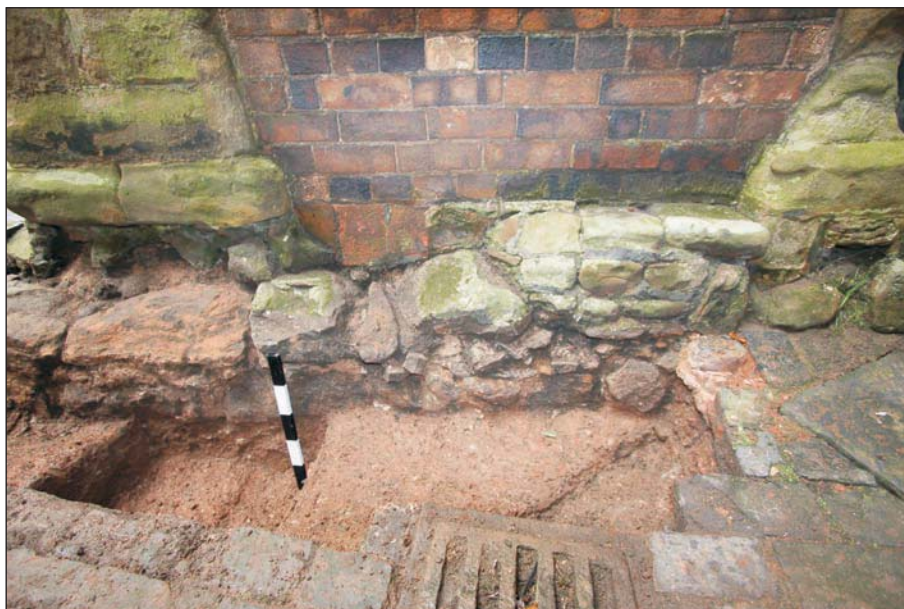
Plate 10: South facing section of Trench 1 showing foundation beneath 19th century blocked opening, later repair, and hanging tiles
