Kelham Rolling Mills, Sheffield An Archaeological Investigation

Ref: 76020
July 2016

KELHAM ROLLING MILLS, SHEFFIELD – AN ARCHAEOLOGICAL INVESTIGATION

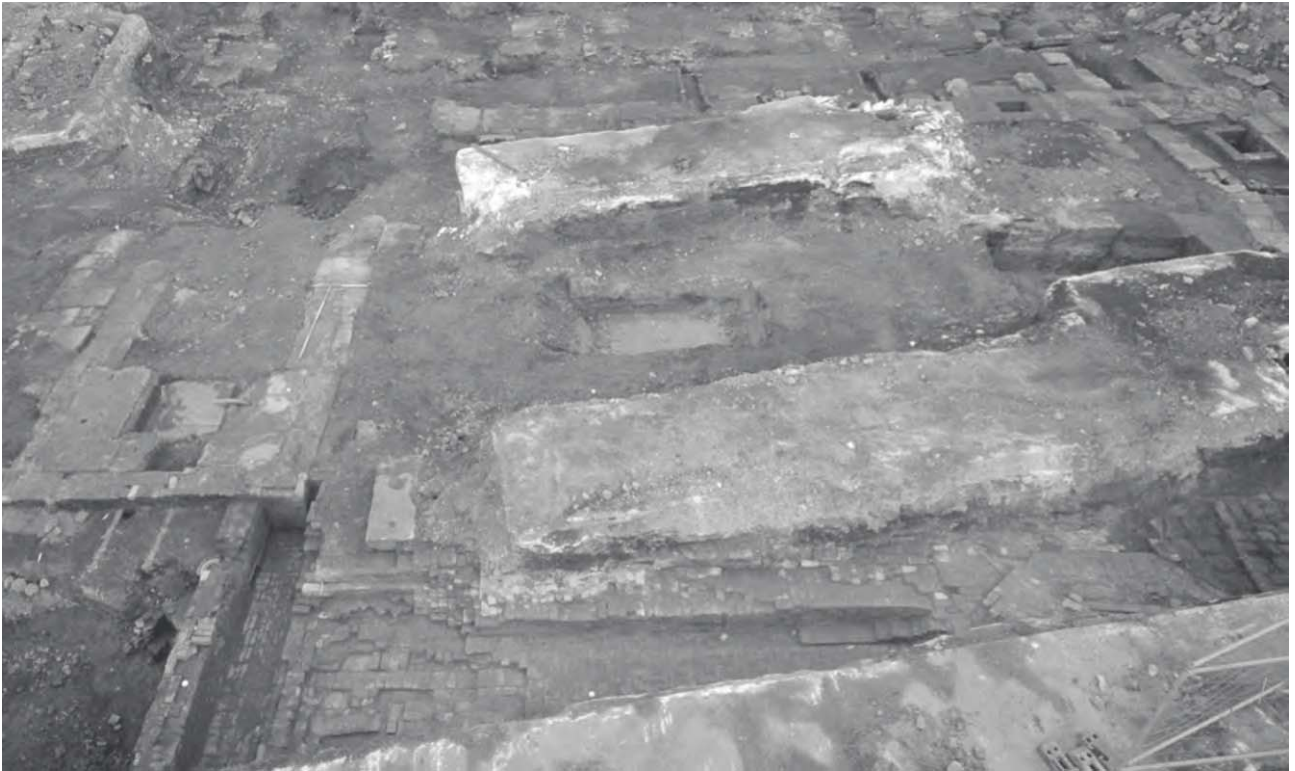
Plate 1: Lancashire boiler base and part of interior of rolling mills, with modern concrete intrusions (area B). From south; scales = 1m and 2m (© University of Sheffield. Reproduced by permission)

At the eastern end, the boiler base was linked to a partially exposed octagonal chimney (D) (Plate 1), and the layout depicted on the 1853 OS map indicates that the chimney served all three boilers shown on the map. A sandstone floor (E) set around the chimney to the north-

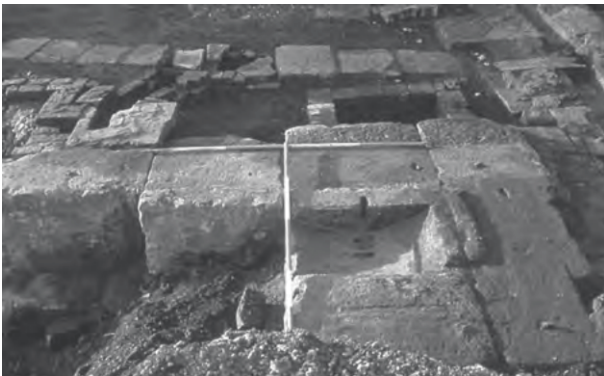
Plate 2: Structure G – drive shaft housing and fly-wheel location (area B). From east; scales = 2m (© University of Sheffield. Reproduced by permission)

The second drive shaft extended to the eastern end of the rolling stands (I) (Figure 3). The drive shaft housing (G), probably with a further fly-wheel (with a diameter of at least 0.65m, indicated by a semi-circular hollow), was anchored to a setting of sandstone blocks (Plate 2). Several iron pins and slots were probably associated with securing the housing and perhaps other machinery linked to the rolls. A drain cut into the blocks at the east end and lined with brick (see water flow on Figure 3) indicates that the rolls were water-cooled when in operation. The drain running from this area fed into a large stone-lined drain (K) flowing alongside the rolling stands (see water flow on Figure 3), confirming their contemporaneity. A steam engine which provided additional power to the east-west drive shaft, via a second north-south drive shaft, could have been located in (or above) a cellared structure (H) to the south of the drive shaft housing (G) (Figure 3). The cellar walls were constructed from handmade red bricks and the floor was sandstone flagged; iron pins in the eastern, buttressed wall were presumably associated with machinery. It is probable that a large iron

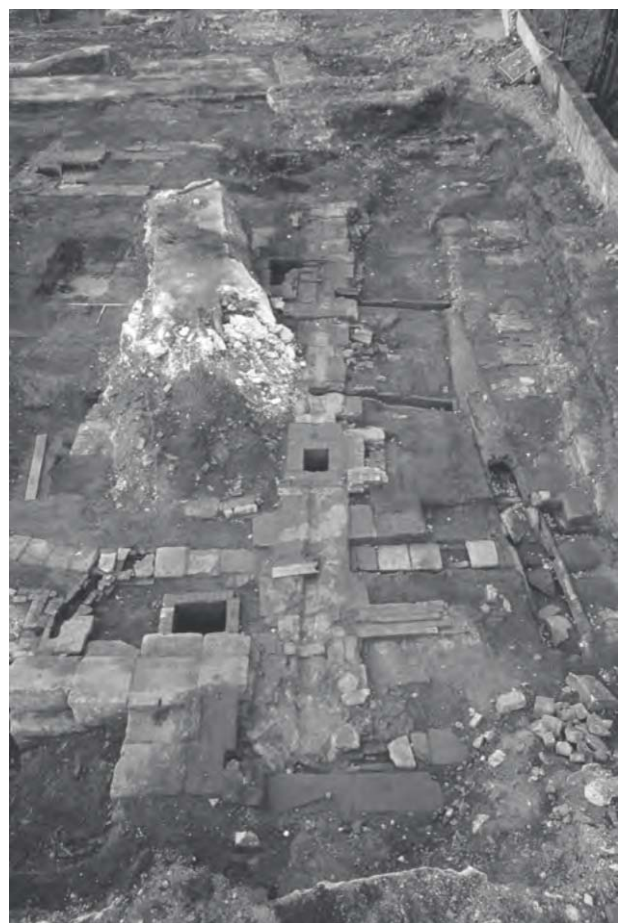
Plate 3: Rolling stands i – iv and associated drains (area B). From south; scales = 1m and 2m (© University of Sheffield. Reproduced by permission)

The principal surviving feature of the Kelham Rolling Mills was the rolling stands themselves. Whilst it is possible that these rollers were located in the first building noted from 1838, they appear to form an integral part of the later, 1853 design. Although the upper portions of the stands were missing, and part of the area had been destroyed by more recent concrete foundations, a surprising amount of structural detail can be gained from the surviving footings. The stands (I) were aligned east-west (Plate 3) and consisted of a series of sandstone blocks (Figure 3), arranged to form the supports for four individual sets of rollers (i–iv) (Figure 3); an arrangement of ‘One row of rolls of four pairs of rollers with driving gear’ was noted in the 1864 flood claim (Appendix 1). It would appear that rollers i and ii were linked by the same group of foundation blocks and probably worked in tandem. A short length of brick wall separated rollers ii and iii, whilst rollers iii and iv were separated by a square recess (J), which appeared to be part of a drain, with openings observed running to the north and south (Figure 3).

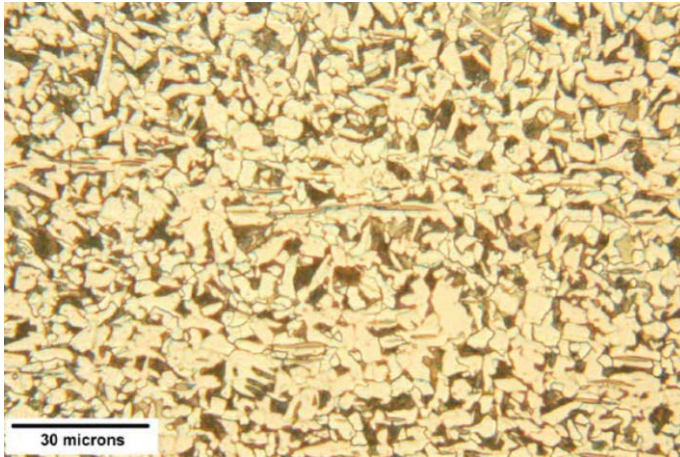
Plate 5: Metallographic section of rail showing generally uniform microstructure of pearlite and ferrite

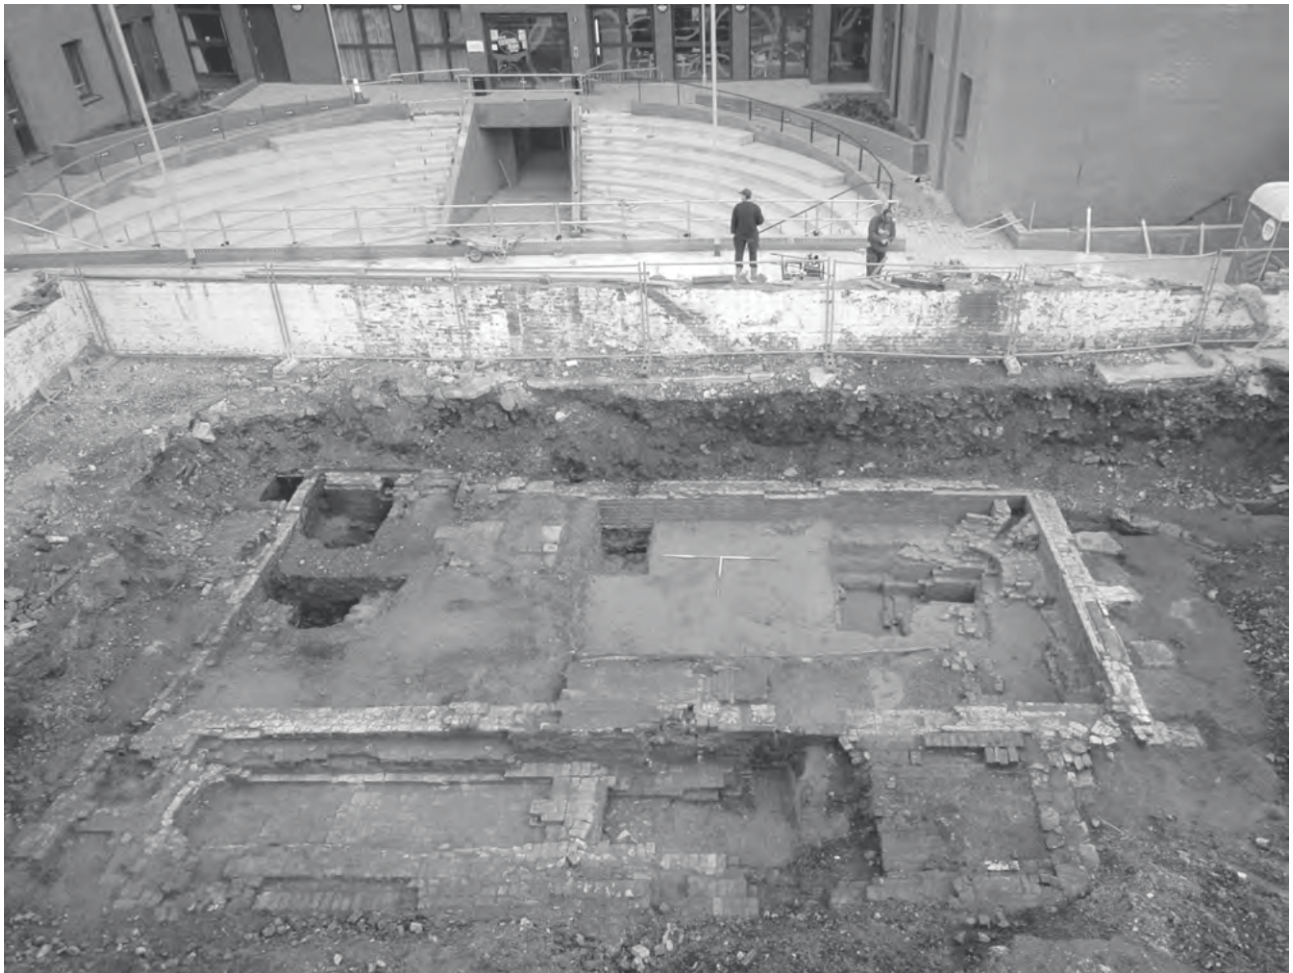
Plate 7: Building A with boiler 'annexe' on west side (area C). Scales = 1m and 2m (© University of Sheffield. Reproduced by permission)

The excavations revealed the brick walls of the more northerly building (A) (Figure 6), which measured 13.75m by 6.25m (Plate 7). The walls were constructed from red handmade bricks on a sandstone foundation, and at least nine courses of the wall had survived. Some repair was evident within the walling and there was the remains of an internal partition; no

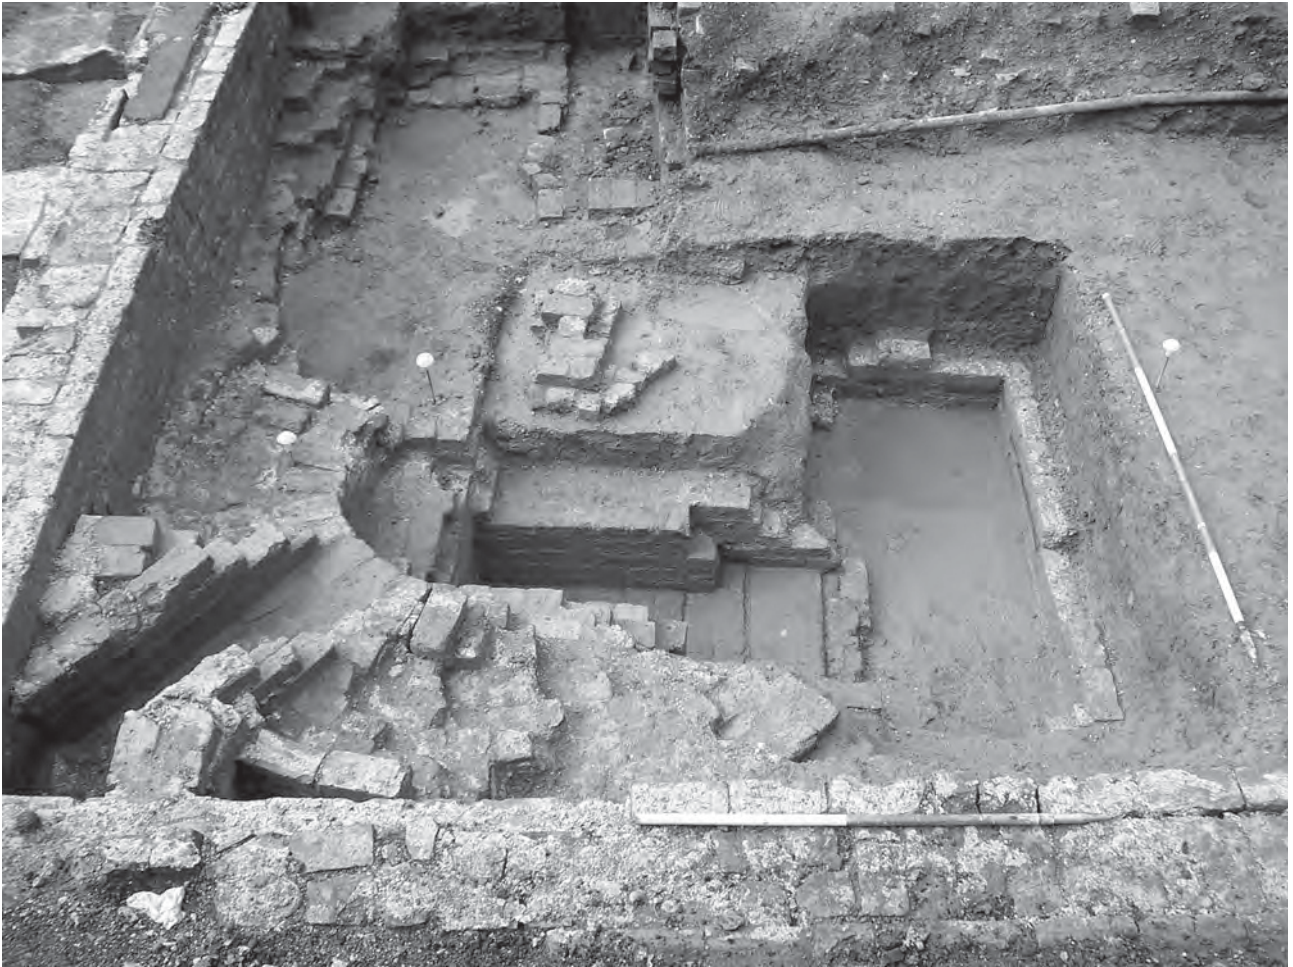
Plate 8: Building A – structures B, C and D in south-west corner (area C). Scales = 1m and 2m (© University of Sheffield. Reproduced by permission)

Within building A was an enigmatic, red handmade brick, lime-mortared, semi-circular structure (B) containing a core of firebricks (Figure 6; Plate 8). This structure was built within the south-eastern corner of the building, with a short flue which extended to the corner of the building. The bricks of the semi-circular structure abutted the building's brickwork suggesting that it was a later addition, possibly contemporary with the Lancashire Boiler (see below). The exact function of structure B remains unclear; however, the presence of a substantial firebrick feature with a flue leading directly from the probable firing area suggests the presence of a boiler. The possible cylindrical nature of this installation and its proximity to the smithy, directly to the south, may indicate a vertical boiler and blowing engine. Within this part of structure B was a small, L-shaped room with a brick floor (D) which was keyed into the semi-circular structure. It is possible that this room provided access to structure B, possibly to stoke the boiler above. The northern part (C) of the L-shaped structure (D) could have formed a small recess to house the fly-wheel which may have driven an air pumping cylinder located above the boiler.

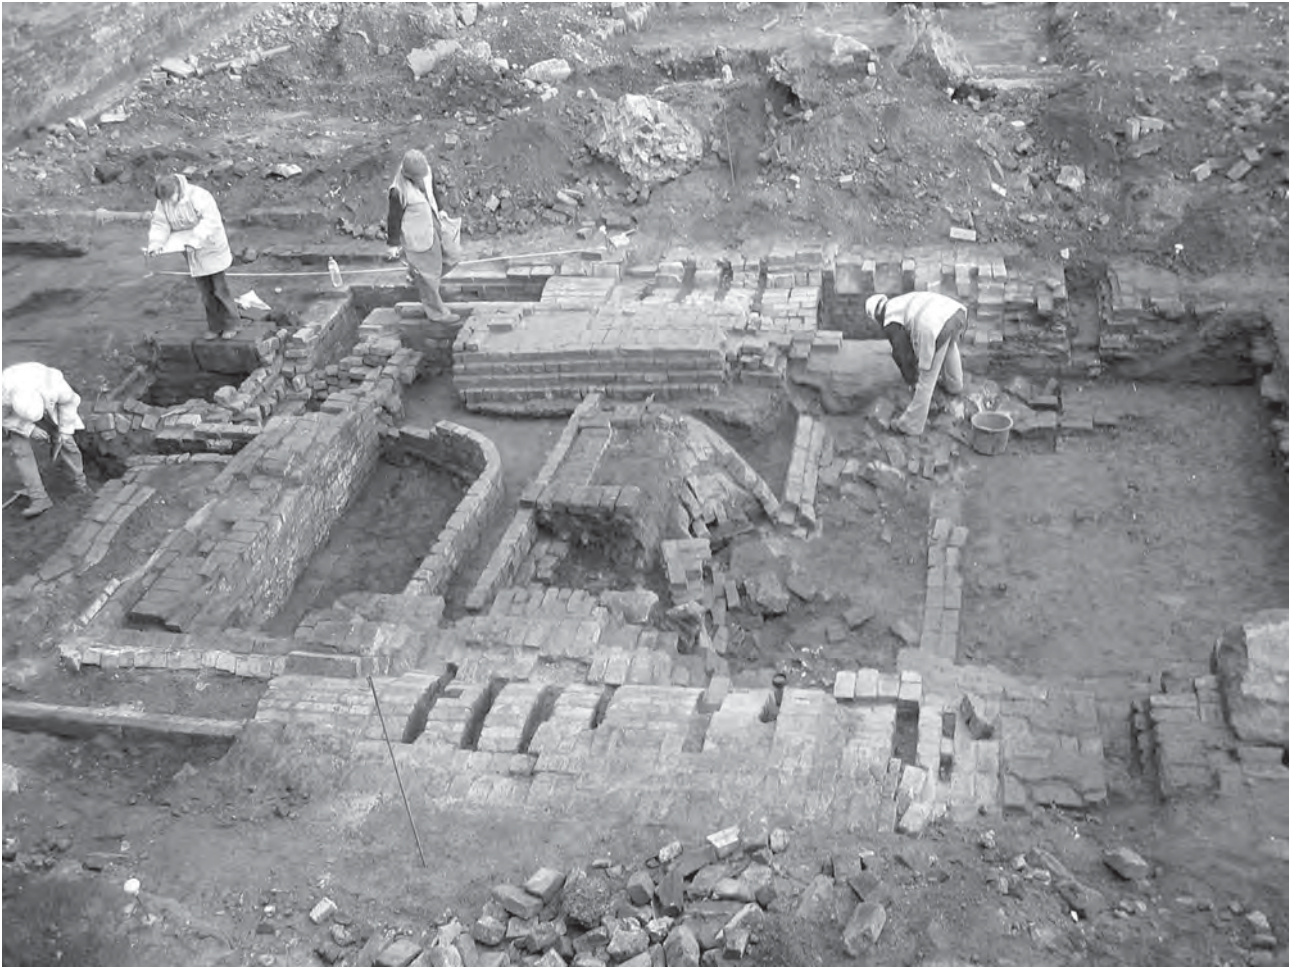
Plate 11: Brick kiln (and earlier) flues (area A). From south (© University of Sheffield. Reproduced by permission)

The sub-surface features of the brick kilns comprised two substantial L-shaped structures (B and C) which mirrored each other (Figure 7). The flue structures measured over 8m east-west in length with 3m long returns which fed into the eastern end of chimney flue A (Plate 11). The flues were constructed predominantly from firebricks and measured 1m deep with a vaulted roof extending from the vertical walls. At the western end of the flues were two sets

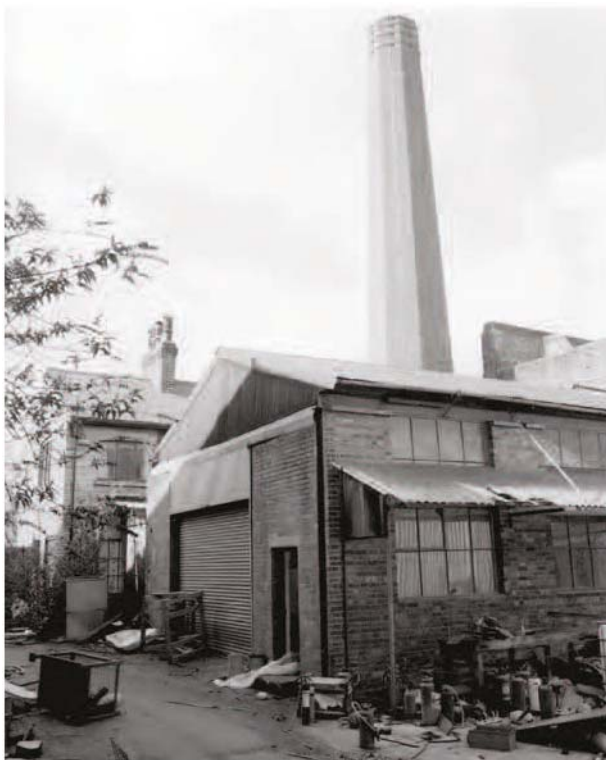
Plate 12: Brick kiln building, with octagonal chimney (building G4) to rear. From north-east (© University of Sheffield. Reproduced by permission)

The brick kiln, of probable down-draught type, was constructed within a purpose-built structure (G5) with windows and a wide entrance to the east. At the western end of the flues were two sets of four transverse slots built along the top of the flue structure, these slots indicating the position of the down-draught vents bringing hot air from the furnace via the brick kiln drying chamber above. Although no evidence of a furnace was found, it is probable that this lay close to the drying chamber, at or above ground level. From the kiln, exhaust gases passed through the series of flues and then into the octagonal chimney located at the south-western corner of the site.
