## Colne Priory, Earls Colne Near Colchester, Essex

Archaeological Evaluation and Assessment of Results

Report reference: 77503.01

**April 2012**

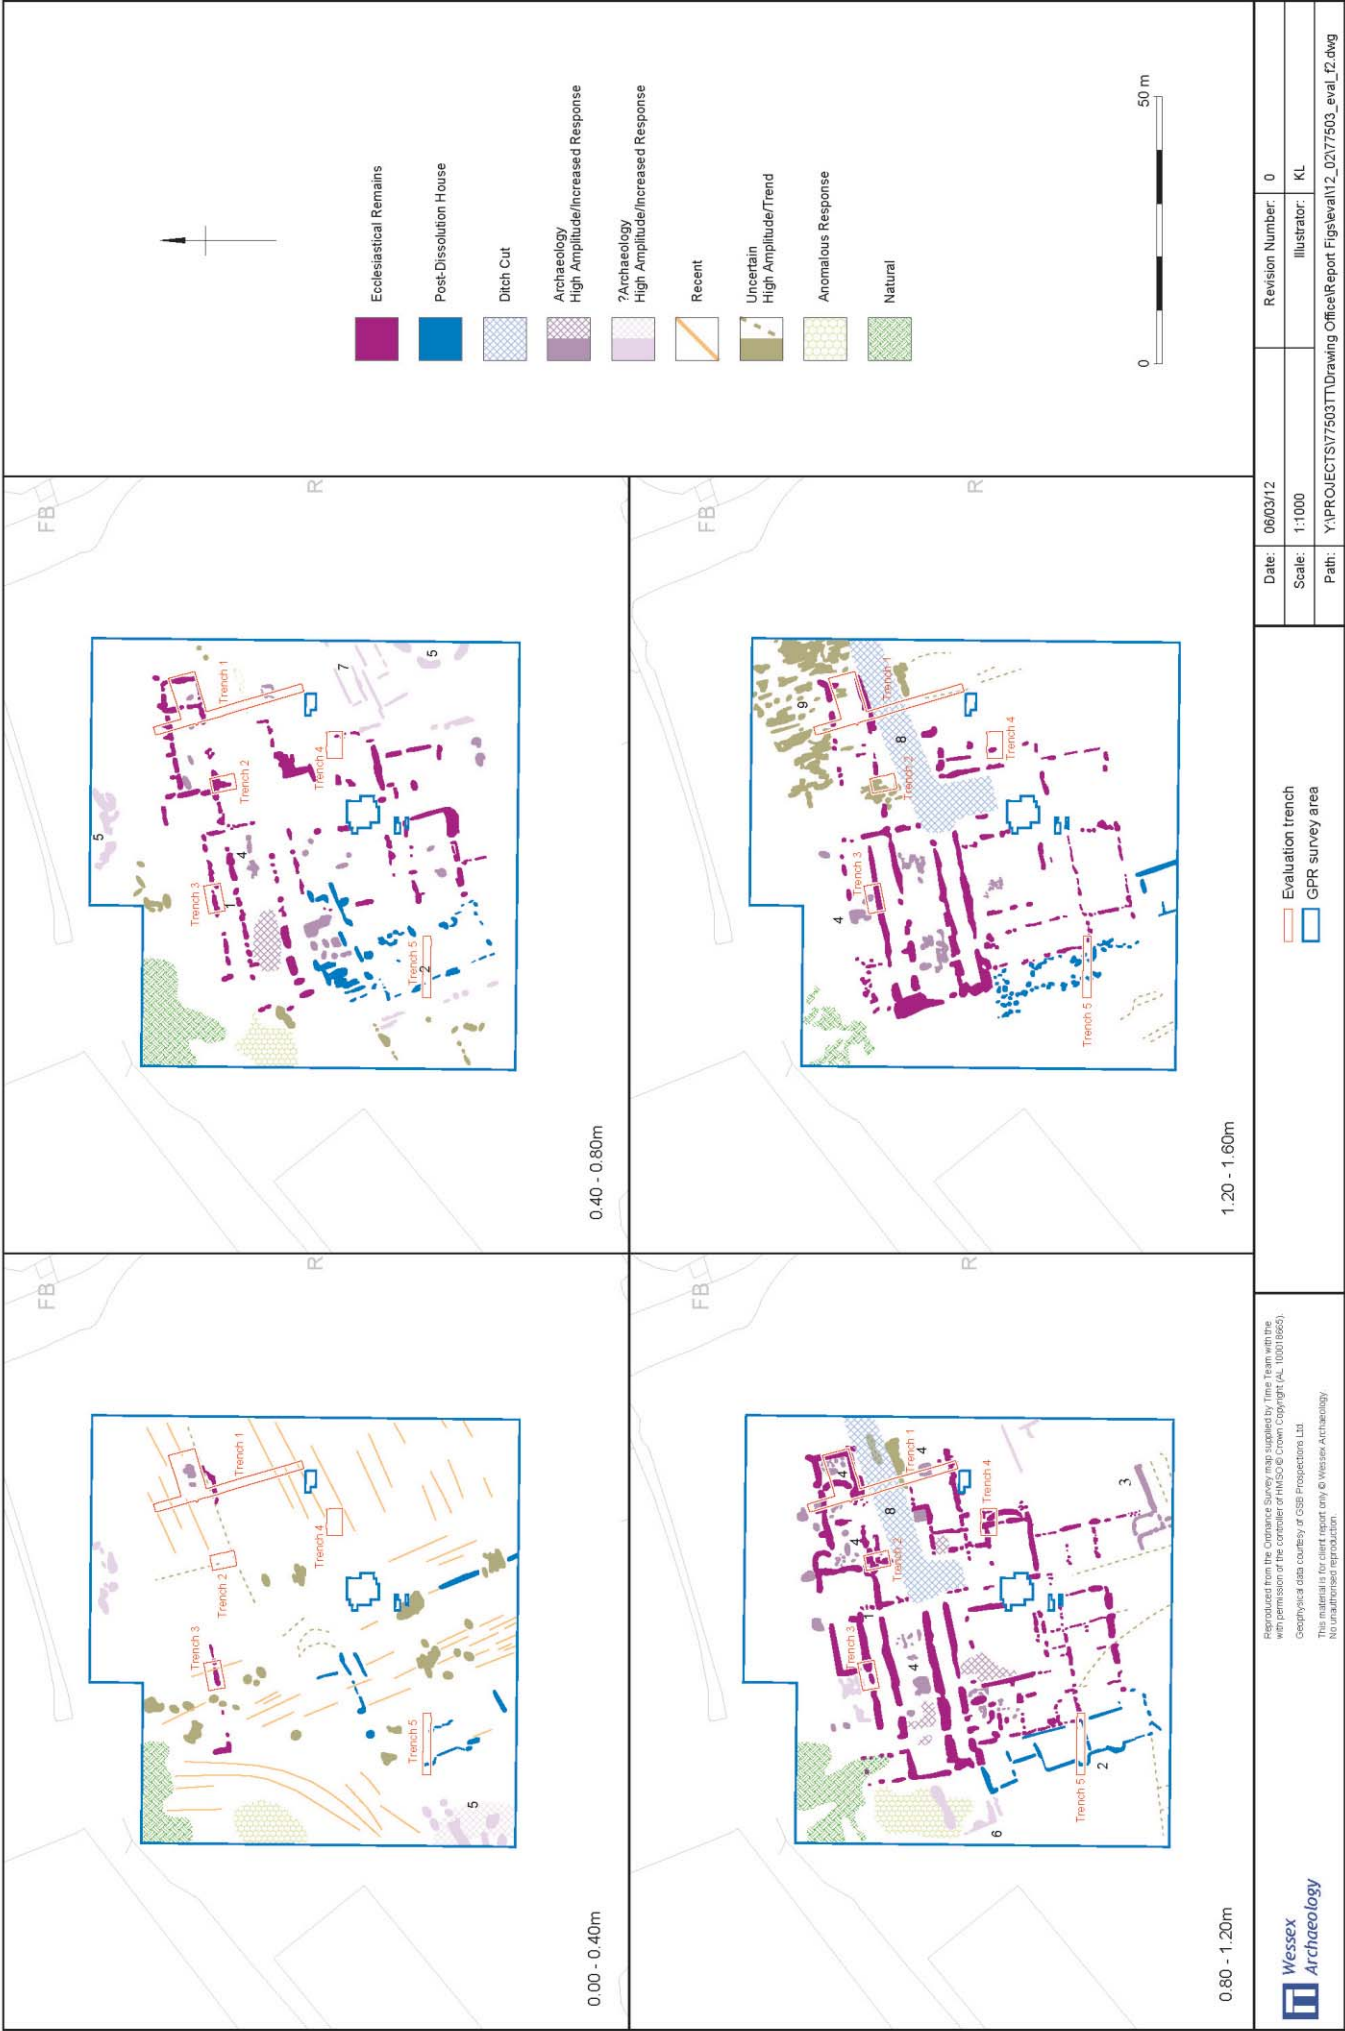
Figure 1

Site location, trench location and location of survey area

1.1.1 Wessex Archaeology was commissioned by Videotext Communications Ltd to undertake a programme of archaeological recording and post-excavation work on an archaeological evaluation undertaken by Channel 4's *Time Team* at Colne Priory, in the village of Earls Colne, Essex (hereafter the 'Site') (**Figure 1**).

- 3.2.1 Five trenches (Trenches 1-5) of varying sizes were excavated, their locations determined in order to investigate and to clarify geophysical anomalies and to address specific research objectives (**Figure 1**).

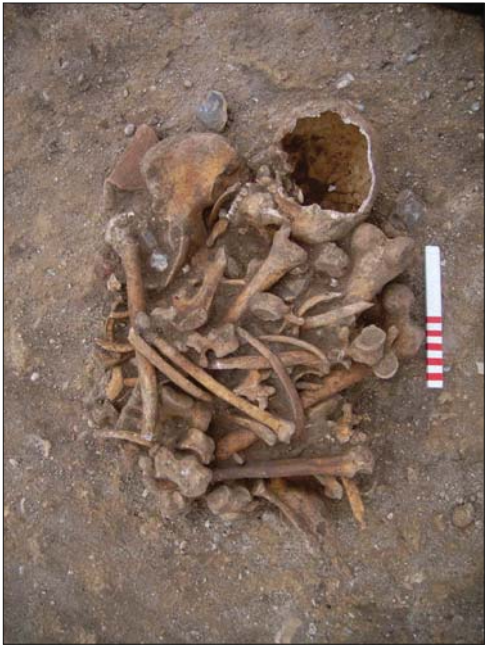
Plate 3: Charnel remains 126, view from north-west

- 4.3.15 Four charnel groups were found in Trench 1 (**126**; **115** in cut **114**, **122** in cut **121** [not illustrated on **Figure 5**]; **141** in cut **140**). Charnel group **126** (**Figure 6, Plate 3**) did not lie within a cut but appeared to have been contained in a small bag placed directly upon the robbed wall (**152**). The other three deposits were all within small cuts (**Figure 6, Plate 4**).

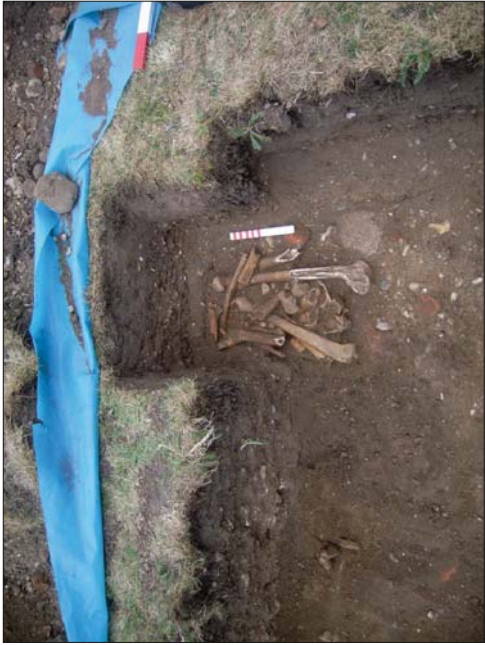
Plate 4: Charnel remains 114, view from east

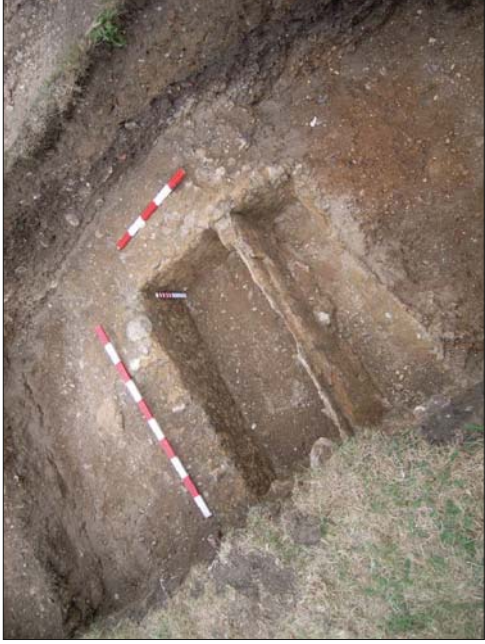
Plate 5: Tomb Group 194 cutting southern presbytery wall 144, view from north-east

- 4.3.12 A second vault/tomb Group **194** lay to the north, composed of cut **105/108**, mortar lining **110** and internal wall **112**. This vault/tomb had been cut directly into the foundation of the southern Presbytery wall **144** (**Figure 6, Plate 5**), indicating that this wall had been removed to provide access though into the Lady Chapel from the Presbytery. Both tombs were constructed to receive two individuals, most likely husband and wife, although the remains had been subsequently removed (see below, Phase 3).

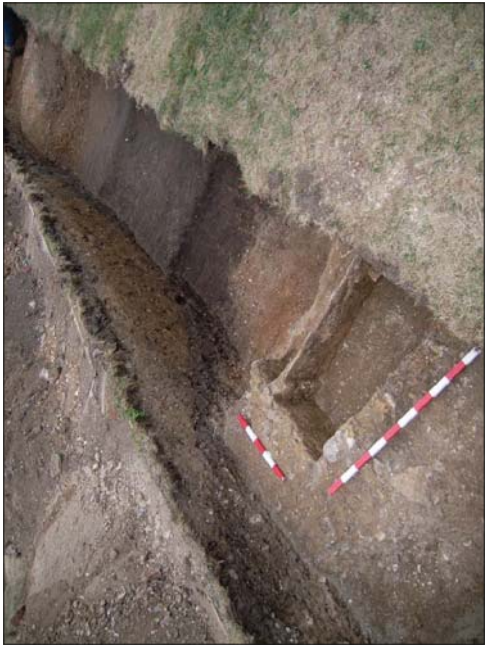
Plate 6: Tomb Group 194 cut by ditch 103, view from south-east

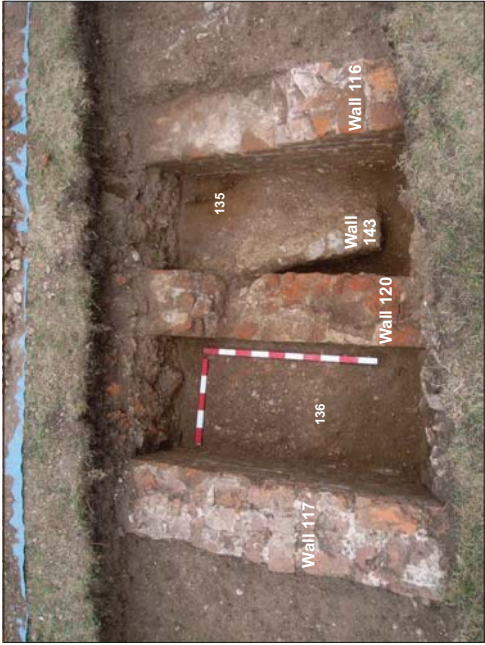
Plate 7: Tomb Group 189, view from east

- 4.3.19 A single wall aligned roughly north-east to south-west (**143**) was observed below the floor of Tomb Group **189** (**Figure 6, Plate 7**). The feature clearly pre-dates the 15th/16th century tomb, but a closer date could not be assigned. It is just possible that it belongs to a pre-12th century construction, perhaps related to the pre-Norman Minster recorded in the will of Leofgifu (c.1045), as it is clearly on a different alignment to the main body of the Priory church. This is, however, purely conjectural as not enough of the feature was revealed for interpretation, but the alignment of the wall does correspond with anomaly (7) from the GPR survey (**Figure 2**), which was interpreted as possible evidence of pre-Priory structures on a different orientation.

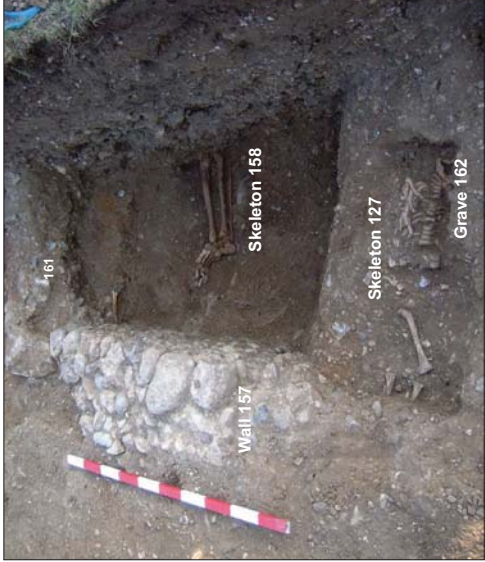
Plate 8: Tomb Group 190, view from east

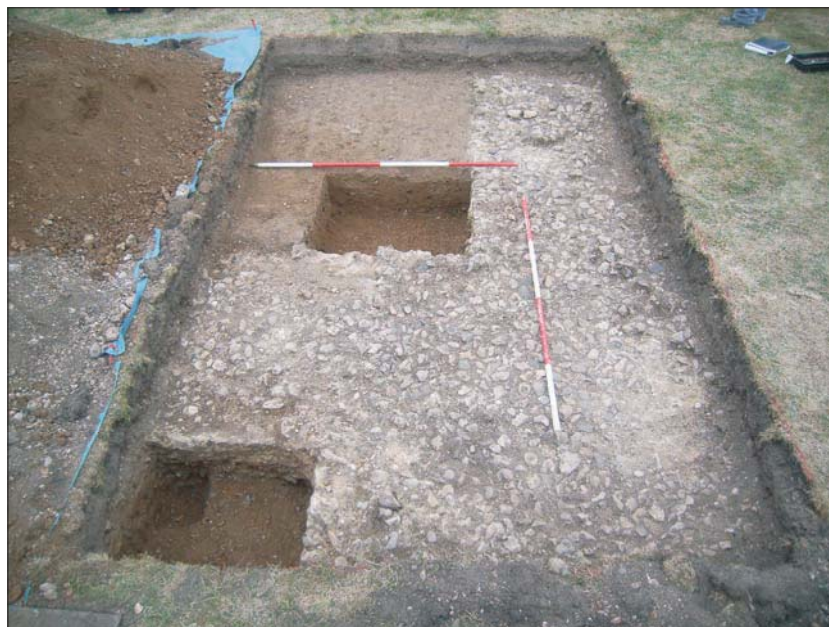
Plate 9: Trench 2, view from north

- 4.3.20 Trench 2 was positioned at the north-west corner of the presbytery, at the junction with the crossing tower and the northern transept as indicated by the geophysical survey (**Figure 4**). The earliest recorded layer was **206/207**, a probable alluvial layer which overlay the natural river terrace gravels **210**. A single sherd of Roman pottery was recovered from **207**; it was cut by **203**, the foundation trench for walls **204** and **205**. Constructed in the same manner from flint nodules within mortar slurry, **204** formed the northern respond for the eastern arch of the crossing tower leading into the presbytery, while **205** formed the northern wall of the presbytery (equivalent to **150** in Trench 1) (**Figure 7, Plate 9**). A small sondage was excavated through **206** at the junction of **204** and **205** which revealed that they were contemporary and constructed upon a rammed gravel and mortar foundation.

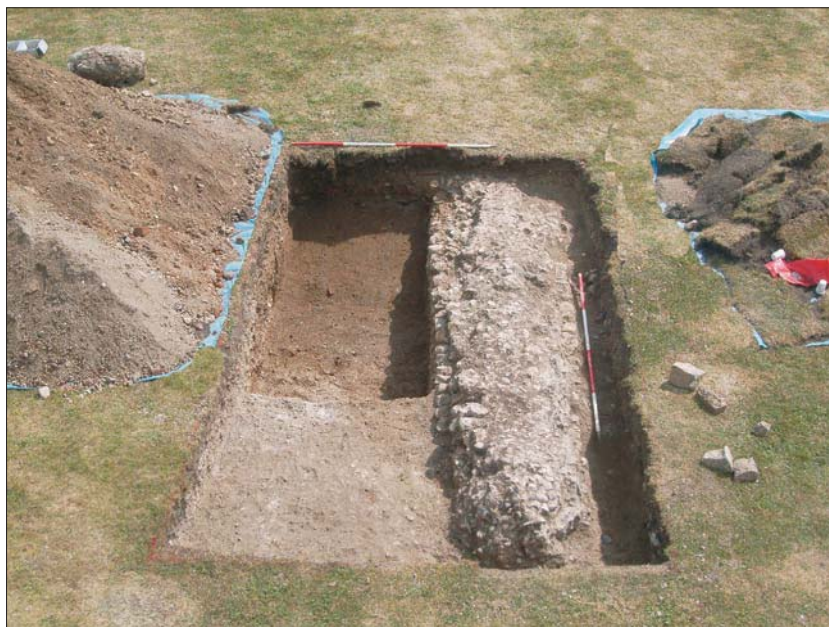
Plate 10: Trench 3, view from west

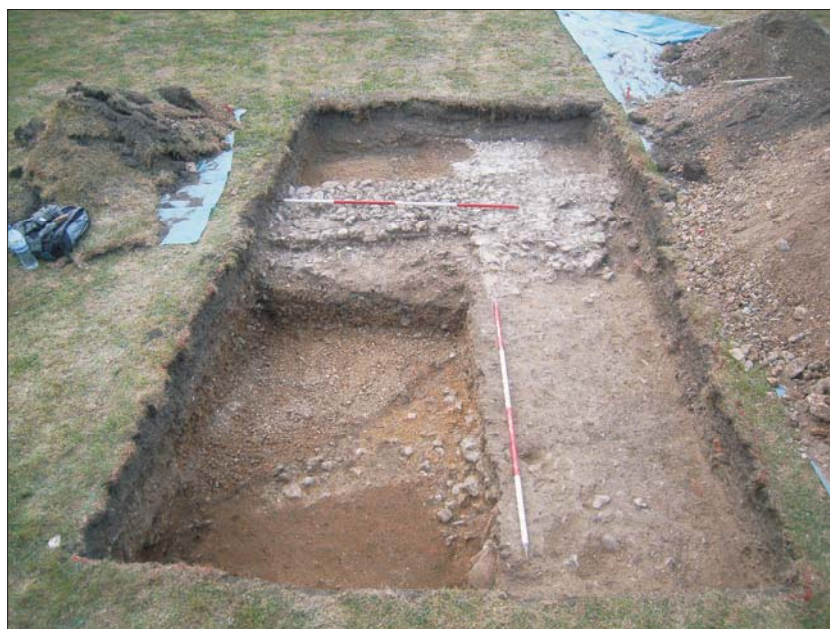
Plate 11: Trench 4, view from east

- 4.3.26 The north-east corner of the Chapter House, as identified in the geophysical survey (**Figure 4**), was investigated by Trench 4. The natural river gravels and a sealing alluvium layer (**409**, **413** and **415**) were cut by **410**, the foundation trench for the apsidal end to the Chapter House. Only the foundation material **412** survived for the apse within **410**, layer **411** filling the void between the foundation and the foundation trench (**Figure 9, Plate 11**). Wall **404** at the west end of the trench was identified as the northern wall of the Chapter House.

- 4.3.27 The apsidal end of the Chapter House was subsequently demolished and replaced with a squared end with buttresses. The demolished apse was sealed by layer **408** which contained 11th century pottery and ceramic building material of 13th century date or later. Wall **403** was built on layer **408**, with buttresses at the north-east corner.

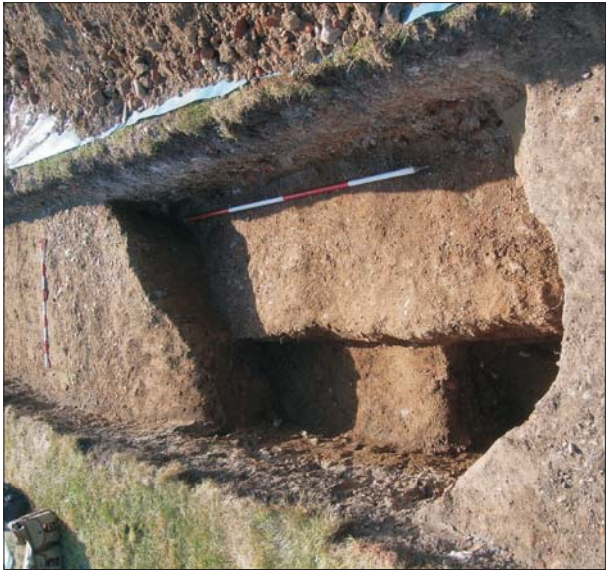
Plate 12: Trench 5, view from west showing robber trench 504

- 4.3.30 Following the Dissolution, wall **514** was removed by robber cut **511**, and a large scale levelling deposit (**505/515/516**) was laid down. This was cut by feature **513**, which was in turn cut by foundation trench **509** for a possible timber beam slot. This was contemporary with **507**, and these two features appear to form the corner of a timber building. This timber phase of the mansion pre-dates the alterations of c.1740 by John Wale.
