## Buckler's Hard, Beaulieu, New Forest, Hampshire

### Archaeological Evaluation Report

**September 2012**

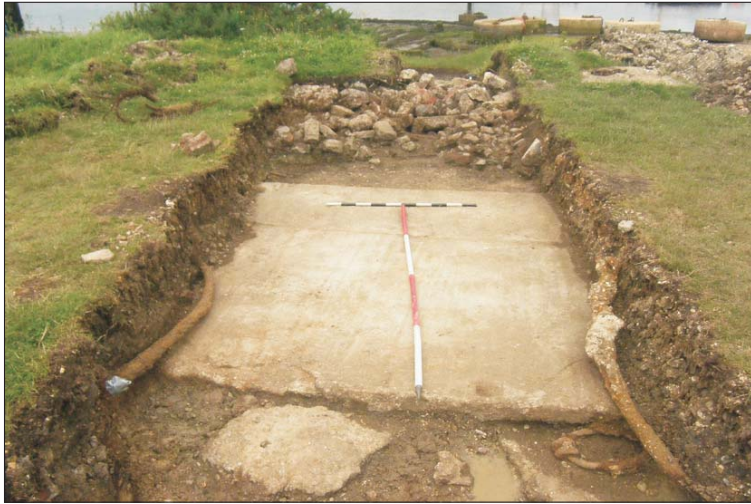
- 3.2.3 Beneath **105** a 2.4m wide area of concrete hard-standing **108** was uncovered (**Figure 2, Plate 1**). Being such a comparably narrow section makes it unlikely to be a floor within one of the buildings. Composed of two adjoining sections, **108** overlay hardcore and preparation deposits **111** and **118** within construction cut **112**. Abutting this platform on the north-east edge was layer **110** which was overlain by a re-deposited clay layer **109** which slightly overlapped this side of the hard-standing. Also beneath layer **110** was a thin pale grey gravel lens, derived from the north-west (riverward).

Plate 1: Concrete hard-standing **108** and rubble bank **103**, view from the south-west

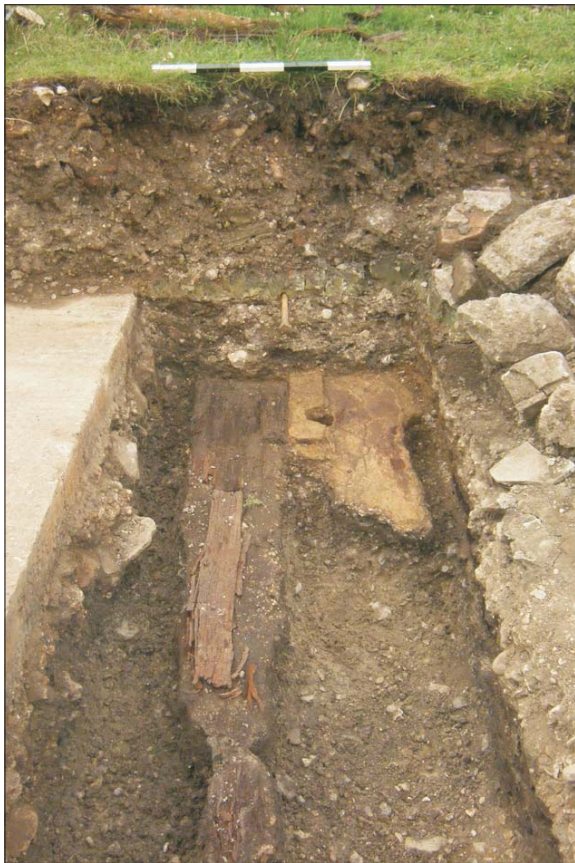
- 3.2.5 However a sondage dug along the north-eastern edge of the concrete hard-standing **108** exposed a number of horizontally laid planks **114** (**Figure 2, Plate 2**). Layer **113**, which overlay these timbers, was cut by the construction cut **112**. Exposed were the remnants of two planks side by side, the northernmost of which was discoloured suggesting mineralisation. Within this plank was a hole presumably for an upright fitting. The end of a third plank was also visible in the eastern edge of the slot and further wood could be seen in the south facing section, underlying the bank. It seems most likely that this wood is the remnants of a jetty pre-dating the WWII activity.

Plate 2: Possible jetty **114**, view from the south-east

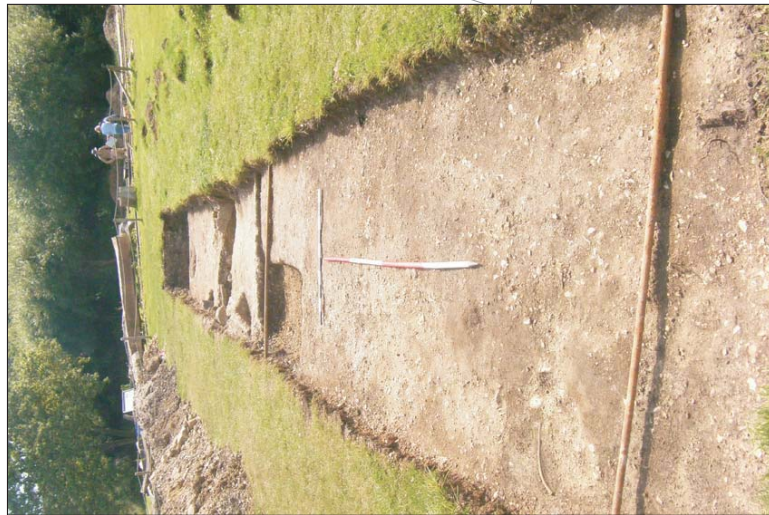
Plate 3: Trench 2, view from the north-west

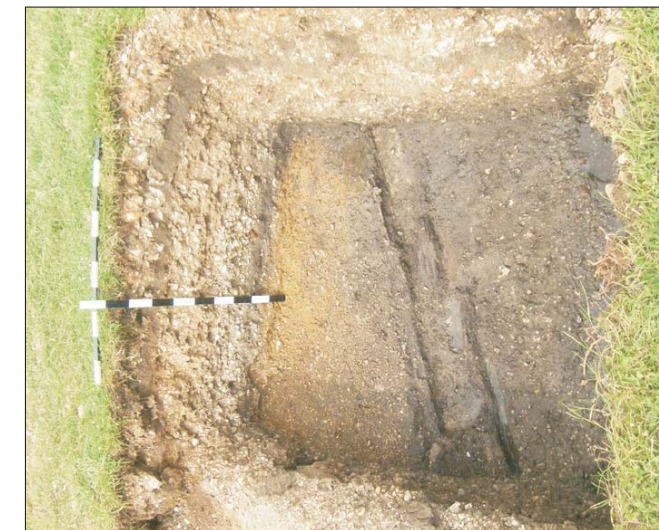
- 3.3.5 At the eastern end of the trench the opportunity was taken to machine excavate a deep sondage (**Figure 3, Plate 4**). Here, beneath layer **203**, a buried soil horizon **204** was seen. This overlay two gravel layers **205** and **208** which are most probably levelling or made ground layers. The lower of which, **208**, overlay another humic deposit **206**, most likely representing yet another former ground surface. Within this deposit was a large timber **213**. Although the timber was originally considered to be a timber-lined culvert, on closer inspection it appeared the internal part of the timber had rotted away and was therefore interpreted as a section of tree trunk. Due to the depth of excavation, not all the timber was exposed, however, there were no clear tool marks visible and a fragment of clay pigeon was recorded in the surrounding deposit (see section 7.1.2).

Plate 4: Sondage - Trench 2, view from the south-west

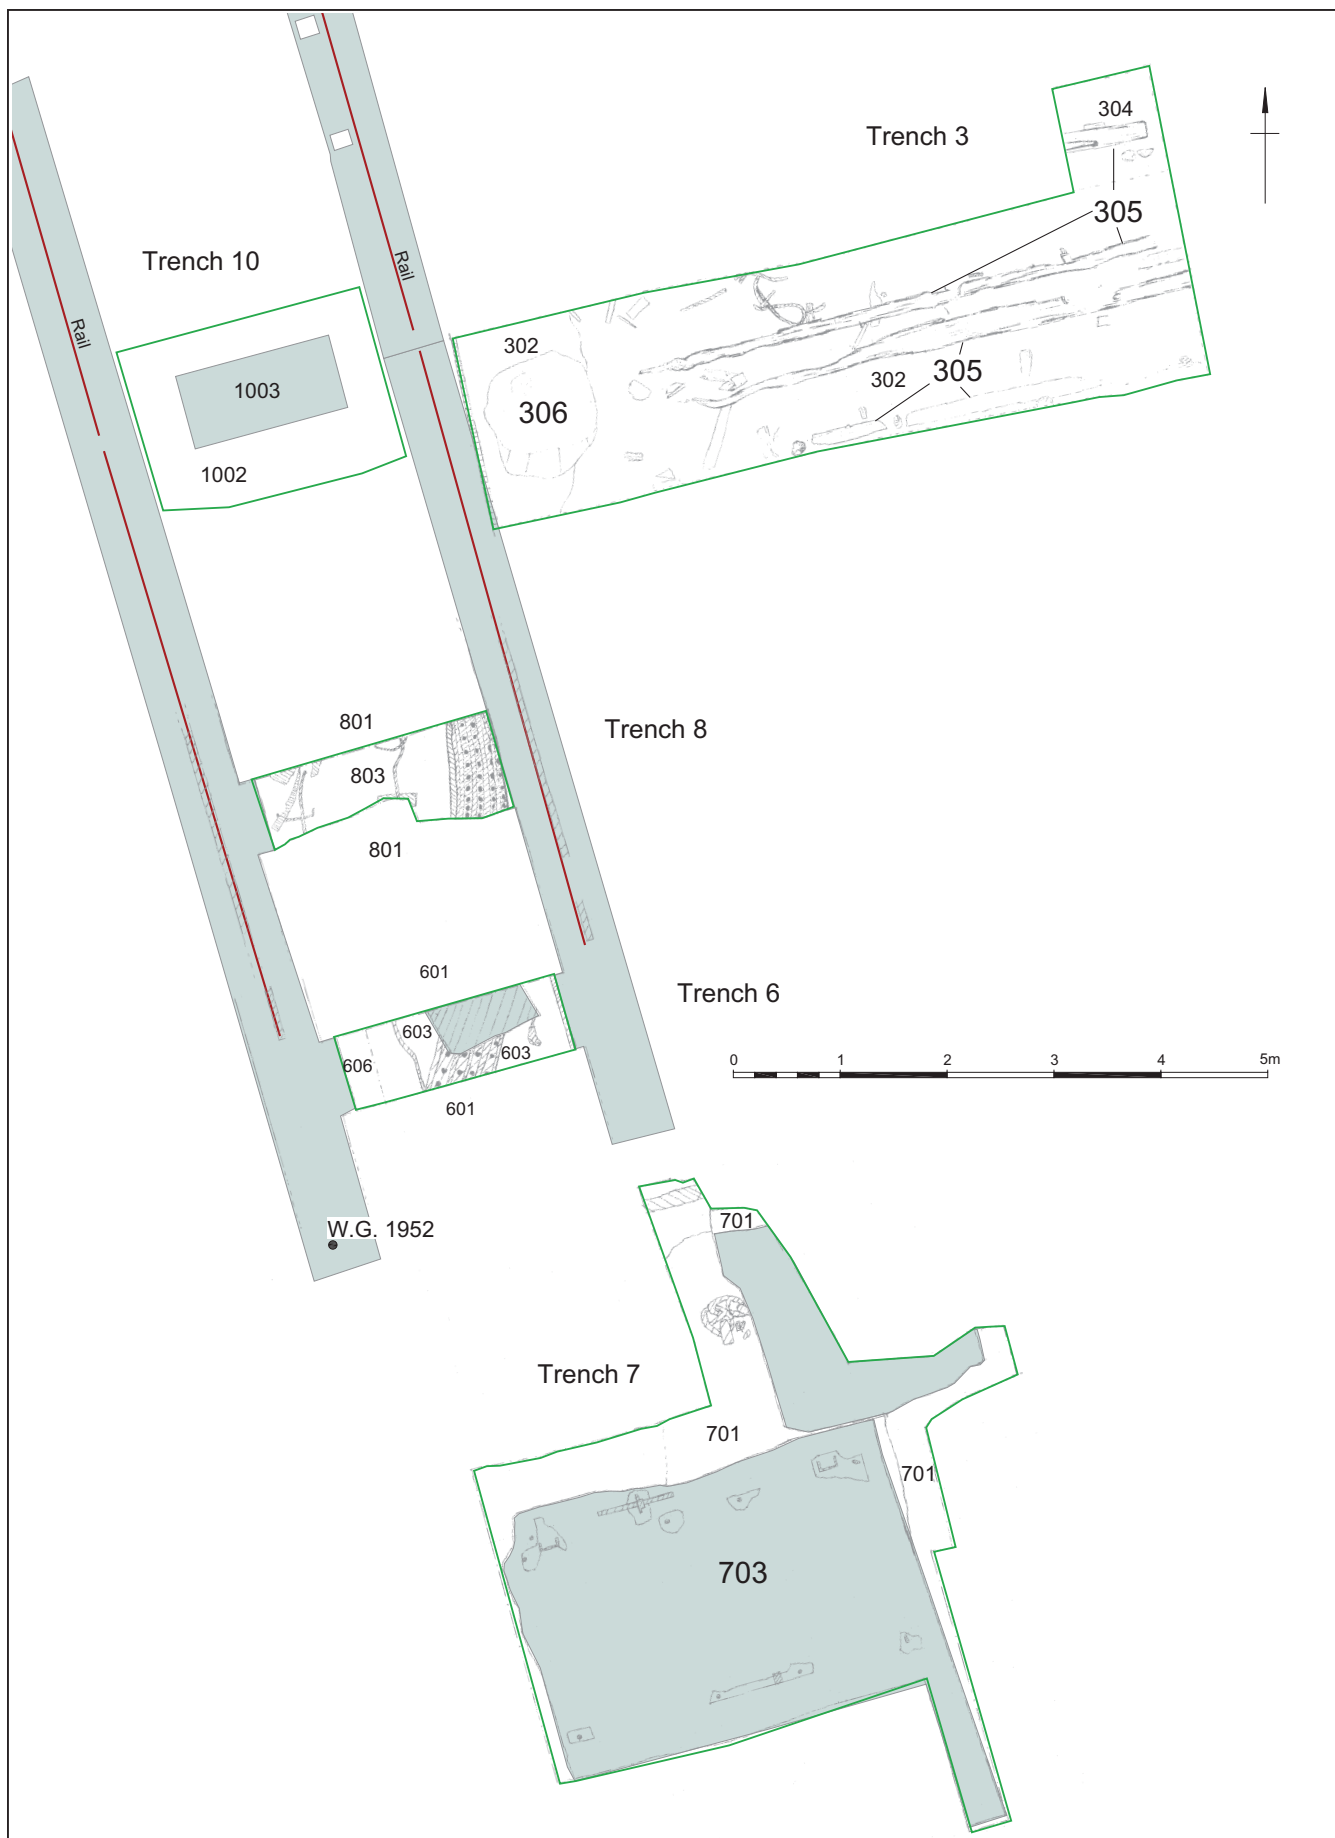
Figure 4

Trenches 3, 6, 7, 8 and 10

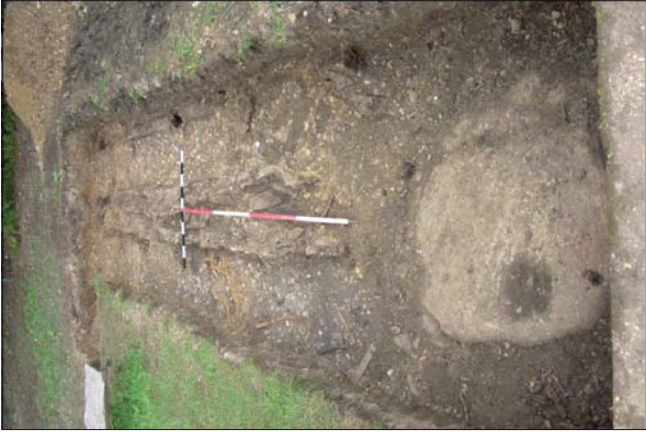
- 3.4.3 Beneath the subsoil **302** and within the gravel layer **303** below was a number of lengths of roughly hewn timber, **305**, aligned roughly south-west – north-east (**Figure 5, Plate 5**). Below these, shorter sections of timber could be seen lying tangentially to these, as well as a number of smaller pieces and off-cuts of wood situated within this deposit. A few possible upright timbers were also identified. It is not entirely clear whether these timbers represent a succession of superimposed structures (they seem to lack enough coherence to one deliberate structure) or whether some or all of these timbers have been moved from their original position and may in fact be something like the remnants of a dismantled cradle.

Plate 5: Trench 3, view from the south-west

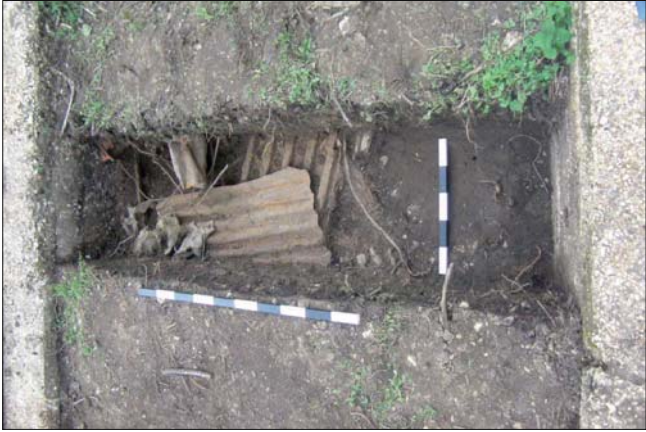
Plate 6: Trench 6, view from the south-west

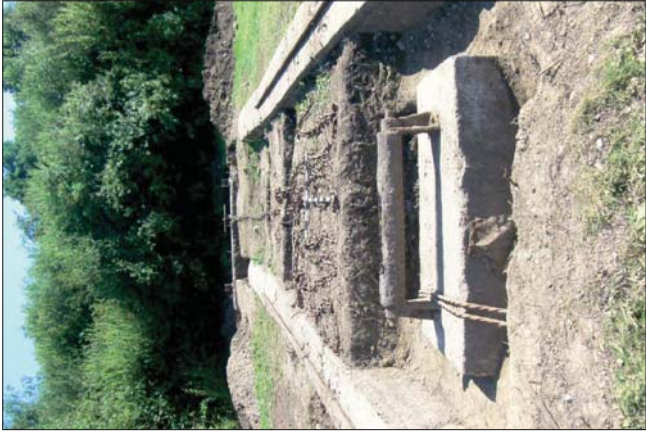
Plate 7: Iron roller - Trench 10, view from the north-west

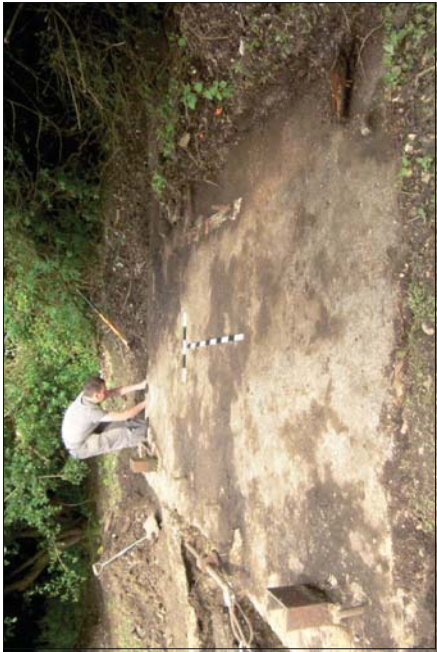
3.8.2 The concrete hard-standing **703** itself was shown to 3.7m x 3.9m in size at around 0.45m high (**Figure 5, Plate 8**). A number of *in situ* fixtures and fittings were observed including a number of upright bolts, two cut off upright girders and an T-bar handle. It seems likely that not all these fixtures are contemporary. According to B. Grindey the winch engine which once stood there was later moved to Hythe. The off-centre alignment of the platform is deliberate as the winding drum would have been situated at the end of the engine.

Plate 8: Concrete platform 703, view from the south-west

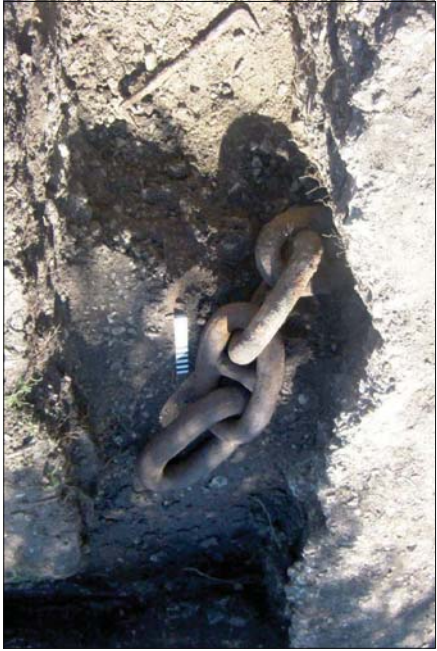
3.8.3 The adjacent concrete block, thought to be a dead man was seen to abut the concrete hard-standing. This had been broken on the south-west edge in line with the anchoring chain (**Figure 5, Plate 9**).

- 4.3.3 An iron 'dog' used in timber preparation was found in layer **701**, two more were exposed at the base of Trenches 7 and 8 but left *in situ* (**Figure 5, Plate 9**).

Plate 9: Anchoring chain and 'dog', view from the north-west

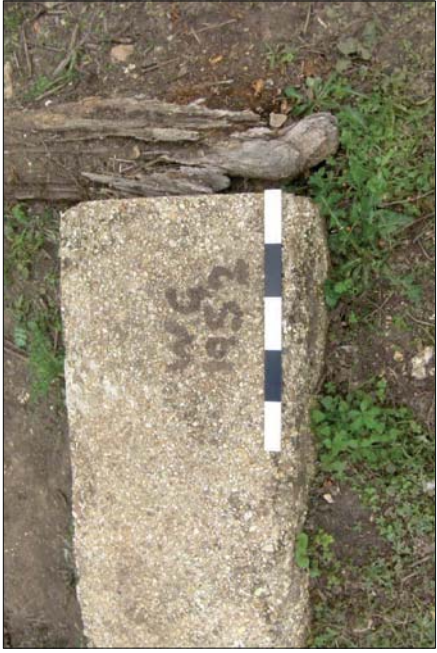
Plate 10: marked initials at top of slipway

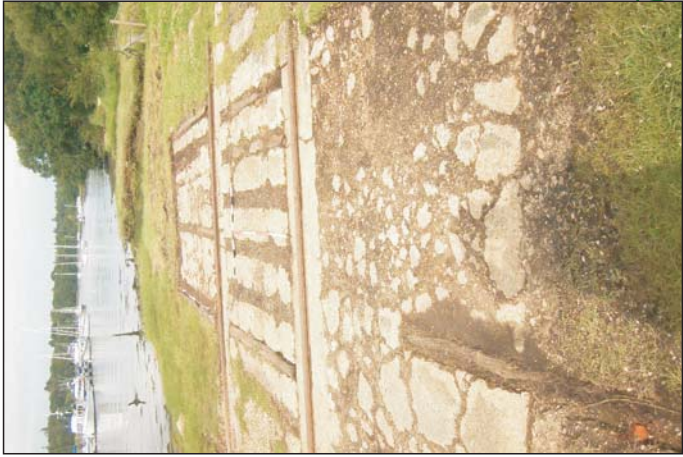
Plate 11: Area of Trench 9, view from south-west

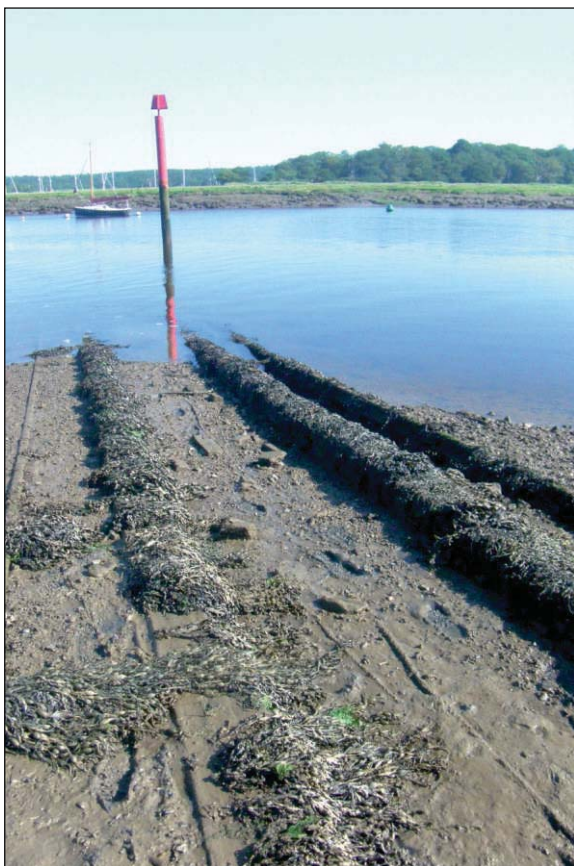
- 7.1.4 The slipway itself was seen to be in generally good condition though some of the concrete has been damaged, particularly by root action where it has been turfed over and the lower portion of the rails shows some corrosion from immersion in the river (**Figure 7, Plate 12**). The WWII slipway still exists to a length of over 65m with the 1950's extension giving it an overall length of over 73m. It was shown to consist of two parallel concrete beams 0.6m wide and widening to just over 0.9m and set 2.4m apart (8ft). The iron rails themselves are set around 3m apart (10ft), they would have guided the

Plate 12: Lower portion of slipway, view from the south-east

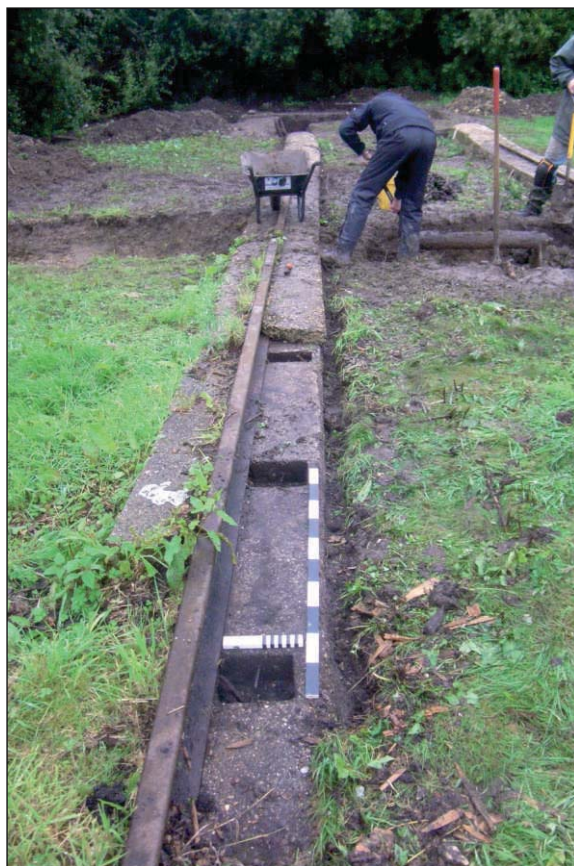
Plate 13: Exposed square voids, view from the north-west
