**Land at New Farm,  
Northington Road,  
Itchen Abbas, Hampshire**

**WINCM: AY322**

**Archaeological Watching Brief Report**

Reference: 65790.03

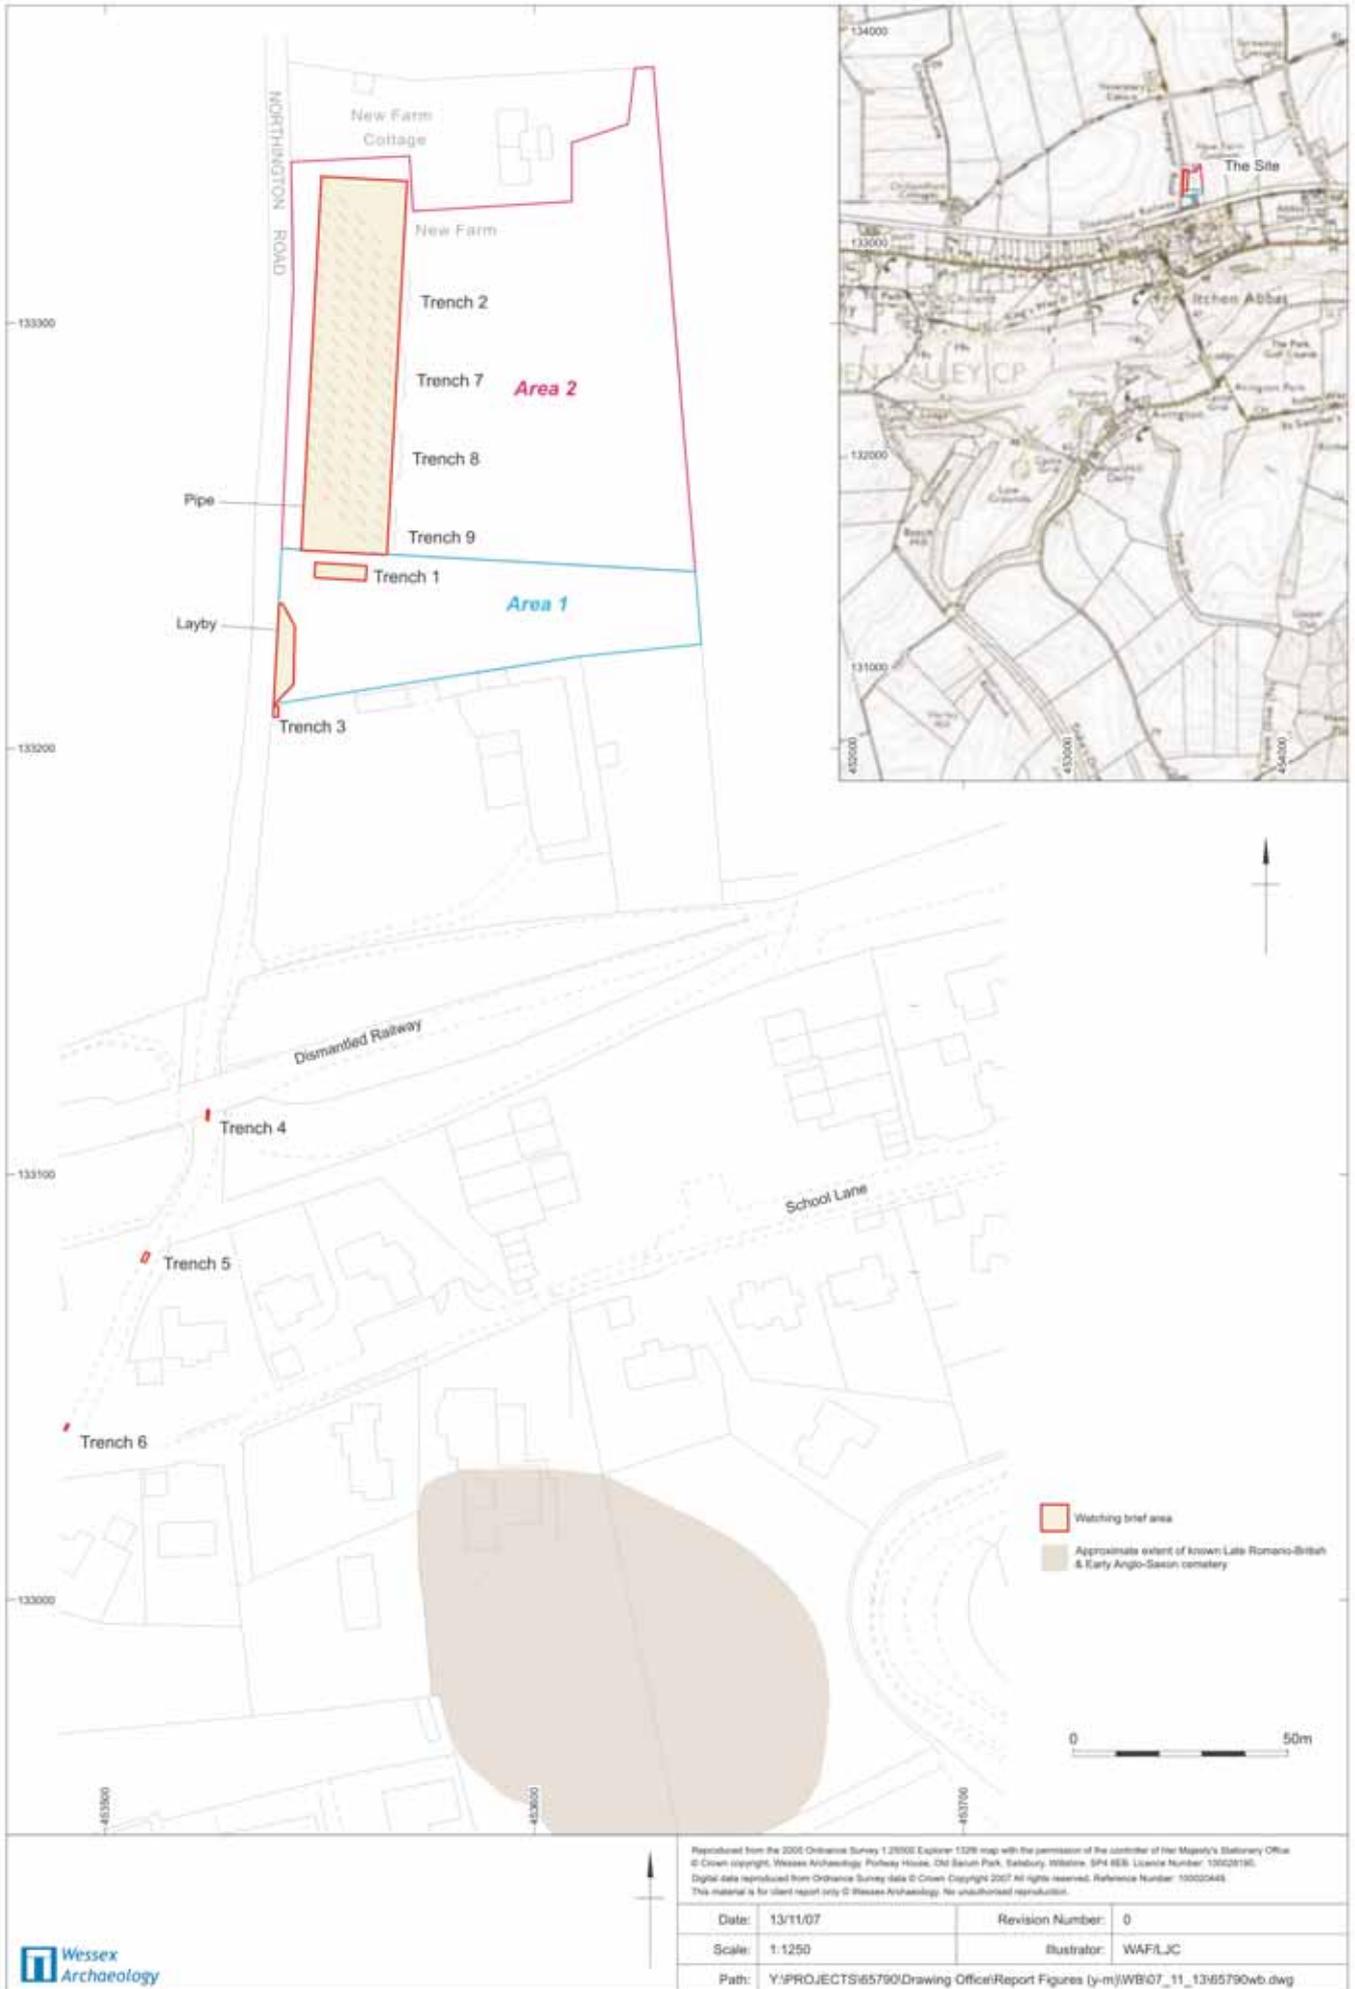
Figure 1

Site location plan showing watching brief areas

3.1.2 Groundworks were carried out on the Site within two main areas; the location of the proposed sewage works itself (**Figure 1, Area 1**), and an area of sub-irrigation immediately to the north (**Figure 1, Area 2**). Additional service trenches and pipe-work trenches were also excavated in the vicinity.

- 3.3.1 Immediately to the north of the footprint of the proposed sewage treatment works, parallel with the road and oriented north-south, groundworks for sub-surface irrigation were carried out (**Figure 1, Trenches 2,7,8 and 9**).

- 4.4.1 The 21 irrigation trenches, oriented north-west to south-east within Area 2, were grouped into 3 blocks of 5 and 1 block of 6 to improve ease and clarity of recording (**Figure 1**).
- 4.4.2 **Trench 2:** Group comprised the 5 northern-most irrigation trenches within the area.

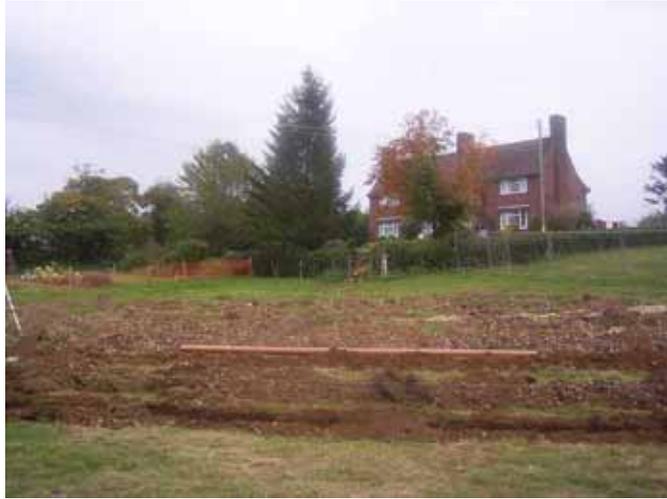
Plate 1: Irrigation trenches under excavation

- 3.3.2 The sub-surface irrigation area measured 88m x 20m. Within this area 21 narrow trenches were dug in a "herringbone" formation, oriented north-west to south-east within Area 2. Each of these trenches was 0.6m wide and 0.8m deep. After excavation each trench was filled with 0.3m of pipe bed at the base, backfilled with shingle, above which the trenches were backfilled with excavated material and topsoil replaced on the surface.

- 4.4.8 The irrigation trenches were stripped to a depth of 0.8m and therefore did not extend below the colluvial deposit, consequently natural chalk bedrock was not reached.

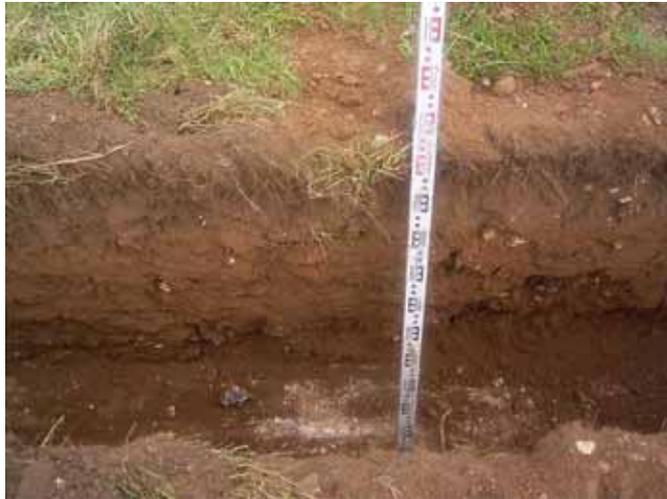
Plate 2: Representative section of irrigation trench (Trench 2)

- 4.4.5 **Trench 9:** Group comprised the 6 southern-most irrigation trenches within Area 2.
- 4.4.6 In Trenches 2, 7, 8 and 9, the topsoil was a grey-brown, loose silty loam. The deposit contained occasional sub-rounded and sub-angular flint inclusions of <0.09m, and occasional chalk fragments of < 0.03m. The topsoil depth ranged from 0.18m in Trench 7 to 0.22m in Trench 8.

- 4.4.7 Below the topsoil a mid brown colluvium deposit was observed in all of the Trenches. Occasional inclusions of sub-rounded and sub-angular flints <0.02m were recorded in conjunction with occasional chalk fragments <0.03m.

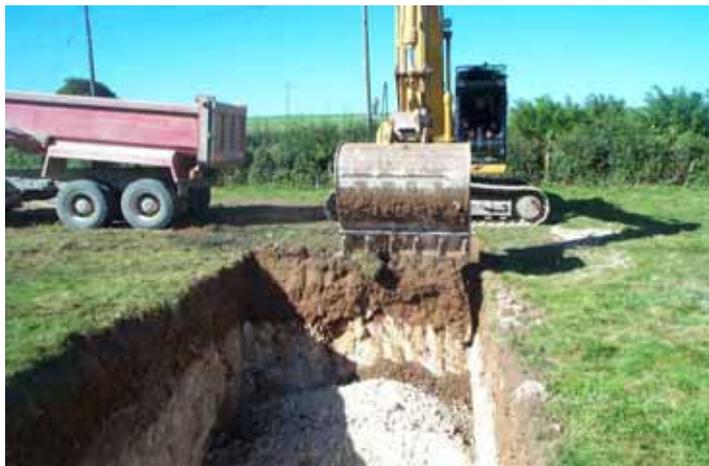
Plate 3: Excavation of settling tank trench

4.2.1 The trench for the sewage settling tank, located within Area 1, was dug to a depth of 3.2m. A light grey silt topsoil, up to 0.3m deep, which contained occasional modern finds of plastic, glass, metal and ceramic that were noted but not retained overlay a colluvium deposit with a sharply defined boundary.

- 4.2.2 The colluvium deposit was a mid to dark reddish brown clay silt, a loose deposit with horizontal banding of coarser materials. The deposit was a maximum of 1.3m deep, increasing in depth from east to west. The deposit was well drained, with increasing clay content towards the base. The horizon with the underlying natural chalk bedrock was sharp and undulating.
- 4.2.3 The natural chalk bedrock was encountered from a depth of 1.3m onwards. The upper 0.3m of the chalk represented a weathered and bioturbated horizon, which was friable with loose chalk fragments. Below this interface the bedrock chalk was more dense, white and compact.
- 4.2.4 No archaeological features were identified nor any finds recovered from Trench 1.
- 4.2.5 The excavation of trenches for the rising mains pipe was also watched within the Area. No archaeological features were identified nor any finds recovered.

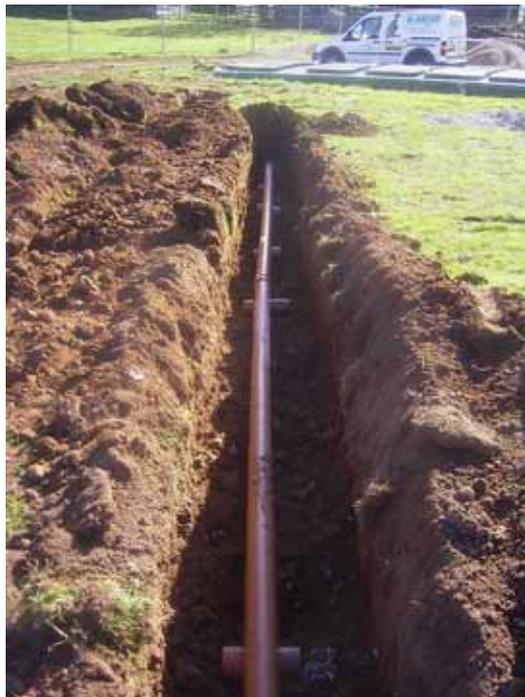
**Plate 1 Irrigation trenches under excavation**

**Plate 2 Representative section of an irrigation trench (Trench 2)**

**Plate 3 Excavation of settling tank trench**
