## Broadwater Road, Thamesmead London Borough of Greenwich

Archaeological Watching Brief Report

**Museum of London Site code  
TCB04**

**November 2004**

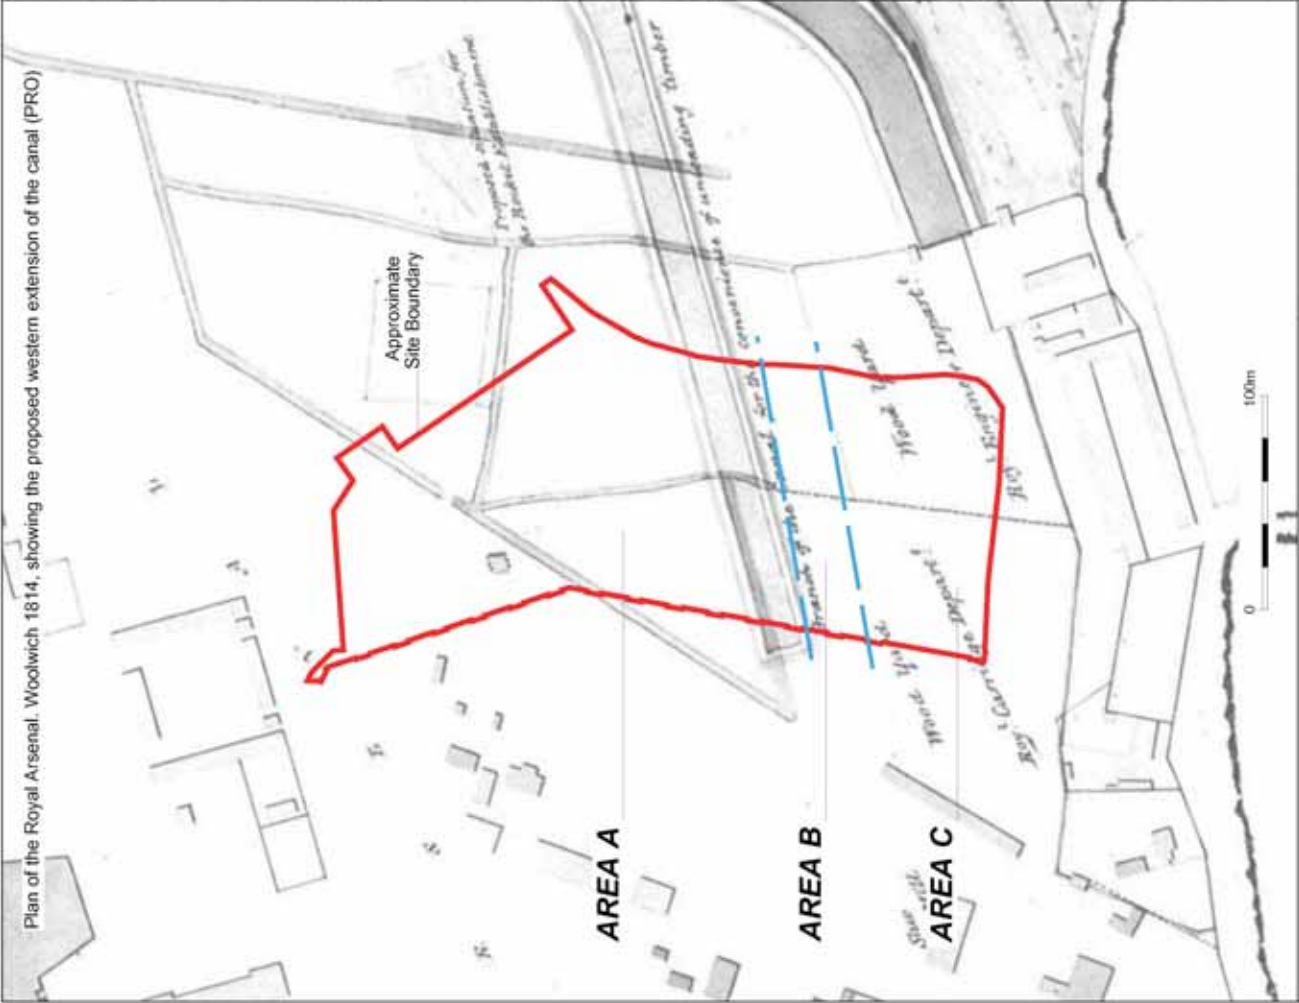
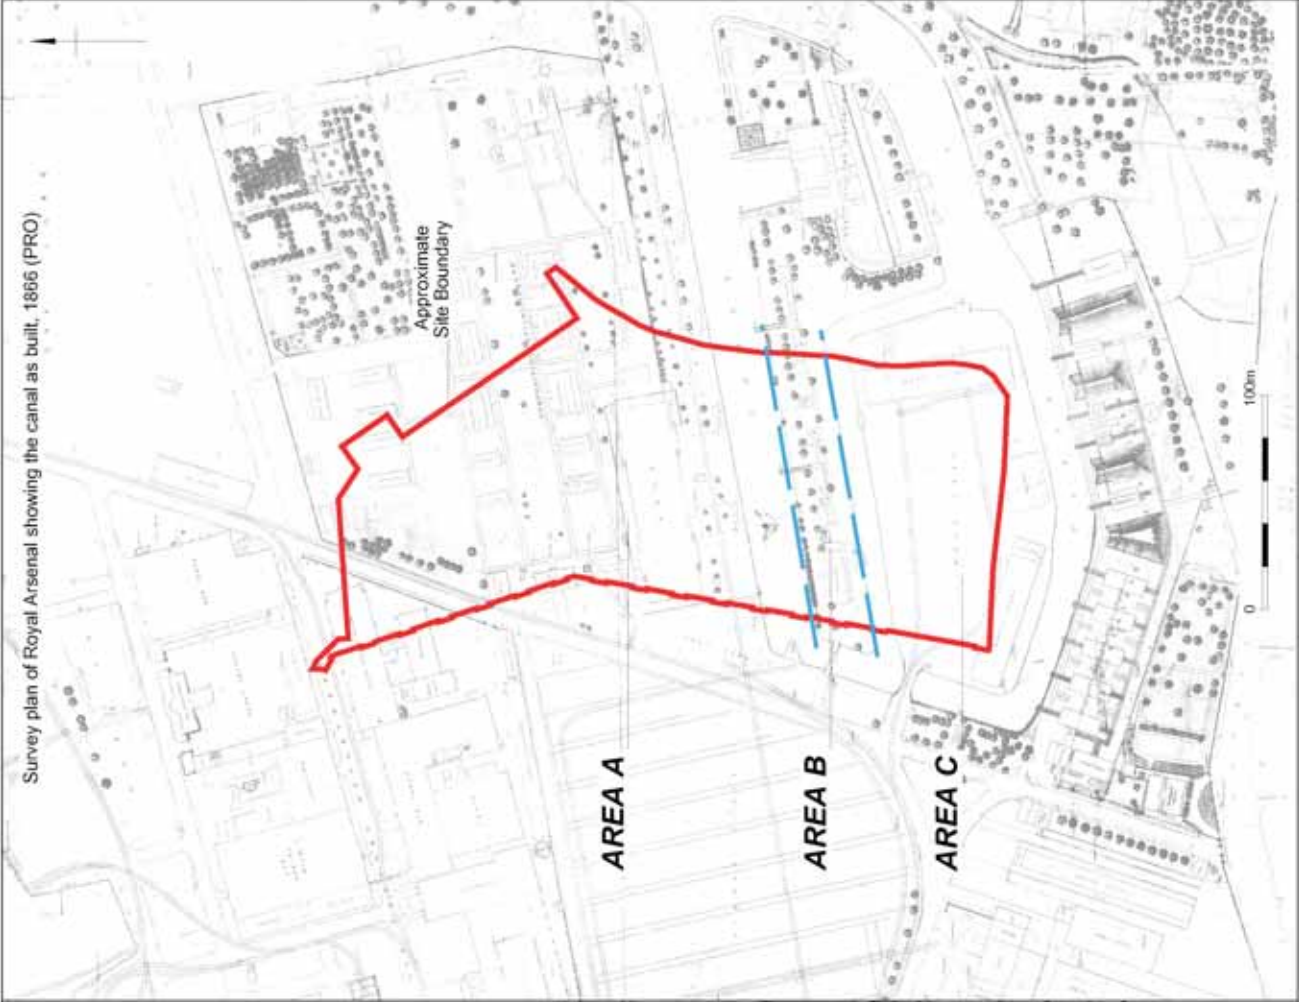
Figure 2

Nineteenth Century plans of the Royal Arsenal, Woolwich

- 1.3.3 This development was associated with a canal (the Pilkington canal) constructed in 1812–14. The canal acted both as the eastern defensive boundary of the Arsenal, as well as providing a transport link between the depot and the Thames (**Figure. 2**). The original canal was extended soon after 1814 and a western branch of this canal, constructed in 1814–16, is shown on the Ordnance Survey map of the Arsenal in 1866 (**Figure. 2**).

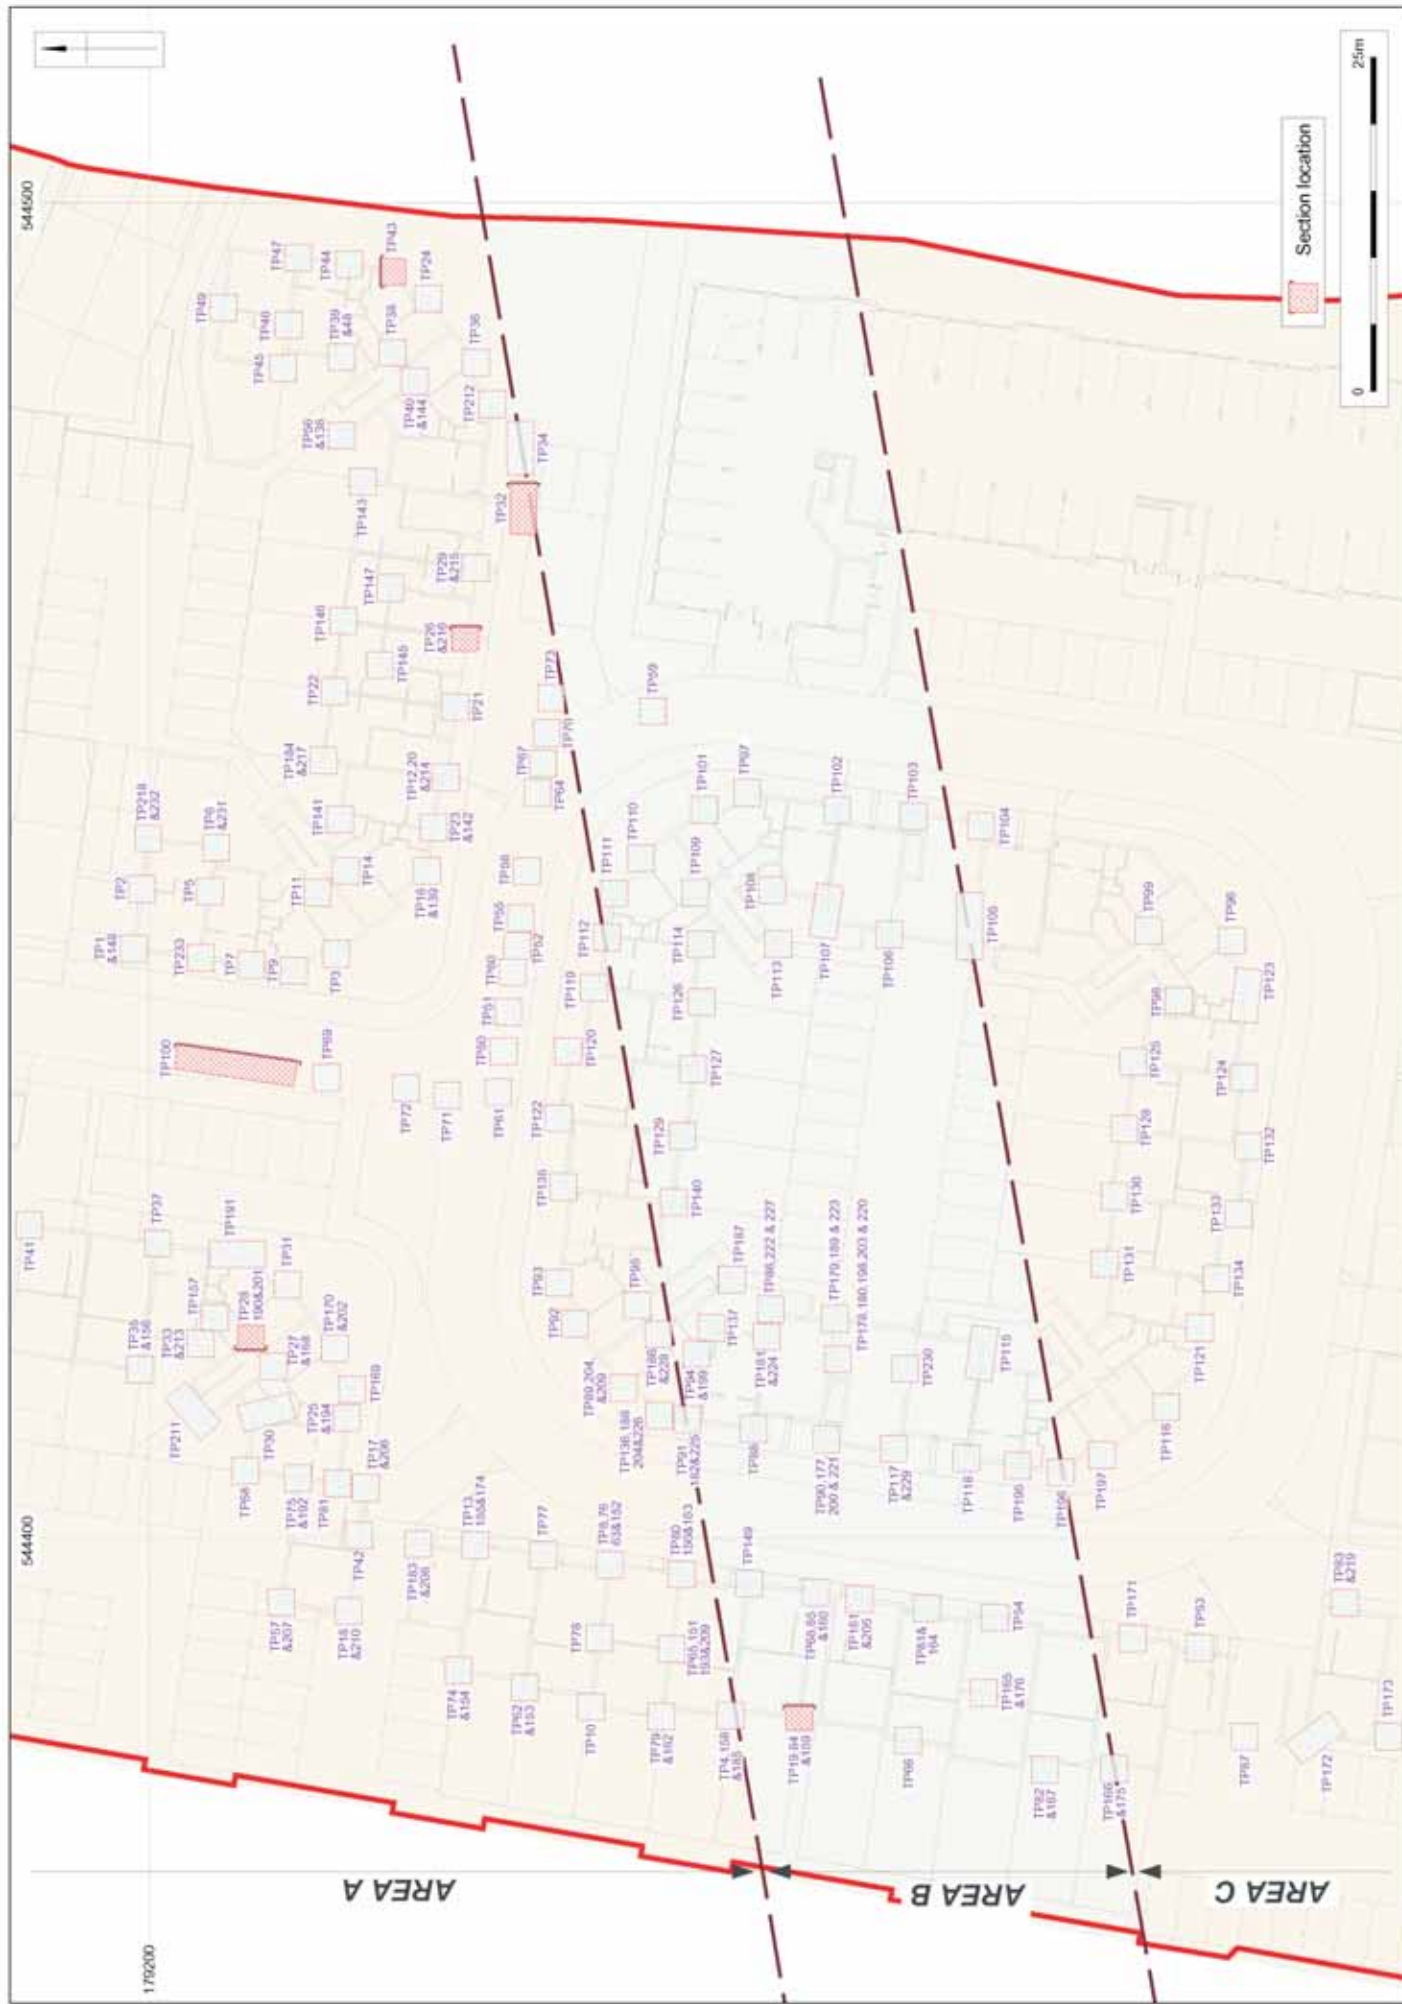
Development plan showing location of Test Pits and illustrated sections

Test Pits: 1, 3, 4, 5, 6, 7, 8, 9, 10, 11, 12, 13, 14, 16, 17, 18, 19, 20, 21, 22, 23, 24, 26, 27, 28, 29, 30, 31, 32, 33, 34, 36, 37, 38, 39, 40, 41, 42, 43, 44, 45, 46, 47, 48, 49, 50, 51, 52, 55, 56, 58, 60, 61, 62, 63, 64, 65, 67, 68, 69, 70, 71, 72, 73, 74, 76, 77, 78, 80, 91, 92, 93, 95, 100, 111, 112, 119, 120, 122, 129, 135, 136, 138, 139, 141, 142, 143, 144, 145, 146, 147, 148, 150, 151, 152, 153, 154, 155, 156, 157, 158, 162, 163, 168, 169, 174, 182, 183, 184, 185, 186, 188, 190, 191, 192, 193, 194, 201, 204, 206, 207, 208, 209, 210, 211, 212, 213, 214, 215, 216, 217, 225, 228, 231, 232 and 233 were excavated close to, or within, the line of the former northern canal (**Area A. Figure. 3**).

Test Pits: **54, 59, 66, 79, 81, 82, 84, 85, 86, 88, 89, 90, 94, 97, 101, 102, 103, 106, 107, 108, 109, 110, 113, 114, 117, 118, 126, 127, 137, 140, 149, 159, 160, 161, 164, 165, 167, 176, 177, 178, 179, 180, 181, 187, 189, 193, 195, 198, 199, 200, 202, 203, 205, 218, 220, 221, 222, 223, 224, 226, 227, 229** and **230** were excavated in the area between the two former canals (**Area B, Figure 3**).

Test Pits: **53, 54, 66, 81, 82, 83, 87, 96, 98, 99, 103, 104, 105, 106, 115, 116, 117, 118, 121, 123, 124, 125, 128, 130, 131, 132, 133, 134, 164, 165, 166, 167, 171, 172, 173, 175, 176, 197, 219 and 221**. Were excavated close to, or within, the line of the former southern canal (**Area C, Figure 3**).
