King's Arms Hotel, Christchurch, Dorset

Archaeological Evaluation and Watching Brief Report

Reference 59752.02

February 2008

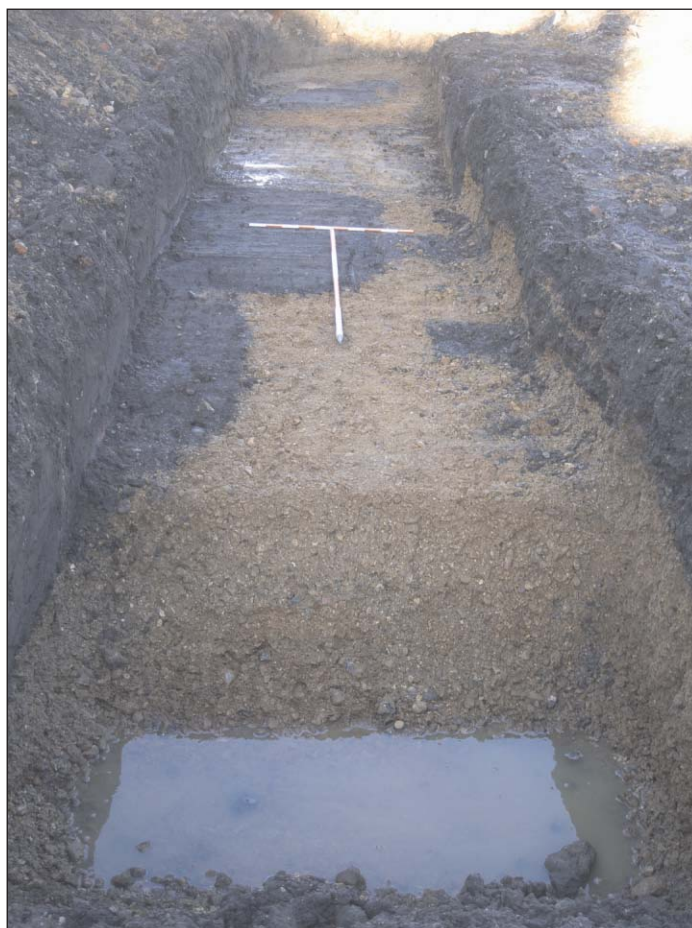
Plate 1: Modern features

- 4.2.4 Five cut features of uncertain origin but including at least one tree throw, were observed truncating the basal geology.
- 4.2.5 Stratigraphically the earliest feature (**122**) could be interpreted as a large pit. The feature was only partially exposed but the three fills recorded (**123**, **124** and **125**) appeared to be natural infilling events.

- 4.2.6 The large feature (**122**) was in turn cut by three smaller features (**108**, **112** and **118**). Similarly to the underlying feature all the fills of these later cuts were characteristic of natural infill, although a single isolated dump (**114**) of charcoal rich ash material was retrieved from **112**.

- 4.2.7 The nature and function of the pit and the later interventions is unclear, due to the paucity of artefacts they are unlikely to be refuse pits. Similarly the apparent natural depositional regime by which the features were filled does not indicate use as cess pits.

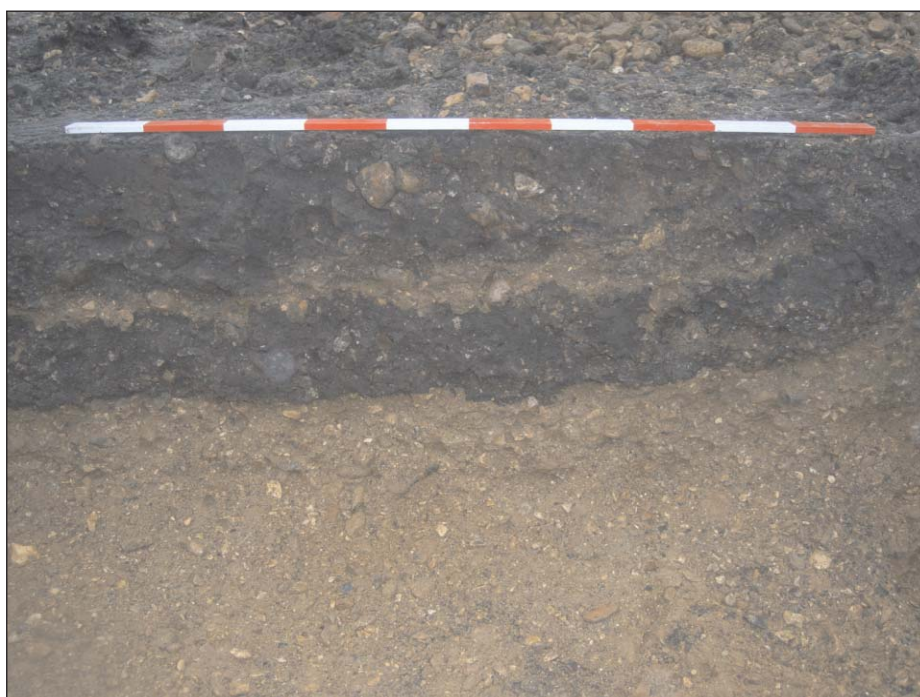
Plate 2: Edge of river channel

- 4.3.3 The first identified feature was the edge of the river channel inferred from the previous evaluation. The channel meandered through the centre of the Site. The highly disturbed edge (disturbed as a result of water action) of the

water channel was identified sloping away to the east and filled with a gyttja-like deposit, a sedimentary peat formation which occurs at the edge of slow moving water courses. A number of lenses of shell, including oyster shell, were identified within the dark organic deposit but no dating evidence was recovered. The deposit was observed extending over a distance of 15m from its point of origin in the west to the east, at the latter point the deposit dipped below the base of the foundation trench and is assumed to continue to the east.

- 7.1.4 The edge of the river channel recorded in 2007 is aligned with the row of posts identified within Trench 2 of the August 2006 evaluation, further suggesting that these posts potentially relate to the stabilisation of the edge of the water course or were used to stabilise the backfill material.
