## Extension of Office Accommodation at Bourne Hill, Salisbury, Wiltshire

Assessment Report on a Series of  
Archaeological Investigations

**Report reference: 61002.04**

**January 2010**

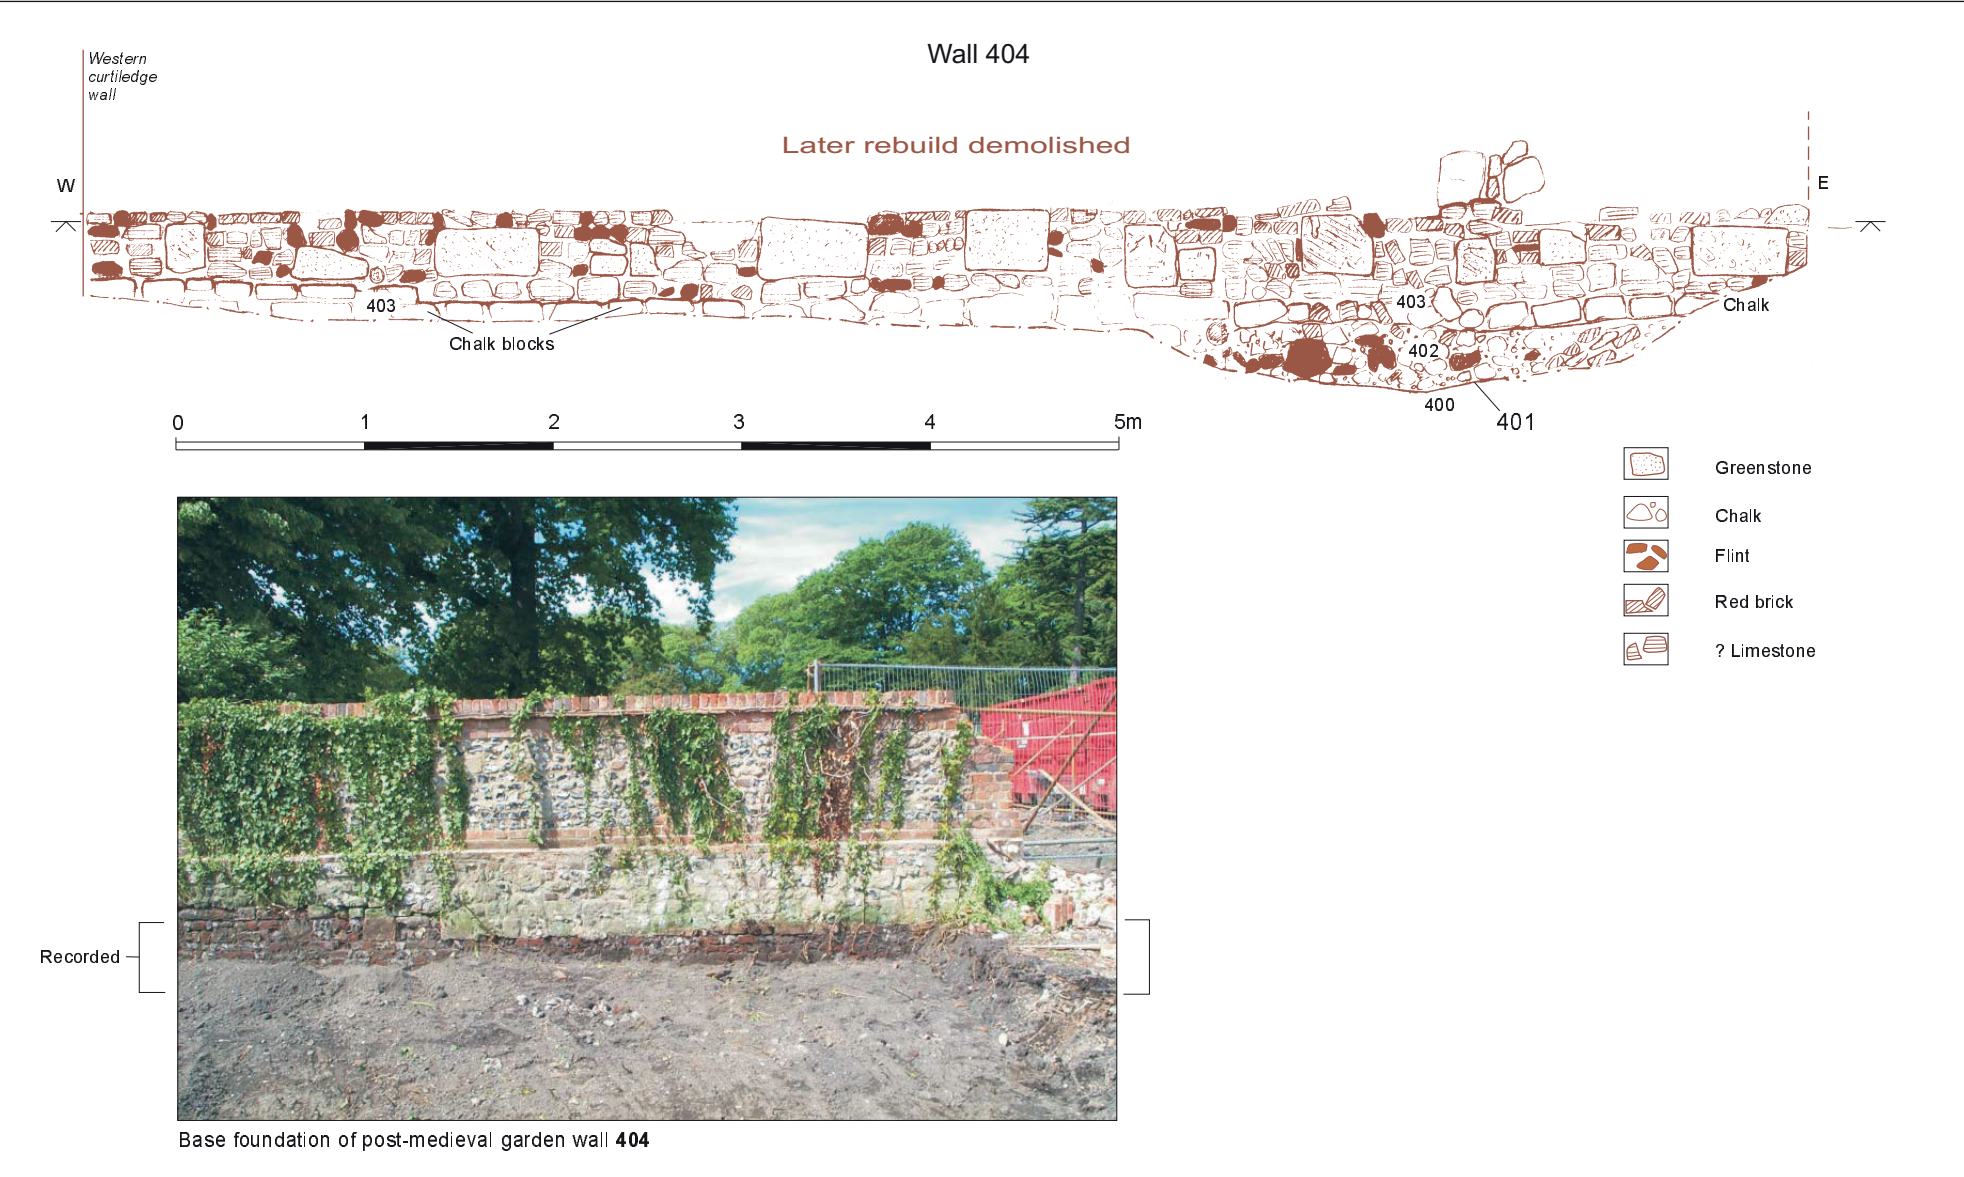
Figure 4

South elevation of garden wall **404**

- 7.2.14 Following initial soil stripping and removal of tarmac and modern services; only further dark soil with some intermixed mortar flecks and fragments was noted beneath the topsoil/overburden. Further detail of the lower courses of the east-west garden wall was revealed and recorded (see **Figures 1, 2 and 4**)

- 7.2.16 Wall **404** sat on top of one to two courses of sub-rectangular chalk blocks **403**, up to 470mm x 200mm. These blocks were laid end to end, based on a course of stretcher bond, and were also bonded with the same lime mortar. A second course was observed at the west end, and was traced for 1.4m. It is likely that **403** represented, a levelling foundation course, upon which the wall was constructed and it is unlikely that this chalk course was meant to be above ground level.

- 7.2.17 The chalk foundation levelling course sat directly on top of a foundation deposit **402**, filling foundation cut **401**. The fill comprised mainly compacted, randomly organised rubble, possibly demolition debris. The rubble was predominantly chalk (80-200mm) and limestone (150-250mm), with flint nodules and blocks (>100mm & 250-300mm), square-peg tile fragments and unfrogged, crumbly red bricks. There also appeared to be slight tip lines within the material at the eastern end. The foundation cut was 0.34m deep, and presumably similar in length and width as the surviving wall (foundation only partially revealed). The matrix of the foundation material was dark grey/brown silt/clay, possibly remnant topsoil mixed with demolition debris. There was a small quantity of lime mortar incorporated into the deposit. The foundation cut **401** cut into the underlying natural reddish brown clay.

- 7.2.18 The presence of peg tile and unfrogged red brick in the foundation material suggests that this wall probably dates no earlier than the late 17th century. The lack of other artefacts suggests that this wall was likely to have been built between the late 17<sup>th</sup> and late 18<sup>th</sup> centuries (M. Rous pers. comm. 2007). If we assume that Richard Woods submitted his 'design for the improvement for the gardens of Penruddocke Wyndham, Esq. of Salisbury, Wilts. no later than 1790 (and possibly as early as 1770 as some would argue) it is safe to assume that the earliest phase of the east-west aligned garden wall dates to the last quarter of the eighteenth century (RMP 2005) since it is not indicated on any earlier extant plan.

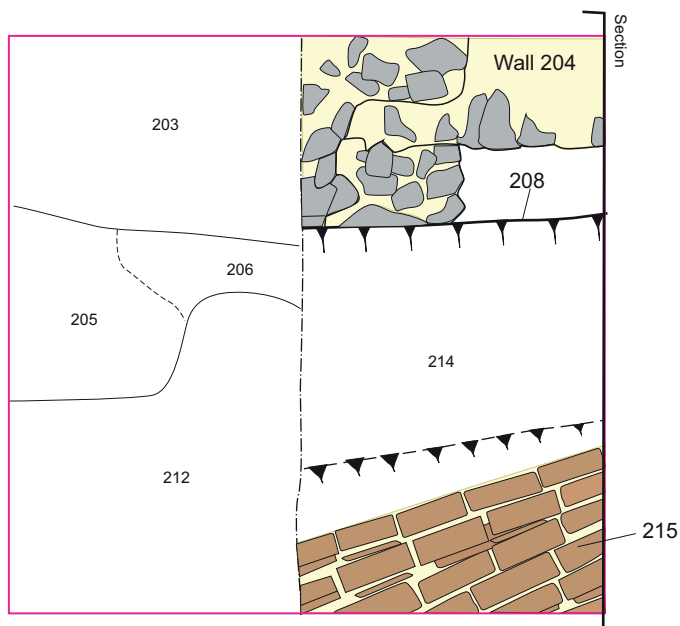
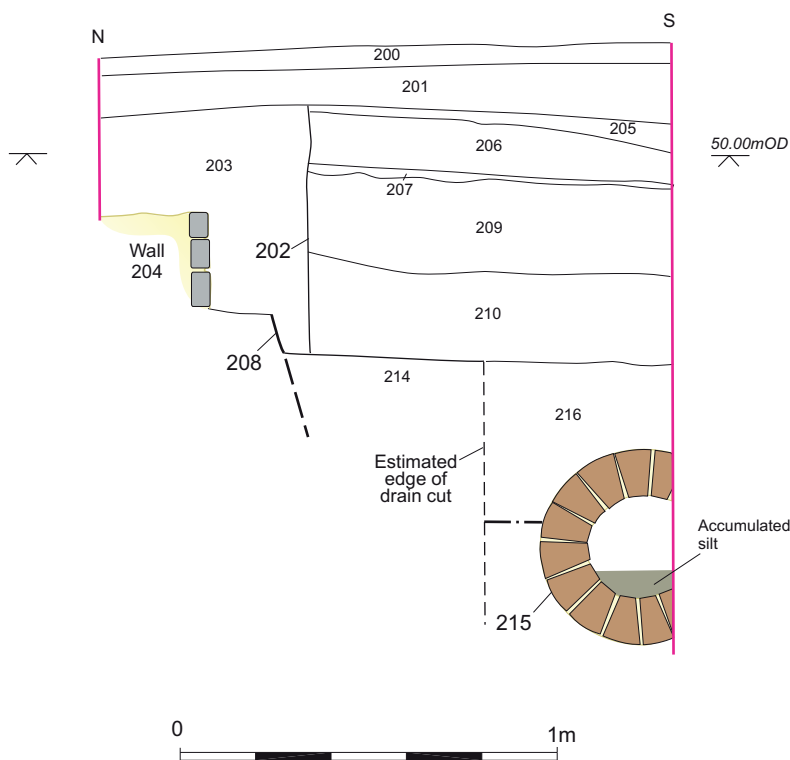
Figure 7

Plan and west facing section of **Trench 2**

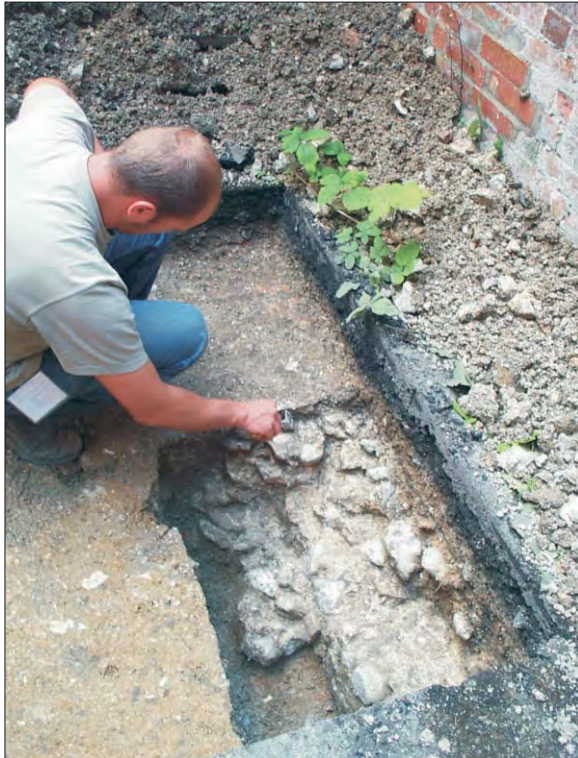
Plate 1: **Trench 2** - Medieval wall **204** as exposed in base of robber cut, looking west

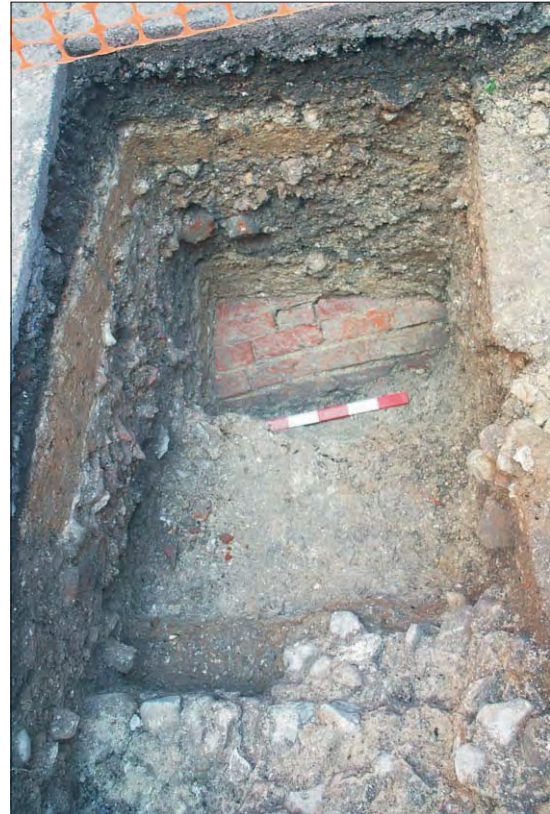
Plate 2: **Trench 2** - Medieval wall **204** and late 18th century drain **215** ( 0.5m scale)

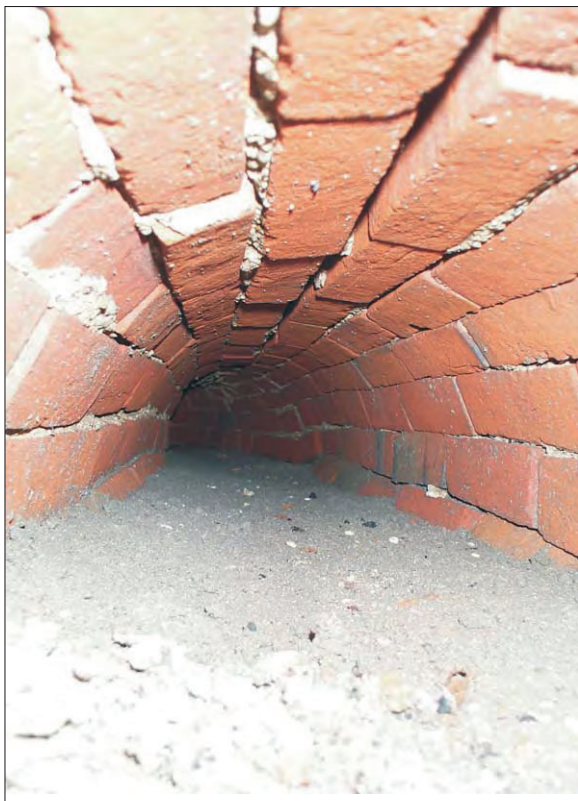
Plate 3: **Trench 2** - Interior of drain **215**, looking west

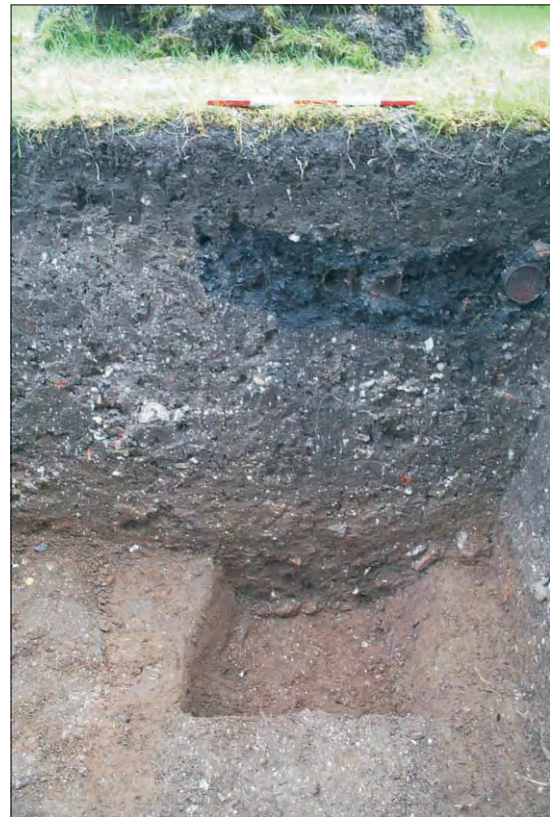
Plate 4: **Trench 3** - Intervention across probable medieval gully **310** (0.5m scale)

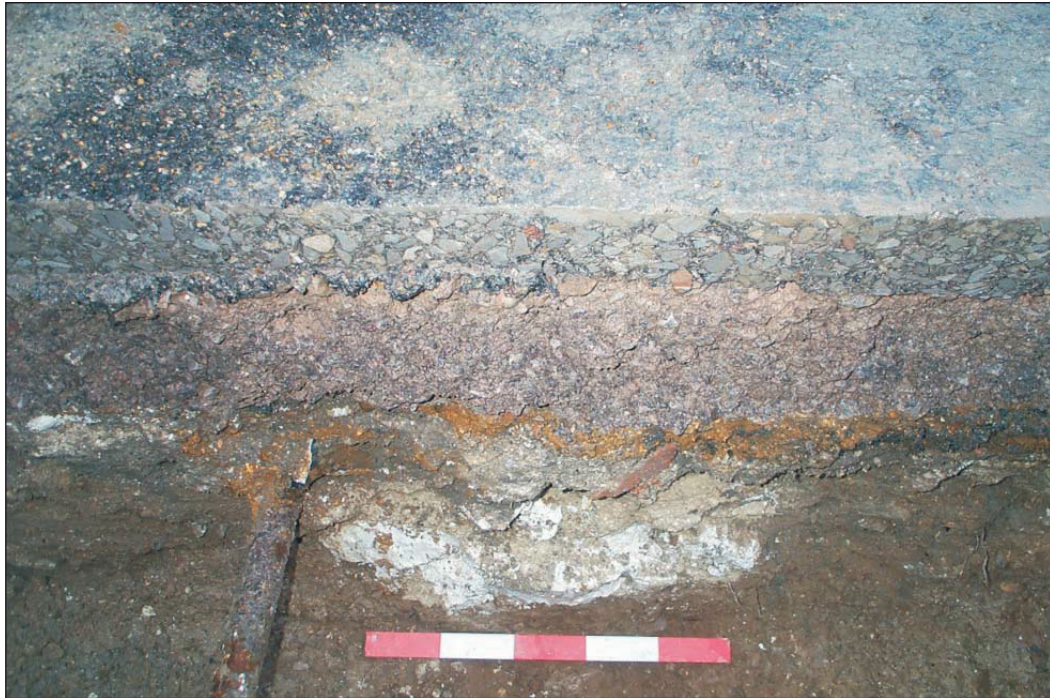
Plate 5: **Trench 13** - 16th century east-west wall footing **127**

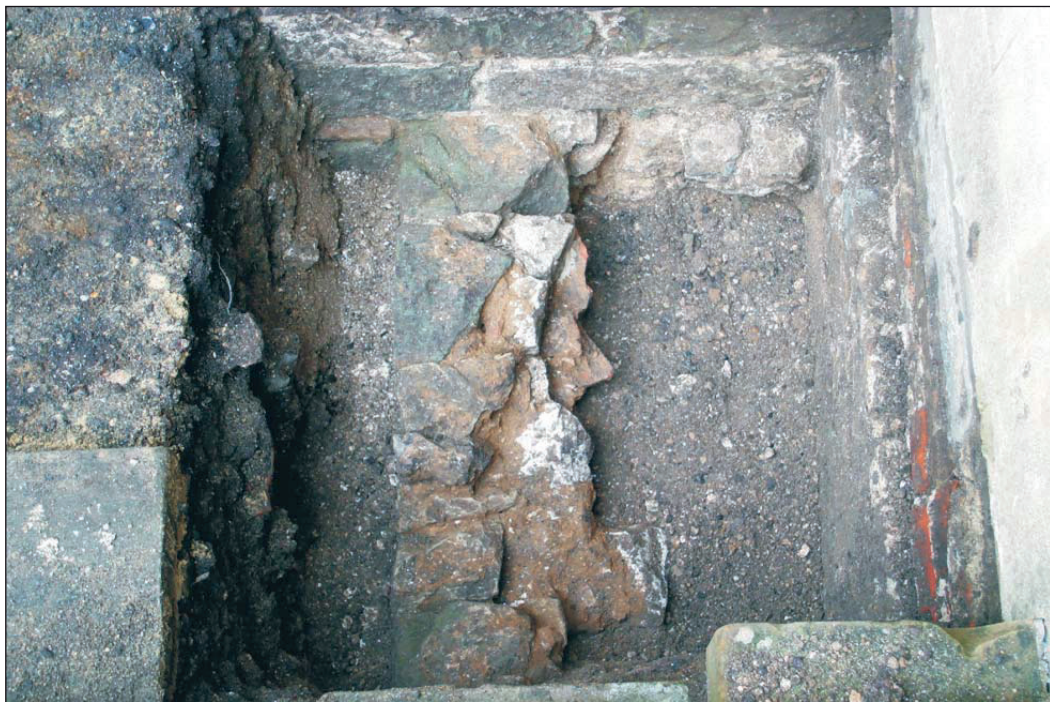
Plate 6: **Trench 13** - 16th century north-south wall **235** seen in plan
