Henham Park Wangford With Henham, Suffolk

Archaeological Evaluation and Assessment of Results

Ref: 85204.01
November 2014

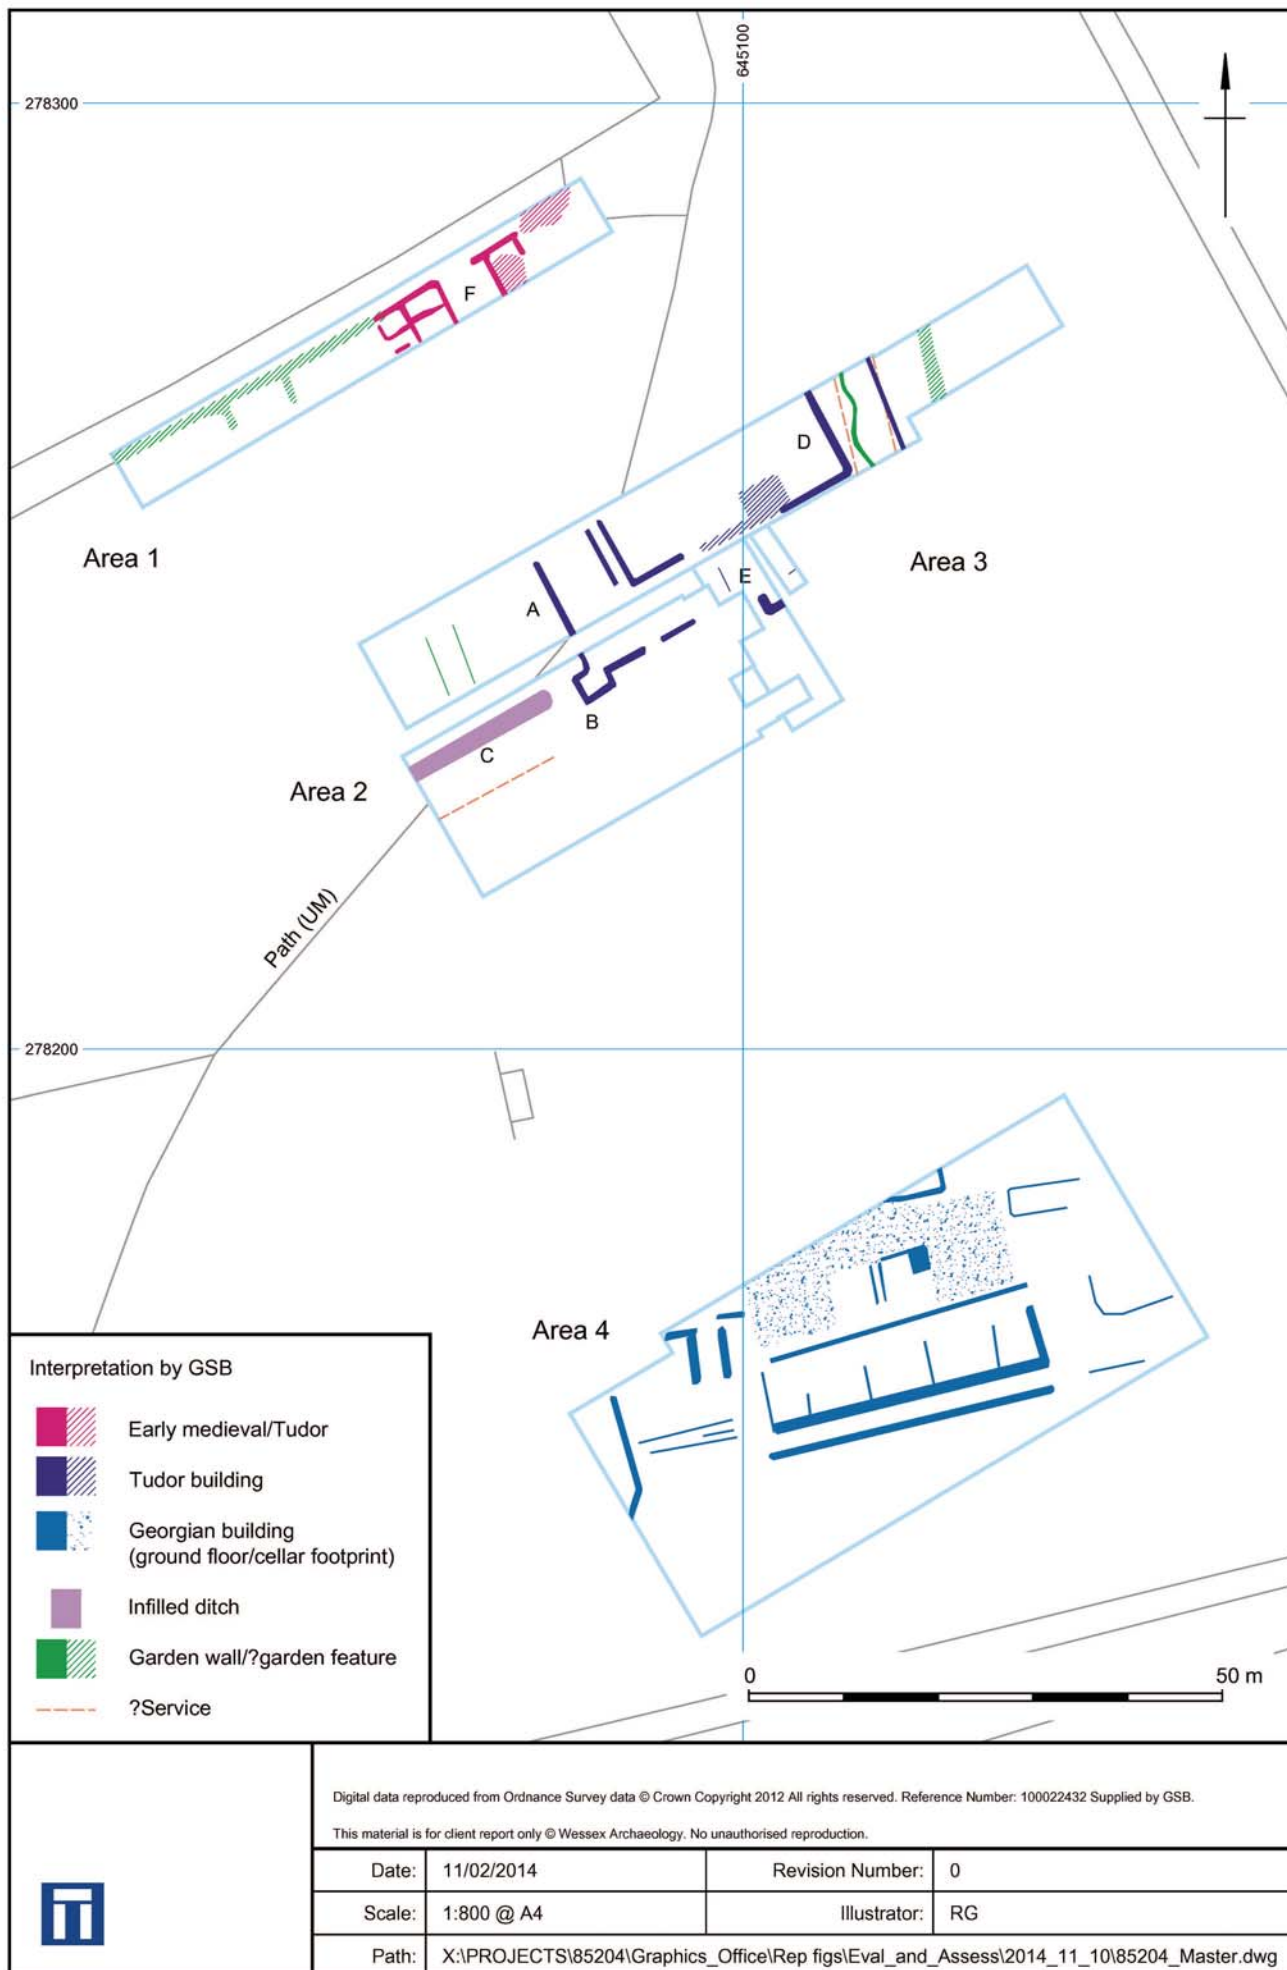
Figure 3

Ground penetrating Radar results

- 4.2.5 The western range [A] of the Tudor house's main court have been partially identified, with a south-western corner bastion [B] very clear. Beyond this to the west is what was thought to be another wall line [C] but, upon excavation, rather than being a solid foundation it was found to be a ditch back-filled with demolition material. The eastern range [D] is also discernible, as well as some reflectors [E] in the centre associated with the gatehouse; however the remainder of this structure was not surveyed due to trenching and spoil heaps.

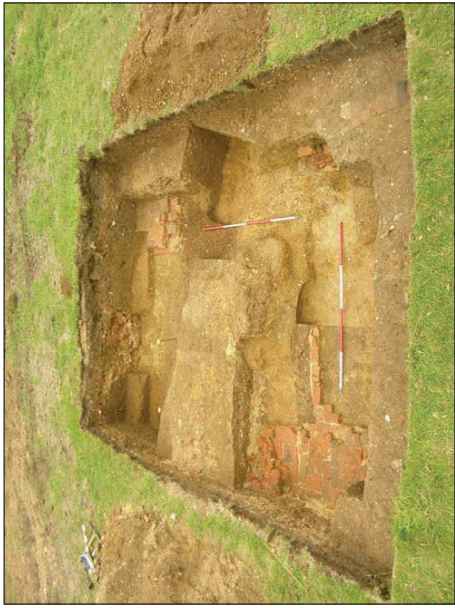
Plate 3: View of Trench 1, from the south-west

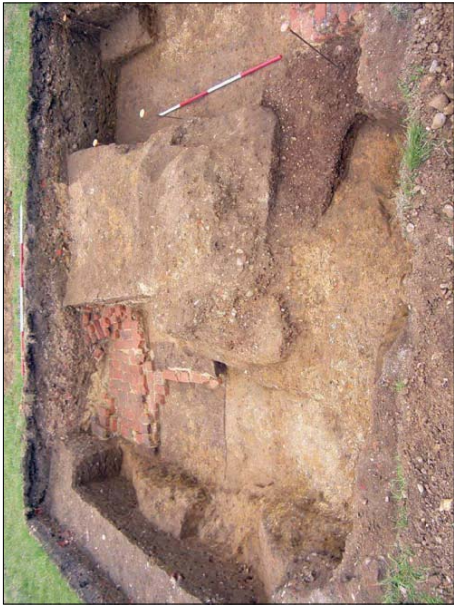
Plate 4: View of Trench 1; robber cuts 103 and 119, view from the south-east

- 4.3.11 A further robber cut (**119**) was also seen within the footprint of the tower. Slightly narrower than **103**, this would seem to represent the removal of an internal wall within the tower, perhaps associated with a staircase. Some traces of sand and brick at the base of the cut (**120**) are all that remains of the disturbed foundation, while above this was a deliberate backfill deposit (**121**) similar to that within **103**.

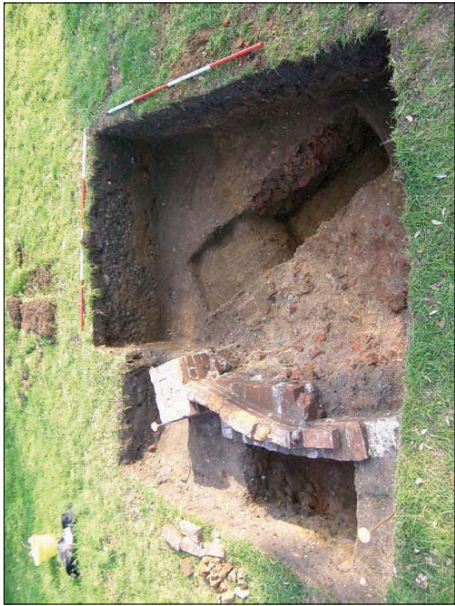
Plate 5: Trench 2, view from the north-east

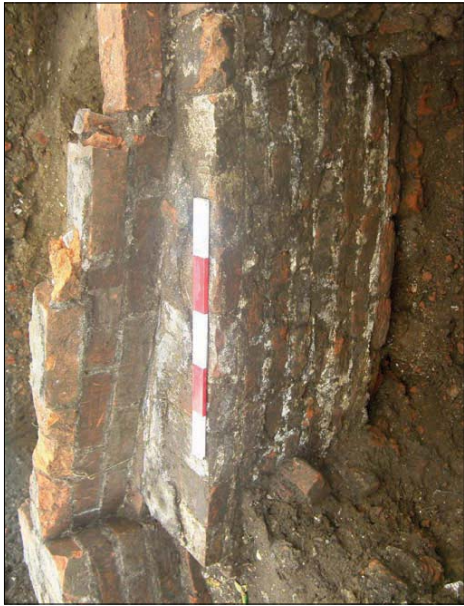
Plate 6: East-facing elevation of structure 210

- 4.3.18 Cutting both **206** to the west and made ground deposit **202** to the east was **209**, a construction cut for wall **210**. Wall **210** was of the type known as 'crinkle-crankle' or serpentine. These walls, often associated with growing fruit, normally date from the mid-18th century. An upstanding north-south aligned crinkle-crankle wall can be seen on the south-west side of the walled garden. The foundation for the wall **210** is markedly different from the intended visible extent, being constructed of re-used bricks probably derived from the earlier Tudor structure (**Figure 5, Plate 6**). The curving part of the wall by contrasts uses bricks of different proportions (200 x 100 x 70mm or 8 x 4 x 2¾ inches), more consistent with 18th or 19th century brickwork.

210	<i>Structure</i>	Garden wall of crinkle-crinkle type. Red brick foundation utilising re-used 'Tudor' brick (23x10x6cm), eight courses on west side with three courses abutting on east side to support curve of wall. Three courses of single skin red brick (20x10x7cm) curving wall on this foundation. Pale grey-white mortar. 0.48m wide. Overlies 205.	0.72 high
211	<i>Structure</i>	Gate pillar or post, butts 210. Red brick (23x10x6cm) 4 courses high on 2 course foundation. Square in plan, 44x44cm. Pale grey-white mortar.	0.35 high
212	<i>Natural</i>	Natural sand, or could possibly be made ground or old subsoil. Dark yellow. <1% stone, rounded, <1cm. Compact. Occasional diffuse mottling. Overlies 213.	0.85-1.05 bgl
213	<i>Natural</i>	Natural sand. Mid-yellow with occasional mid-brown mottles and rare sandy clay mottles. Compact.	1.05+ bgl
214	<i>Structure</i>	Wall remnant; projects forward from main robber cut alignment so may be buttress. Composed of red brick (23x11cm) bedded with mid-yellow sand. Length 0.48m, width 0.20m. Height not fully exposed but thought to be only one course. Overlies 212.	0.04+ high

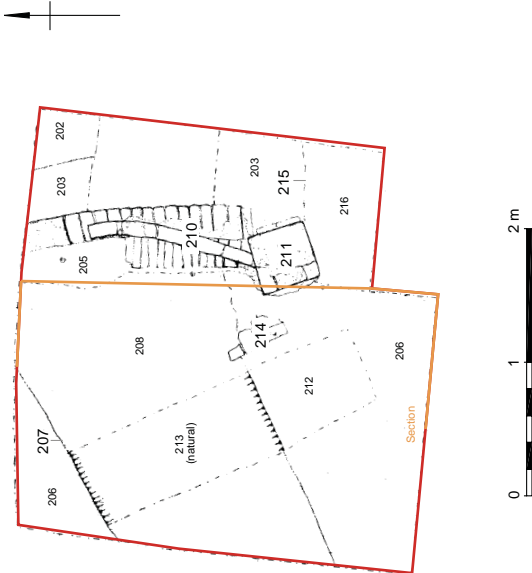
Section showing structures 210, 211 and features 215 and 217

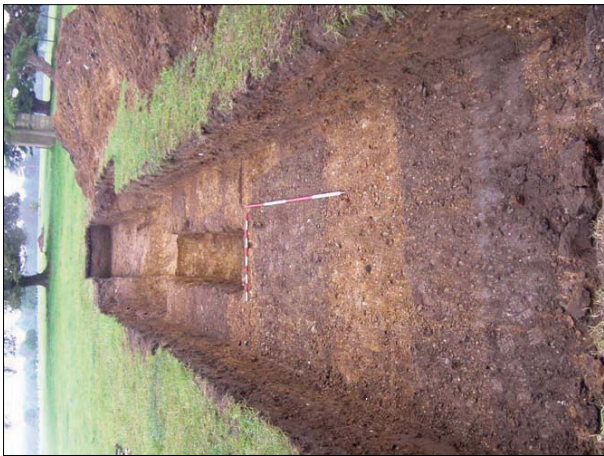
Plate 8: View of Trench 3, from the north-west

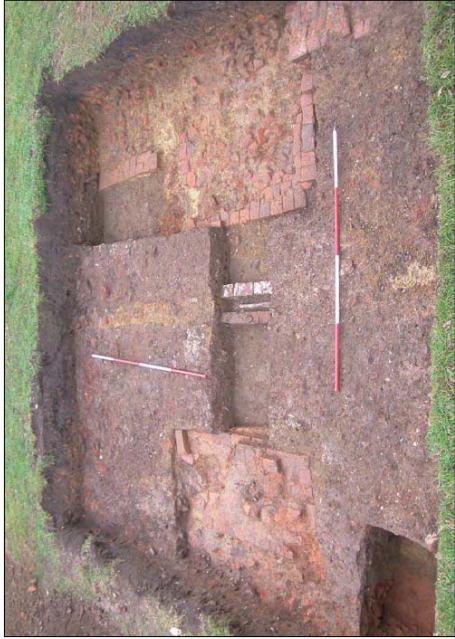
Plate 9: Trench 4, view from the south-east

- 4.3.25 Trench 4 was targeted on the gatehouse of the house and lay just over 15m to the north-east of Trench 1. As with Trench 1, the topsoil overlay a layer of mixed demolition debris (**402**). A late 17th century Charles II farthing was found within this debris.

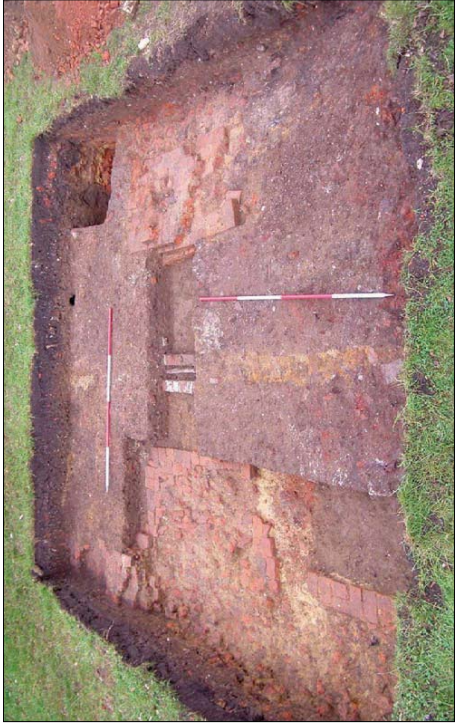
Plate 10: Trench 4, view from the north-west

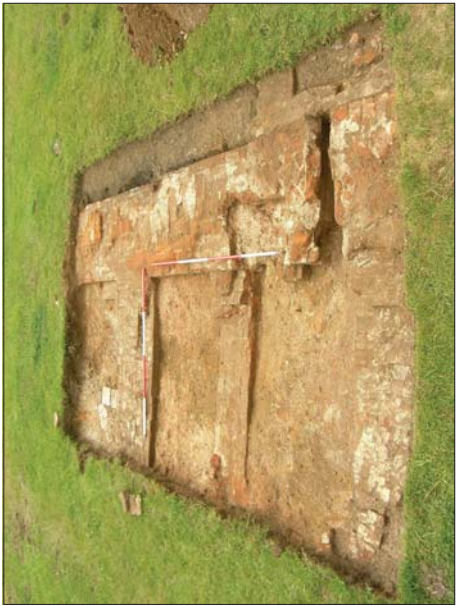
Plate 11: Trench 5, view from the north-west

- 4.3.36 Plans of the new house produced by James Wyatt in 1793 indicate that the trench is situated on the south-western edge of the 18th century house, with **502** forming the foundation for the external wall. The plans suggest that the southern part of the cellar storey was not used as rooms, as they lack the labels and door annotations shown within the northern part of the building. Wall **504** apparently formed the division between these cellar rooms and the foundations to the south. Walls **505** and **506** correspond to divisions within the ground floor above, where this area was divided into a water closet, strong closet and office. The position of the water closet, which lies above the northern end of the trench, explains the built-in drain **503** seen within wall **502**.

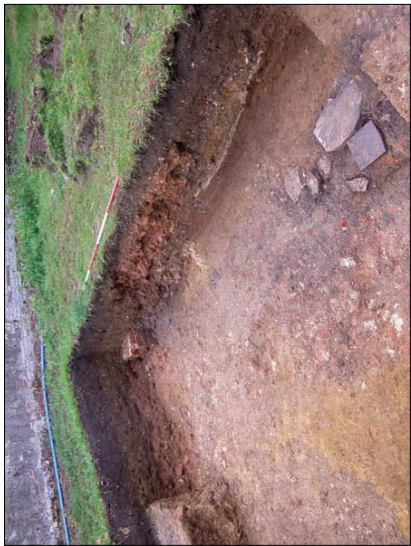
Plate 12: South-west facing section Trench 6, oblique view

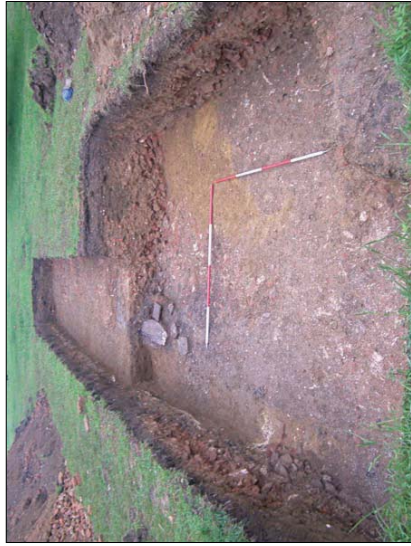
Plate 13: Trench 6, view from the north-west

- 4.3.40 Trench 6 was targeted on the north-western, back range of the house, the most likely location for the Great Hall and potentially the oldest part of the house. Here, a relatively deep deposit of modern topsoil was found to overlay a slightly discontinuous subsoil layer (**602**), which also varied considerably in depth. This was the only trench in which a subsoil deposit was found and, given the varied depth of the deposit, it is likely that (as elsewhere) it also represents a period of levelling after the demolition of the house.

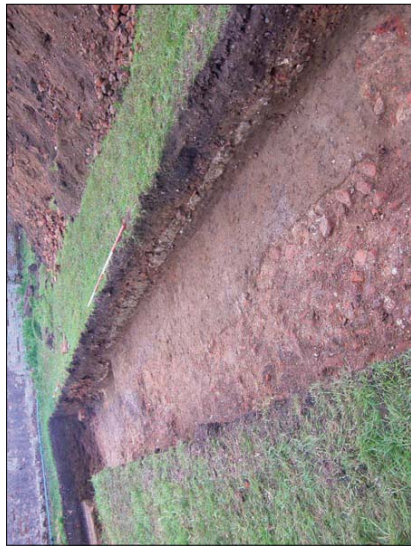
Plate 14: Trench 6, view from the south

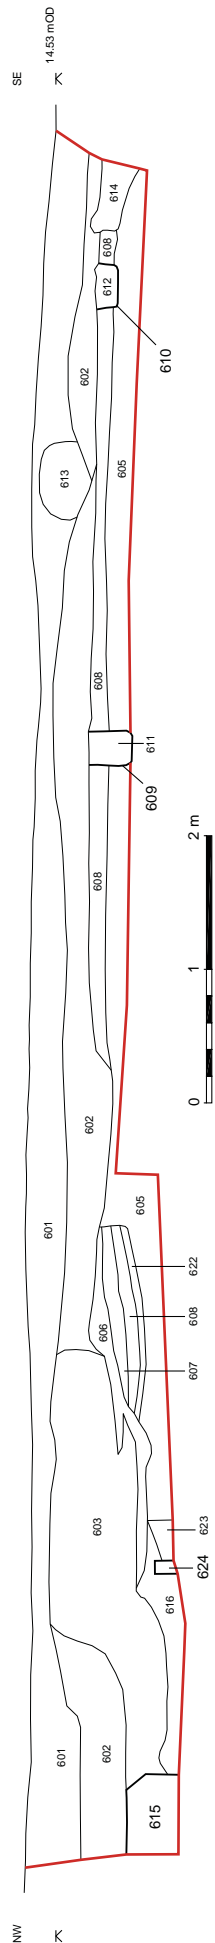
South-west facing section, Trench 6

- 4.3.42 A number of demolition deposits were visible within the north-western part of the trench, including **603**, which contained abundant brick rubble; **606**, which appeared to reflect an episode of burning; and **607**, which contained brick and mortar fragments. This evidence accords with the documentary sources, which record the destruction of the house in a fire in 1773. Several of the lead and glass fragments recovered from **603** showed the effects of heat distortion. The last phase of use of the house are represented by jetons dating from the late 16th and 17th centuries found within demolition deposit **603** and the topsoil, as well as pottery dating to this period. Also within deposit **603** were a number of fragments of moulded ceramic building material, which would have originated in the Tudor house. The concentration of demolition rubble within this part of the trench suggests that the majority of the structures were situated at this end of the trench.
