# Upton Castle, Near Cosheston, Pembrokeshire, Wales

Archaeological Evaluation and Assessment of Results

Ref: 85207.01  
May 2016

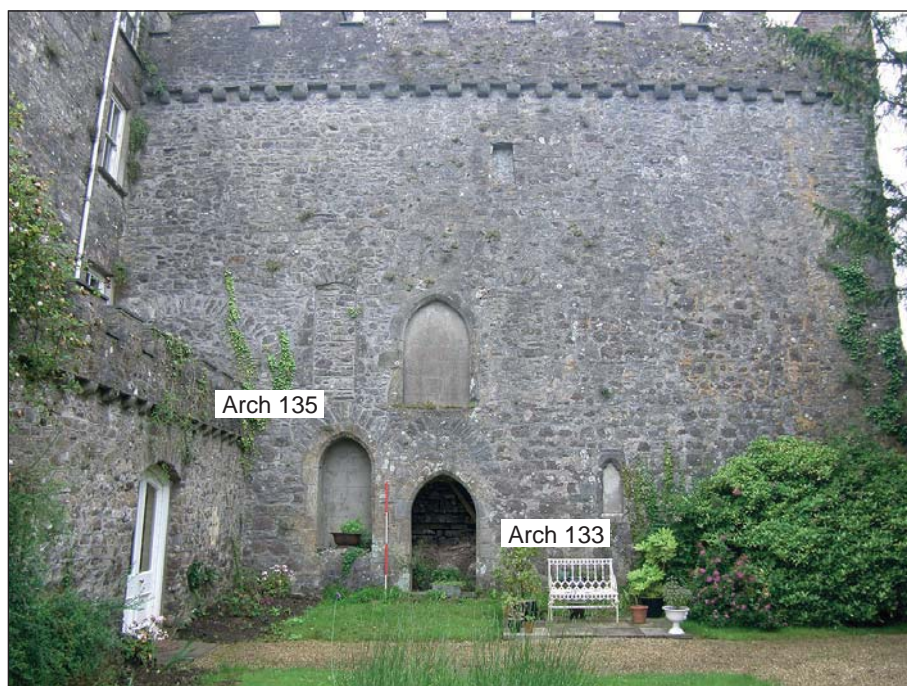
Plate 1: South facing elevation of the eastern chamber

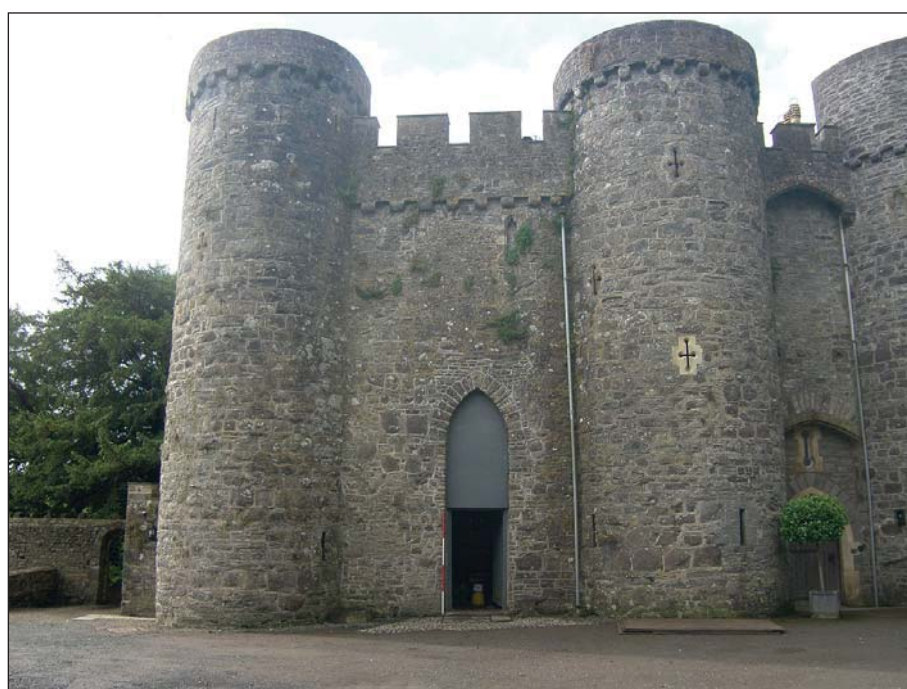
Plate 2: North facing elevation of the eastern chamber

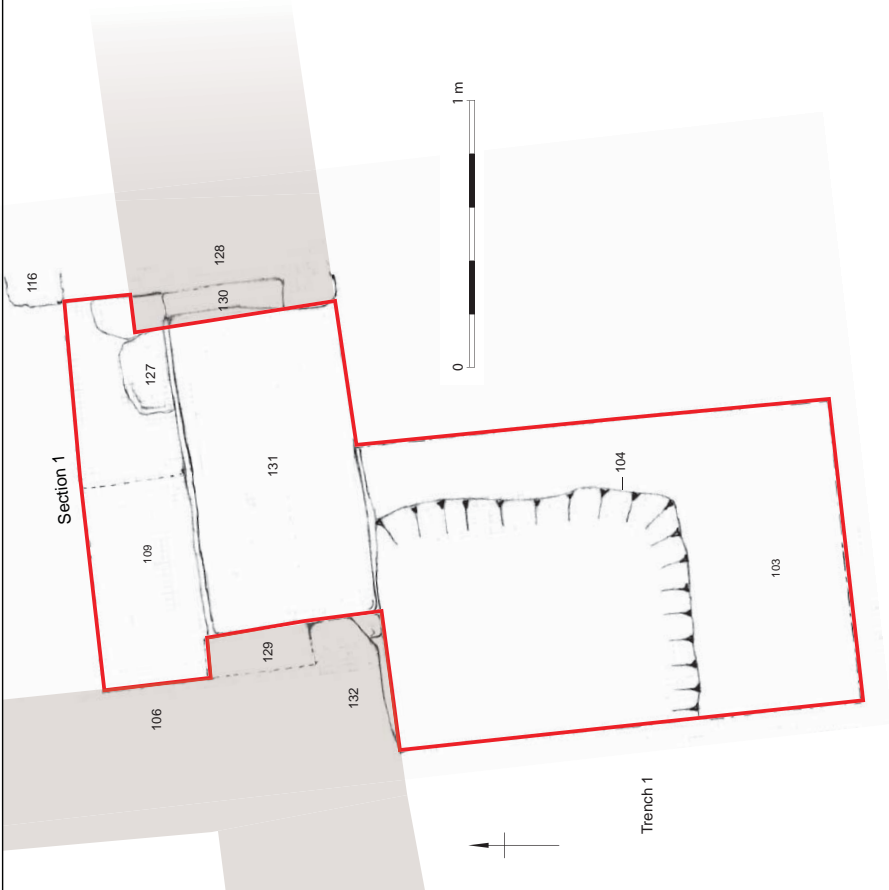
Section 1: South facing section of floor layers 127, 114 and 124/126 and associated make-up layers

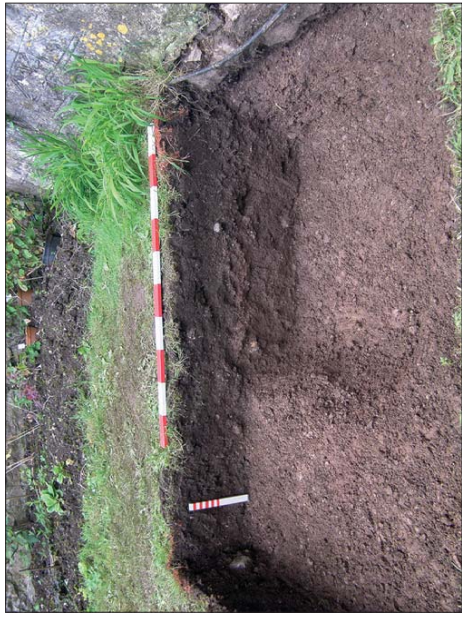
Plate 4: East facing section of Trench 1 (scales 1 m, 0.2 m)

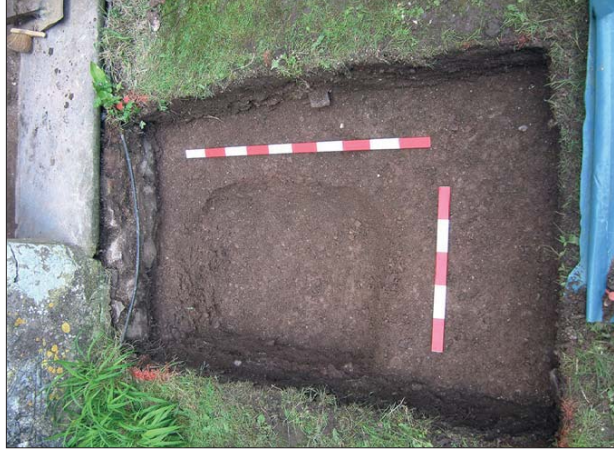
Plate 3: Trench 1 view from the south (scale 1 m, 0.5 m)

- 5.3.8 To the south, outside the line of the wall, the natural geology **103** was encountered at 0.28m below the current ground surface (at c. 88m aOD). This was cut by a tree hole (**105**) of probable modern date (**Figure 3, Plates 3 and 4**). Overlying this was a layer of degraded natural which was overlain by the current topsoil and turf of the garden. The medieval ground surface was not identified. Sherds of post-medieval North Devon gravel-tempered ware and 17th/18th century Staffordshire-type slipware were recovered from topsoil and degraded natural.

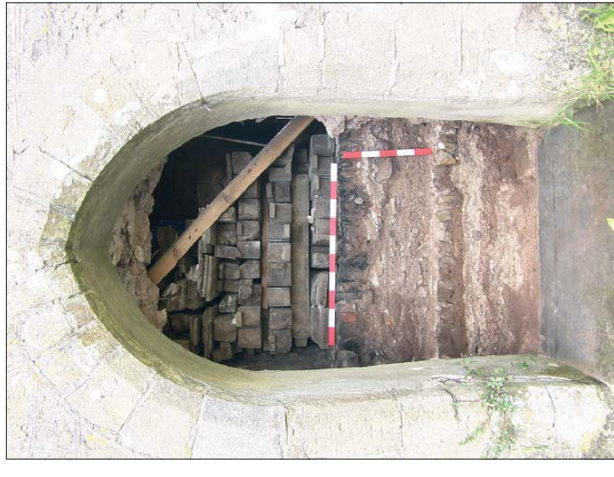
Plate 5: South facing section through floor layers 127, 114 and 124/126 and associated make-up layers (scales 1 m, 0.5 m)

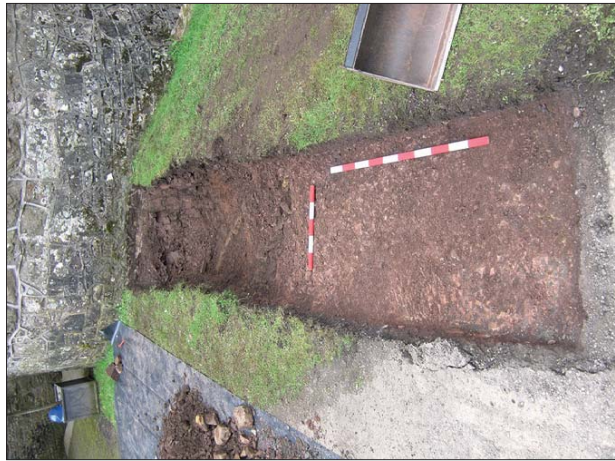
Plate 7: Trench 3 view from the north (scale 1 m, 0.5 m)

- 5.3.14 The natural bedrock **308** was encountered immediately under the topsoil, and it was clear there was no moat at this point. The foundation structure 302 for 303 (the extant standing wall of the tower) lay directly on 308, and it was cut by drains 304 and 306 (**Figure 5, Plates 7-8**).

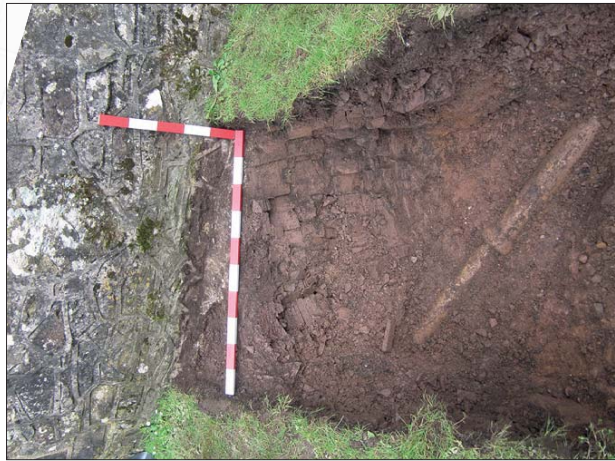
Plate 8: Trench 3 showing modern pipe 304/305, bedrock 308, north wall of western lower slab 302 (scale 1 m, 0.5 m)

9.2.3 On the northern side of the castle, Trench 3 found no evidence of a moat, despite the drawbridge chain holes visible above the current main doorway into the castle. The chain holes and the ‘murder hole’ were perhaps ornamental additions which served no actual practical purpose. It is possible that there was a large pit in front of the main doorway which did not extend as far as the western tower, but no evidence of this was revealed in the geophysical survey and it could not be investigated through trenching.

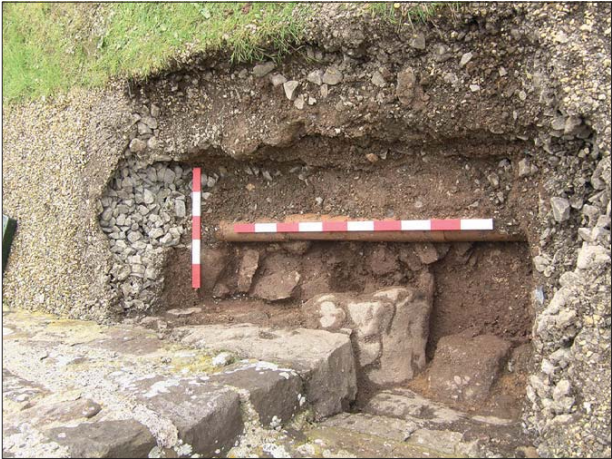
Plate 10: Trench 5, view from the east (1 m, 0.5 m)

- 5.3.18 The earliest structural element encountered was the foundation (**507**) for the north-east corner of the nave wall (**506**), which was butted by deposit **505**, possibly a trample deposit or levelling associated with the nave construction. The chancel was clearly a later addition, and its foundations and northern wall **508/509** butted the east-facing nave wall (**Figure 6, Plate 10**). Physically overlying **505** and butting **508** was a reworked natural layer (**504**) containing fragments of mortar and medieval roof tile fragments, indicating its deposition during works around the chapel. Cutting **504** was a modern ceramic drain (also observed in Trench 4).

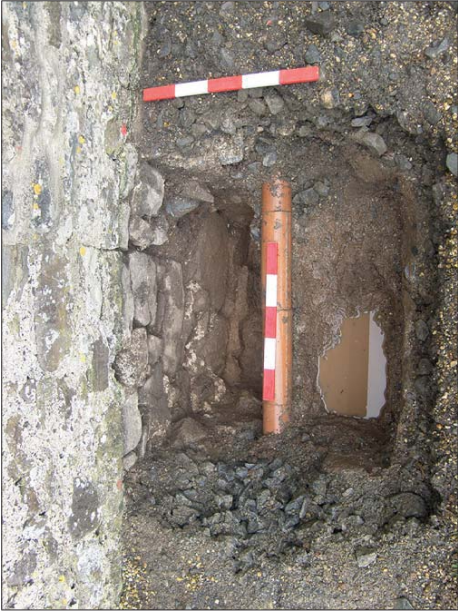
Plate 11: Trench 4, view from the north (2 x 0.5 m)

- 5.3.15 Trench 4 lay on the northern side of the chapel, on the site of the blocked northern or 'Devil's' door into the nave. The northern wall of the nave (**408**) was constructed of roughly shaped stone blocks with a foundation of similar material. The foundation appeared to be butted by layer **407**, which appeared to be reworked natural, resulting from trample activity during the construction of the chapel or later.

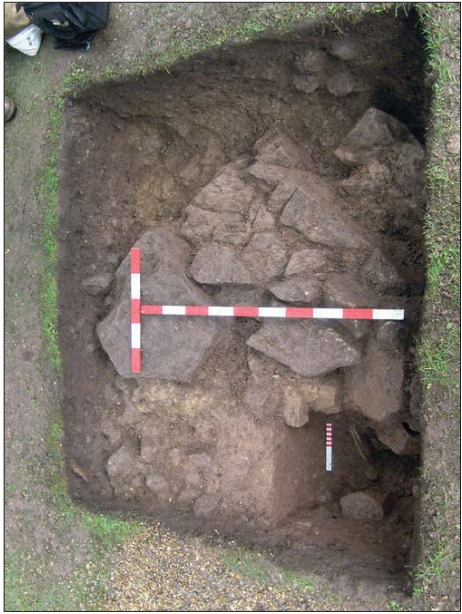
Plate 12: Trench 6, view from the east (scales 1 m, 0.5 m, and 0.2 m)

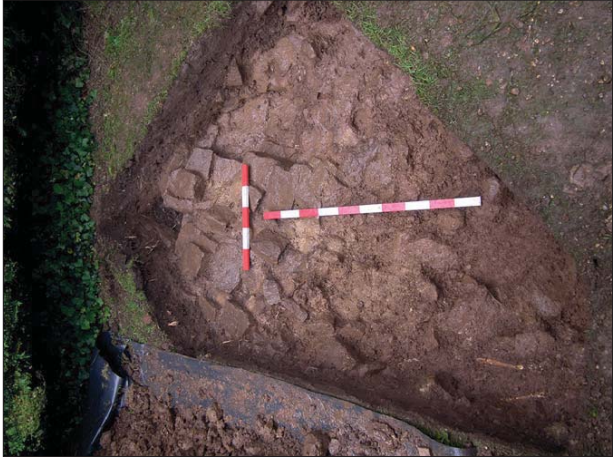
Plate 13: Trench 7, view from the east (scale 1 m, 0.5 m)

- 5.3.21 Trench 7 lay due west of the chapel. The natural geology (**705/706**) was encountered at 0.31m below the current ground surface at a height of c. 87.10m aOD. Five graves were recorded within Trench 7 (**Table 1**). These were only partially exposed and none were excavated although skeletal material was observed (**Figure 7, Plate 14**). All graves were cut through the natural geology, except for grave **713** which cut the fill of earlier grave **711**.

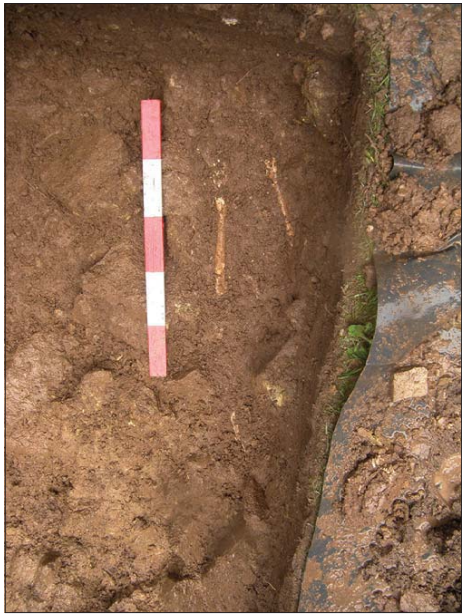
Plate 14: Grave 709 and skeleton 717, view from the south (scale 0.5 m)

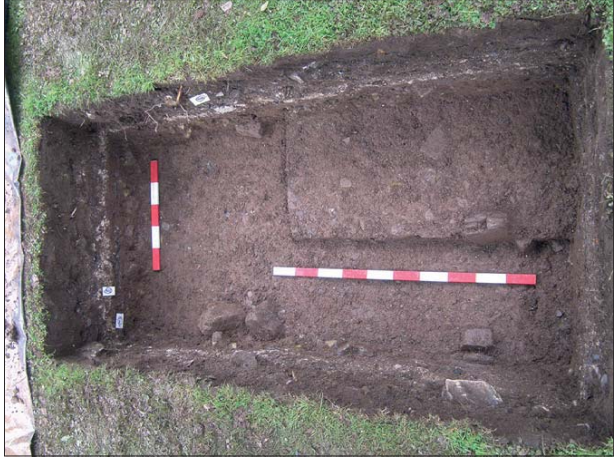
Plate 15: Trench 9 from the south (scale 1 m, 0.5 m)

- 5.3.23 Trench 9 lay due south of the chapel. Under the topsoil, a series of levelling deposits (**902, 904, 905** and **906**) were recorded, which sealed a possible grave (**908**) which cut rubble-rich deposit **903**. Two further possible graves (**910** and **912**) were observed cutting the natural geology following the partial removal of deposit **903**. Deposit **903** contained five sherds of Dyfed gravel-tempered pottery of probable 13th/14th century date. The origin of the deposit is unclear and it may represent reworked natural or an old subsoil layer. No human remains were observed in any of the possible graves.

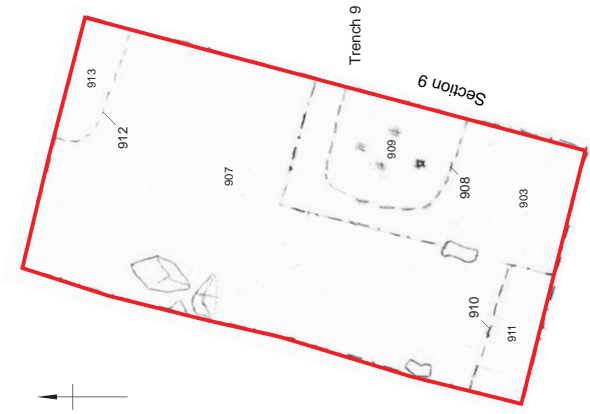
Section 9: West facing section of Trench 9

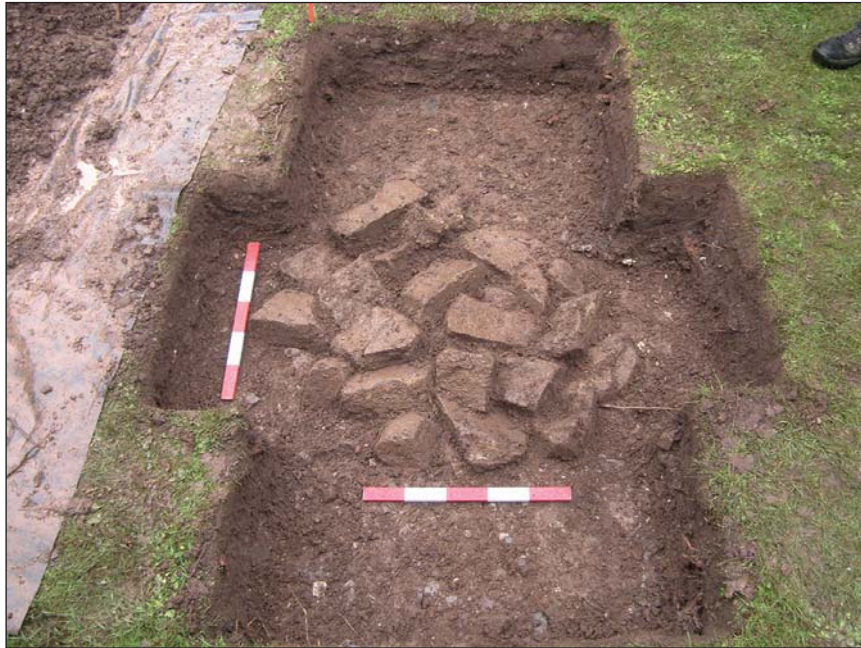
Plate 17: Trench 10, view from the east (scale 2 m, 0.5 m)

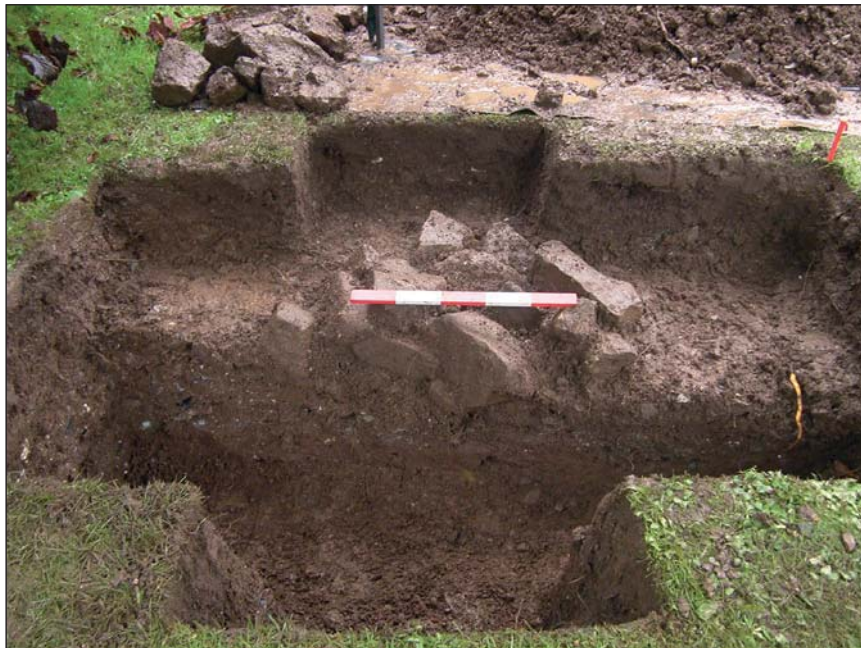
Plate 18: North facing section of Trench 10 showing dumped stone deposit 1004 (scale 0.5 m)
