Cannington Court, Cannington, Somerset.

Post-Excavation Assessment Report
with Proposals for Analysis and Publication

Planning Ref: 13/12/00036/SF
Ref: 88502.01
March 2015

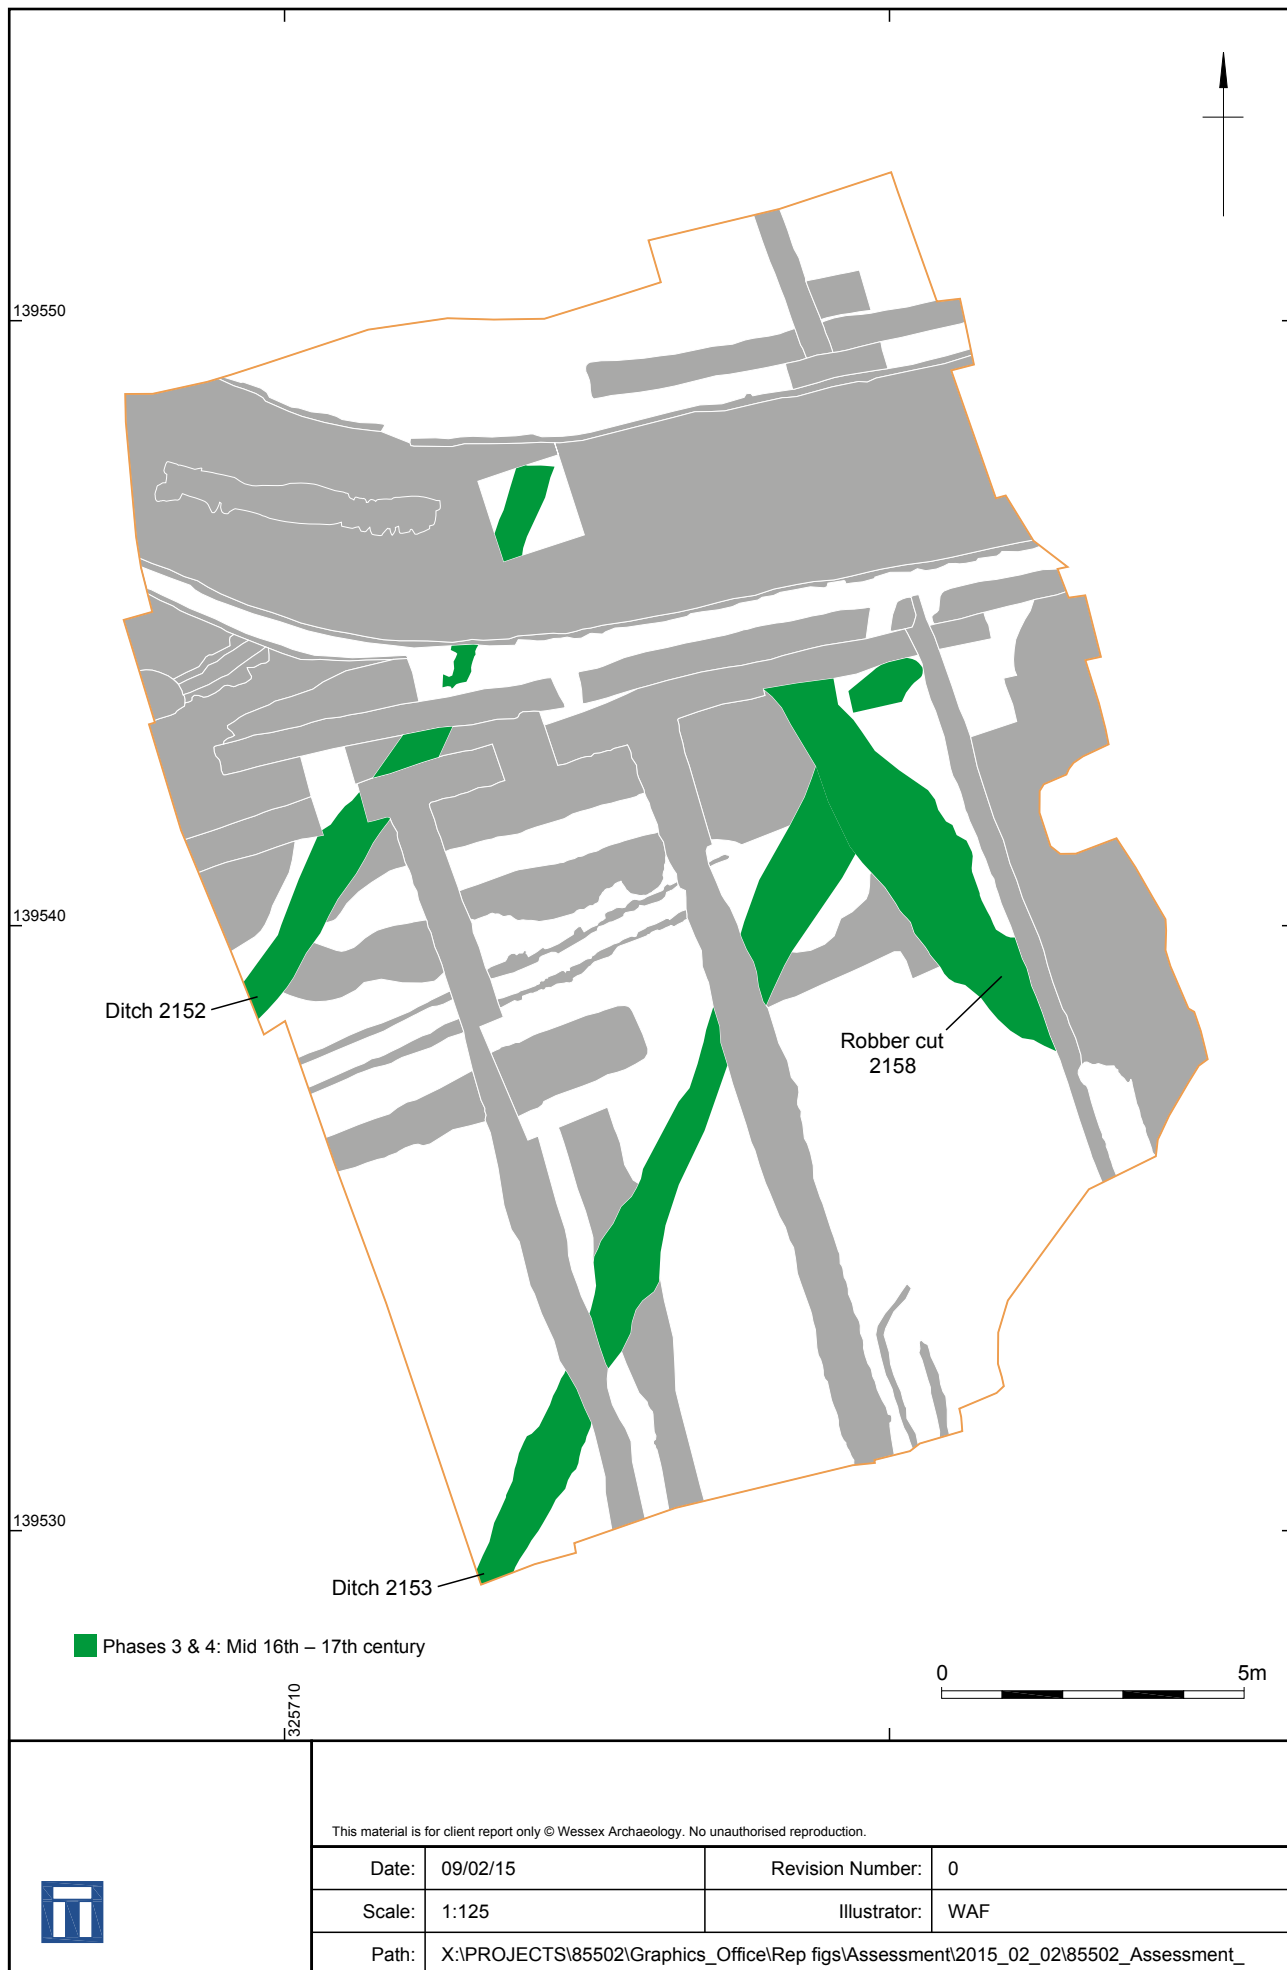
Figure 4

EA 1: Phases 3 & 4: Mid 16th – 17th century

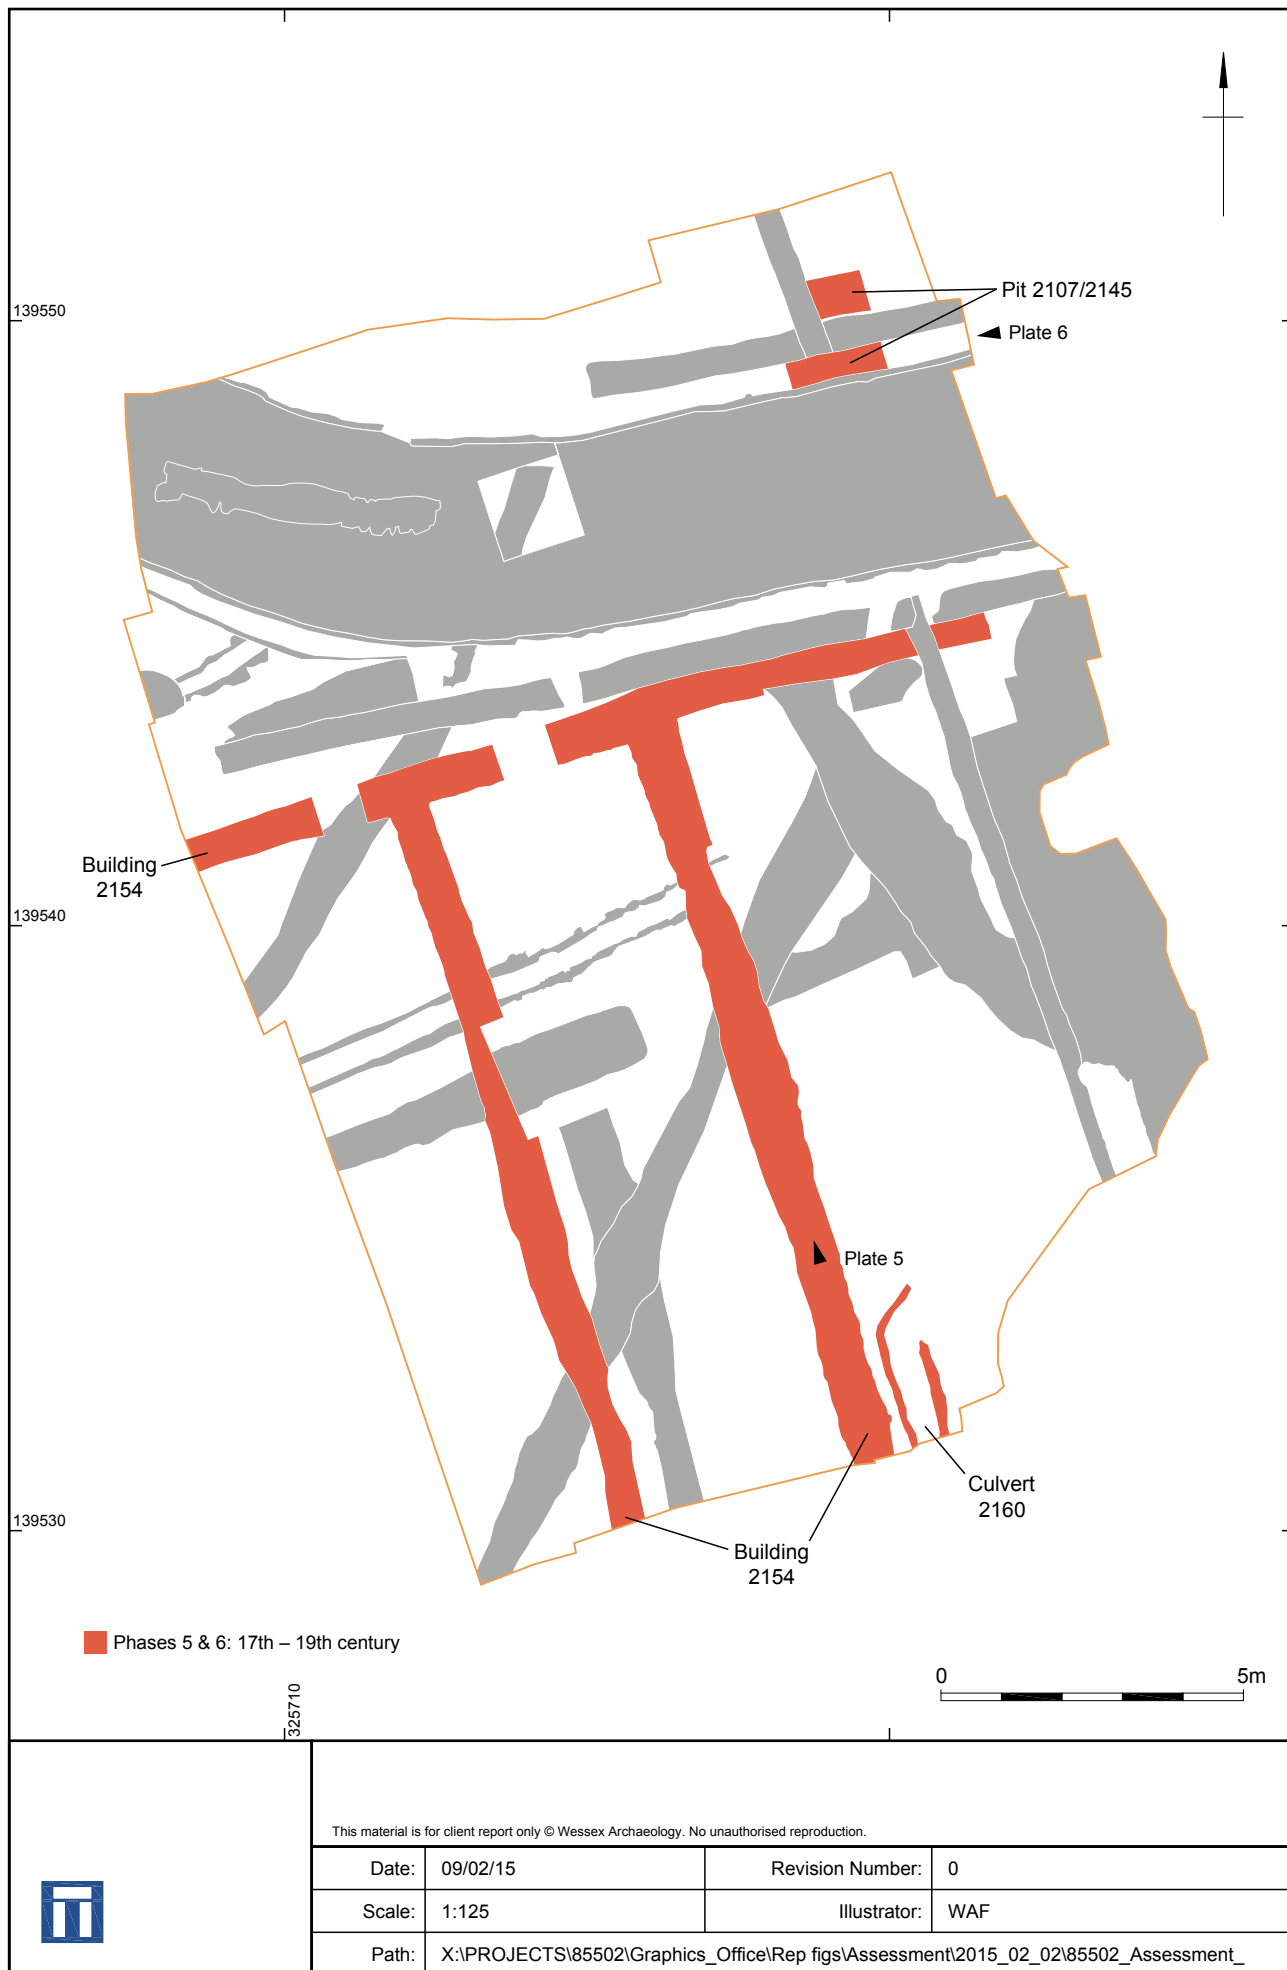
Figure 5

EA 1: Phases 5 & 6: 17th – 19th century

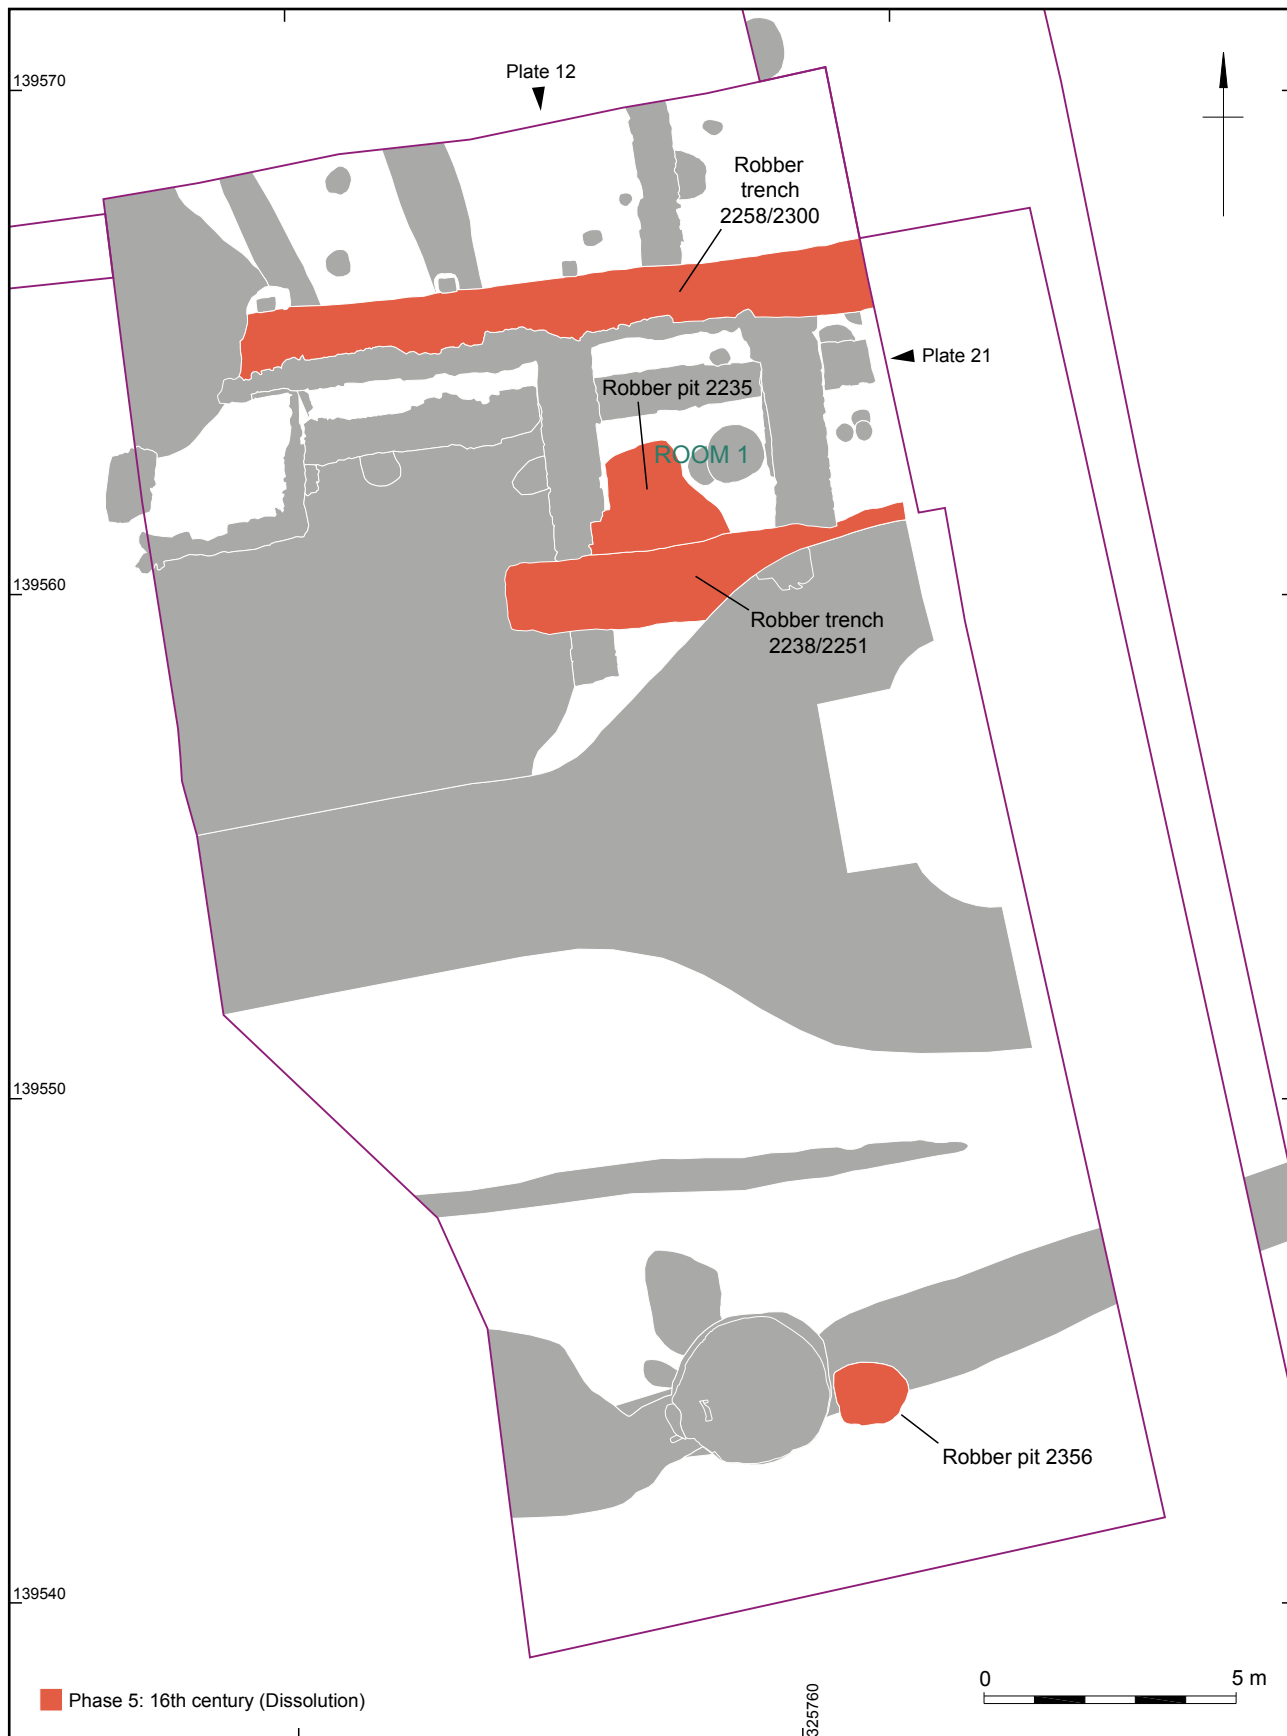
Figure 11

WBA 2: Phase 5: 16th century (Dissolution)

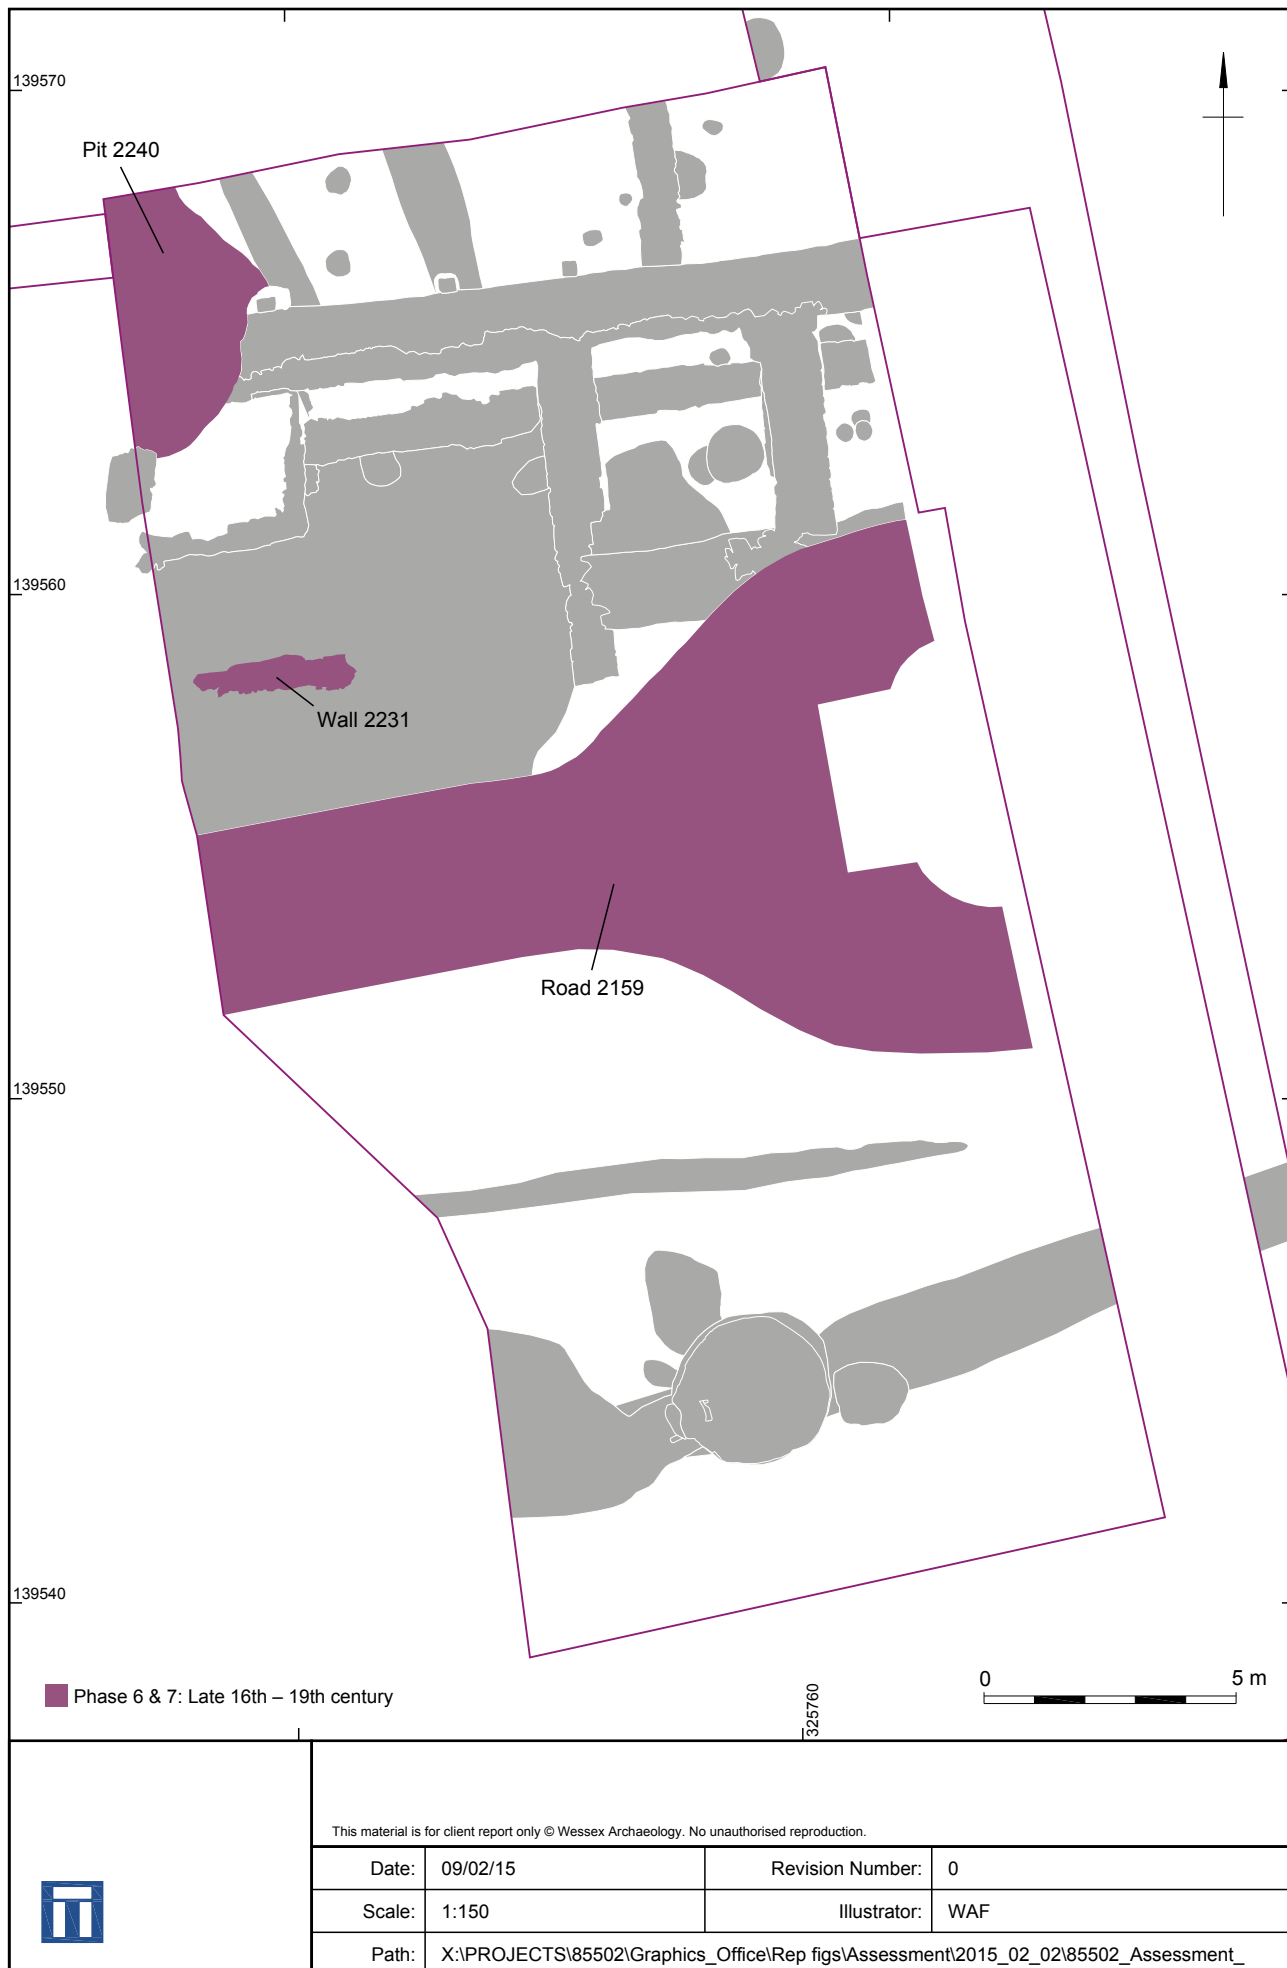
Figure 12

WBA 2: Phase 6 & 7: Late 16th – 19th century

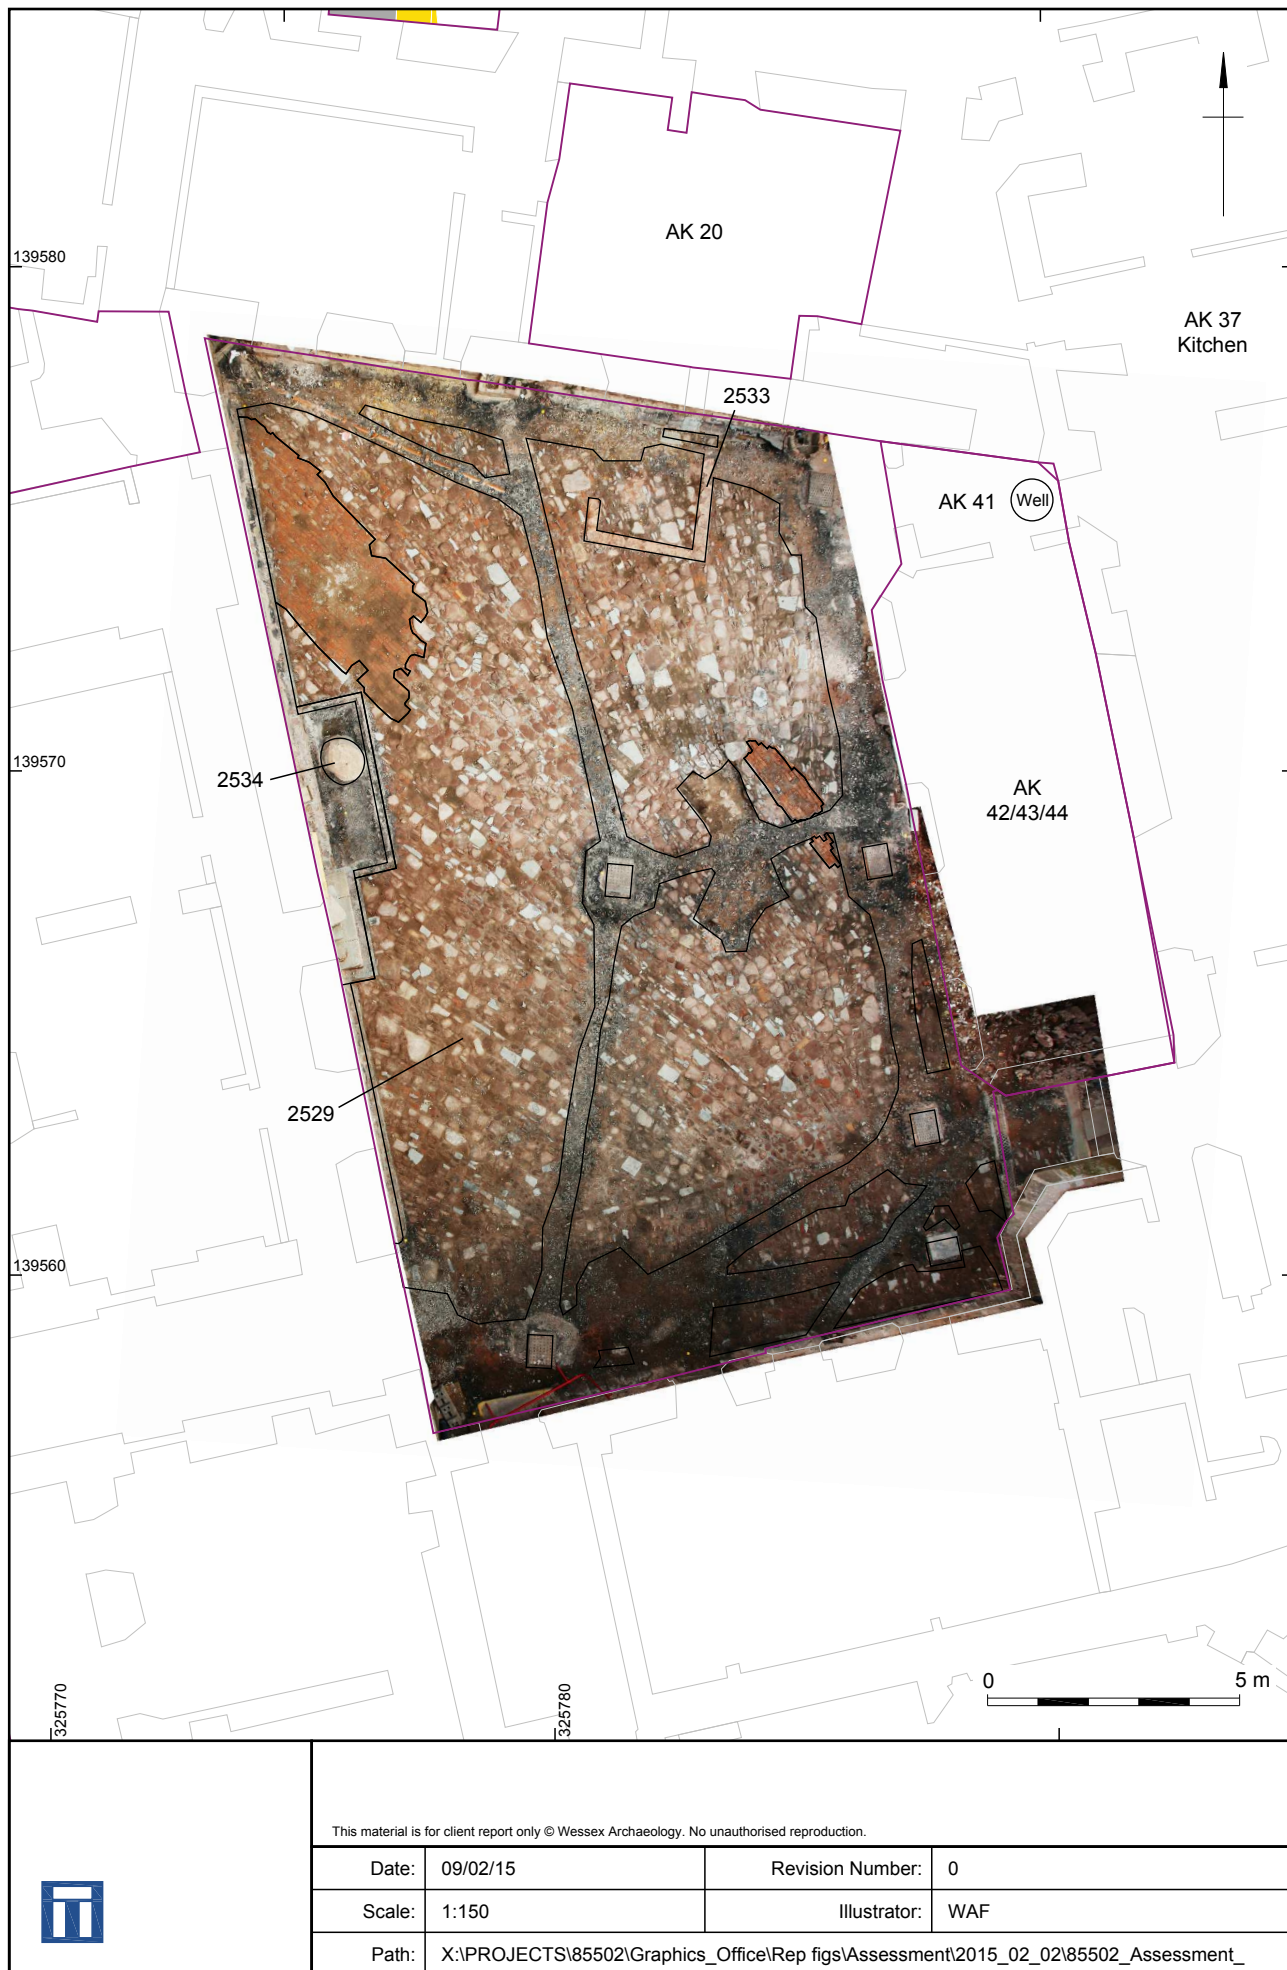
Figure 15

Central Courtyard – Rectified photography survey

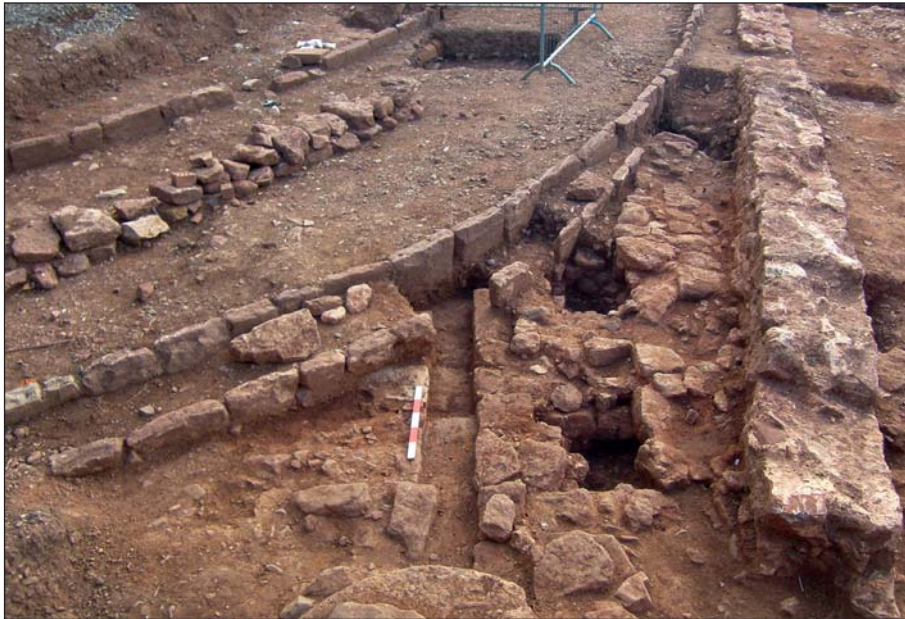
Plate 2: Phase 1 wall 2131 and culvert 2150, capped by 2148 (in foreground).
Truncated by Phase 9 wall 2022 and Phase 10 road 2156. View from the west (scale 0.5m)

- 7.2.4 Culvert **2150** was in excess of 2.2m long and 0.64m, wide and constructed of parallel stone walls **2126** and **2127** built upon stone-flagged base **2140**, within cut **2128**. The culvert channel measured 0.30m wide. Most of the capping stones (**2148**) had been removed, though part of this capping (a broken millstone – bedstone) did survive at the very western limit of the area. Dating of bedstones (the lower stone) is difficult due to the lack of diagnostic attributes, and this example is clearly reused, likely derived from the Priory mill located to the south-west. The culvert was filled with a fine silt deposit (**2129**), an indication that the culvert perhaps carried water into the Benedictine Priory complex as opposed to carrying waste out.

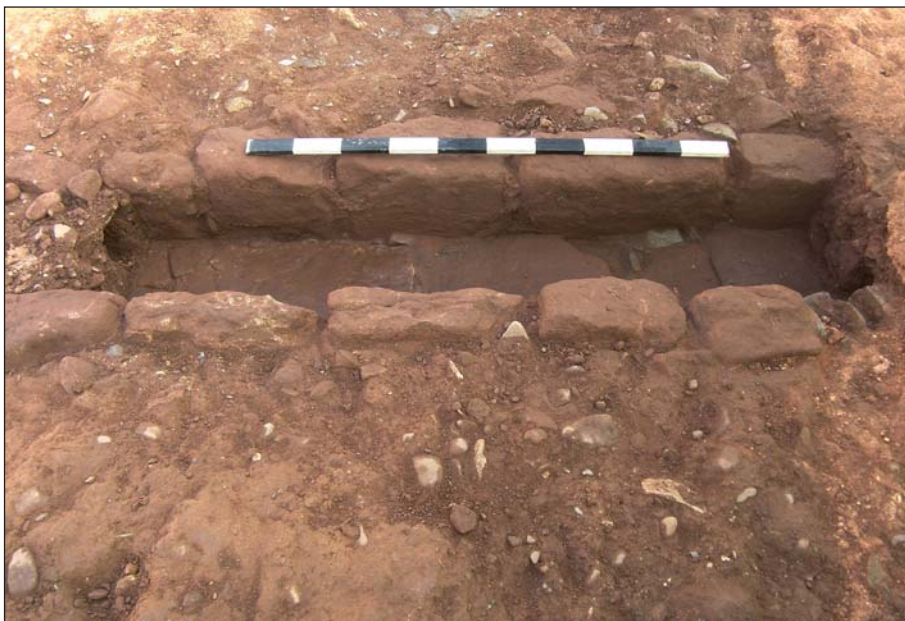
Plate 3: Phase 1 culvert 2157 (cut 2018, linings 2007, 2008, and base 2055).
View from the south (scale 1m)

- 7.2.6 A second, potentially contemporary culvert, **2157**, running parallel to and 6.7m south of **2150** was constructed in the same manner, of the same materials and was of similar dimensions. It was at least 7.9m long, by 0.7m wide) and comprised parallel culvert walls **2007** and **2008** built upon stone-flagged base **2150** within cut **2018**. It was in-filled with **2017/2122**. No capping stones were observed and so it is possible the culvert was an open drain.

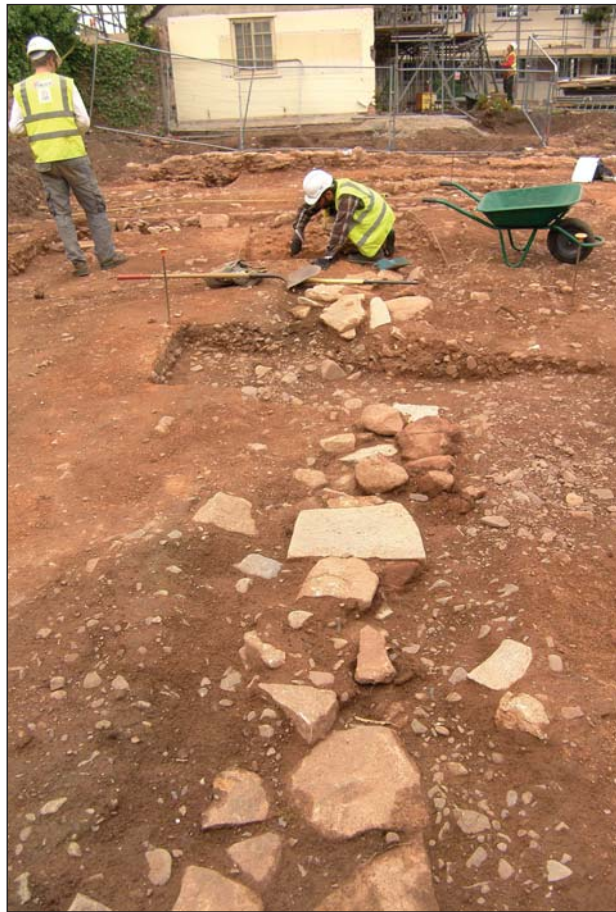
Plate 4: Phase 1 robber trench 2019 (fill 2006) of Group 2151.
View from the south

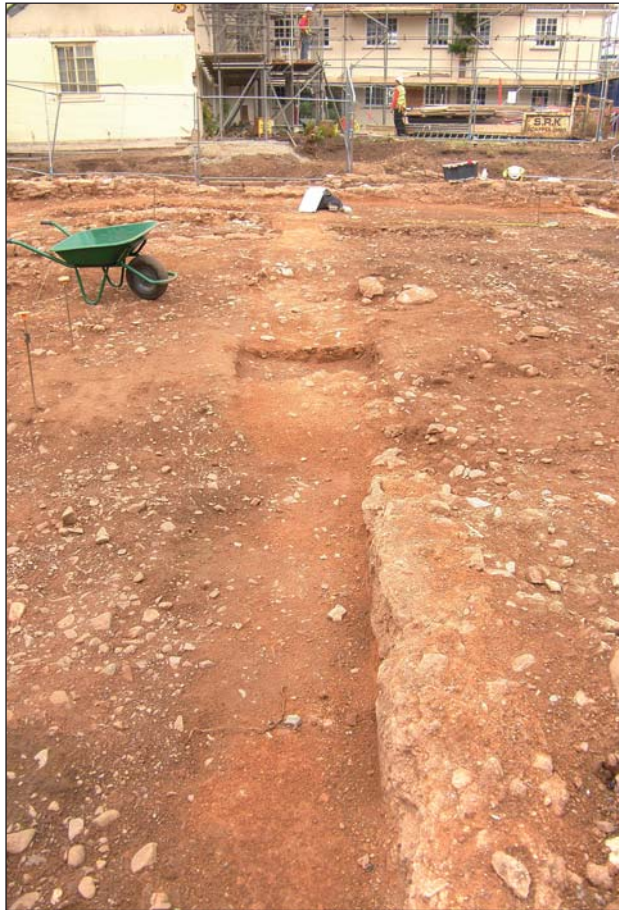
Plate 5: Phase 5 Wall 2011 (Group 2154). View from the south

- 7.2.15 Following the robbing of wall **2132** and subsequent infilling of robber trench **2158**, the construction of building Group **2154** took place. This was composed of two parallel 0.70m wide north–south aligned mortar foundations, **2073** (in cut **2072**) and **2011** (in cut **2071**), which were joined at the northern end by east–west aligned foundation **2035** (in cut **2074**), forming a building approximately 12m by 12m. There was an absence of floor surfaces and the function of this structure is unclear. Culvert **2160** may have been associated with **2154**.

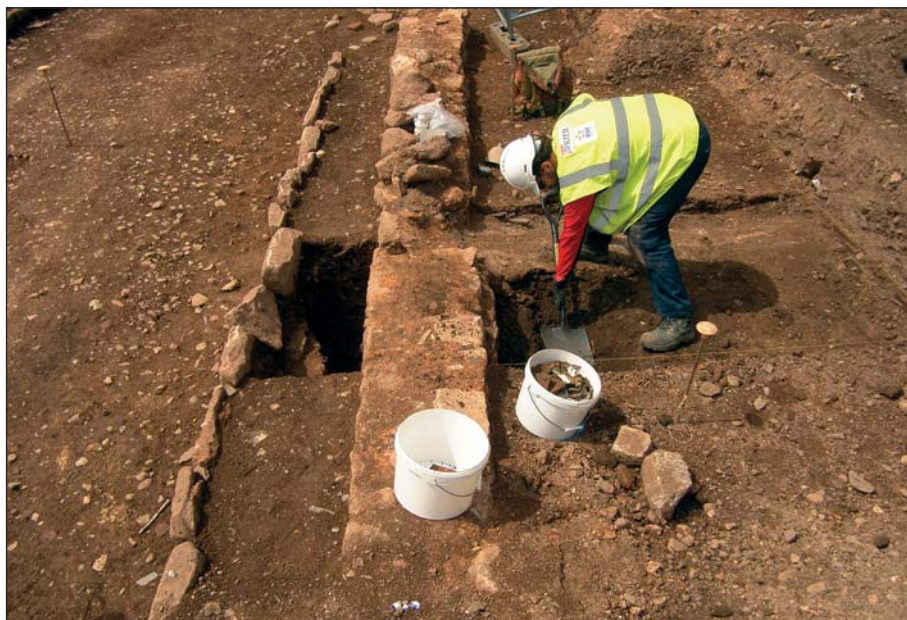
Plate 6: Excavation of Phase 6 pit 2145/2107, truncated by Phase 9 wall 2024 (Group 2156). View from the east.

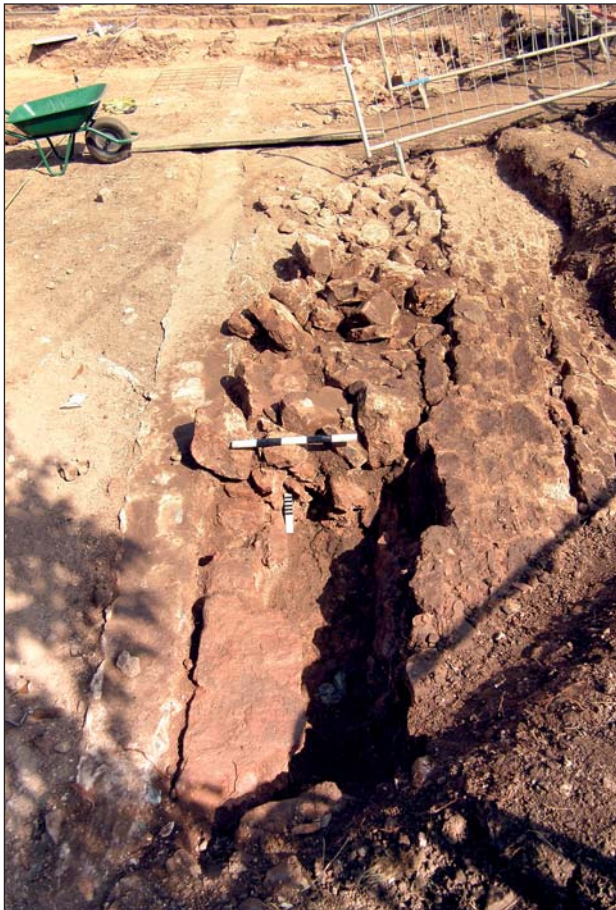
Plate 7: Phase 7 ceramic drain 2155, sealed by Phase 8 collapsed wall 2013/2014. View from the west (scale 0.5m, 0.2m)

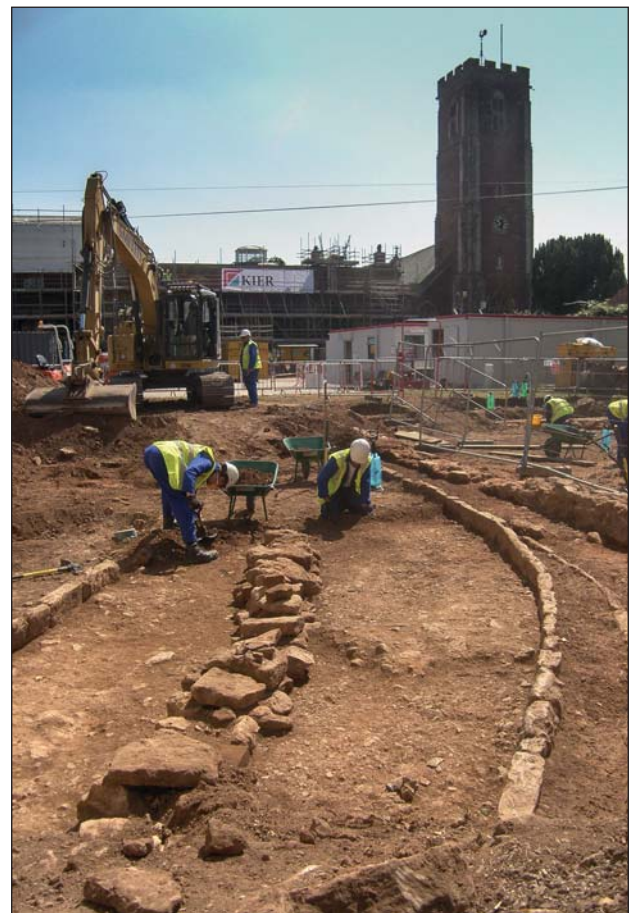
Plate 8: Phase 10 road Group 2159 showing kerbs 2026, 2027 and surface 2003, sealed by Phase 11 culvert 2161. View from the north-west.

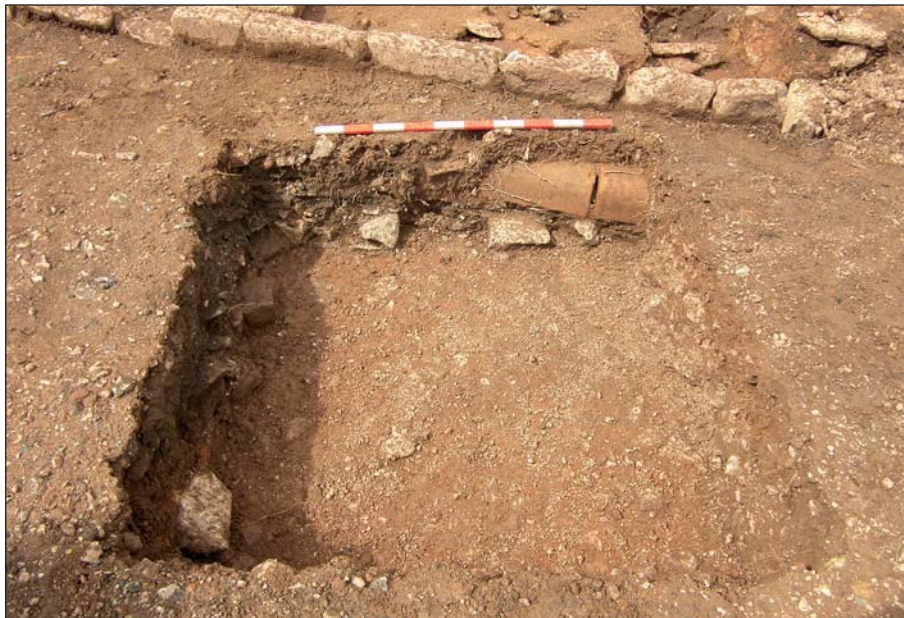
Plate 9: Sondage excavated through Phase 10 road surface 2033, revealing ceramic drain 2115 and base of Phase 3 ditch 2152 (cut 2117). View from the south (scale 1m)

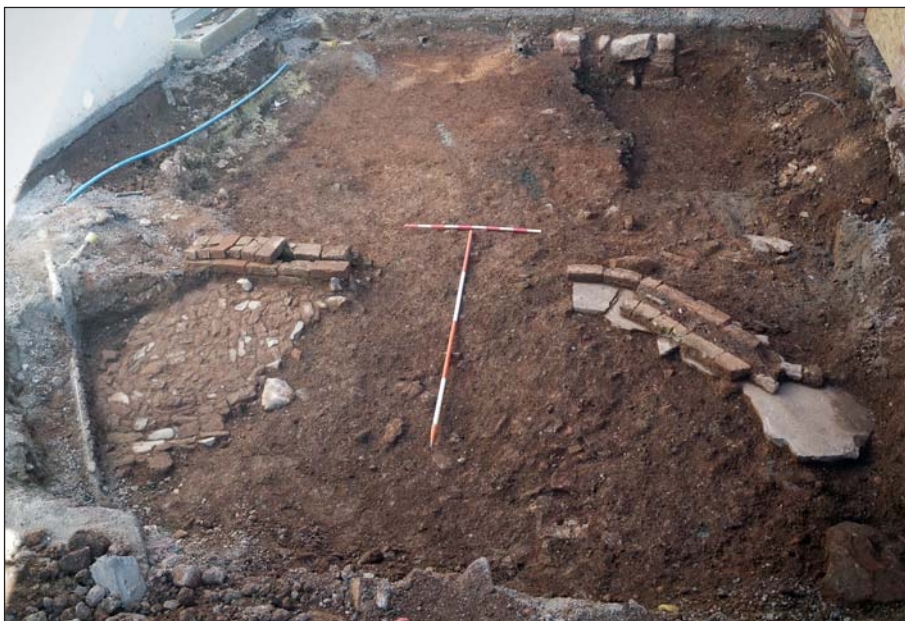
Plate 10: Excavation Area 2 (EA 2) showing metallated surface 2526 and drain 2524. View from the south (scale 2m, 1m)

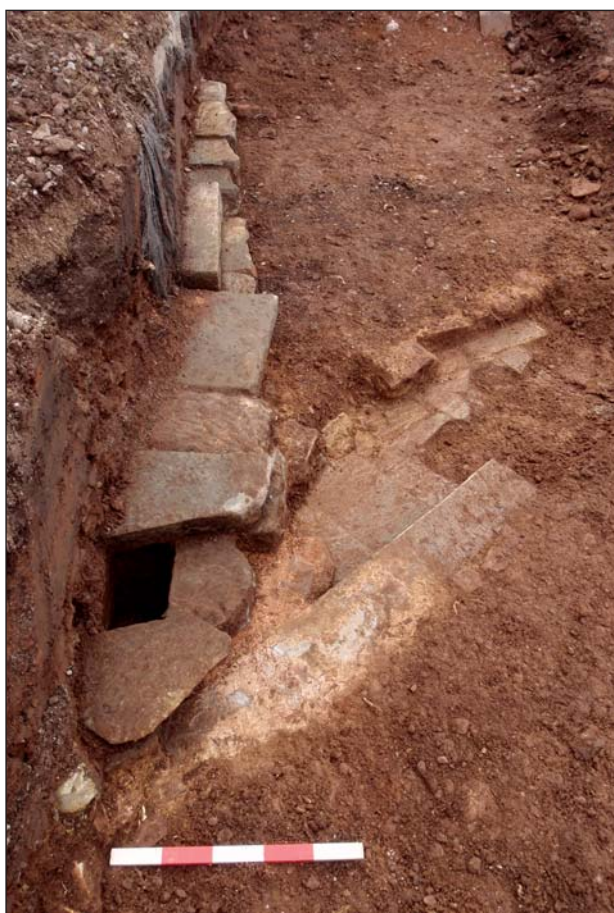
Plate 11: Watching Brief Area 1 (WBA 1) Structure 2205 and culvert 2206 from the east. (scale 0.5m)

7.4.2 Two further structures were observed cutting the natural geology **2204**; roughly east–west aligned stone-built culvert **2205** and north–west to south–east culvert **2206**. Both culverts were constructed of blue lias, forming the base, walls and capping stones. The stone work appeared to be sawn, perhaps machine-milled, and therefore likely to be much later in date than the culverts observed in **EA 1**.

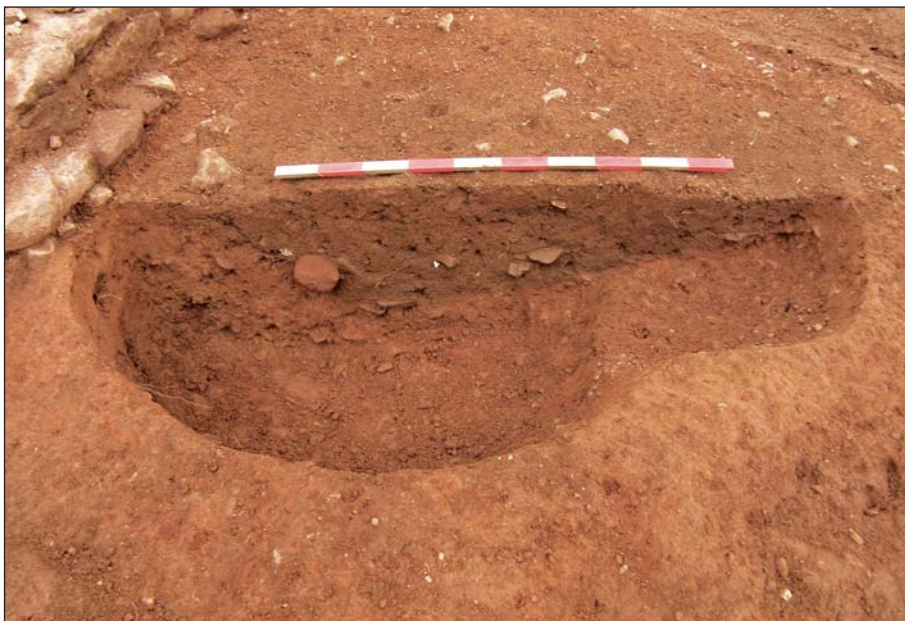
Plate 14: North-facing section of pits 2278 and 2312 (scale 1m)

- 7.5.4 The largest of the pits, **2278 (Plate 14)**, a probable cess pit, contained medieval coarseware pottery dating to the 11th–12th century and clearly predated the second phase of building as it was sealed beneath floor levelling deposits within the interior of Room 1 (see below). A further pit, **2482**, was revealed in the same area during the Watching Brief (WBA 3), while two further pits (**2403** and **2332**) were revealed 17m south of **2278**, adjacent to east–west aligned gully **2173**. A single, small, abraded sherd of Roman Black Burnished ware was recovered from **2403**, while **2173** contained medieval coarseware dating to the 11th–12th century. Further medieval coarseware was recovered from large tree throw **2293/2308**, which pre-dated the first phase of construction (Phase 2) (see below).

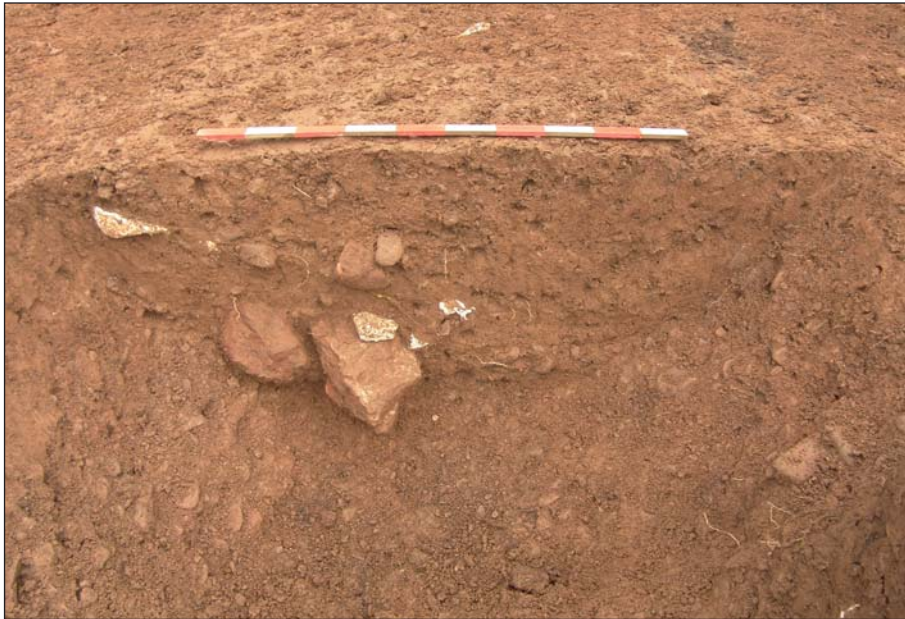
Plate 15: West-facing section of ditch 2352 (scale 1m)

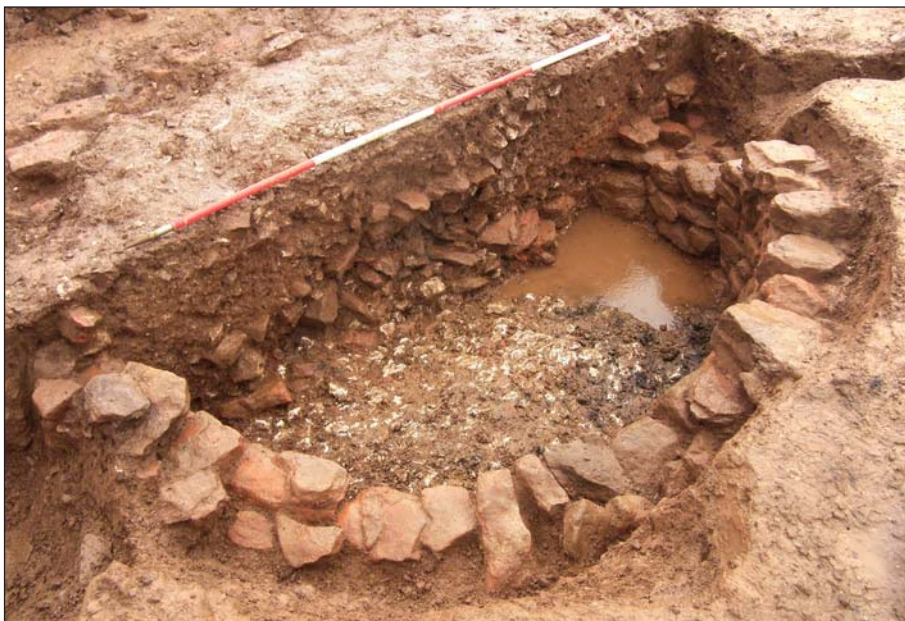
Plate 16: North-facing section of infilling of Kiln 2174. View from the north-east (scale 2m)

- 7.5.10 Following the final use of the kiln it was backfilled with a series of deposits; at the base was **2394**, a crushed sandstone layer, sealed by **2338**; containing common unburnt and partially burnt limestone blocks. Above this was **2337**, which contained many burnt sandstone blocks derived from lining **2329**, overlain by a series of rubble-rich layers, **2337**, **2334** and **2331**, before the final silting **2330**. No dateable finds were recovered from the backfill of the firing chamber. The flue was filled with **2398** and **2399**, which contained a single rim sherd of medieval coarseware pottery dating to the 11th–12th century.

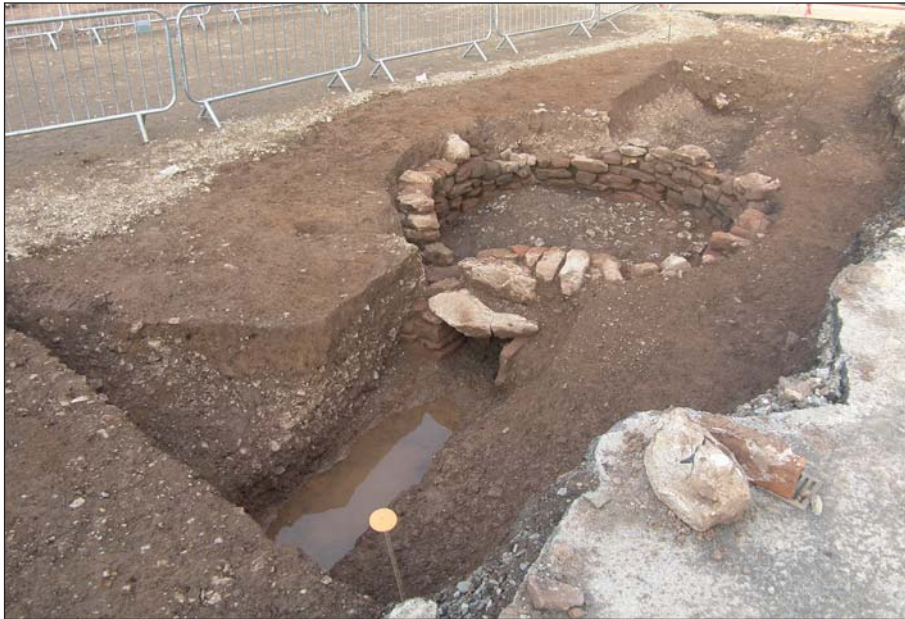
Plate 17: Kiln 2174 under excavation, showing flue 2397 (in foreground) leading to chamber with Phase 1 ditch 2352/2413 in background

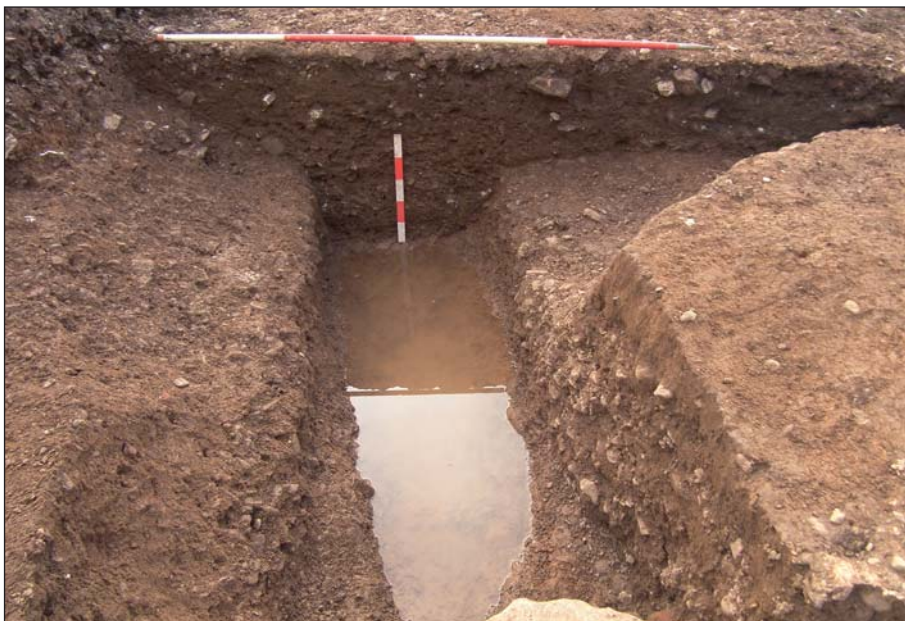
Plate 18: East-facing section of flue 2397 (scale 2m, 0.5m)

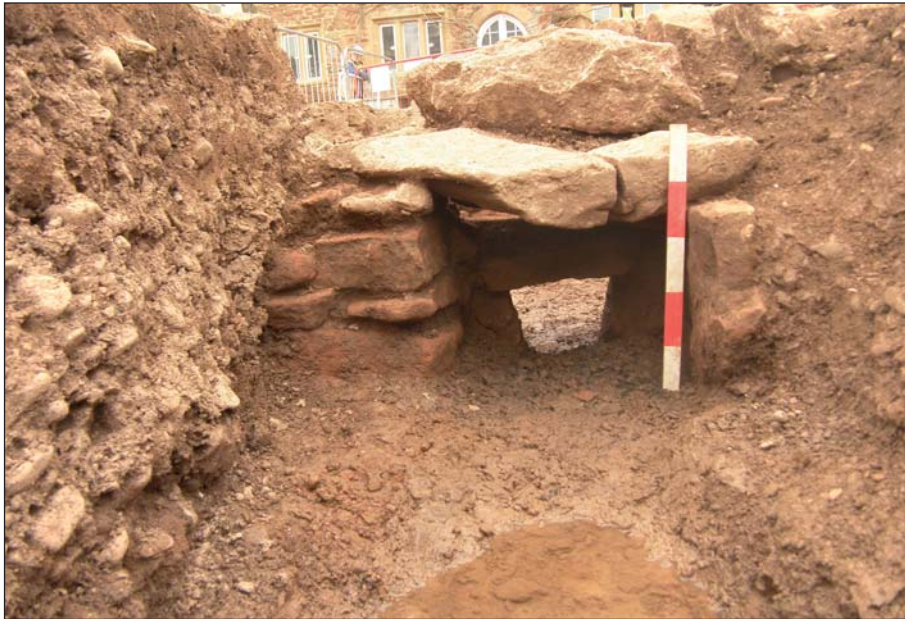
Plate 19: East-facing elevation of tapering channel from flue 2397 into firing chamber 2328 (scale 0.5m)
