Cannington Court, Cannington, Somerset.

Post-Excavation Assessment Report
with Proposals for Analysis and Publication

Planning Ref: 13/12/00036/SF
Ref: 88502.01
March 2015

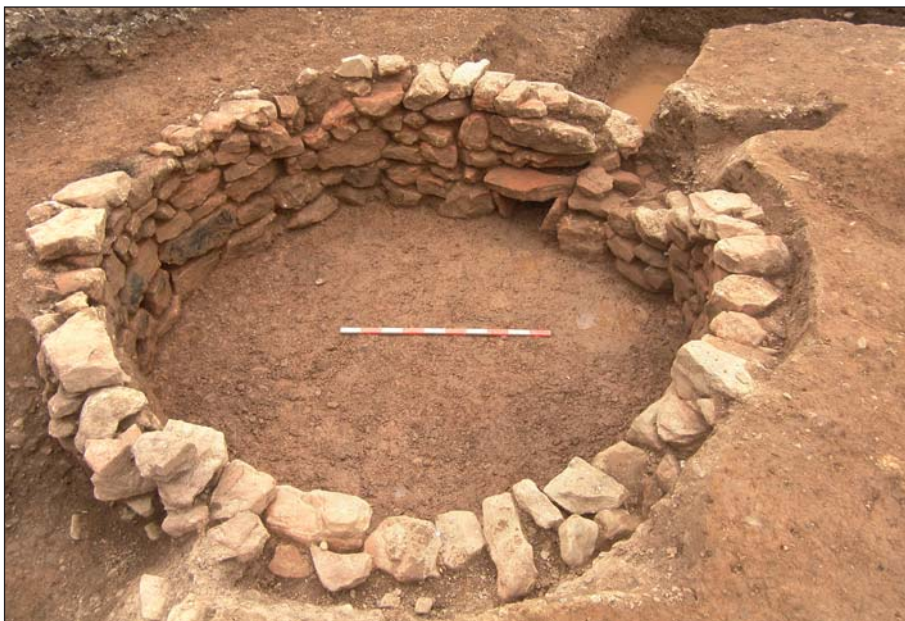
Plate 20: Kiln 2174 from the north-east showing firing chamber 2328, lining 2229, and tapering channel leading to flue 2397 (scale 1m)

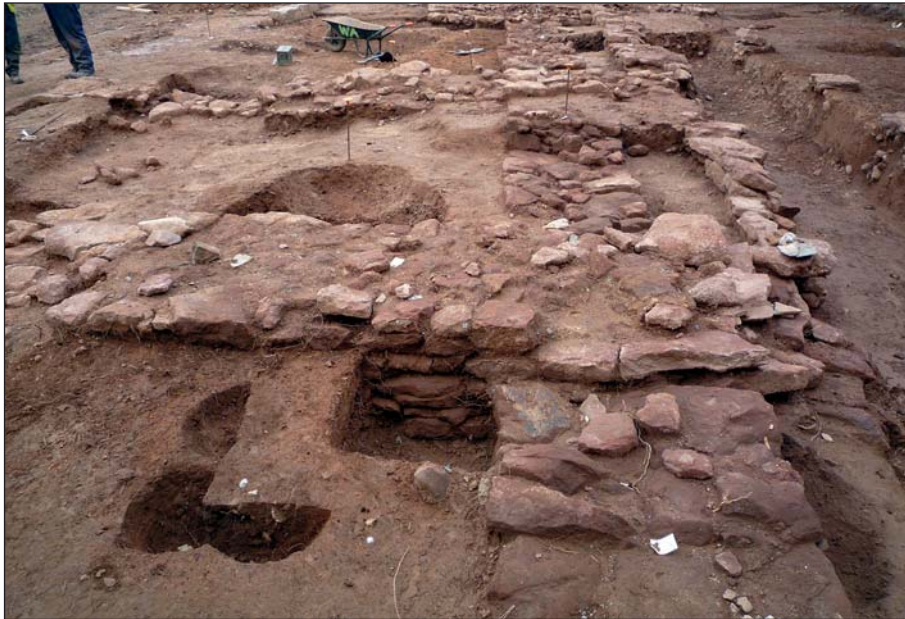
Plate 21: Wall 2170, truncated by later structures. View from the east

- 7.5.11 The second phase of activity within **WBA 2** saw the first phase of building construction represented by an east–west aligned wall foundation (**Figure 9; Plates 12, 21–22**). Group **2170** (composed of **2227/2280/2262/2221**) was at least 11.5m long by 0.85m wide and survived as two horizontal courses of red sandstone blocks to a height of 0.30m. The wall foundation was constructed with roughly hewn facing stones and a rubble core. At the western end of wall **2170** was the remains of small, possibly square structure, Group **2171**, 4m long (east–west) by 3m wide (north–south) and composed of 0.50m wide walls **2362**, **2229**, **2298** and **2373**, with foundation deposit **2363**. The junction of wall **2170** and structure **2171** had been strengthened by the addition of **2291**, acting as a possible buttress. Group **2171** had been truncated on its northern side by Phase 4 wall **2219** (in construction cut **2218**) and by large modern pit **2240** (Phase 7), and so its actual shape and size is unknown.

- 7.5.14 The interpretation of **2170** is difficult as it only survived as foundations with no associated floor surfaces, and so it is possible it is a simple garden wall leading to the small, possibly square structure **2171**. The interpretation of **2171** is also hampered by later truncation, however the size and shape is not dissimilar to dovecotes of the medieval period, though dovecotes of this period are predominately circular. A possible grander function to the structure may perhaps be inferred from the recovery of fragments of ‘Grisaille’ decorated glass, which was first used in the 12th century and became increasingly popular in the 13th century, which was incorporated into levelling deposits derived from the demolished Phase 2 building (see below).

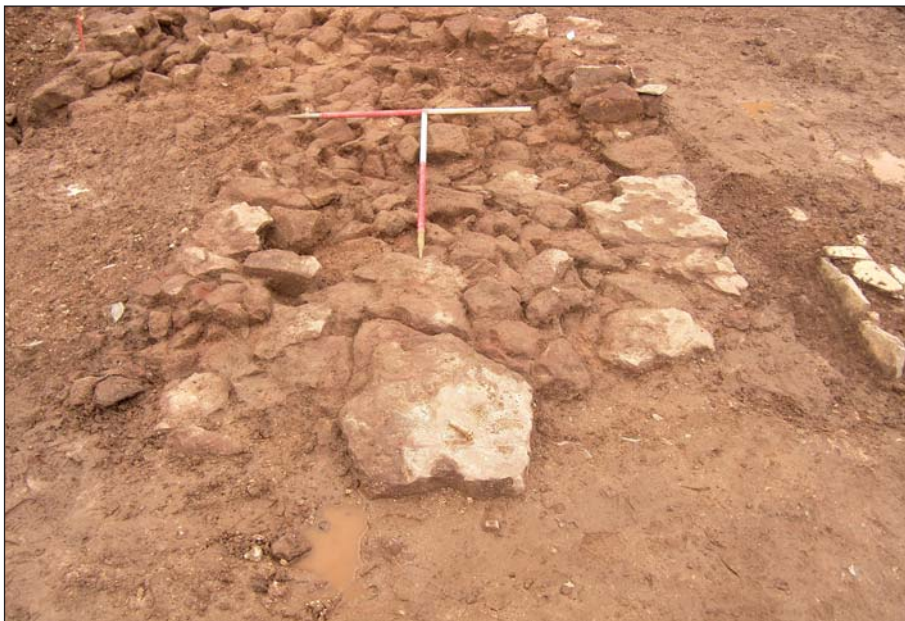
Plate 22: Building 2171. View from the west (scale 2 x 2m)

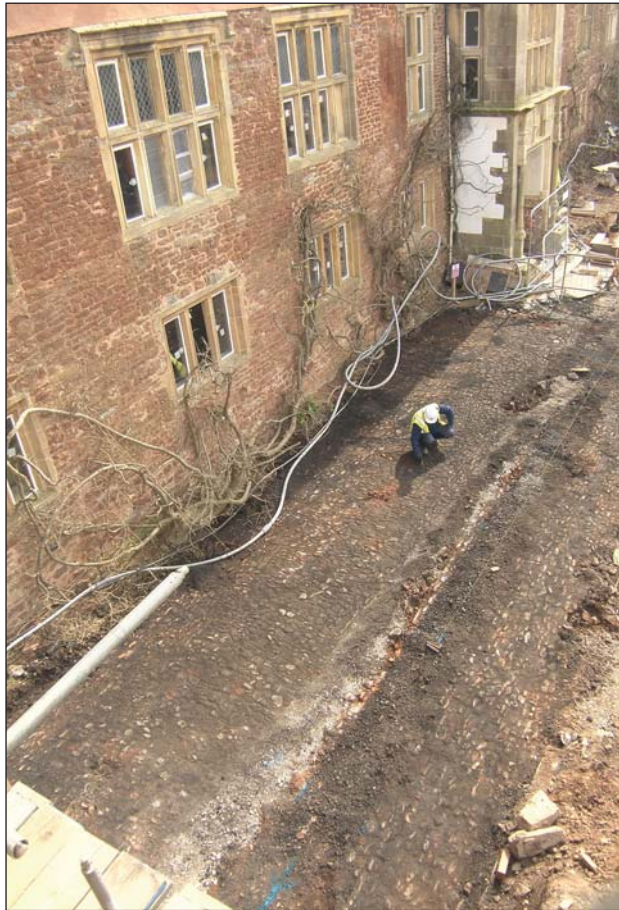
Plate 23: Watching Brief Area 3 (WBA 3).
Cobbled surface 2411. View from the north west

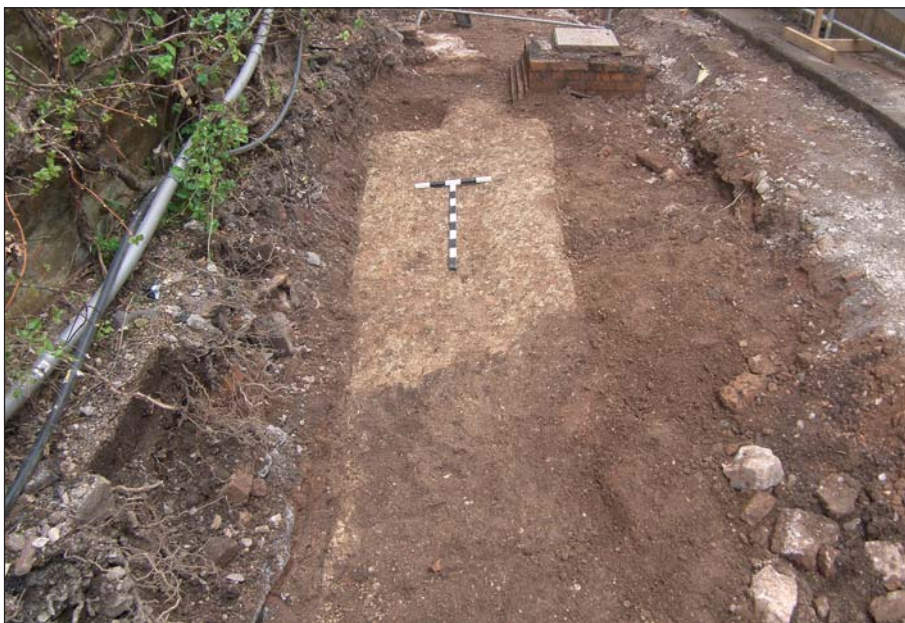
Plate 24: WBA 3. Rammed mortar surface 2479 and wall remnant 2481.
View from the north (scale 1m, 0.5m)

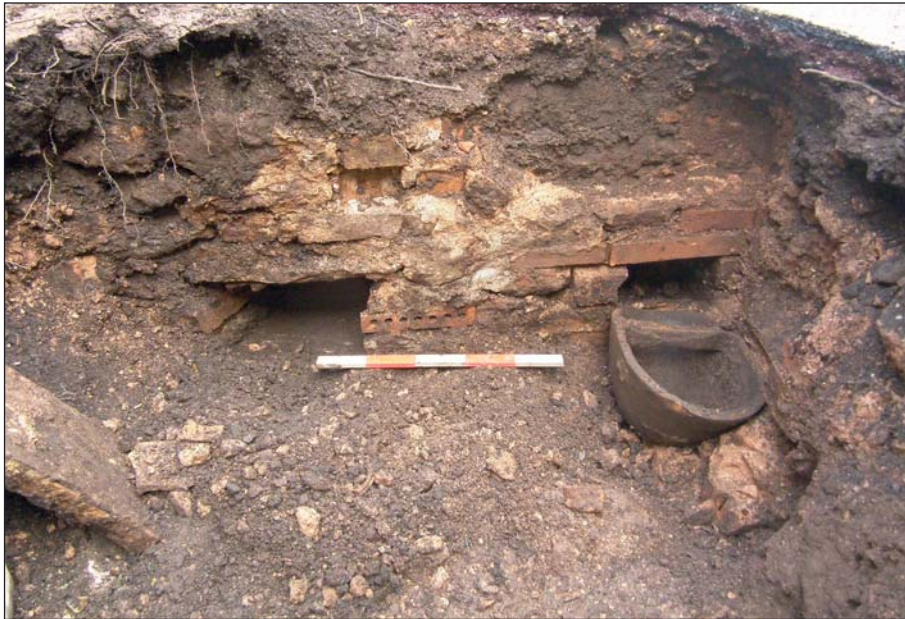
Plate 25: WBA 3. South-facing elevation of post-medieval silt trap 2543 (scale 0.5m)

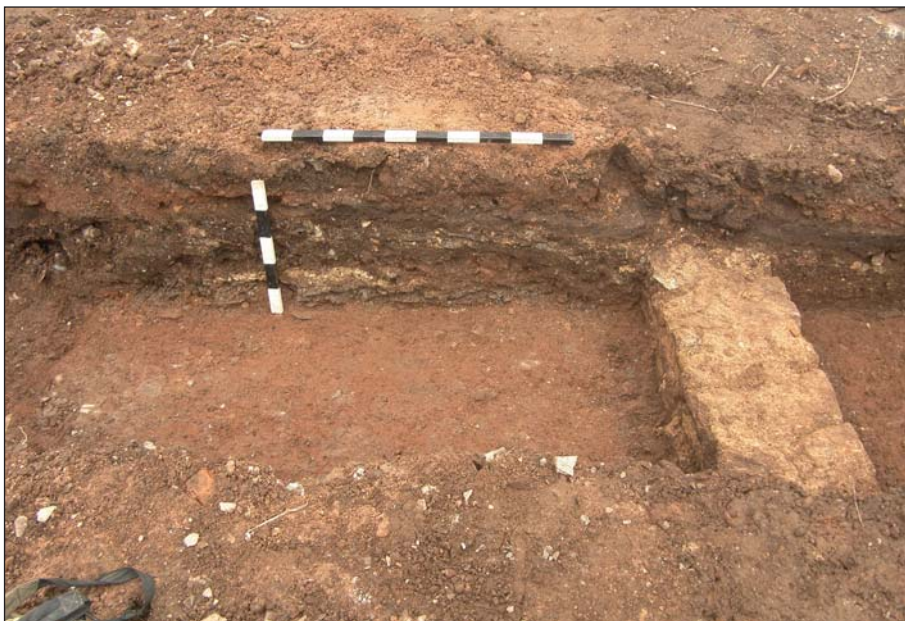
Plate 26: WBA 3. Wall 2491 from the south, with associated deposits. (scale 1m , 0.5m)

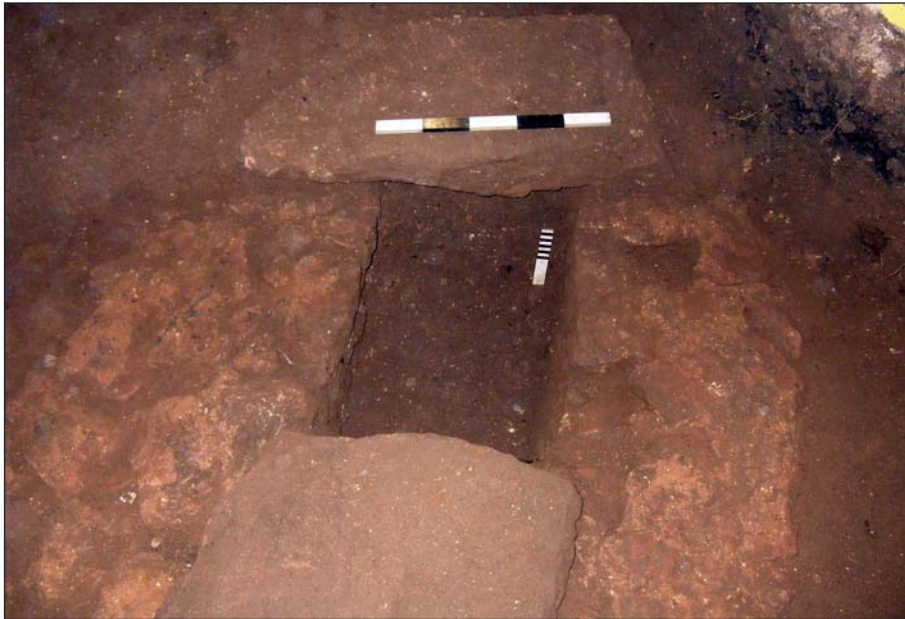
Plate 27: WBA 3. AK14 – culvert 2508. View from the south. (scale 0.5m, 0.2m)

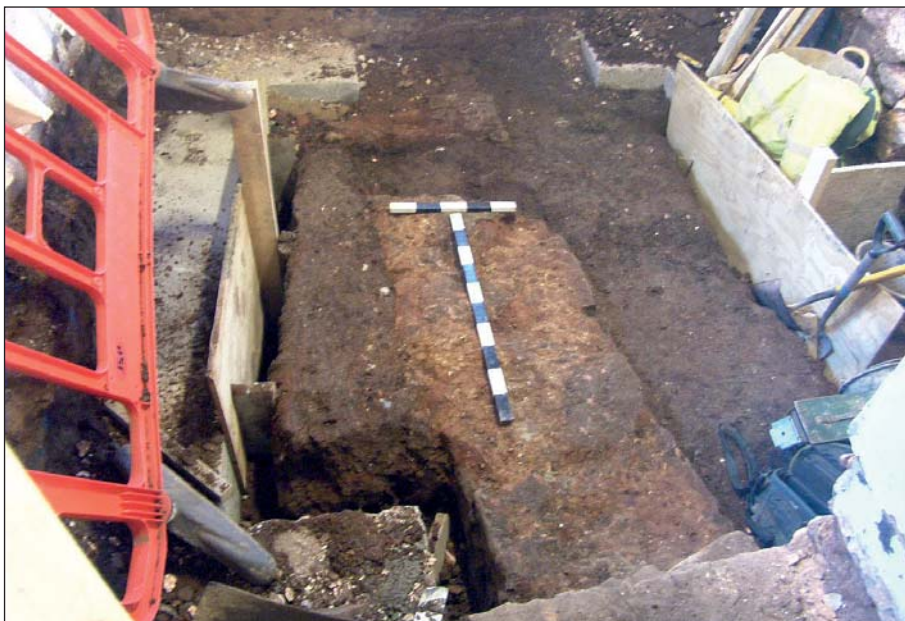
Plate 28: WBA 3: AK 15/16 – Wall 2382/2501/2504. View from the south (scale 1m)
