# The ‘Gresham Ship’: an interim report on a 16th-century wreck from Princes Channel, Thames Estuary

By JENS AUER and ANTONY FIRTH

*SUMMARY: The ‘Gresham Ship’ was found in Princes Channel by the Port of London Authority in 2003. Investigations culminated in the recovery in 2004 of the remains of a small to medium-sized armed merchant ship built soon after 1574, probably in East Anglia or Essex. The wreck provides archaeological evidence of the documented practice of ‘furring’ (rebuilding a ship to increase its breadth). The cargo included folded iron bars, lead ingots and tin ingots, and amongst the four recovered guns is a rare English early cast-iron saker, marked with the grasshopper motif and initials of Sir Thomas Gresham.*

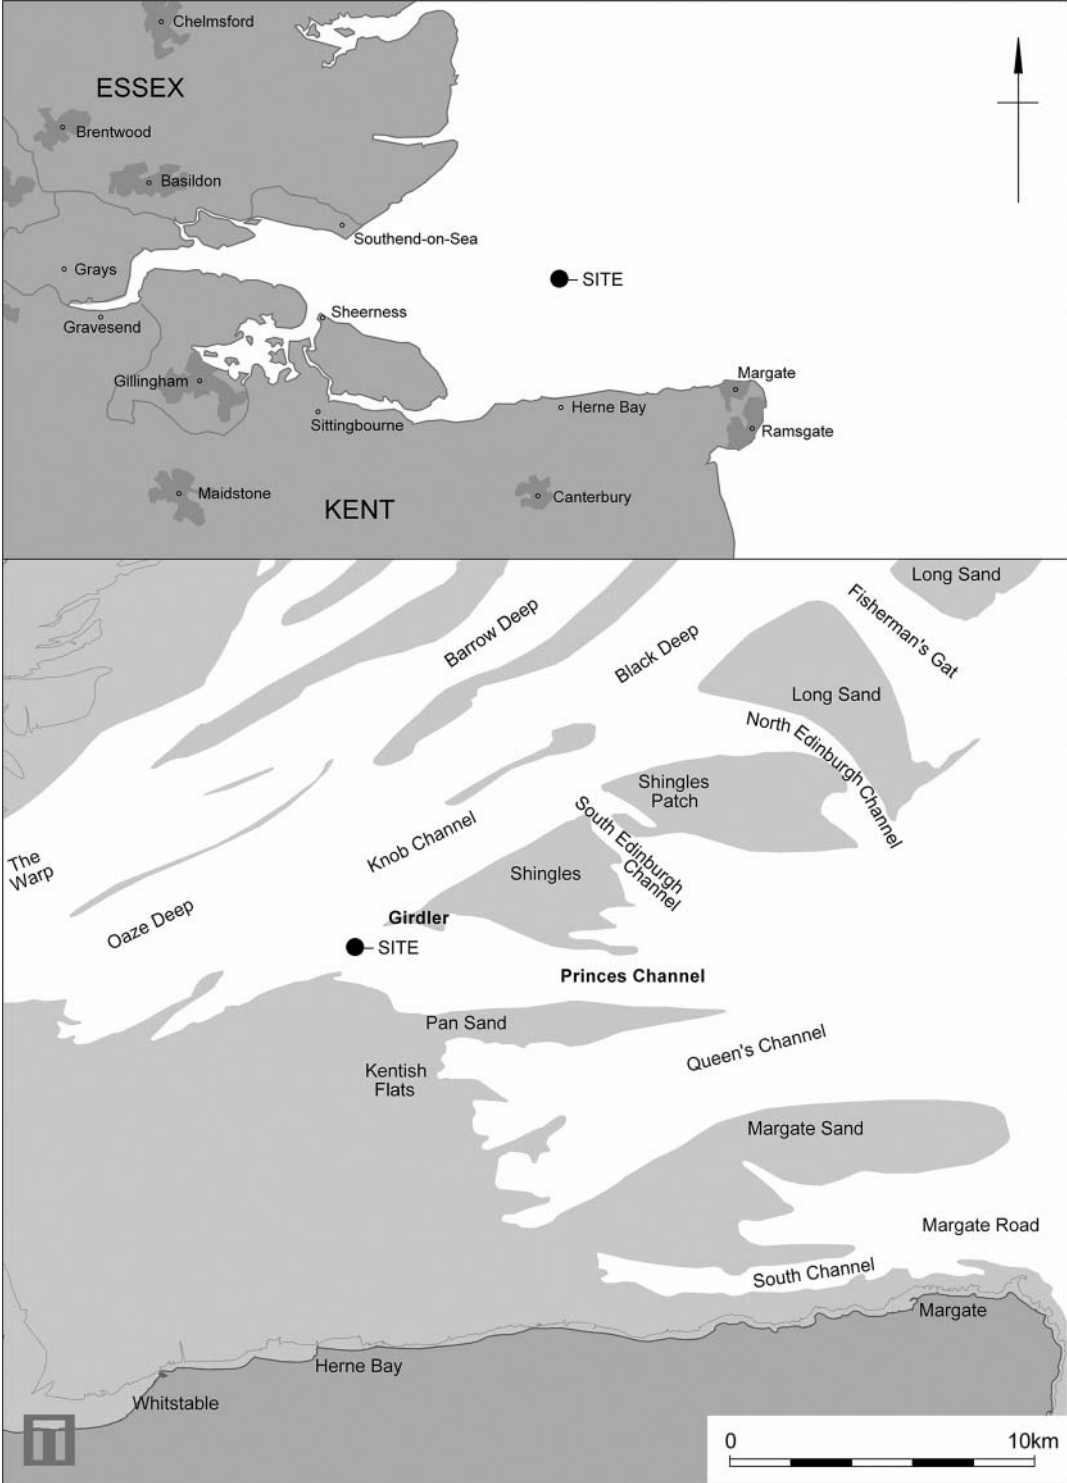
FIG. 1

The 'Gresham Ship': location of the wreck site, showing modern channels and sandbanks (drawn by Kitty Brandon, Wessex Archaeology).

Princes Channel runs east to west from about 11km north-north-east of Margate, Kent, towards Oaze Deep in the main Thames approach (Fig. 1). The wreck was located about 15km north-east of Whitstable in a shallower area of Princes Channel that lies between the sand banks of Kentish Flats and Girdler, on the southern edge of Shingles. The area is charted at 5–6m below Chart Datum (c. 7–9m below OD),<sup>2</sup> the depth on site typically varying between 7m and 10m depending on the

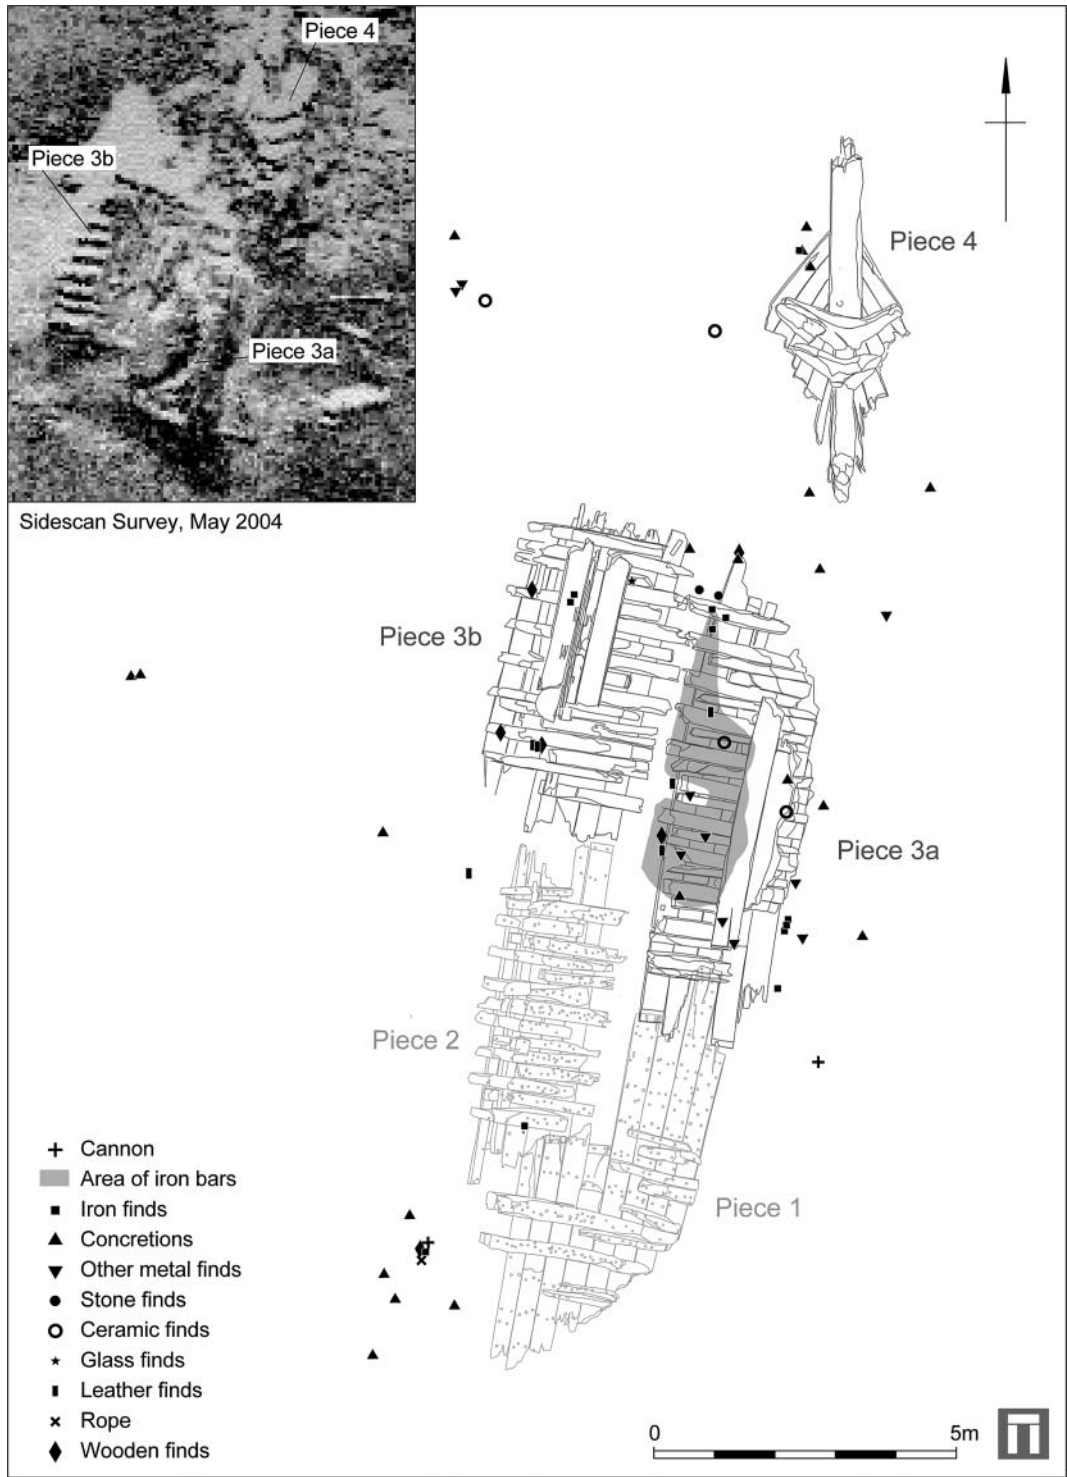
FIG. 2

The 'Gresham Ship': underwater site plan based on diver measurements and land-based recording of the timber sections (drawn by Kitty Brandon, Wessex Archaeology).

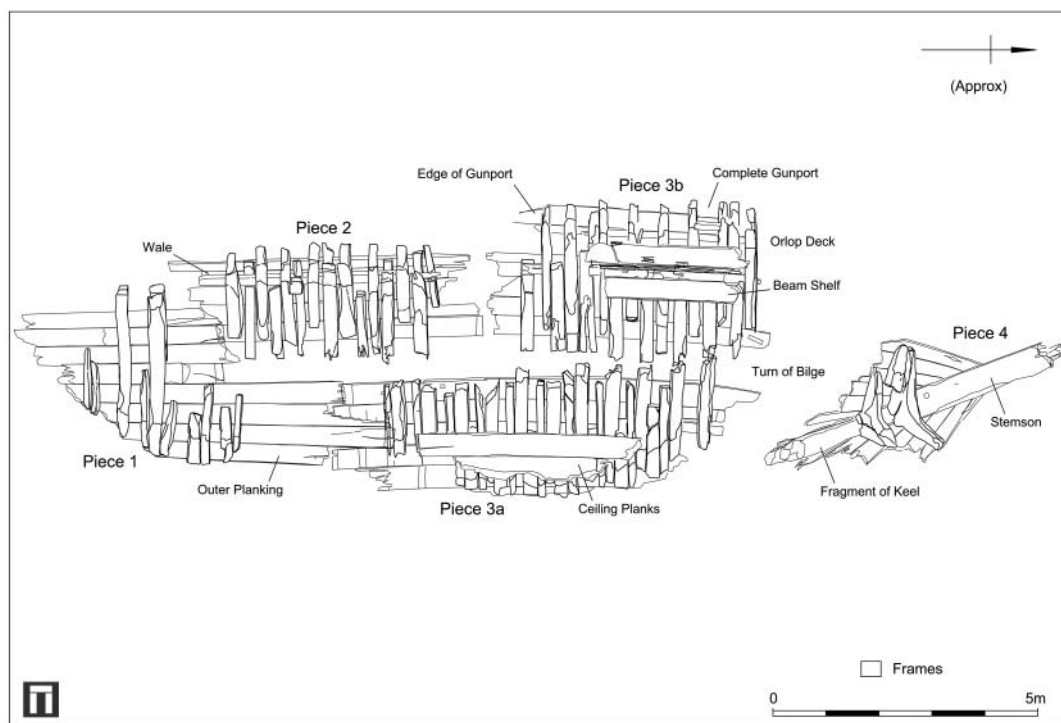
FIG. 3

The 'Gresham Ship': overview of the preserved hull sections of the wreck (drawn by Kitty Brandon, Wessex Archaeology).

Altogether, five coherent hull sections of the Gresham Ship are preserved. They include the bow section of the wreck and an approximately 14m-long run of the port side, from above the keel to a level above the orlop deck (Fig. 3). All sections are of oak. The vessel was carvel-built; an outline

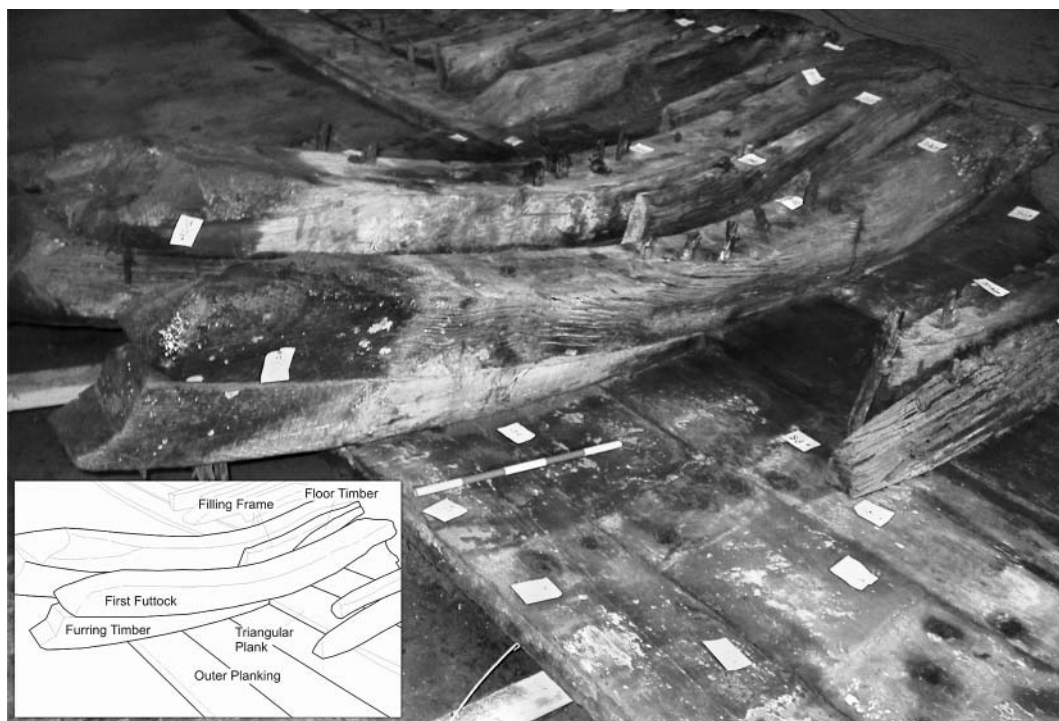
FIG. 4

The 'Gresham Ship': furring timber on first futtock, Piece 1 (photograph, Jens Auer, Wessex Archaeology).

The most noticeable feature in the construction of the 'Gresham Ship' is a doubling of all framing timbers from the turn of the bilge upwards. The double frames taper from their full moulded dimension to c. 50mm. They rest on a plank, triangular in section, which fills the gap between the heel of the outer framing timber and the surface of the first futtock and thus provides a smooth surface for the application of outer planks (Fig. 4). The purpose of the double framing was not fully understood until the explanation of the term 'furring' was found in Sir Henry Mainwaring's *Seaman's Dictionary*, which was composed c. 1620–23:

The 'Gresham Ship' was furred, presumably either during the construction process or shortly thereafter. The original outer planking was removed and a second layer of framing timbers added. On the level of the orlop deck above the waterline, further chocks were inserted at intervals between original frames and furring timbers to achieve the desired moulded dimension. The original wale was left *in situ* between original frames and furring timbers and served as a stringer

to increase longitudinal strength. The triangular-sectioned plank closed the gap between furring timbers and frames and allowed re-planking of the hull. As a result of the furring process the vessel gained *c.* 300mm in width on each side. This increase in fullness is also reflected in the stem rabbet, where filling pieces were used to change the angle of the rabbet and accommodate the hood ends of the planks.

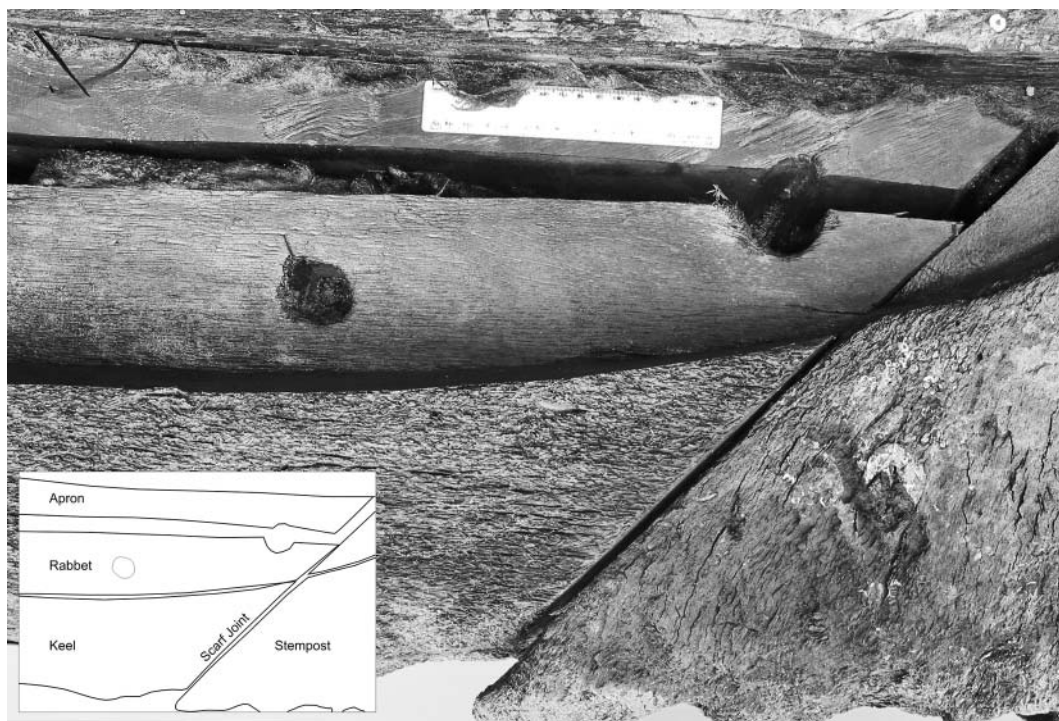
FIG. 5

The 'Gresham Ship': scarf joint between keel and stempost (photograph, Jens Auer, Wessex Archaeology).

Only a 1.82m-long fragment of the forward end of the keel is preserved (Fig. 5). One end is joined to the stempost with a flat vertical scarf joint; the other is broken. The keel is made of oak and is heavily eroded; moulded and sided dimensions appear to be *c.* 250–300mm. The upper 90mm of the moulded dimension is occupied by rabbets between 60 and 65mm deep. In addition to treenails and iron bolts securing the scarf joint, four vertical treenails were observed in the moulded side of the keel fragment. Their function is as yet unclear.

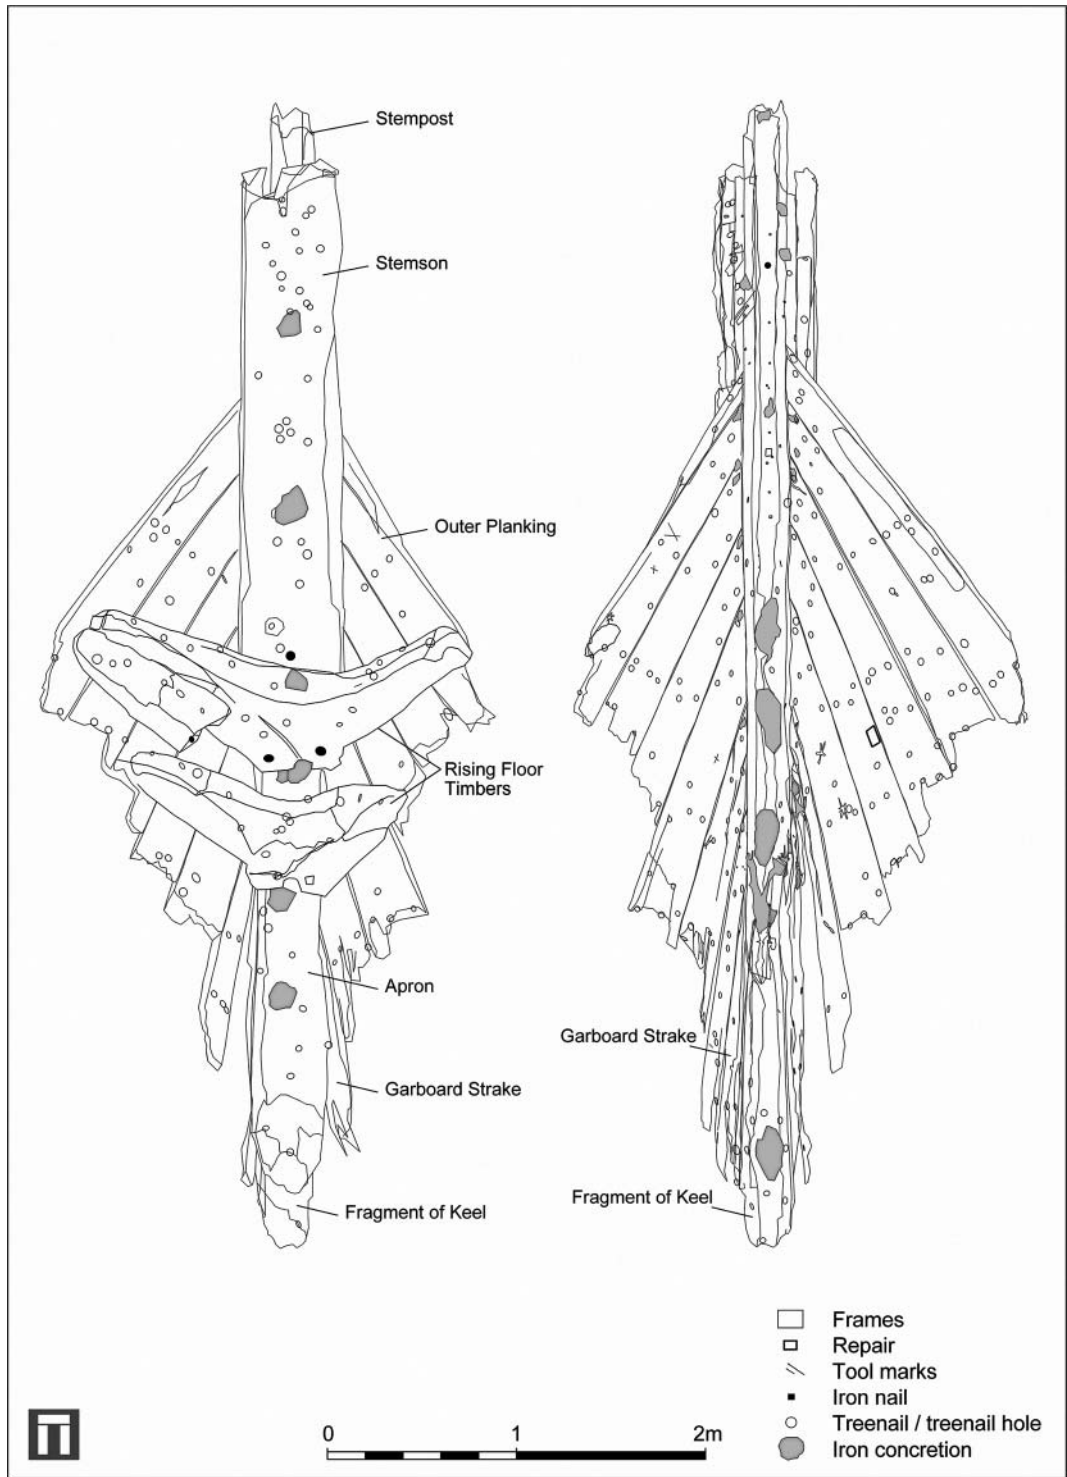
FIG. 6

The 'Gresham Ship': inside view and front view of the bow section (drawn by Kitty Brandon, Wessex Archaeology).

The bow section, termed Piece 4, has a height of 4.9m and a length of 2.2m. It consists of a fragment of the keel which is joined to the stempost. Stemson and apron are partly preserved. Two V-shaped square rising floor timbers are *in situ* on the inside of the section and a single futtock survives on the port side. Broken treenails and treenail holes indicate the positions of further frames, as well as breasthooks. Seven strakes of outer planking, including the garboard strake, are present on the starboard side. As this side was covered by sediment, the planks are well preserved and still show signs of a white protective surface covering. The port side is less well preserved, with six heavily eroded strakes from the garboard upward *in situ*.

The preserved part of the stempost has a total length of 4.86m (Fig. 6). The upper part of the post shows signs of a fresh break, while the heel is joined to the keel. The post has an average sided dimension of 200–250mm on the outside and 250–350mm on the inside. The average moulded dimension is 300mm. The stem rabbets are located between 120mm and 150mm from the outside of the post. They have an average depth of 65–70mm and an angle of *c.* 36 degrees. In the lower part of the post, the hood ends of a series of outer planks are fastened in the rabbet with a combination of tree-nails and iron nails. Toolmarks and cut treenails show that the rabbet angle was modified to reflect the ship's increase in fullness caused by furring. The stemson is fastened to the inside of the stempost with treenails and iron bolts. The visible length is 3.08m; the sided dimension on the inside is 550mm. The moulded dimension is *c.* 250mm. Filling pieces were used to close the gap between post and stemson and provide a smooth surface for planking. All elements of the bow are made of oak. As this section was left assembled, the apron and

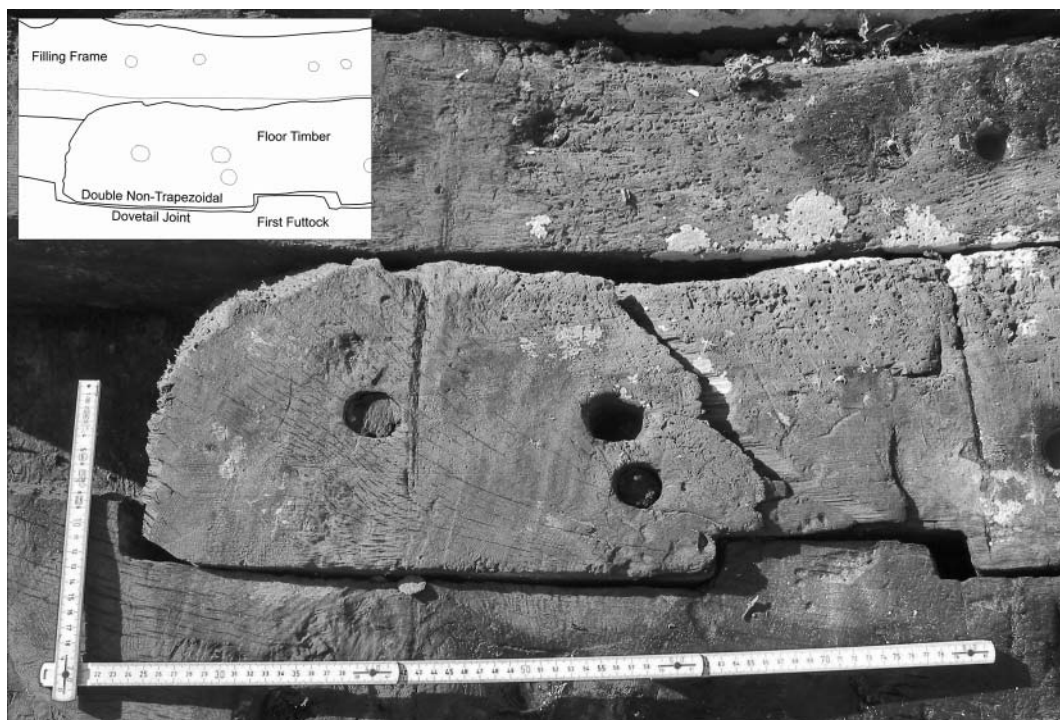
FIG. 7

The 'Gresham Ship': non-trapezoidal dovetail joint between floor timber and first futtock on Piece 3a (photograph, Jens Auer, Wessex Archaeology).

All frames are of oak; they were either sawn or converted with an axe and then dubbed with an adze. Floor timbers, first futtocks and second futtocks, as well as filling frames, are preserved. While the size of the main framing components is fairly consistent, with average moulded and sided dimensions between 150 and 250mm, the filling frames at the turn of the bilge have sided dimensions of only 100–150mm. Floor timbers and first futtocks are joined with double or single non-trapezoidal dovetail joints (Fig. 7), secured with a single treenail through the centre of the joint. First and second futtocks and filling frames are not connected to other framing components.

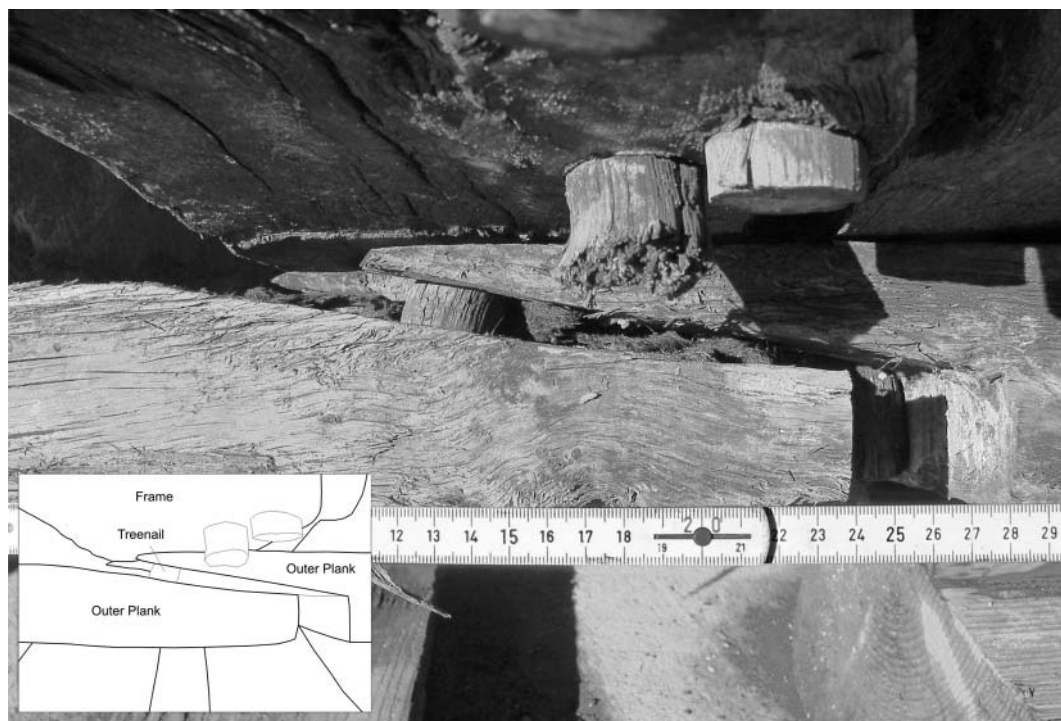
FIG. 8

The 'Gresham Ship': a vertical scarf joint between two outer planks (photograph, Jens Auer, Wessex Archaeology).

70mm. All outer planks are joined with flat vertical scarf joints which are secured with treenails and up to four square-shanked iron nails (Fig. 8). The plank seams are waterproofed using a type of setwork rather than caulking. The lower edges of outer planks have been furnished with V-shaped or U-shaped hollow grooves which are filled with three strands of tarred animal hair. All knots in outer planks have been carefully removed and replaced with small wooden patches fastened with miniature treenails, or in some cases iron nails. On well-preserved planks, a white or cream-coloured surface covering could be observed, possibly so-called 'white stuff'.<sup>11</sup>

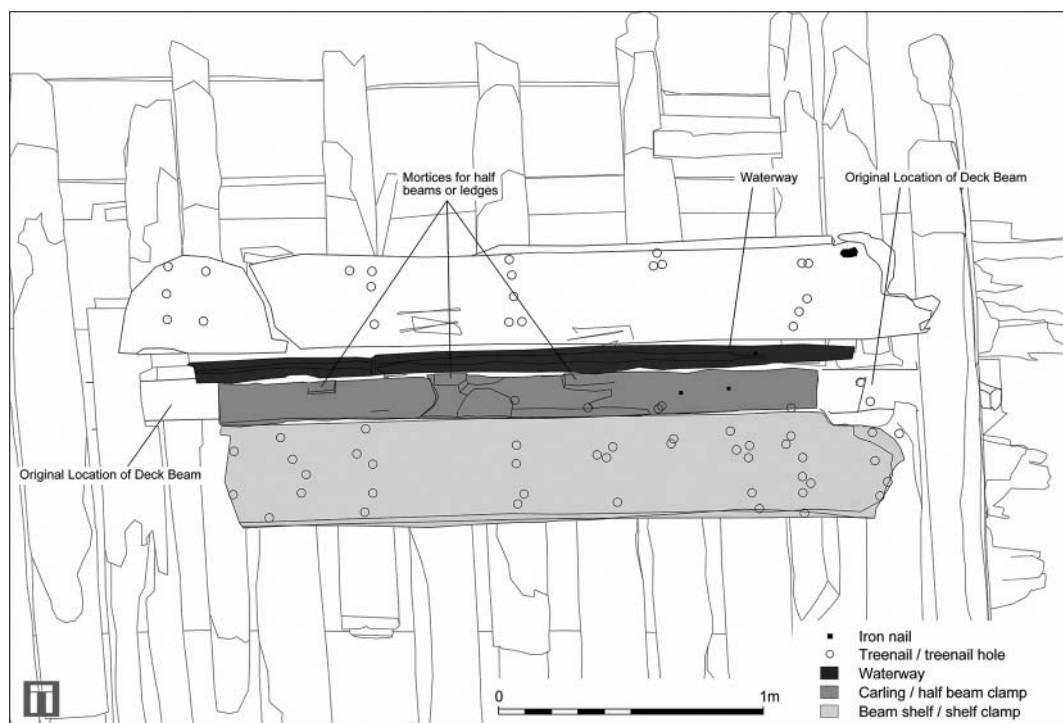
FIG. 9

The 'Gresham Ship': elements of the orlop deck construction on Piece 3b (drawn by Kitty Brandon, Wessex Archaeology).

The construction of the orlop deck is visible on Piece 3b (Fig. 9). Recesses show where two deck beams measuring  $0.20 \times 0.20\text{m}$  rested on the shelf clamp. A 2.34m-long half beam clamp or carling is set between the beams. Mortises of varying size, spaced 0.36m apart, indicate the positions of half-beams or ledges. The edge of the waterway is preserved above the carling. No evidence for hanging knees could be found and it is currently assumed that the deck construction was reinforced with the help of lodging knees.

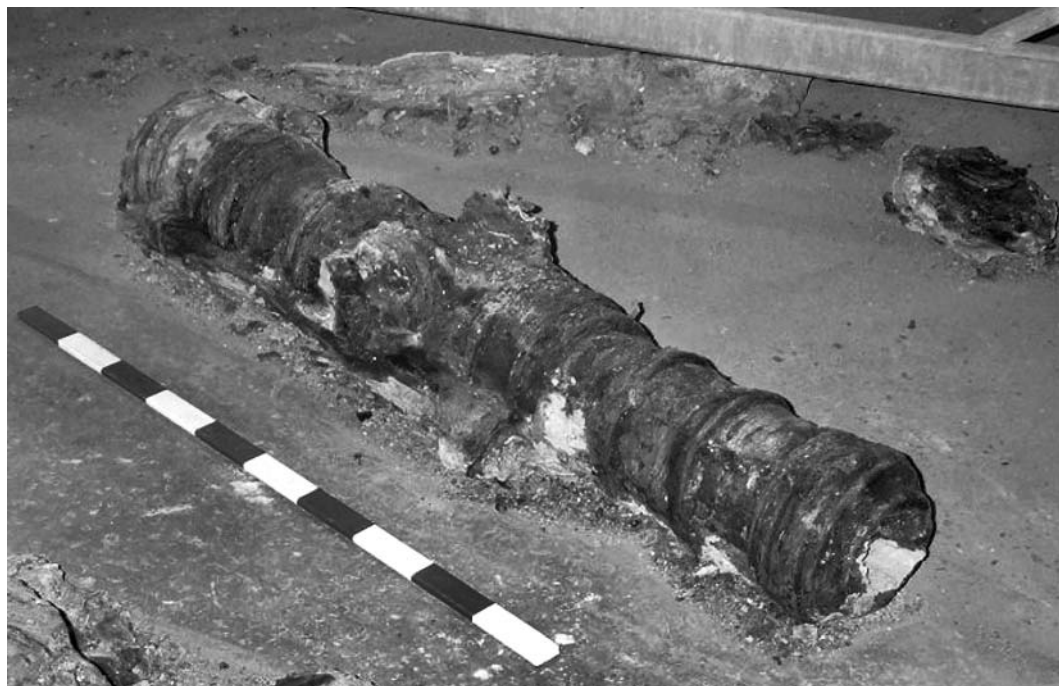
FIG. 10

The 'Gresham Ship': wrought-iron gun (photograph, Mikkel Thomsen, Wessex Archaeology).

Altogether, four guns were recovered from the site. A wrought-iron breech loader (Fig. 10) was found among the grabbed material. It was well preserved in a heavy concretion, which was partly removed. Two lifting rings are positioned centrally on the barrel of the gun, one of which preserves remains of cordage, and another piece of cordage was wrapped around the muzzle end. Near the breech end, and in front of the lifting rings, are pairs of straps for riveting the barrel to the wooden carriage. Fragments of the carriage are preserved in the concretion. The gun is 1.24m long and has a 0.13m bore. The wrought iron breech chamber is 0.37m long and had an apparent calibre of 75mm. The touch-hole is trapezoidal and was fashioned from two iron sheets.

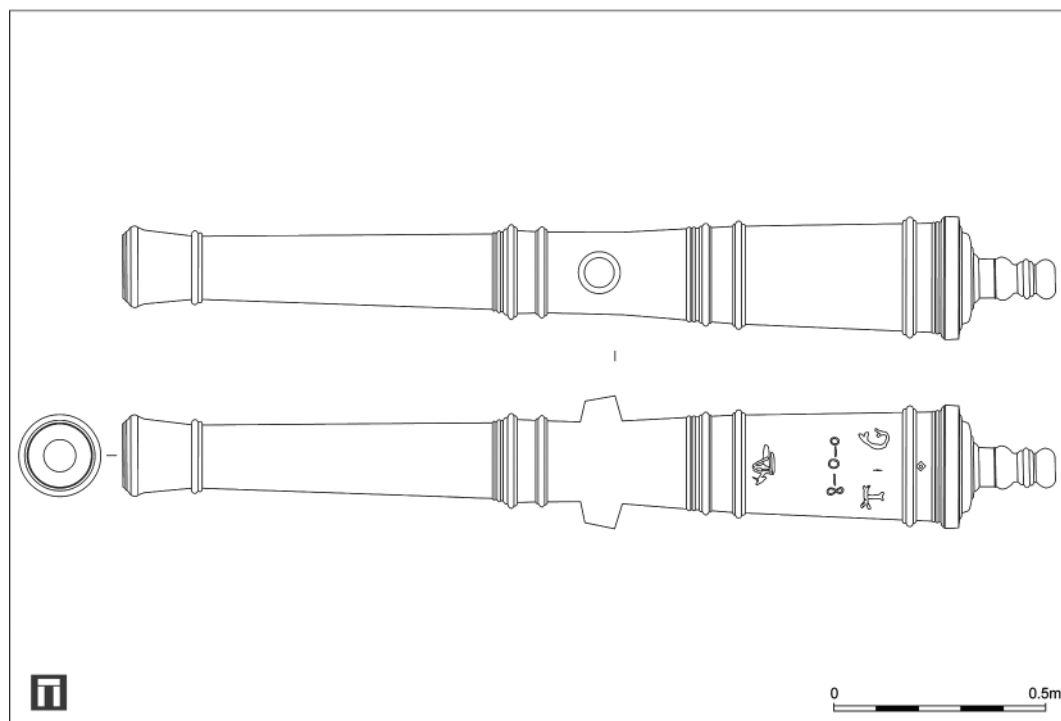
FIG. 11

The 'Gresham Ship': the small saker founded by Thomas Gresham (drawing, Frank Mallon, Jens Auer and Kitty Brandon, Wessex Archaeology).

remains heavily concreted; it is *c.* 2.3m long and has a 80mm bore. The second, 2.2m long and with a bore of 76mm, has been recorded in more detail. Its first reinforce is marked with the moulded initials 'TG', the incised numbers '8-0-0' and the moulded emblem of a grasshopper (Fig. 11). The initials and emblem allow the identification of the founder, the Elizabethan financier and merchant Sir Thomas Gresham, who owned a gun foundry in Mayfield in the Weald from 1567 to his death in 1579. He was involved in arms export and is known to have founded guns for the King of Denmark and others.<sup>12</sup> The number '8-0-0' specifies the weight as 8cwt [406kg]; the gun is a rare example of an early English small saker.<sup>13</sup> Adjacent to one of the guns, parts of an elm gun carriage were found.

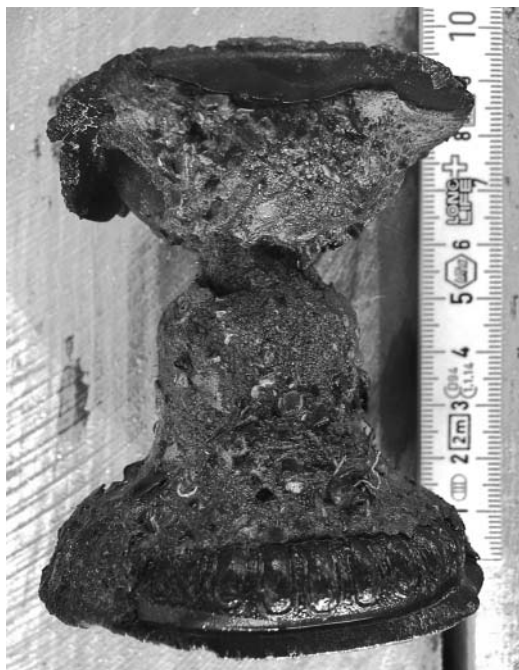
FIG. 12

The 'Gresham Ship': pewter candle-holder (photograph, Jens Auer, Wessex Archaeology).

Most of the small finds recovered from the wreck site are still concreted and awaiting treatment. Notable among them are a pewter candle-holder (Fig. 12), leather shoes and parts of leather garments (Fig. 13), a wooden pike shaft with iron head and a fragment of a Spanish olive jar.

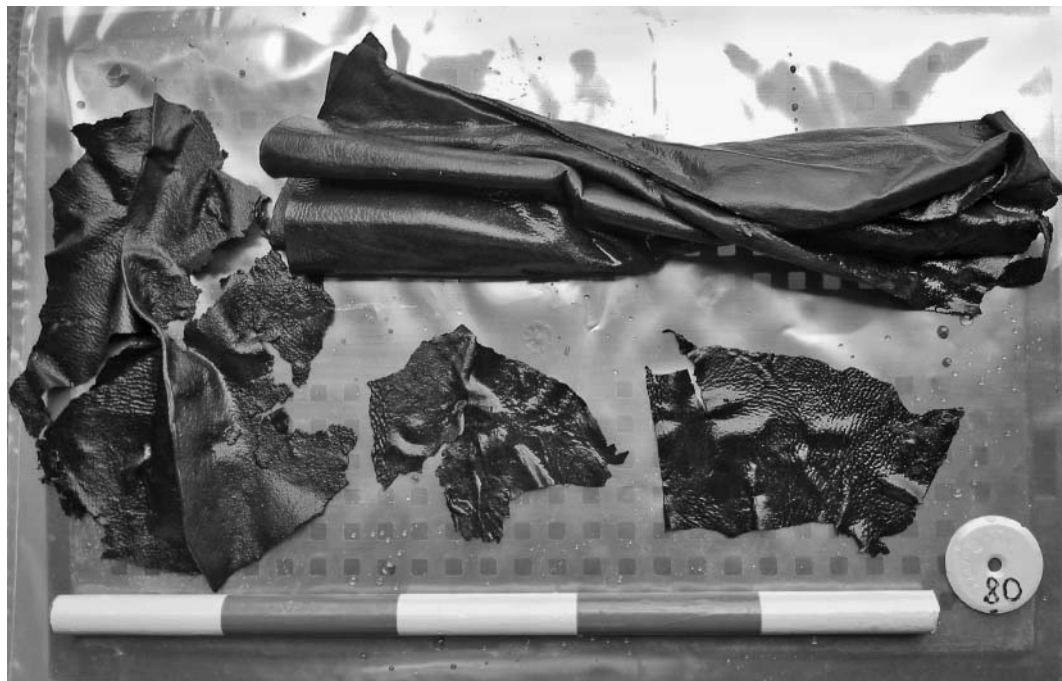
FIG. 13

The 'Gresham Ship': parts of leather garment (photograph, Jens Auer, Wessex Archaeology).

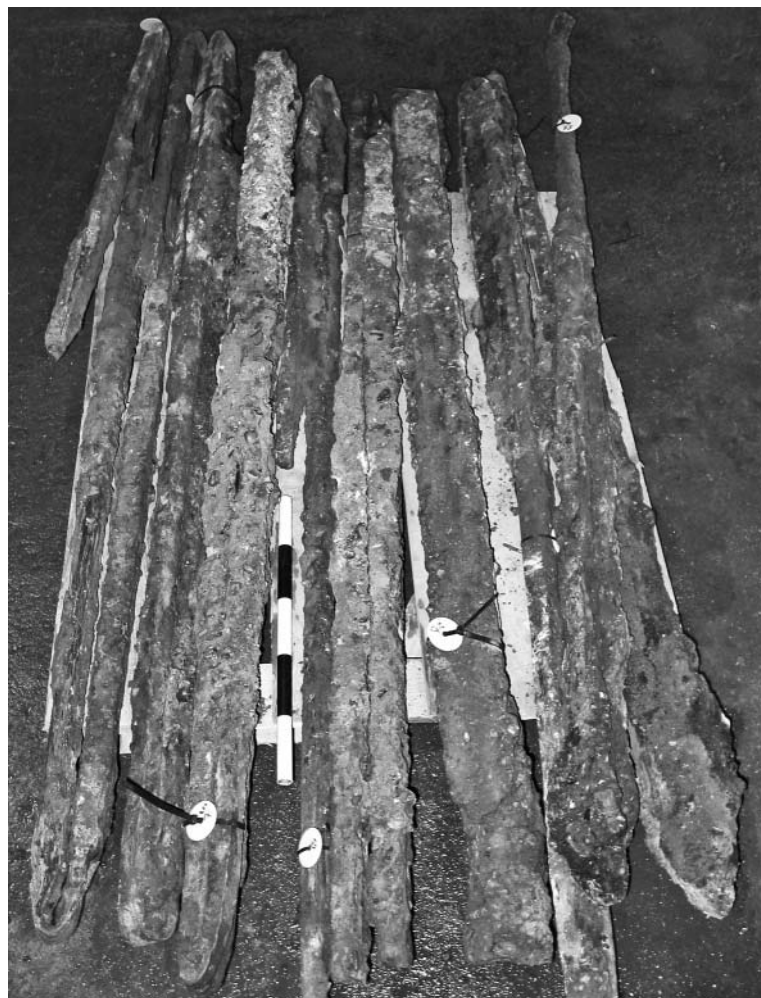
FIG. 14

The 'Gresham Ship': examples of iron bars (photograph, Jens Auer, Wessex Archaeology).

The ship's cargo consisted of iron bars and ingots of lead and tin. While other cargo might have been present, no archaeological evidence for this has yet been found. Two types of iron bar were found (Fig. 14). The first is narrow with a square section of 30 × 30mm, folded four times to lengths between 1.9m and 2m, with an unfolded length of 6m. The

second type has a rectangular section of  $30 \times 80\text{mm}$  and is folded once at the centre. The origin of the iron bars has not been identified.

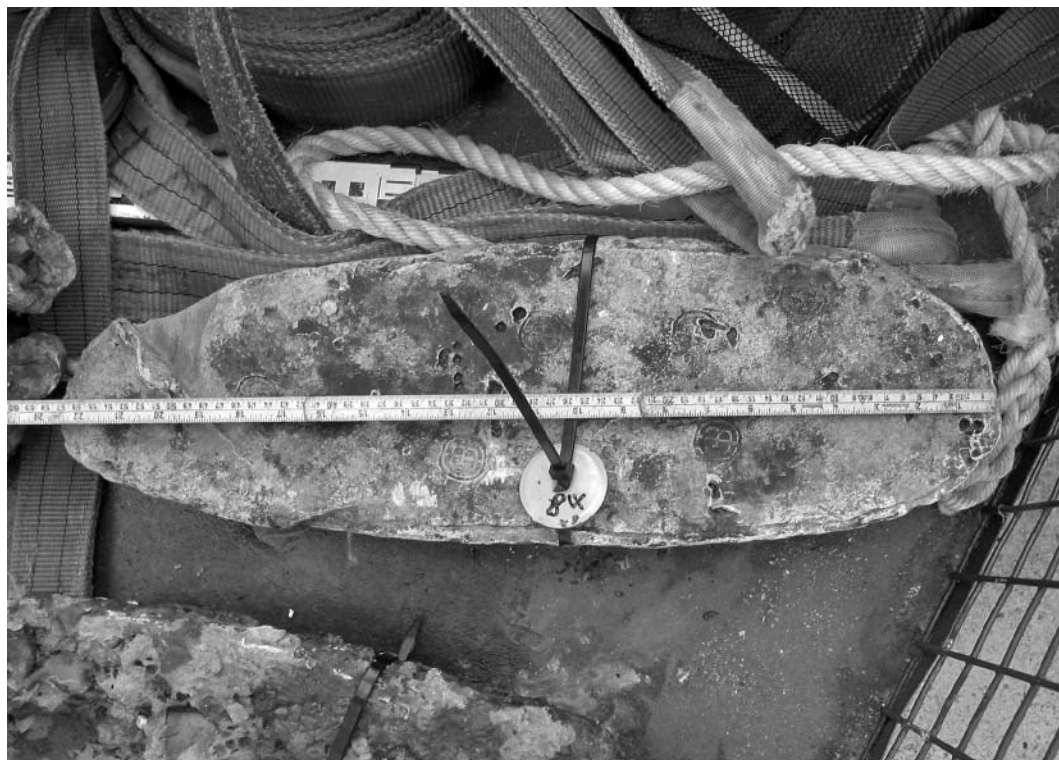
FIG. 15

The 'Gresham Ship': example of lead ingot, with marks (photograph, Jens Auer, Wessex Archaeology).

The lead ingots are boat-shaped (Fig. 15). They measure  $c. 600 \times 220 \times 120\text{mm}$  and have an average weight of 56kg. The upper surface of each ingot has been stamped up to seven times, presumably with a maker's mark. Their provenance is unknown.

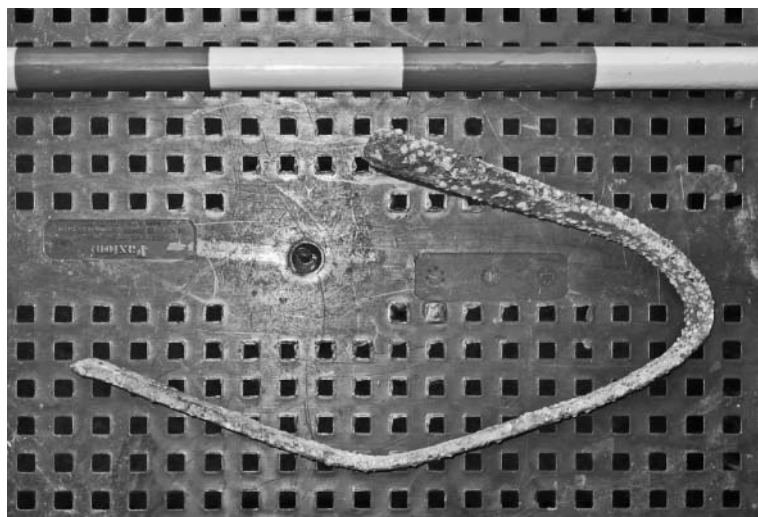
FIG. 16

The 'Gresham Ship': example of tin ingot (photograph, Jens Auer, Wessex Archaeology).

The tin ingots (Fig. 16) measure  $520 \times 16\text{--}18\text{mm}$  and have a trapezoidal cross-section. Their provenance is also unknown.

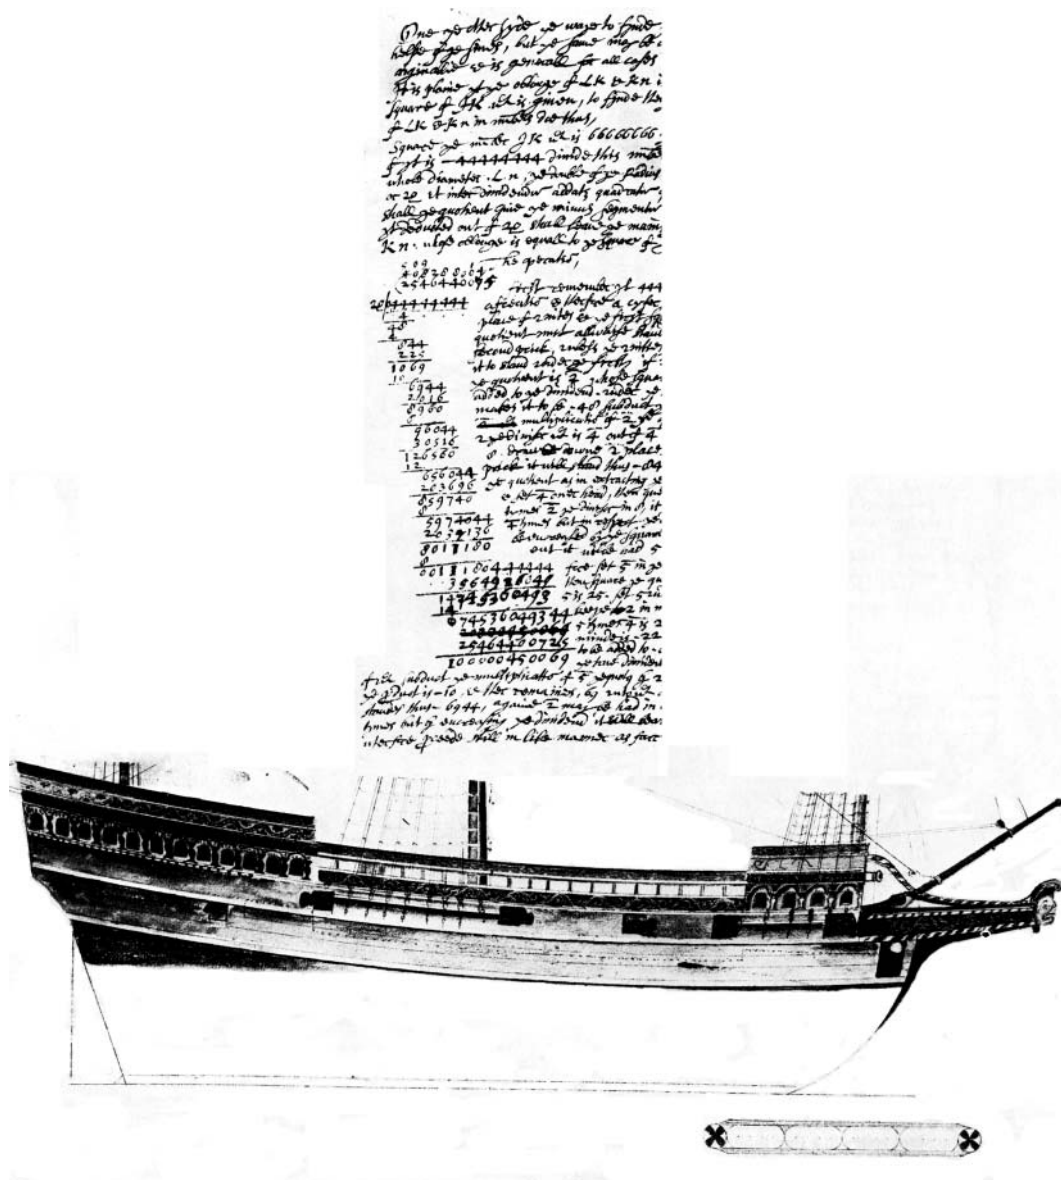
FIG. 17

The 'Gresham Ship': drawing of the ship *Emanuel* from 'Fragments of Ancient English Shipwrightry' (© Pepys Library, Magdalene College, Cambridge).

method. The vessel was subject to 'furring', possibly during the initial construction process. This resulted in an increase in fullness of  $c. 300\text{mm}$  on either side of the ship. Archaeological evidence suggests that the vessel was a small- to medium-sized ocean-going armed merchantman. The lowest deck in the ship, the orlop deck, also served as a gun deck. While a full hull analysis and reconstruction of the ship are still outstanding, the preserved hull sections allow a preliminary estimate of its original size. Currently a keel length of 15–20m and a tonnage of  $c. 150\text{--}250$  tons are assumed. More specific statements will only be possible after a detailed study of the hull remains. The depiction of the small merchantman *Emanuel* of 200 tons with a beam of 26ft [7.92m], in Matthew Baker's 'Fragments of Ancient English Shipwrightry'<sup>14</sup> can serve as a model for the original appearance of the 'Gresham Ship' (Fig. 17).
